Subject: 2016 Annual Monitoring Report
Love Ranch Evaporation Pond Dam
Construction File Number: C-1881
Water Division 6, DAMID: 430220

2016 ANNUAL REPORT

LOVE RANCH 8 EVAPORATION POND (SWD POND) RIO BLANCO COUNTY, COLORADO

2016 ANNUAL REPORT
LOVE RANCH 8 EVAPORATION POND (SWD POND)
LTE Project Number: 012916016

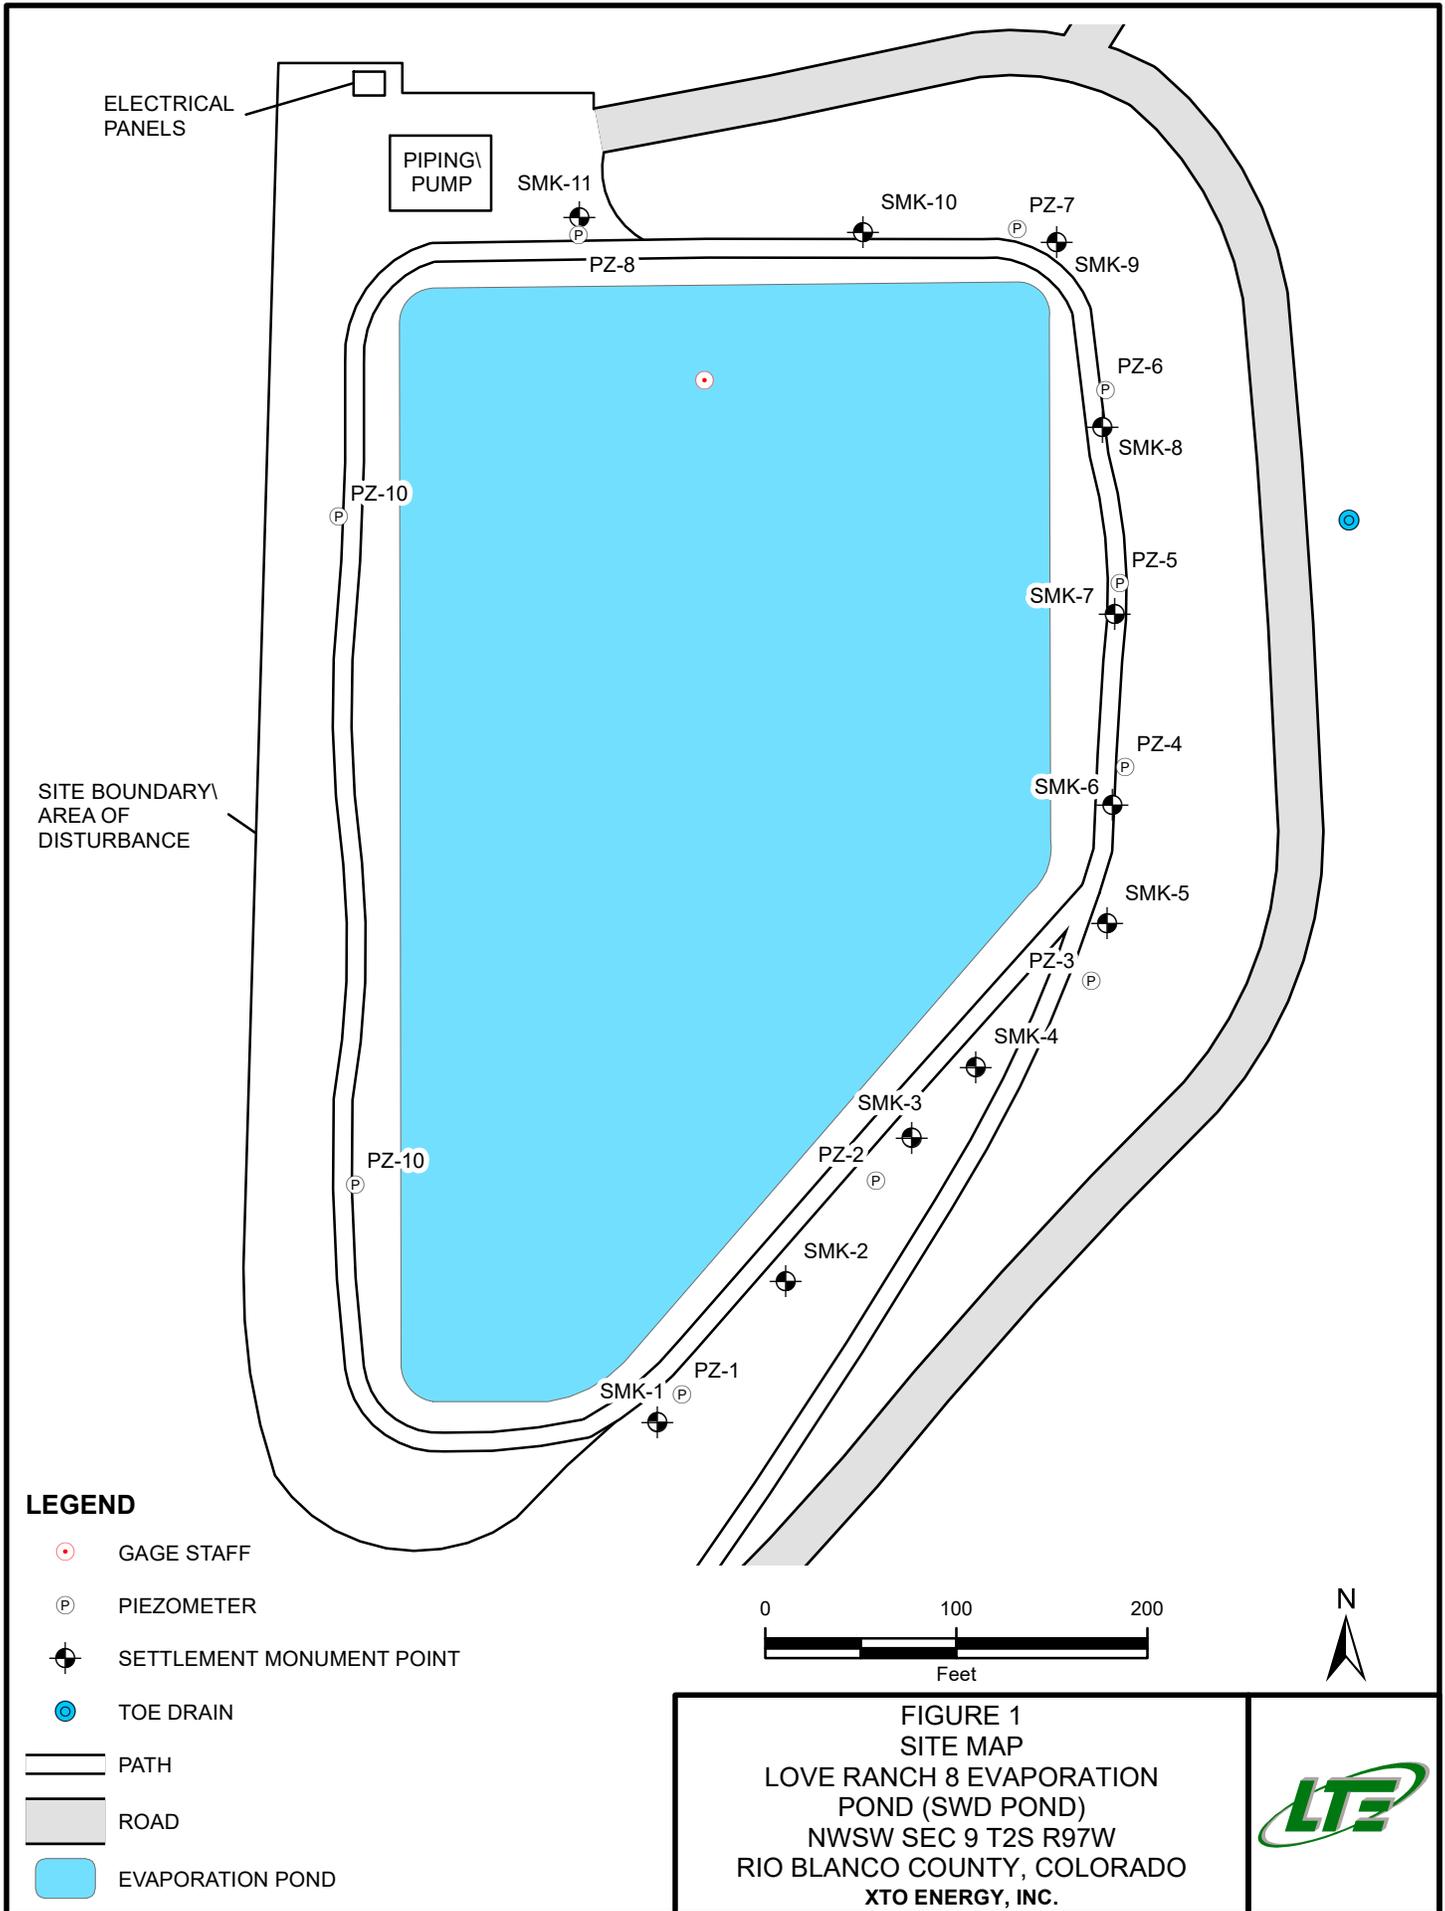
FIGURE 1 – SITE MAP

The quarterly 2016 field monitoring of the piezometers (PZ-1 through PZ-10) indicated trace to no presence of water. Figure 1 depicts the locations of the 10 piezometers and the attached Table 1 presents the piezometer 2016 and historical inspection data.
