Stormwater Inspection

March 21, 2017

Operator: EXTRACTION OIL & GAS LLC - #10459

Inspection Photos
Location Name: Kennedy /18-D Pad
Location ID: 439079

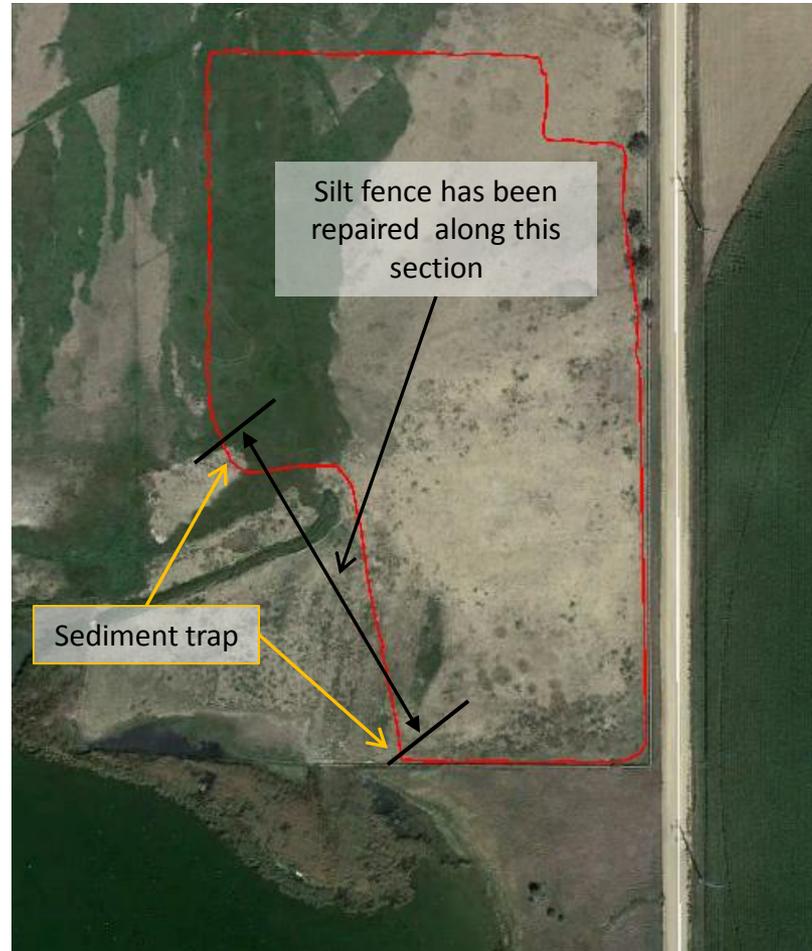
Google Earth aerial photo taken 9/7/2016 illustrating the Kennedy location in relation to Newell Lake to the southwest. Silt fence BMP has been repaired which appears to be in proper functioning condition. Two (2) sediment traps were haphazardly installed and do not appear to be in proper functioning condition. Additionally, S-fence BMP was installed but portions were not properly installed and do not appear to be in proper functioning condition.

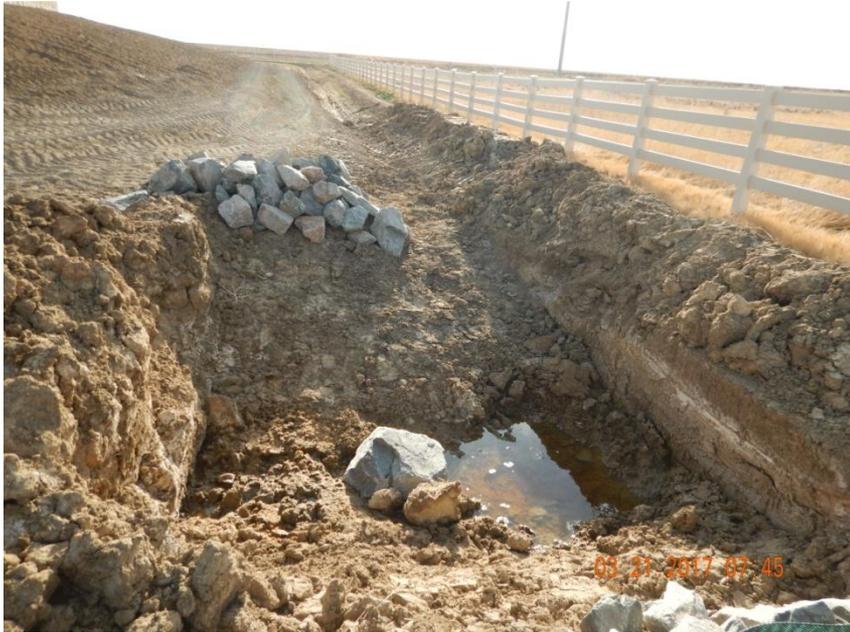
Photo 1. Photo taken from the southwest sediment trap, facing East. Ground water encountered while constructing the sediment trap. Rip rap installed for both inlet and outlet protection has not been installed properly. Unconsolidated soil material dug out from the sediment trap has not been properly compacted.

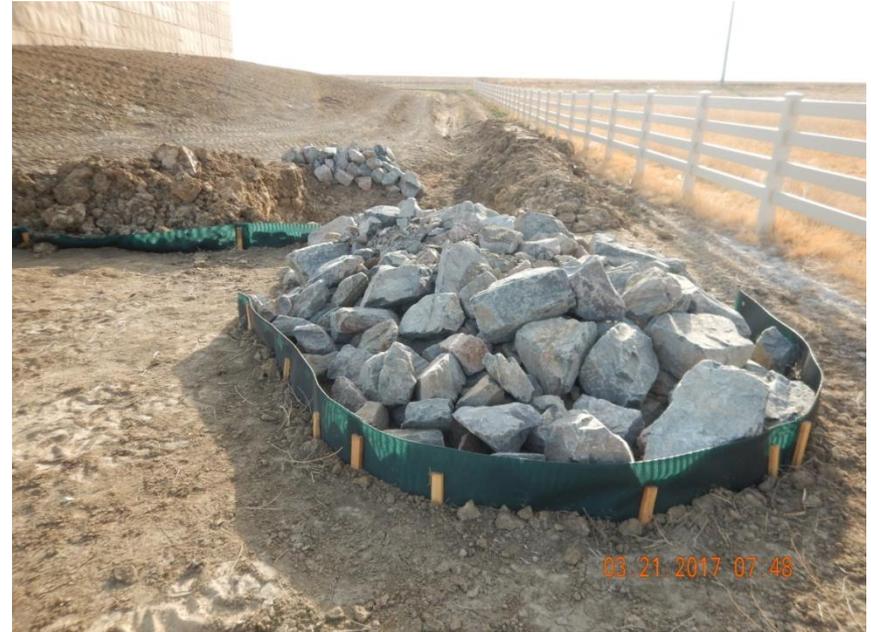
Photo 2. Photo taken from the southwest sediment trap, facing East. Appears this is supposed to serve as outlet protection but it does not connect with the outfall area of the sediment trap. Appears the rip rap was dumped at location without properly installing the BMP to even be a functioning part of the sediment trap.

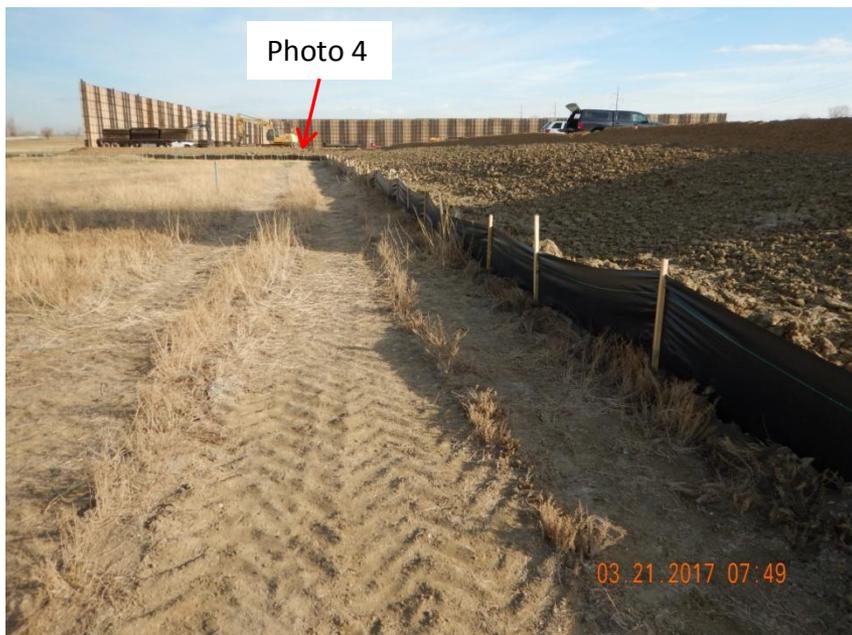
Photo 3. Photo taken from the southwest location, facing North. Silt fence BMP has been repaired and appears to be in proper functioning condition.

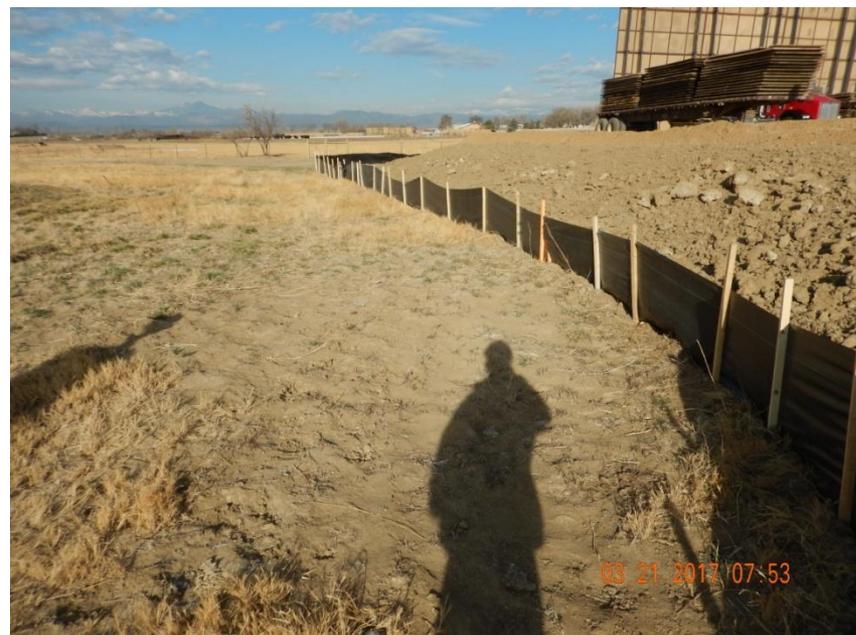
Photo 4. Photo taken from the southwestern location, facing West. Silt fence BMP has been repaired and appears to be in proper functioning condition.

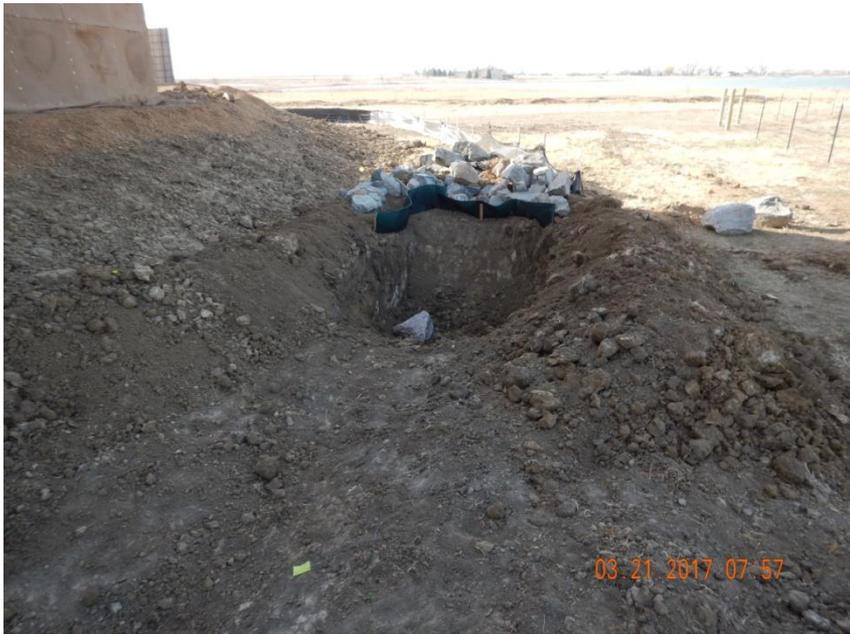
Photo 5. Photo taken from the western sediment trap, facing South. Unconsolidated soil material dug out from the sediment trap has not been properly compacted.

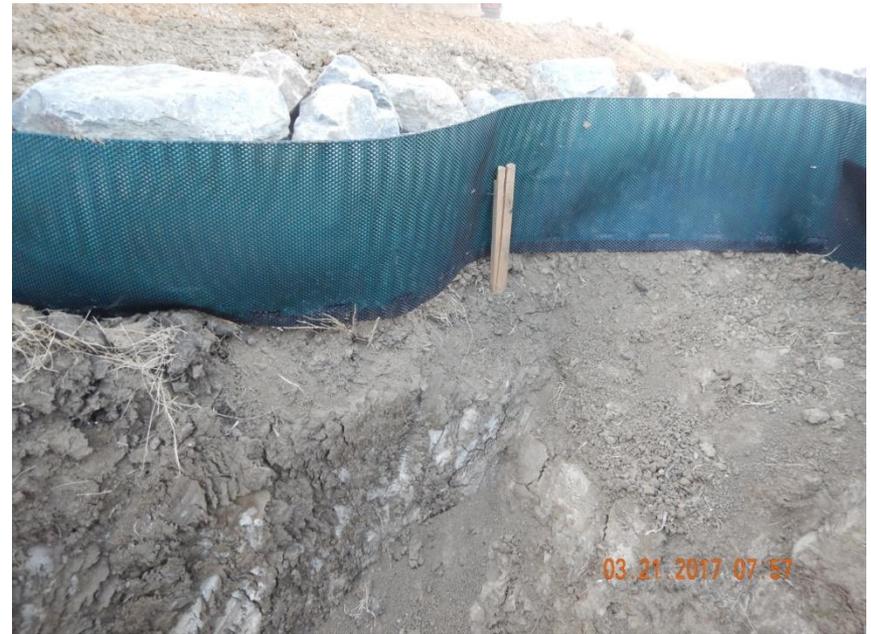
Photo 6. Photo taken of the S-fence BMP along the sediment trap which has not been properly trenched or installed.

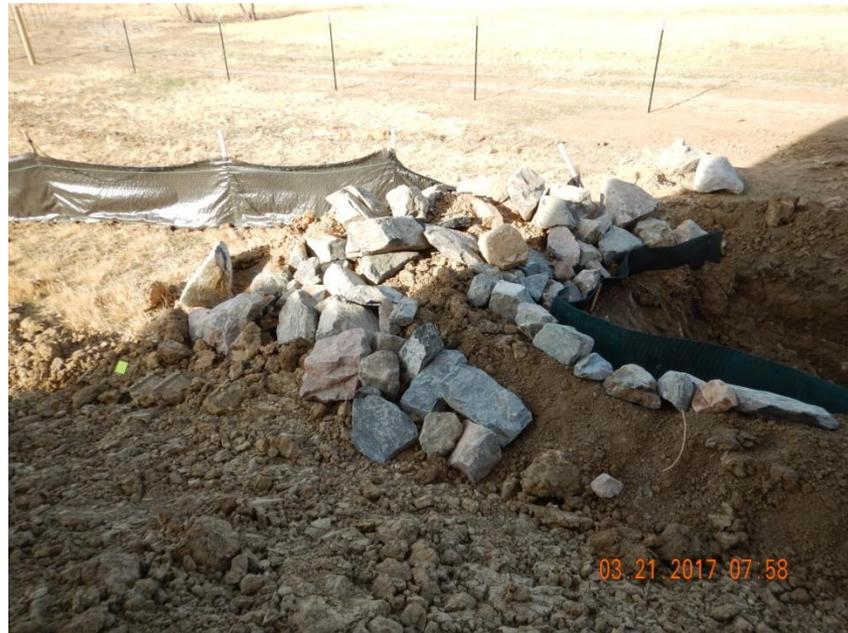
Photo 7. Photo taken of the outlet protection on the western sediment trap, facing West. Rip rap does not appear to be properly installed to function as outlet protection. Rip rap material has fallen onto the S-fence BMP which may likely diminish to S-fence BMP.
