Stormwater Inspection

March 21, 2017

Operator: GREAT WESTERN OPERATING
COMPANY LLC - #10110

Inspection Photos
Location Name: Ocho LD PAD /17-379HN
Location ID: 449174

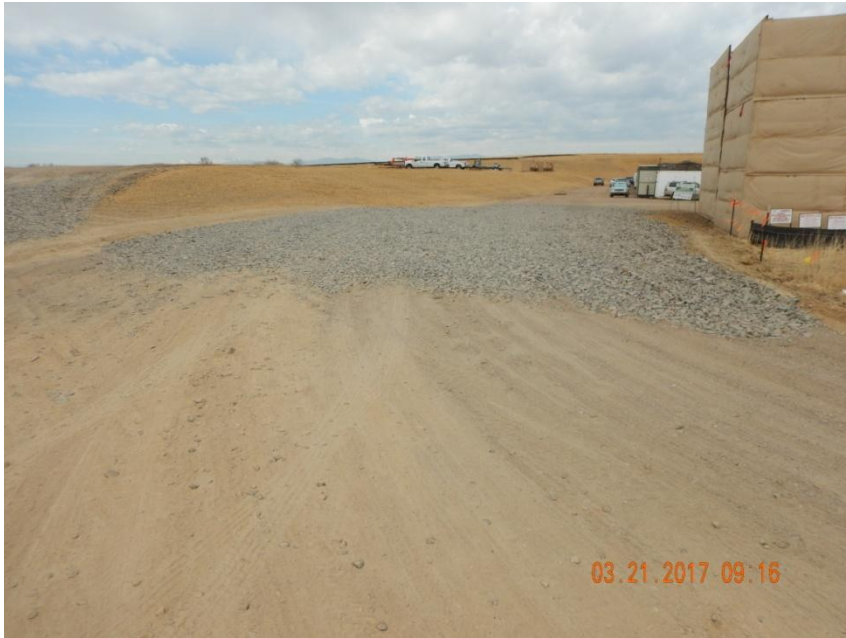
Photo 1. Photo taken from the entrance of location, facing West. Tracking pad installed and appears to be in proper functioning condition. Cut slope along the entrance has been stabilized by crimping straw mulch along the slope.

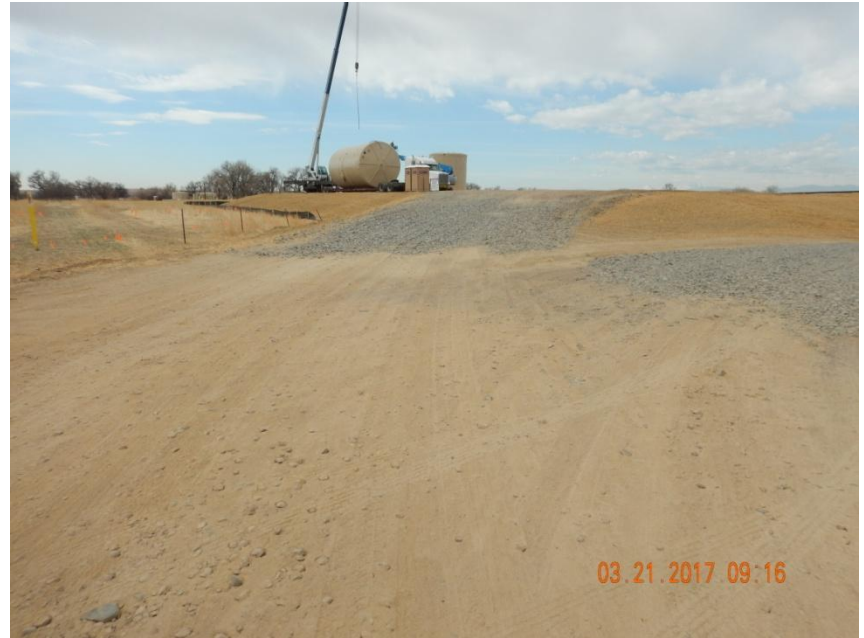
Photo 2. Photo taken from the entrance of location, facing Southwest. Tracking pad installed and appears to be in proper functioning condition.

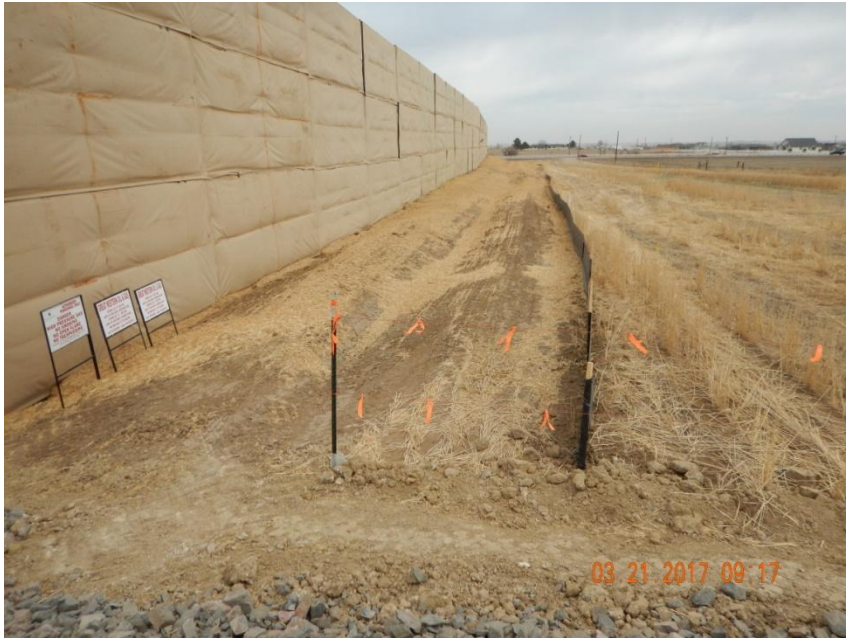
Photo 3. Photo taken from the entrance of location, facing North. A ditch and berm BMP has been installed around the perimeter of the location in conjunction with a silt fence around the perimeter of the location. Also, stormwater areas, cut/fill slopes, and interim areas have been stabilized by crimping straw mulch.

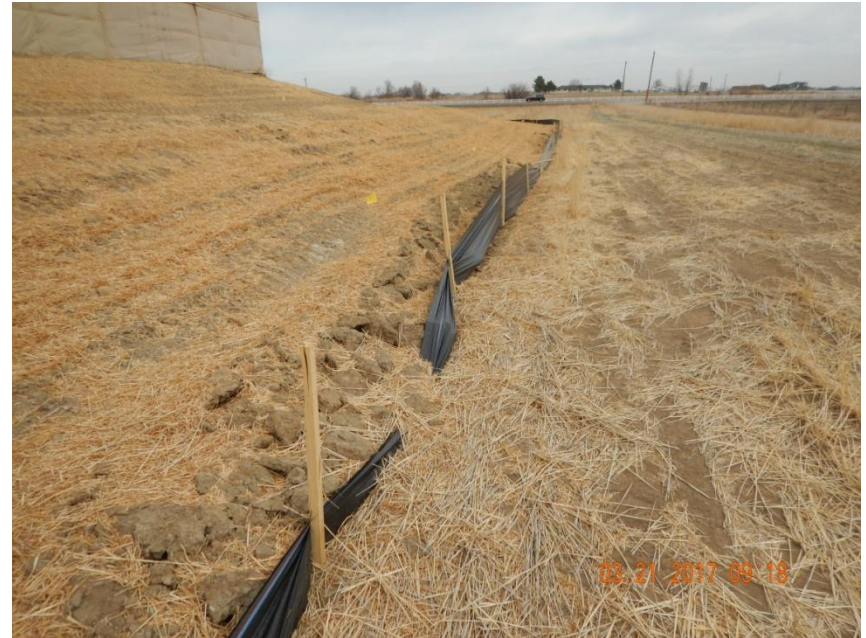
Photo 4. Photo taken from the eastern location, facing North. Silt fence needs repair or maintenance along a portion of the eastern location.

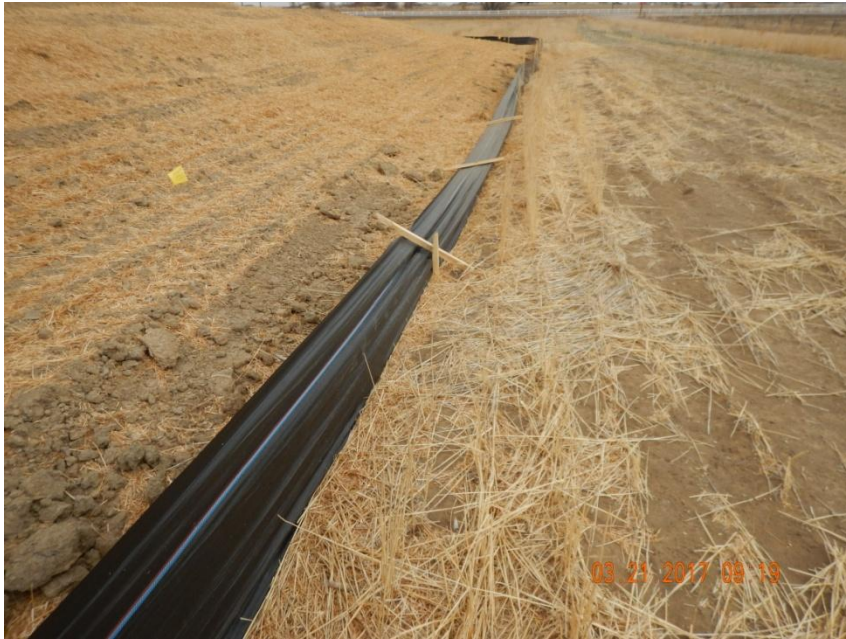
Photo 5. Photo taken from the eastern location, facing North. Silt fence needs repair or maintenance along a portion of the eastern location.

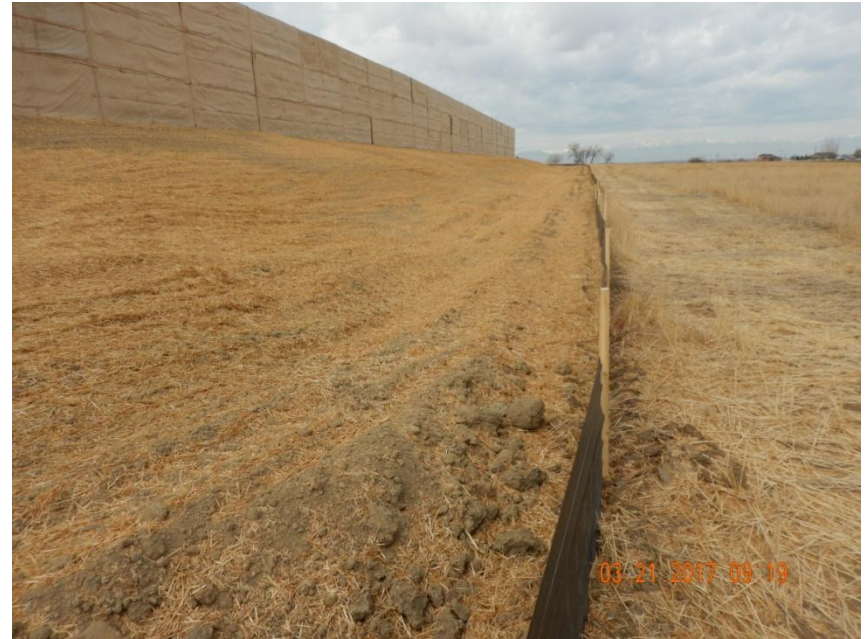
Photo 6. Photo taken from the northeast location, facing West. A ditch and berm BMP has been installed around the perimeter of the location in conjunction with a silt fence around the perimeter of the location. Also, stormwater areas, cut/fill slopes, and interim areas have been stabilized by crimping straw mulch.

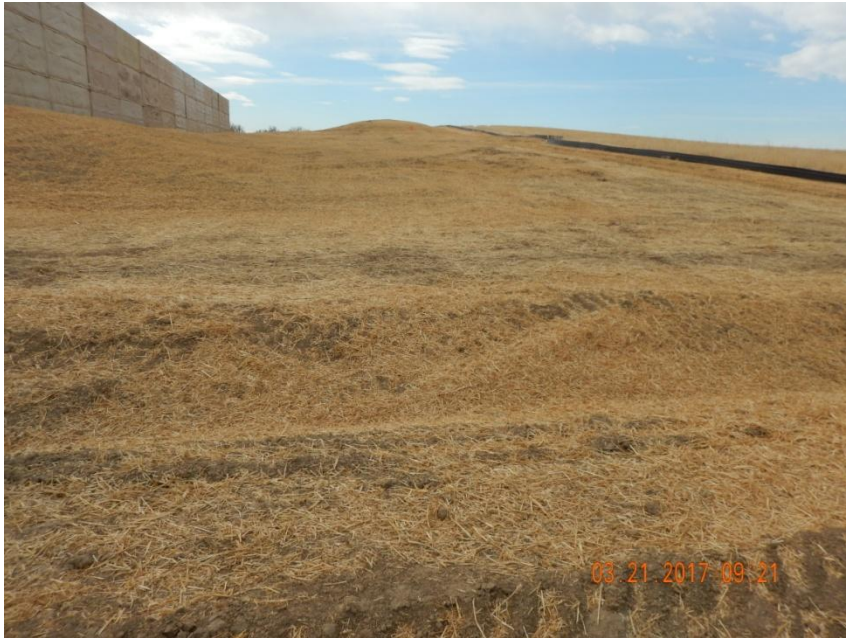
Photo 7. Photo taken from the northwest location, facing South. A ditch and berm BMP has been installed around the perimeter of the location in conjunction with a silt fence around the perimeter of the location. Also, stormwater areas, cut/fill slopes, and interim areas have been stabilized by crimping straw mulch.

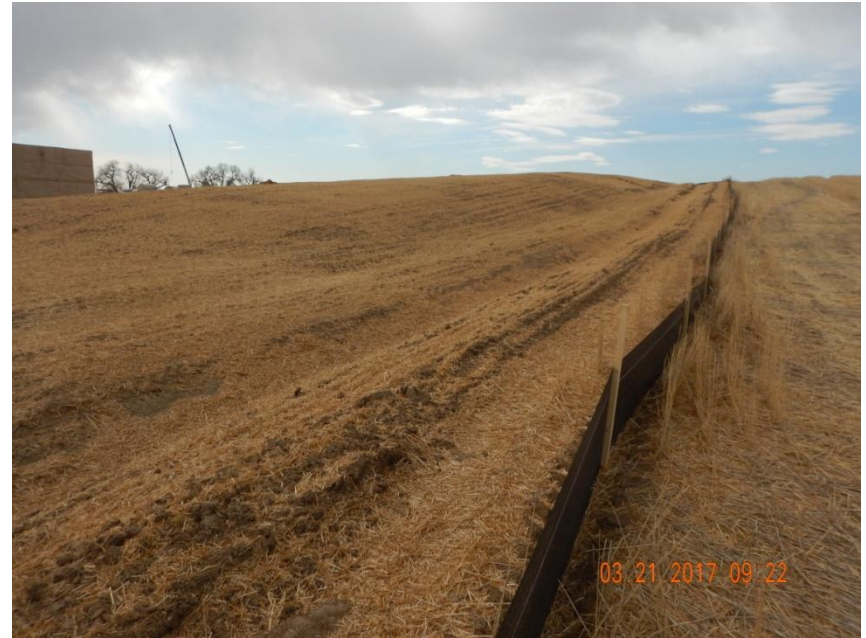
Photo 8. Photo taken from the western location, facing South towards the topsoil stockpile. Topsoil stockpile has been stabilized by crimping straw mulch.

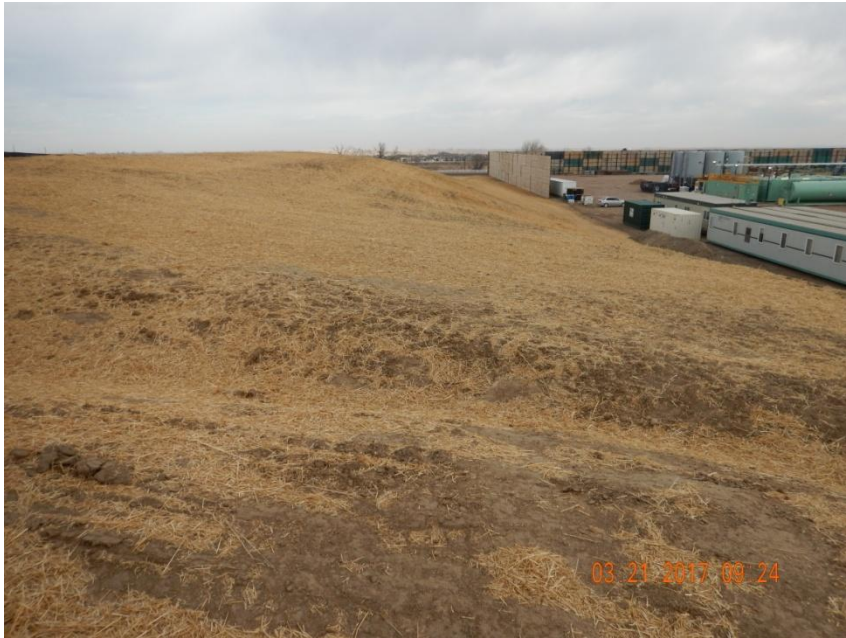
Photo 9. Photo taken from the southwest location, facing North. A ditch and berm BMP has been installed around the perimeter of the location in conjunction with a silt fence around the perimeter of the location. Also, stormwater areas, cut/fill slopes, and interim areas have been stabilized by crimping straw mulch.

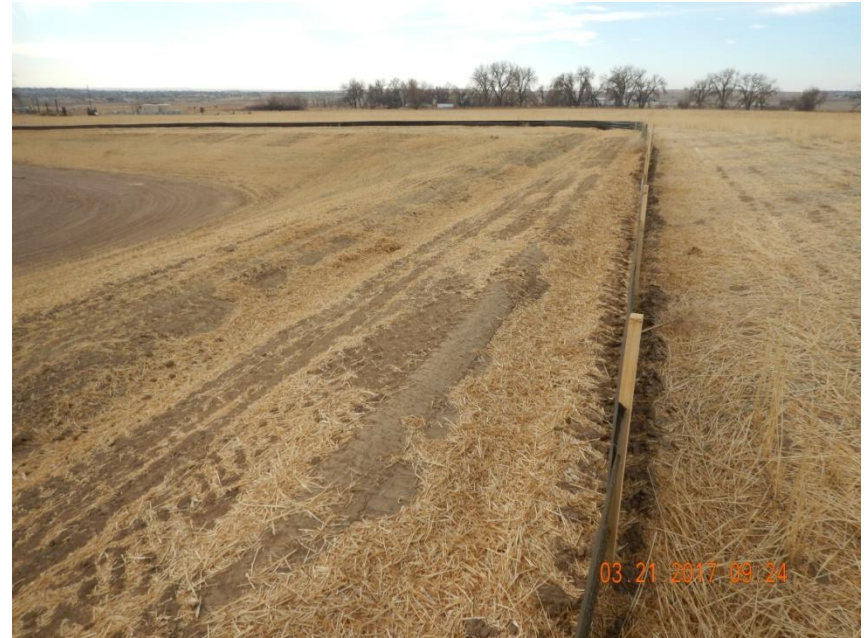
Photo 10. Photo taken from the southwestern location, facing South. A ditch and berm BMP has been installed around the perimeter of the location in conjunction with a silt fence around the perimeter of the location. Also, stormwater areas, cut/fill slopes, and interim areas have been stabilized by crimping straw mulch.

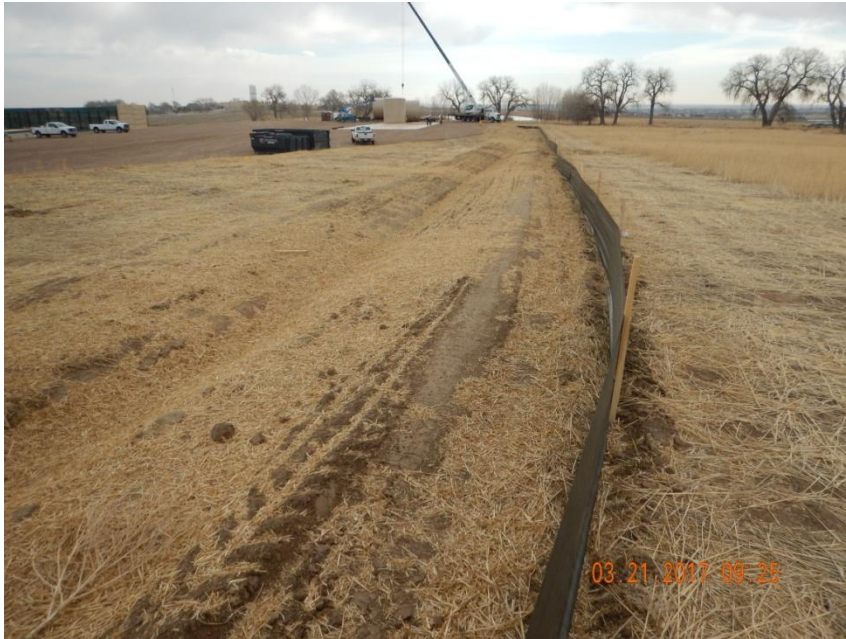
Photo 11. Photo taken from the southwest location, facing East. A ditch and berm BMP has been installed around the perimeter of the location in conjunction with a silt fence around the perimeter of the location. Also, stormwater areas, cut/fill slopes, and interim areas have been stabilized by crimping straw mulch.

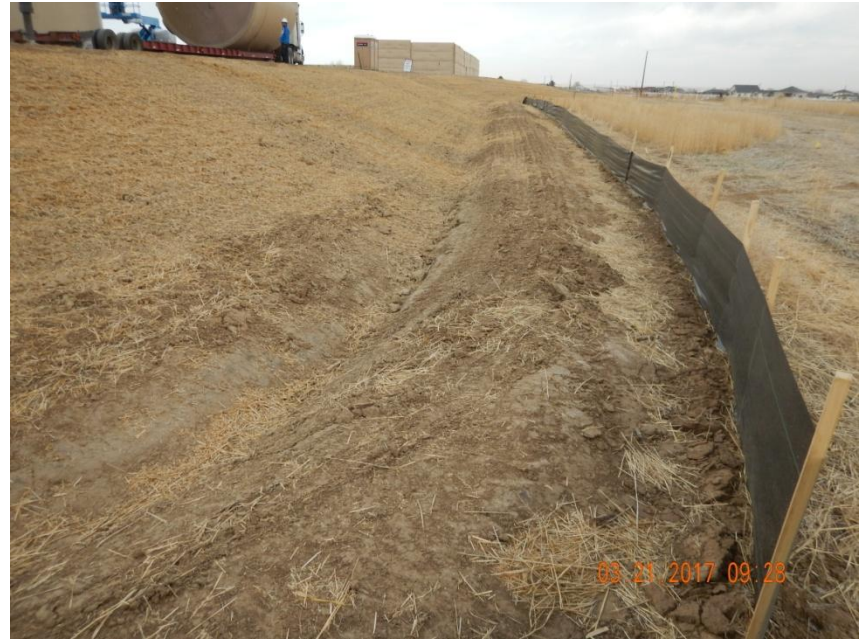
Photo 12. Photo taken from the southeast location, facing North. A ditch and berm BMP has been installed around the perimeter of the location in conjunction with a silt fence around the perimeter of the location. Also, stormwater areas, cut/fill slopes, and interim areas have been stabilized by crimping straw mulch.
