Construction and Stormwater Inspection

March 21, 2017

Operator: WARD PETROLEUM CORPORATION-
#10359

Location ID: 440718

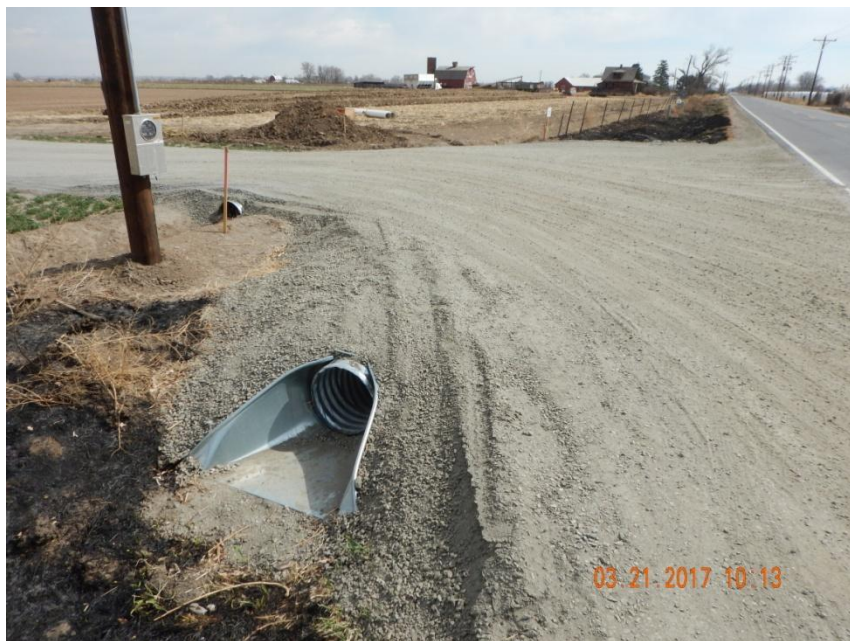
Photo 1. Photo taken from the entrance location, facing East. Two (2) sets of culverts installed in conjunction with existing ditches. Gravel installed at entrance of location.

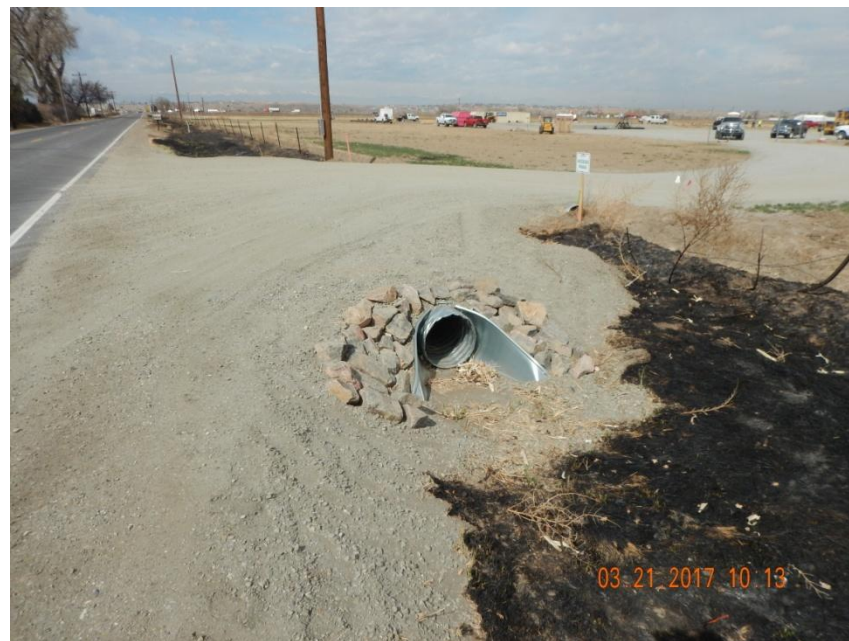
Photo 2. Photo taken from the entrance location, facing West. Two (2) sets of culverts installed in conjunction with existing ditches. Gravel installed at entrance of location.

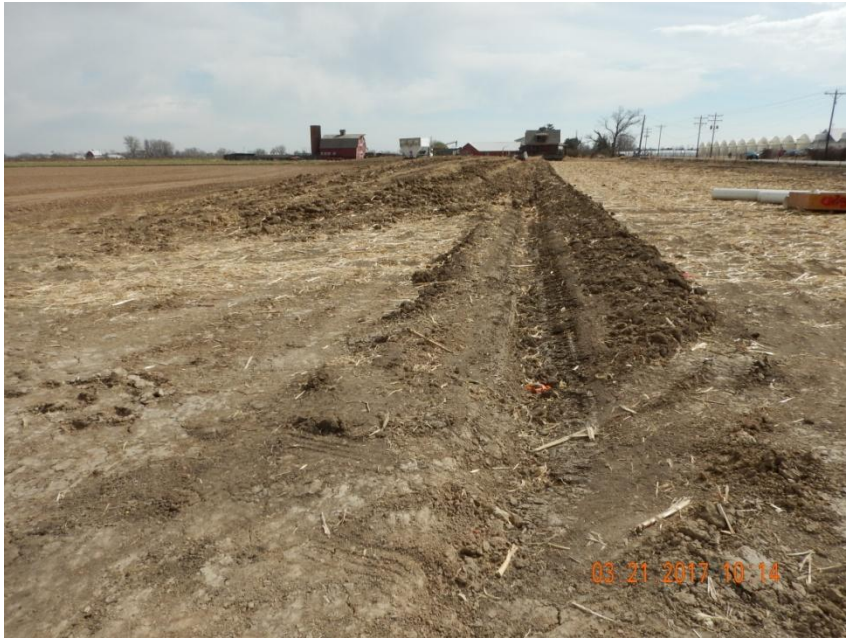
Photo 3. Photo taken from the southwest location, facing East. A ditch and berm BMP has been installed around the perimeter of location. Berm does not appear to be consistently compacted. Topsoil stockpile salvaged and stored along the southern location and along a portion of the southeastern location.

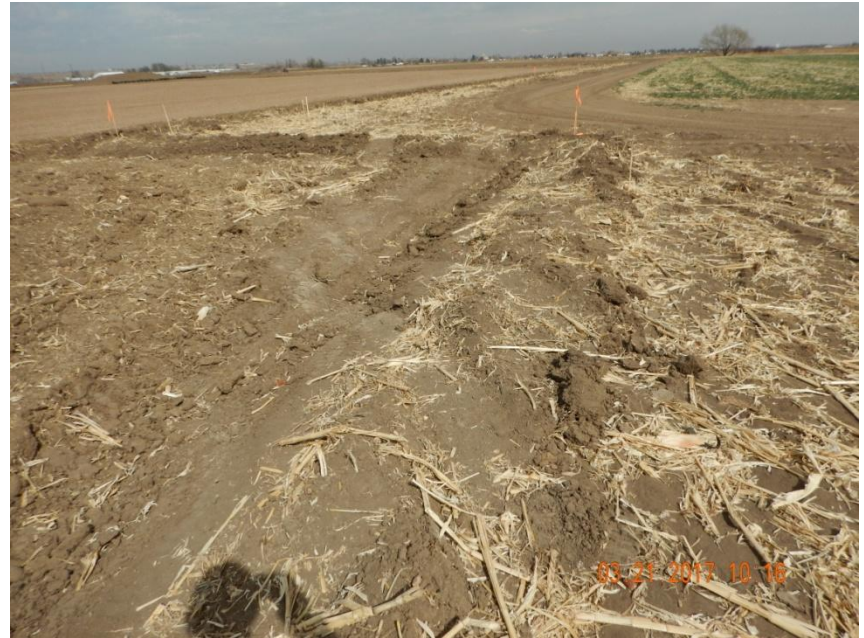
Photo 4. Photo taken from the southeastern location, facing North. A ditch and berm BMP has been installed around the perimeter of location. Berm does not appear to be consistently compacted and vehicle traffic should stay off BMPs to ensure they properly function.

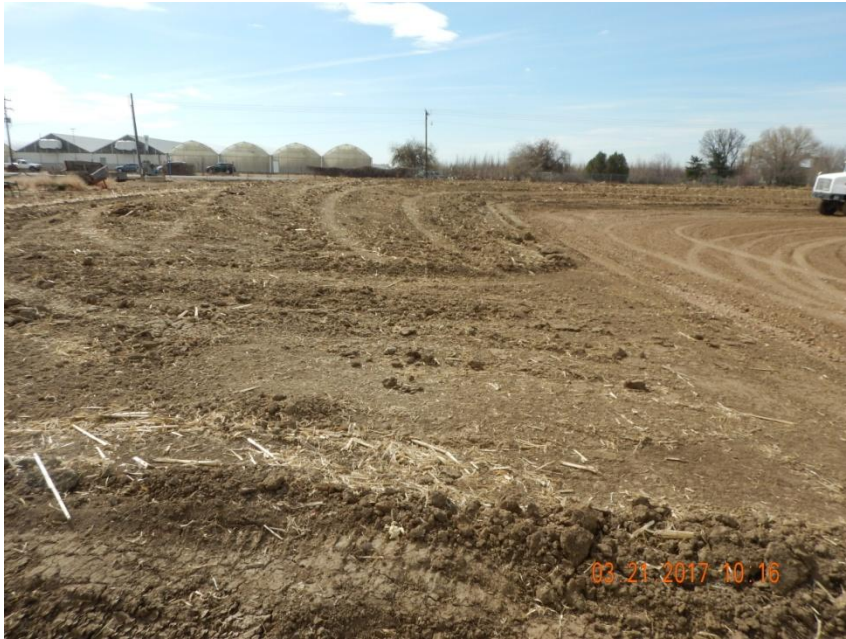
Photo 5. Photo taken from the southeastern location, facing North, of the southeastern topsoil stockpile.

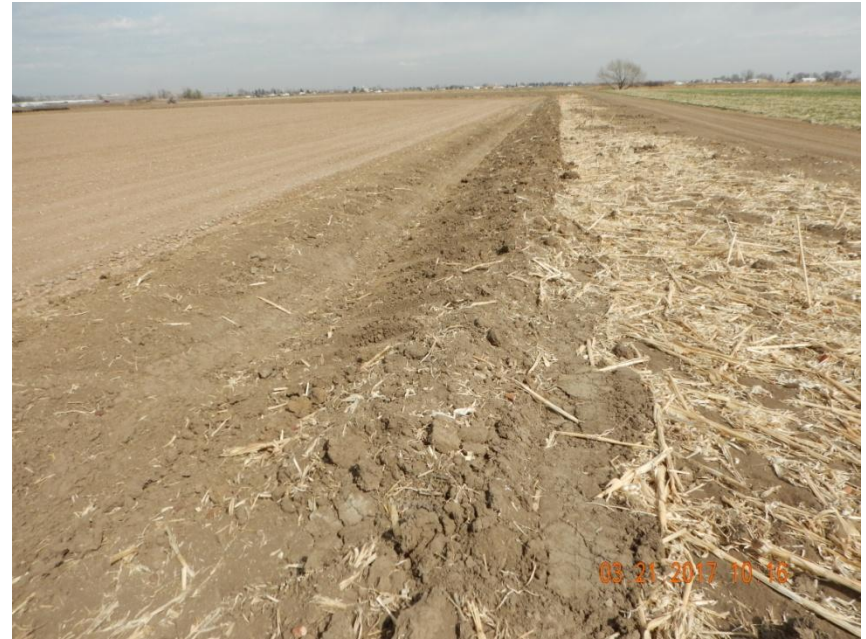
Photo 6. Photo taken from the eastern location, facing North. A ditch and berm BMP has been installed around the perimeter of location. Berm does not appear to be consistently compacted.

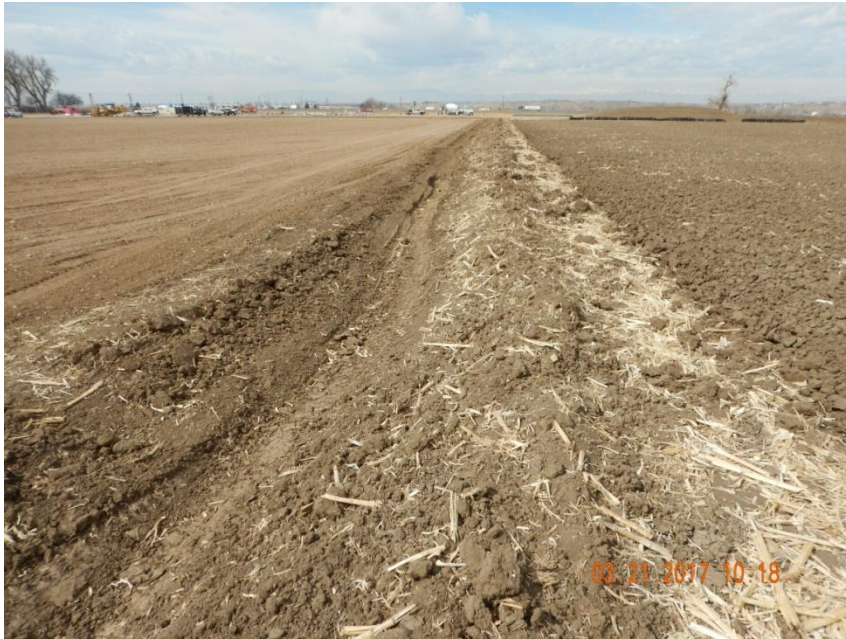
Photo 7. Photo taken from the northern location, facing West. A ditch and berm BMP has been installed around the perimeter of location. Berm does not appear to be consistently compacted.

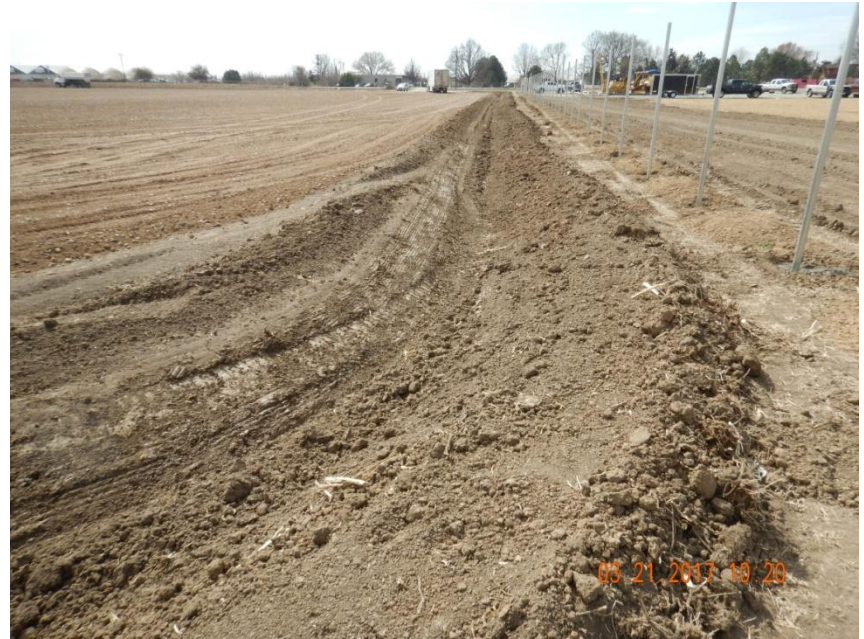
Photo 8. Photo taken from the northwest location, facing South. A ditch and berm BMP has been installed around the perimeter of location. Berm does not appear to be consistently compacted.
