## Inspection Photos

Location Name: Spaur Brothers North Pad 31-219HN

API: 05-123-38693

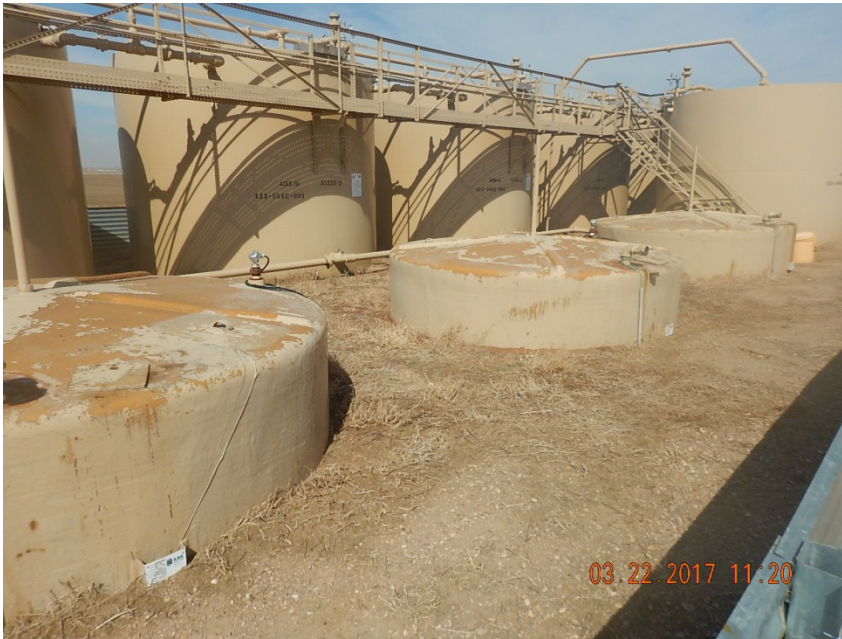
**Photo 1: Weeds in tank battery**

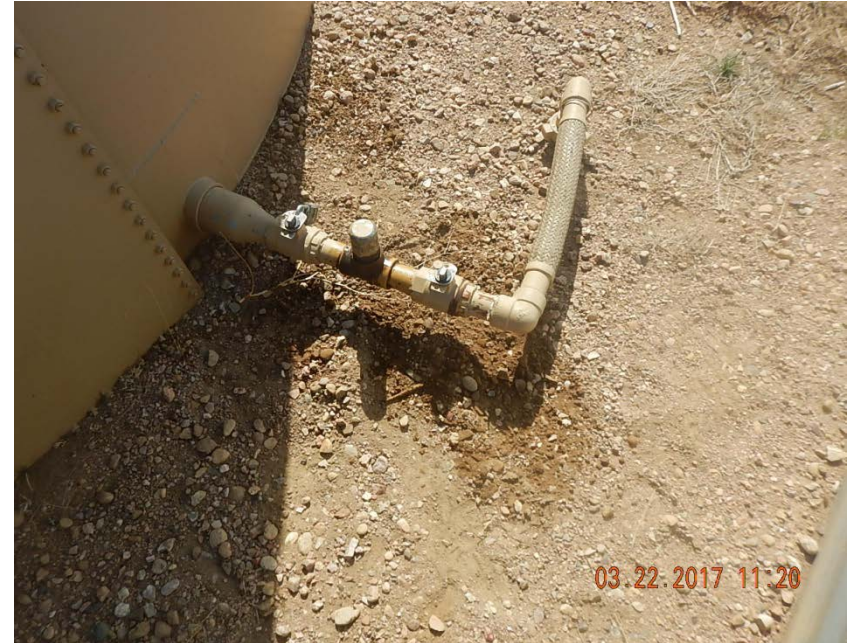
**Photo 2: Stained soil at fitting**

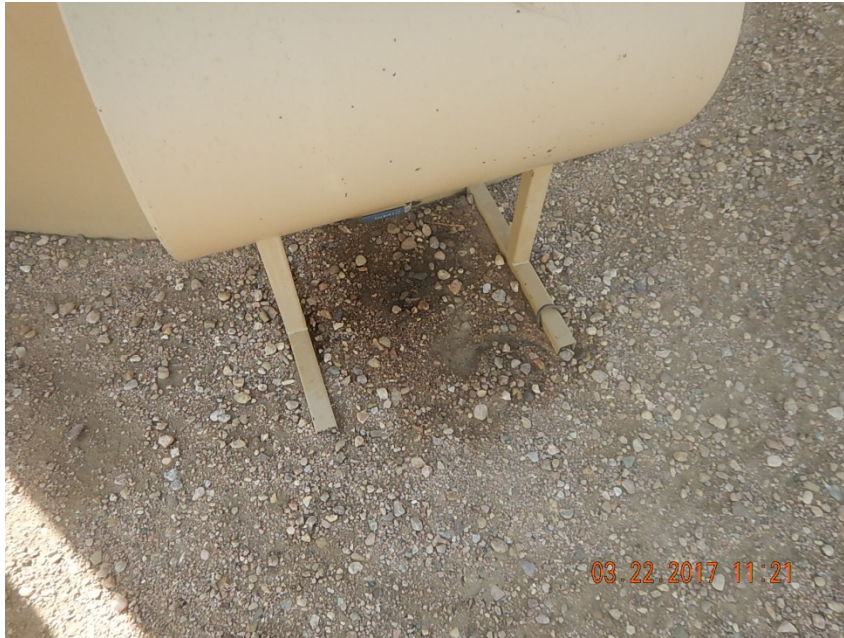
**Photo 3: Stained soil beneath scrubber**

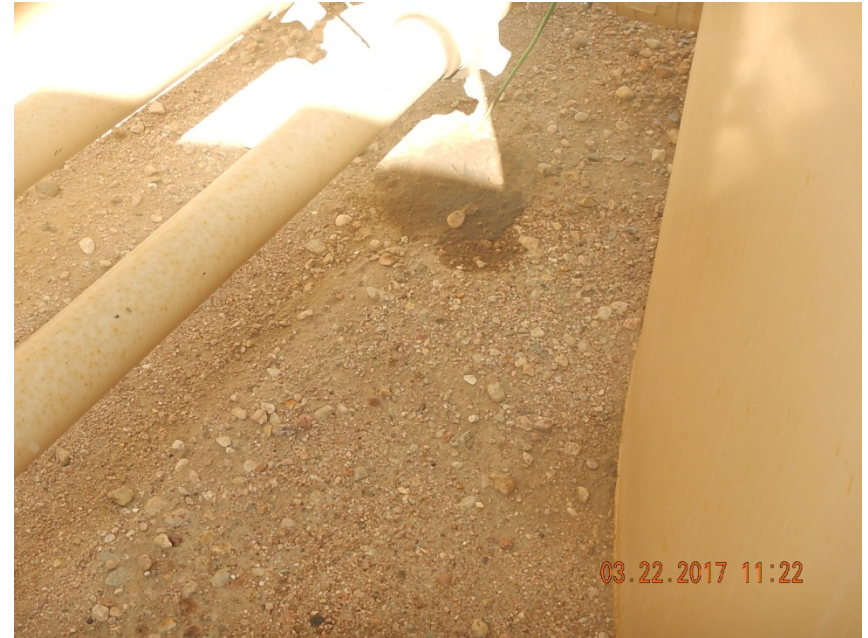
**Photo 4: Stained soil at fitting**

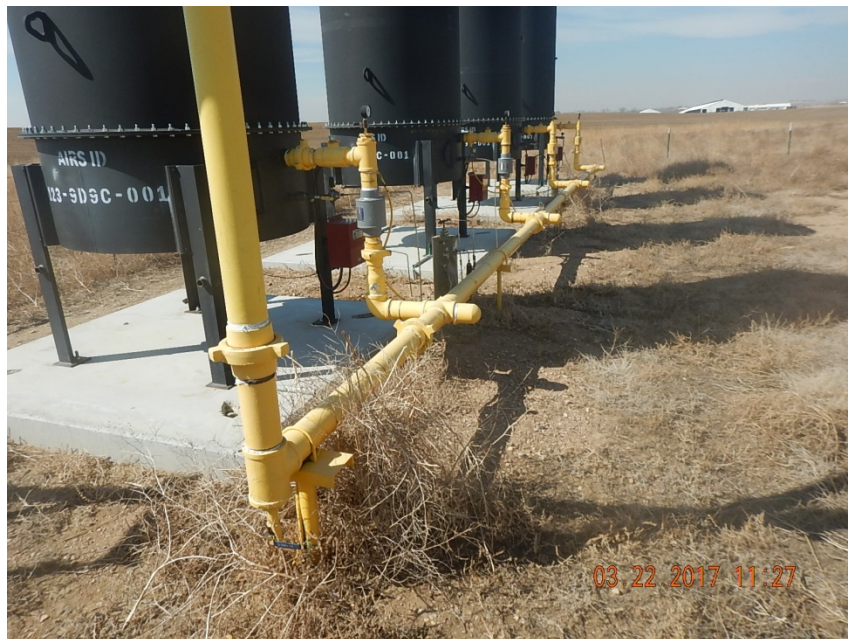
**Photo 5: Weeds at ECDs**

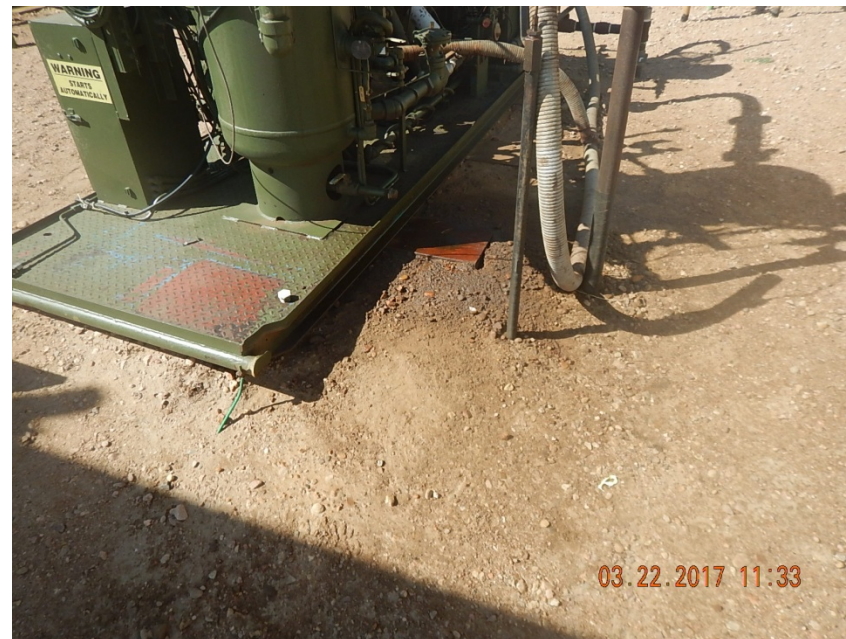
**Photo 6: Stained soil at compressor**

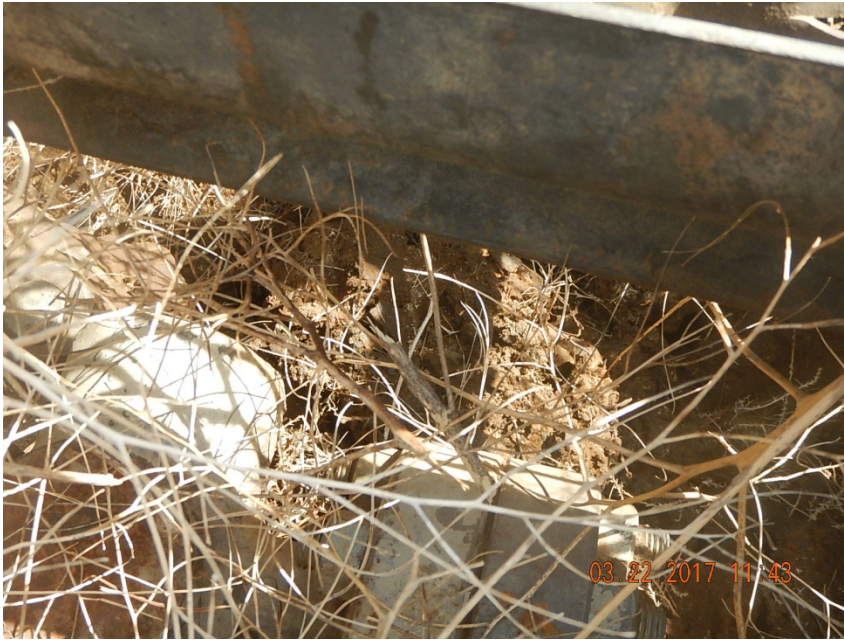
**Photo 1: Stained soil in cellar of Spaur Bros EH 31-259HC.  
Grate made photograph difficult.**
