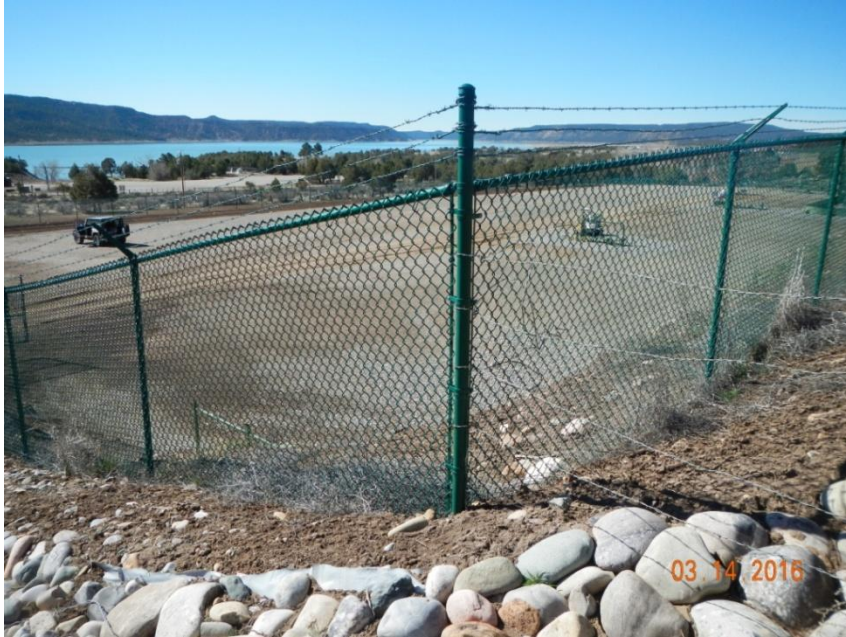
**Photo 1: View of the project area from the northeastern corner facing center.**

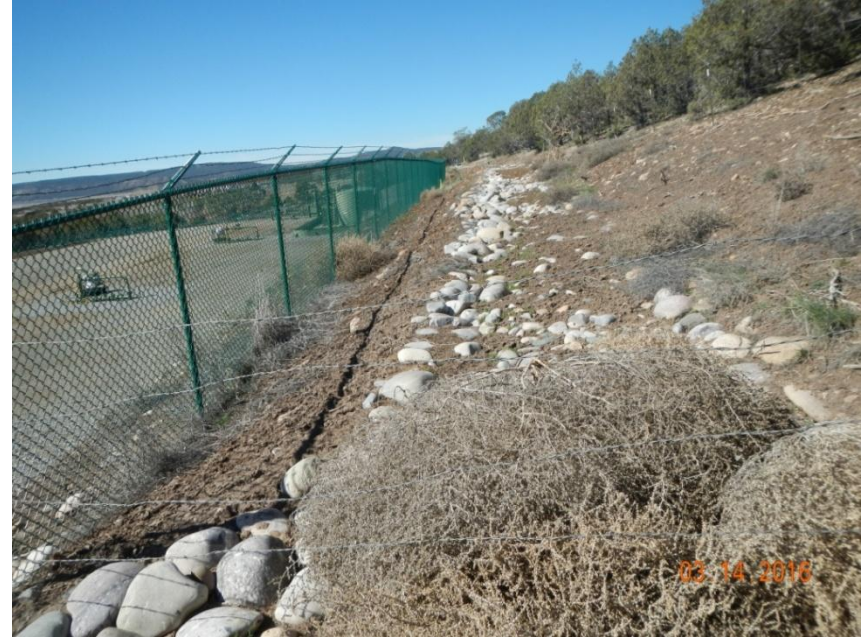
**Photo 2: View of the northern portion of the project area from the northeastern corner facing westward. Cobble diversion channel is filling with sediment and will soon need maintenance.**

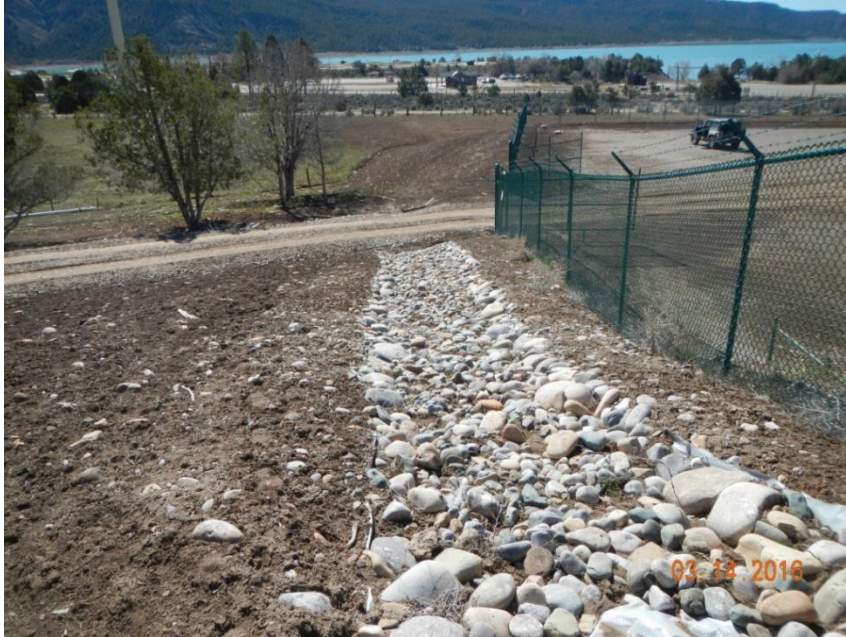
**Photo 3: View of the eastern portion of the project area from the northeastern corner facing southward.**

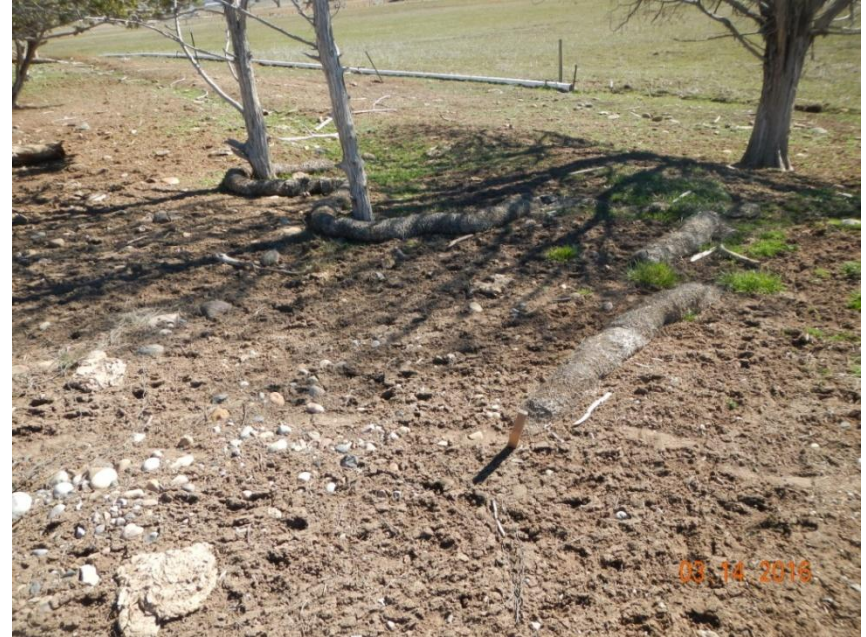
**Photo 4: View of wattles that are no longer functioning in the eastern portion of the project area.**

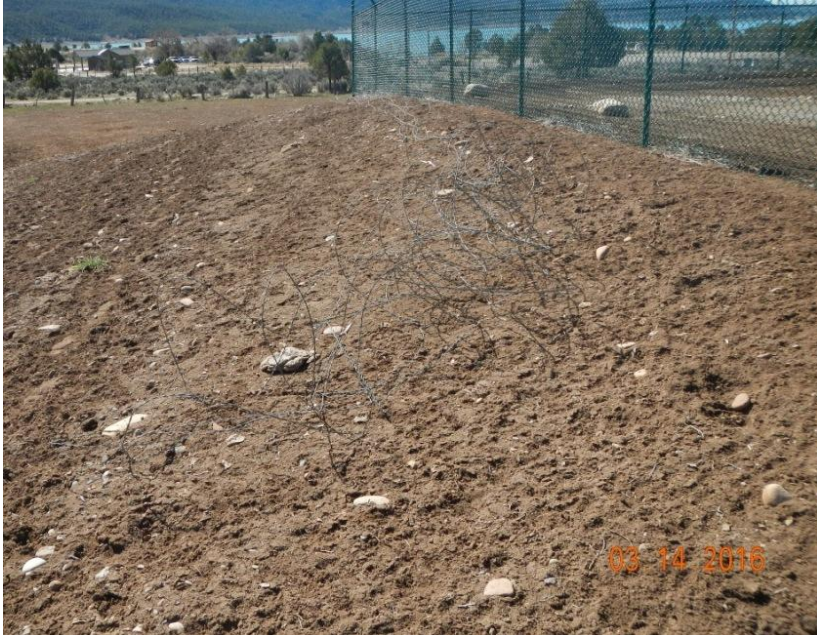
**Photo 5: View of barbed wire debris in the southern portion of the project area.**

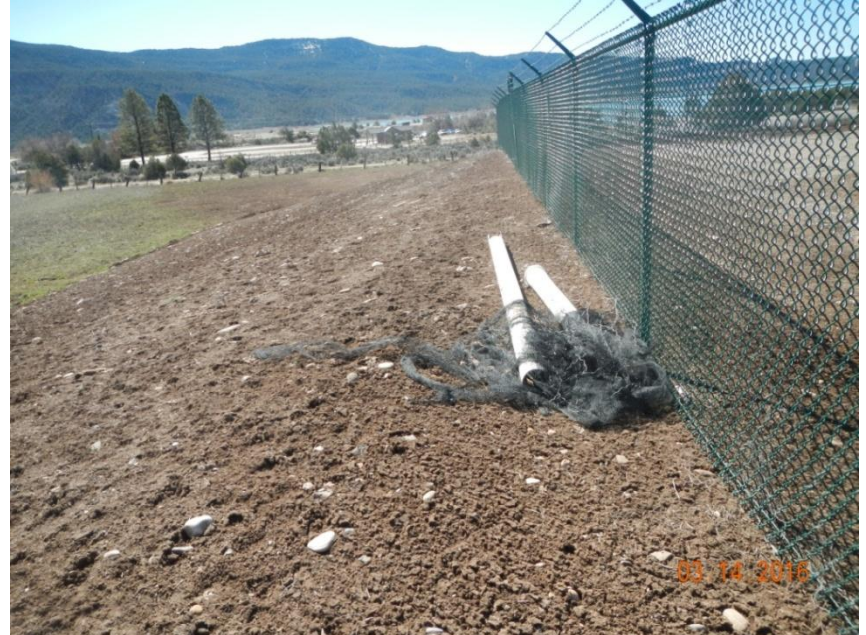
**Photo 6: View pipe and netting debris in the eastern portion of the project area that needs to be removed.**

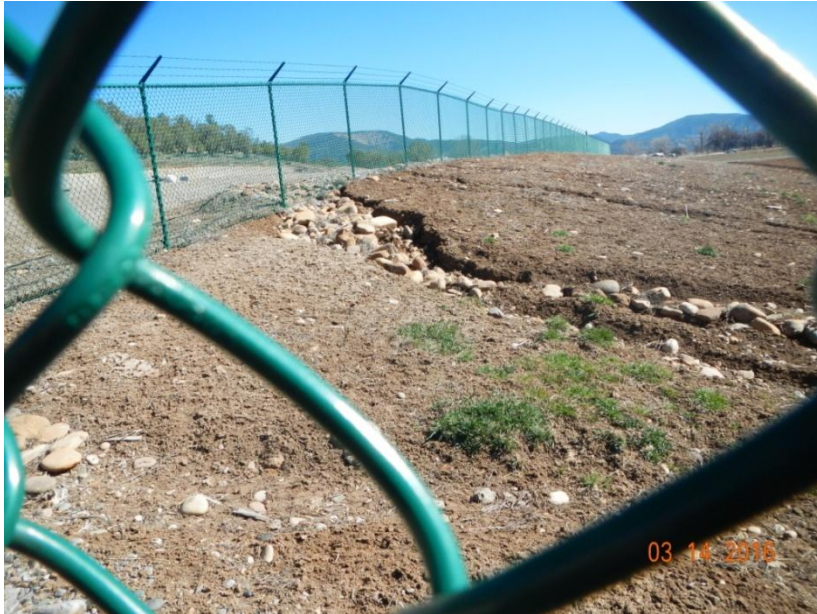
**Photo 7: View of an erosional channel forming in the southern portion of the project area that needs stabilization.**
