Inspection Photos
Location Name: Ptasynski 5
API: 05-081-06493

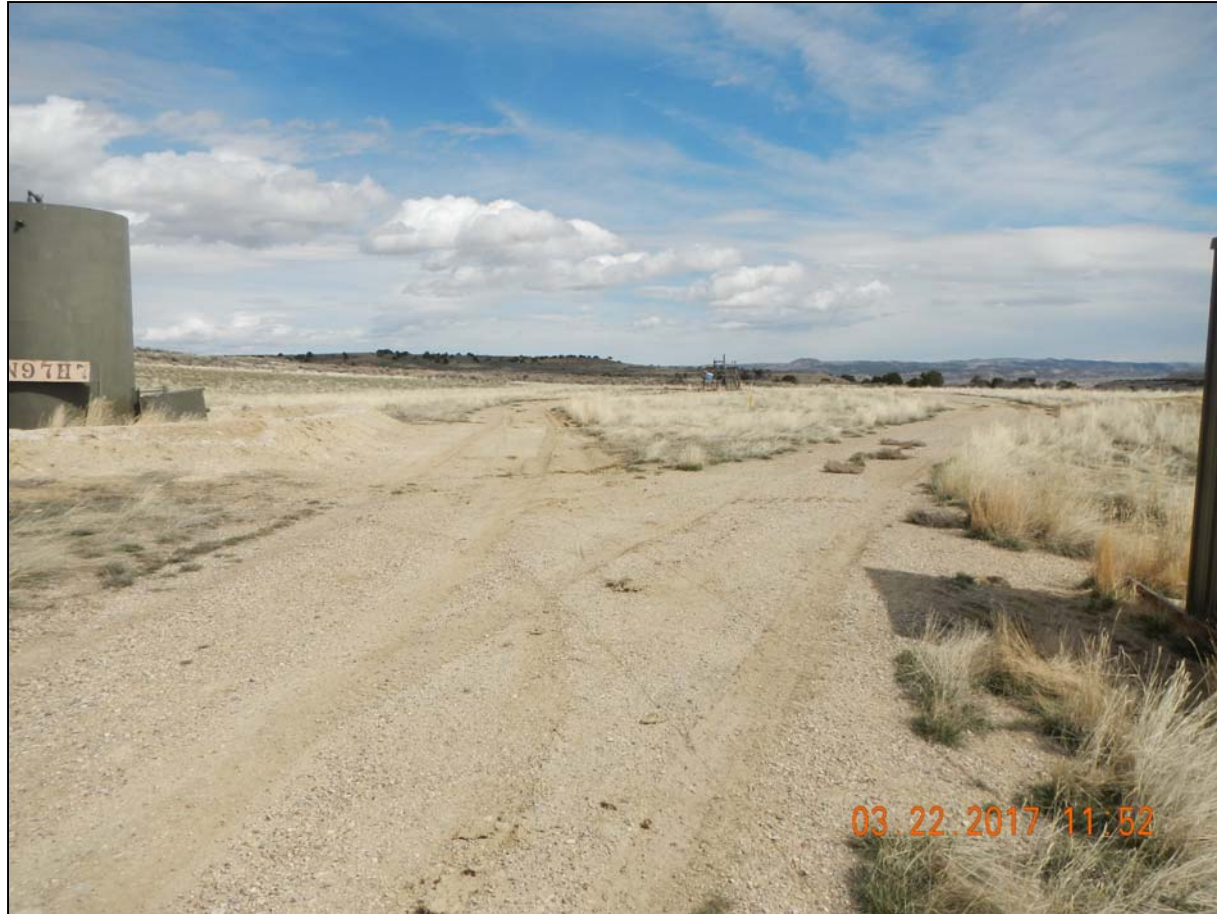
Photo 1. View at entrance to location facing northeast.

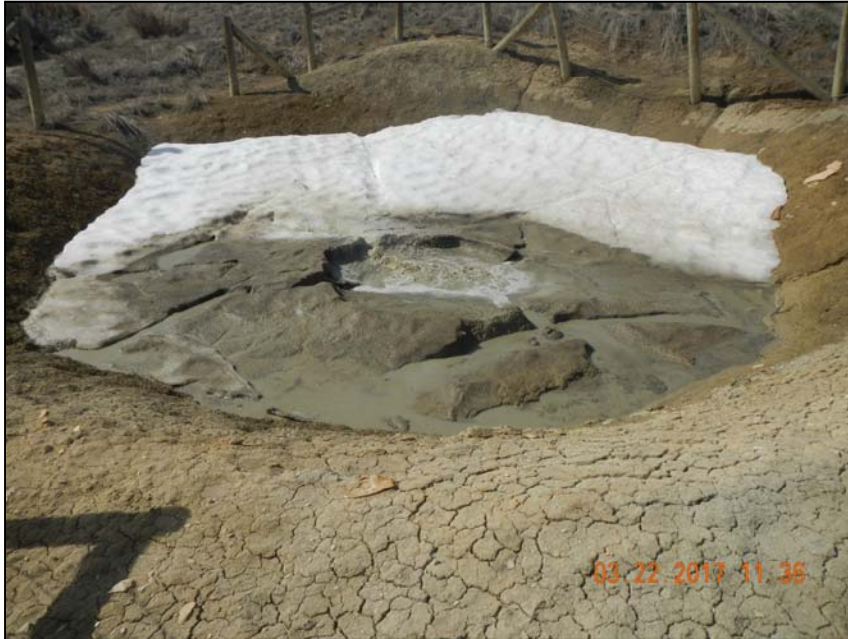
Photo 2. View of pit standing at northeast corner looking southwest. Water in center is bubbling.

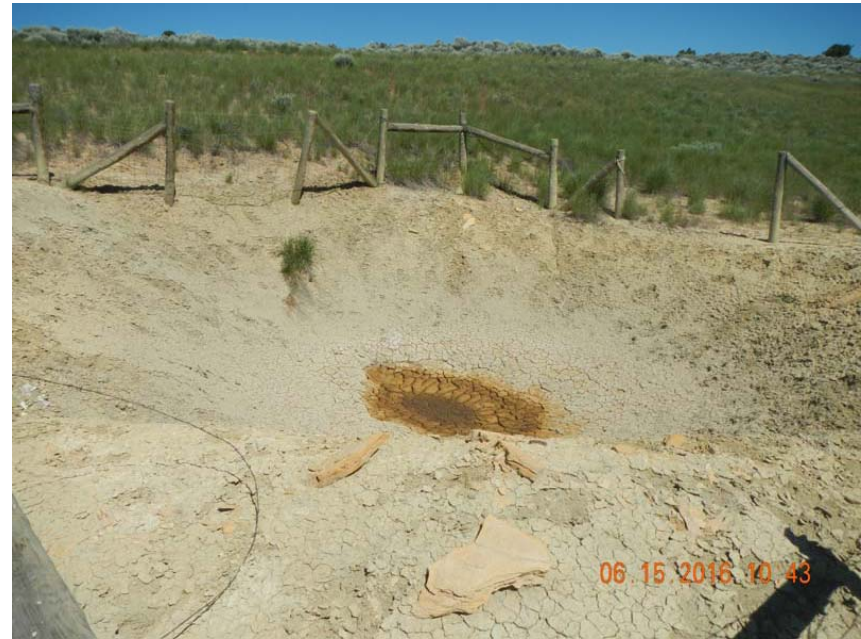
Photo 3. View of pit standing at southeast corner looking northwest during 6/15/2016 inspection.

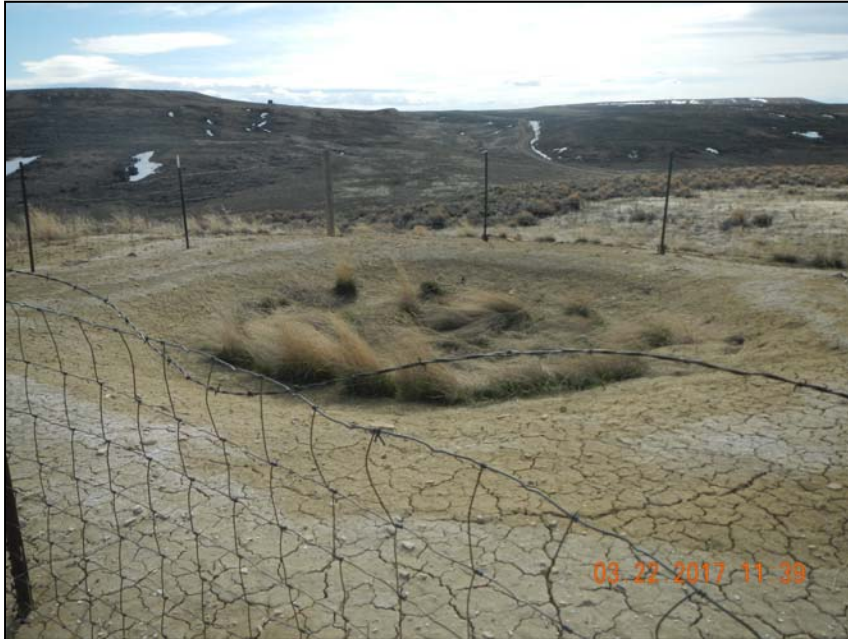
Photo 4. Pit behind separator standing at northwest corner looking southeast.

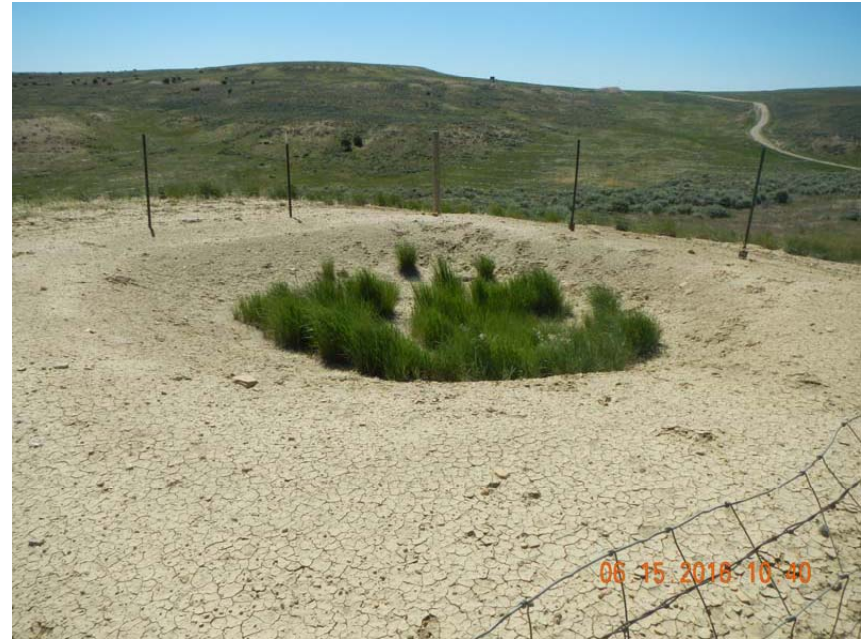
Photo 5. Pit behind separator standing at northwest corner looking southeast from 6/15/2016 inspection.

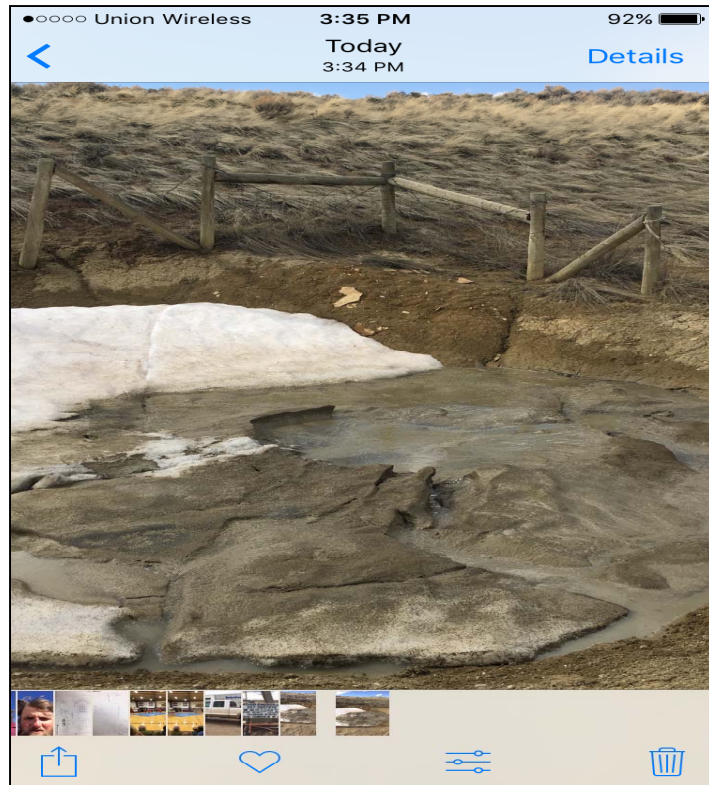
Photo 6. Pit no longer bubbling. Photo courtesy of Clay Evans.
