Inspection Photos
Location Name: Ptasynski 1X
API: 05-081-06614

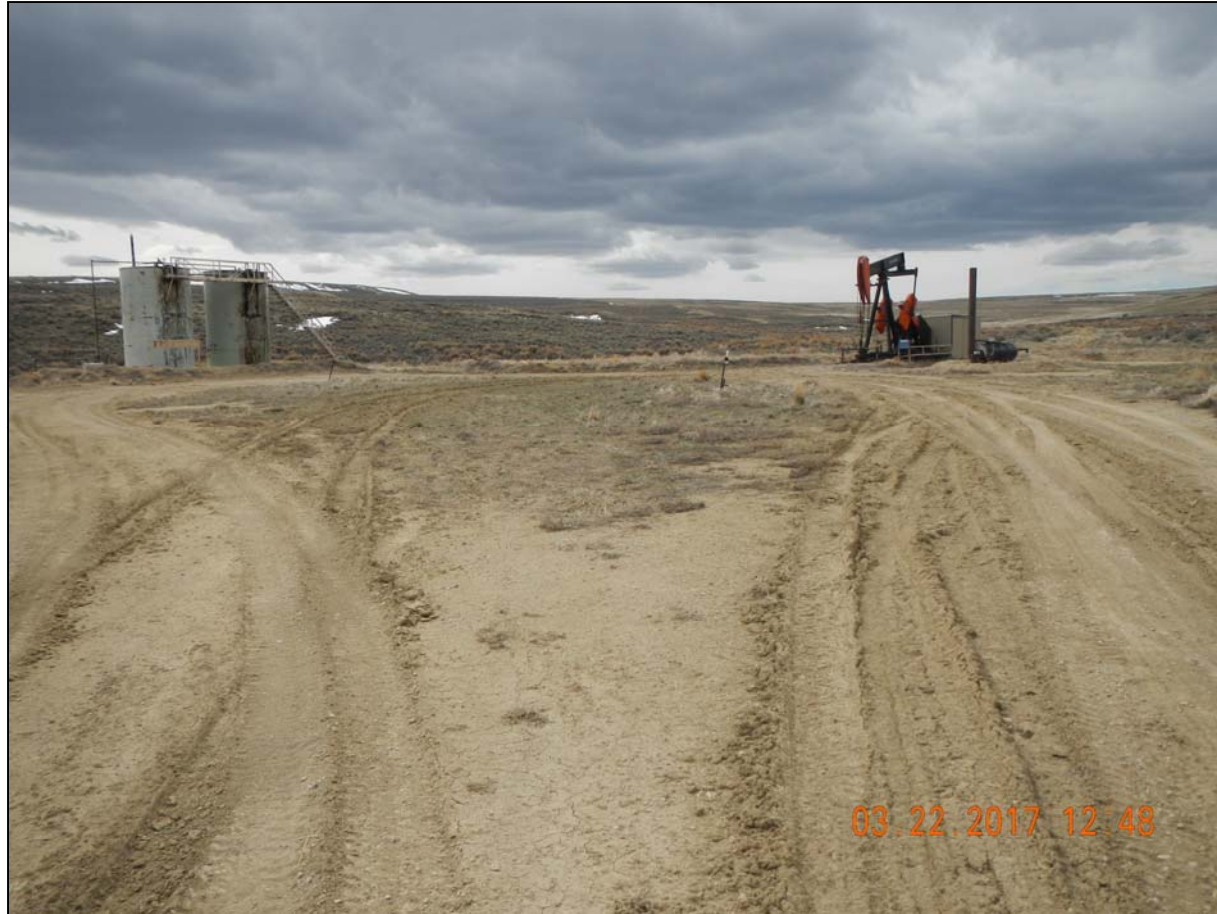
Photo 1. View at entrance to location facing west.

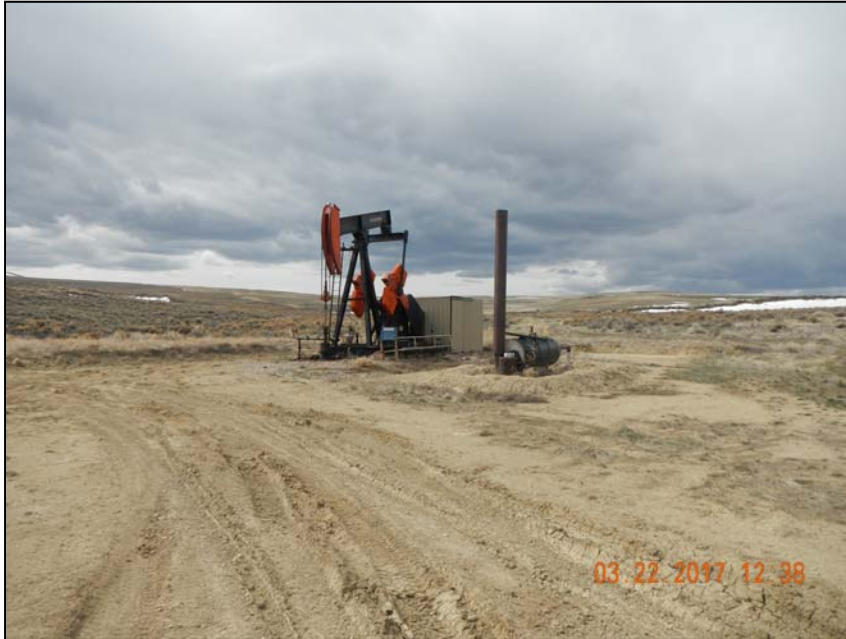
Photo 2. ~18 foot setback between pump jack and heated separator.

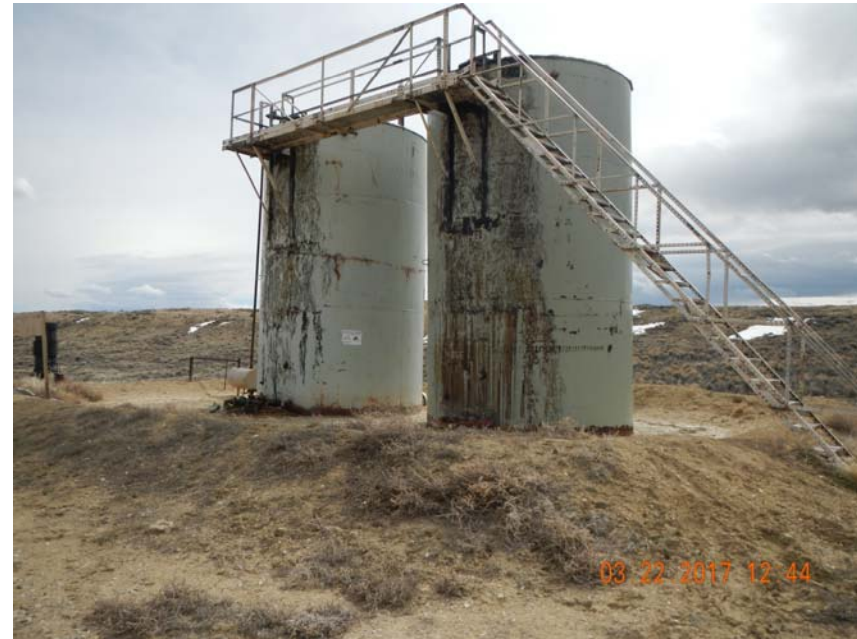
Photo 3. Missing tank label.

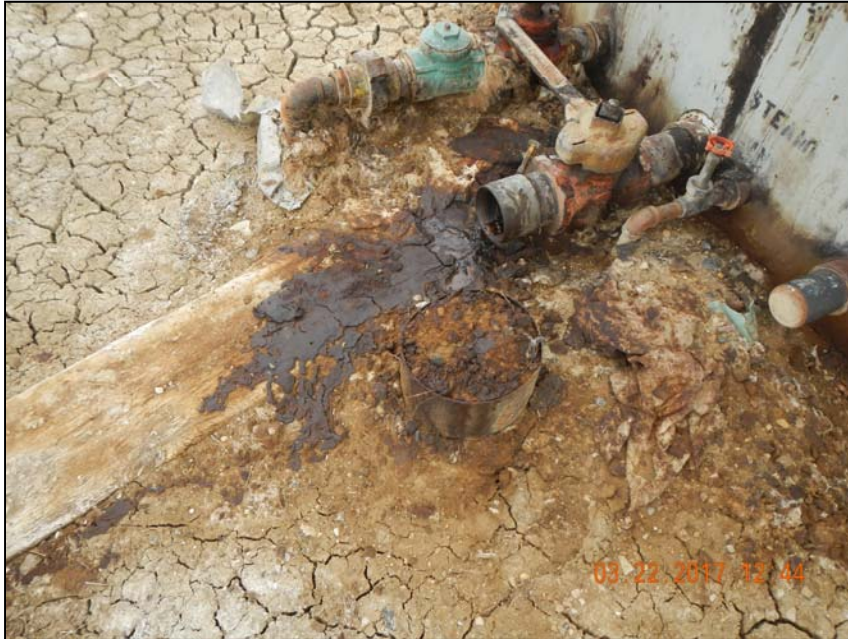
Photo 4. Stained soil at loadout.

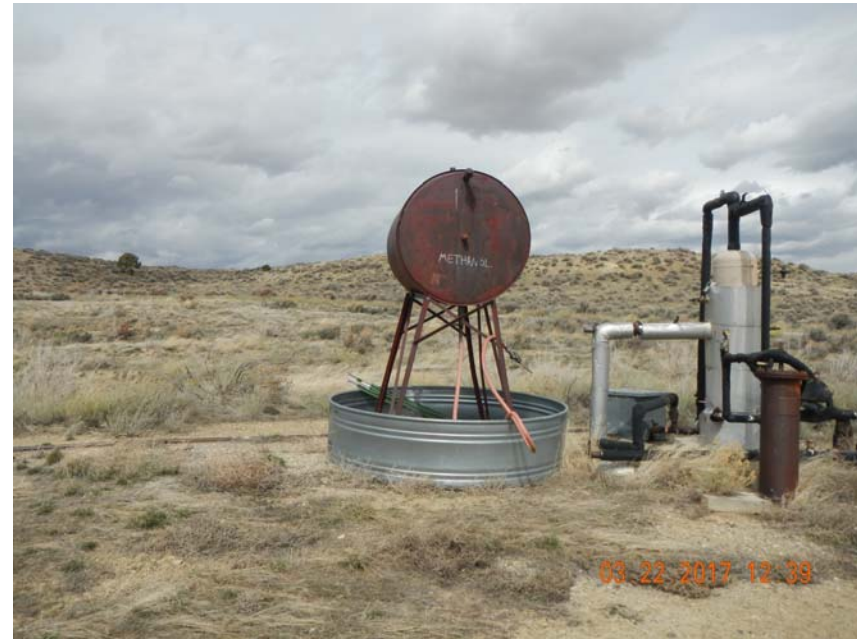
Photo 4. Partially labeled methanol container.

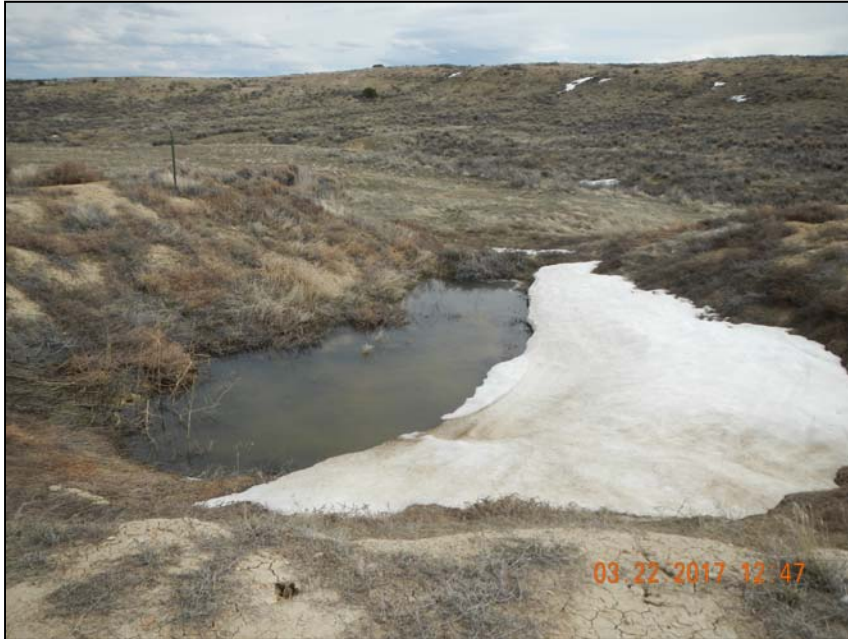
Photo 6. View of pit facing southeast.

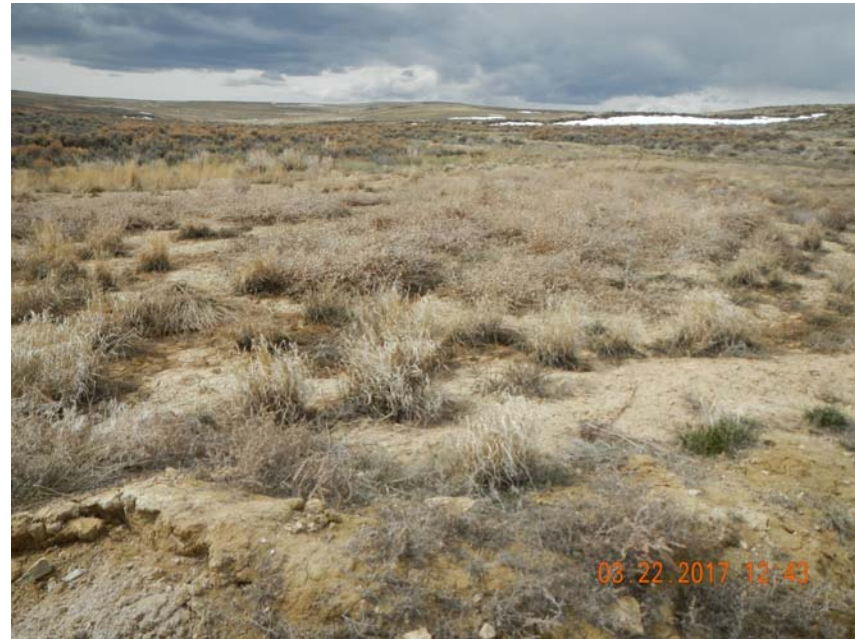
Photo 7. Landfarm area.
