Inspection Photos

Operator: Bill Barrett Corp #10071

Location ID: 449383

Inspection Doc. Number: 682501788

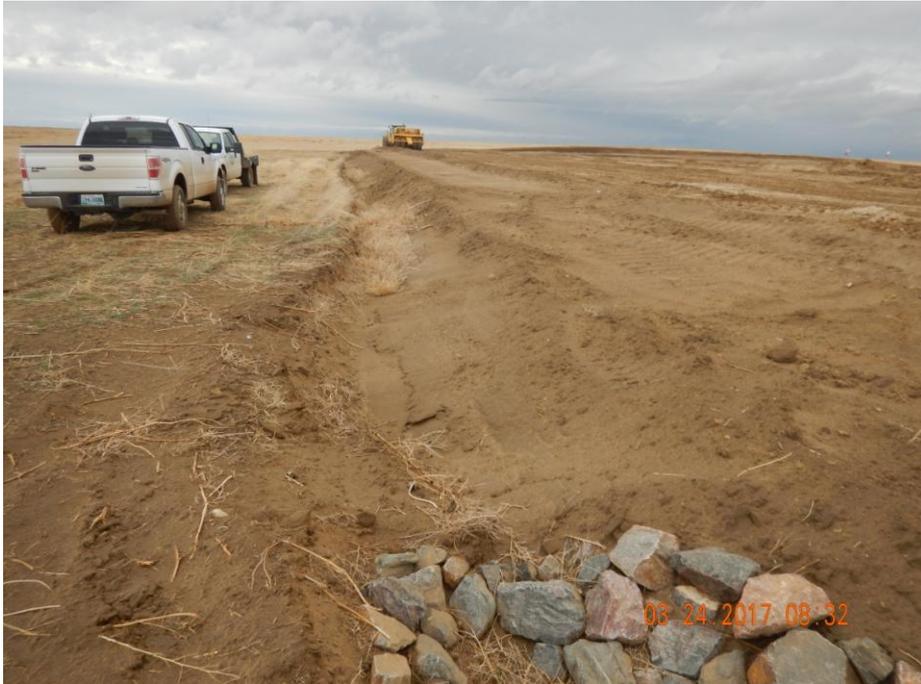
Photo 1: Photo taken from the northwest end of the location facing east. Photo shows stormwater and sediment control ditch along perimeter of the location. Ditch in its current condition is satisfactory as a temporary control for this stage of construction, however, ditch is not consolidated and has been constructed with a steep grade. Alternative BMPs will need to be implemented or ditch will need to be upgraded once pad-construction activities have finished. CDOT recommends ditches be constructed with a grade of 2:1.

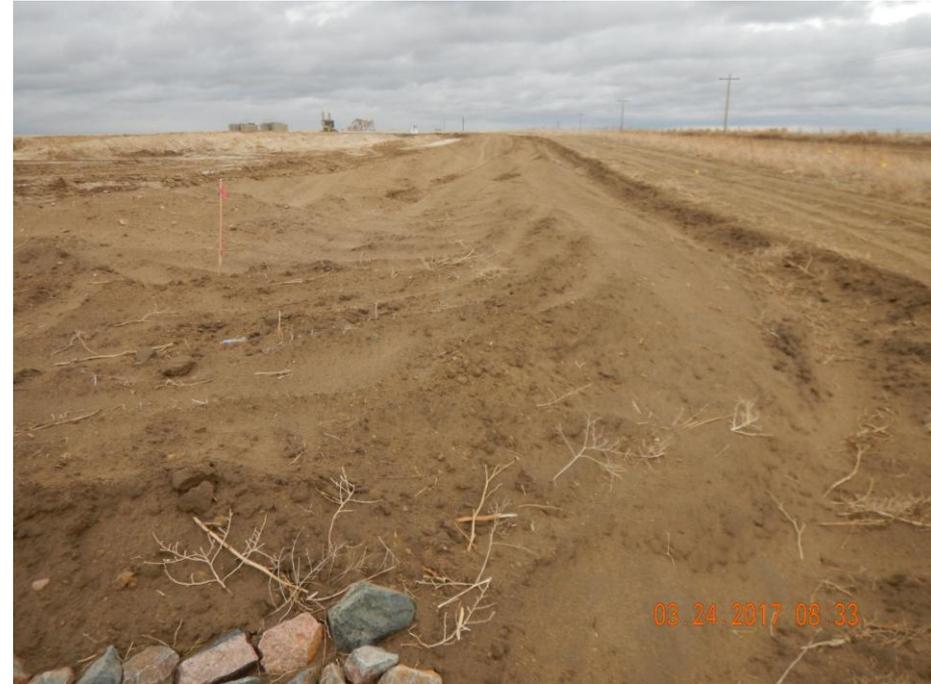
Photo 2: Photo taken from the northwest end of the location facing south. Photo shows stormwater and sediment control ditch along perimeter of the location. Ditch in its current condition is satisfactory as a temporary control for this stage of construction, however, ditch is not consolidated and has been constructed with a steep grade. Alternative BMPs will need to be implemented or ditch will need to be upgraded once pad-construction activities have finished. CDOT recommends ditches be constructed with a grade of 2:1.

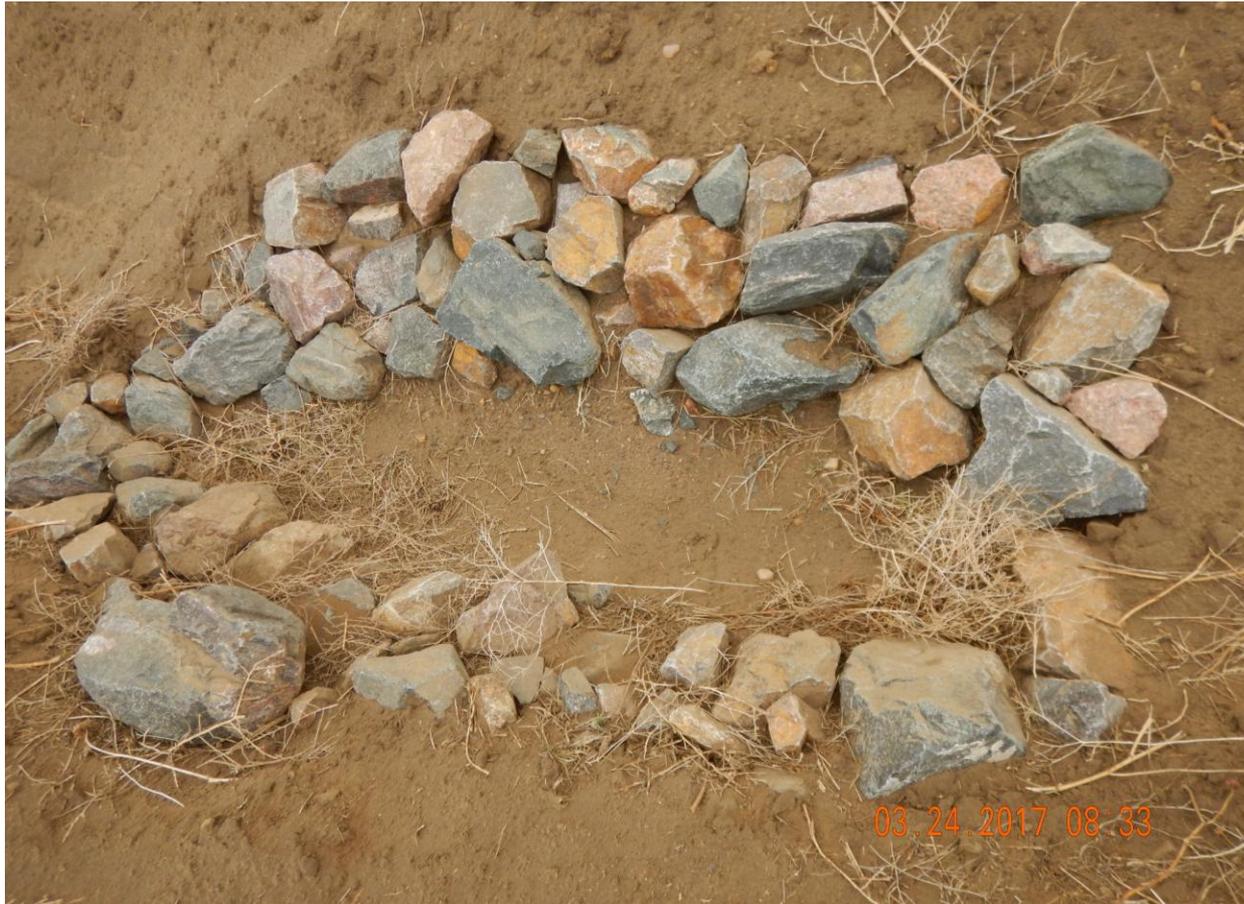
Photo 3: Photo taken from the northwest end of the location. Photo shows sediment trap BMP. BMP has filled with sediment and will require maintenance. It appears only large-sized rock aggregate have been utilized to construct the BMP; using only large aggregates can contribute to erosion degradation as stormwater can be accelerated around or under the material, expanding stormwater impacts and rendering the BMP inadequate.

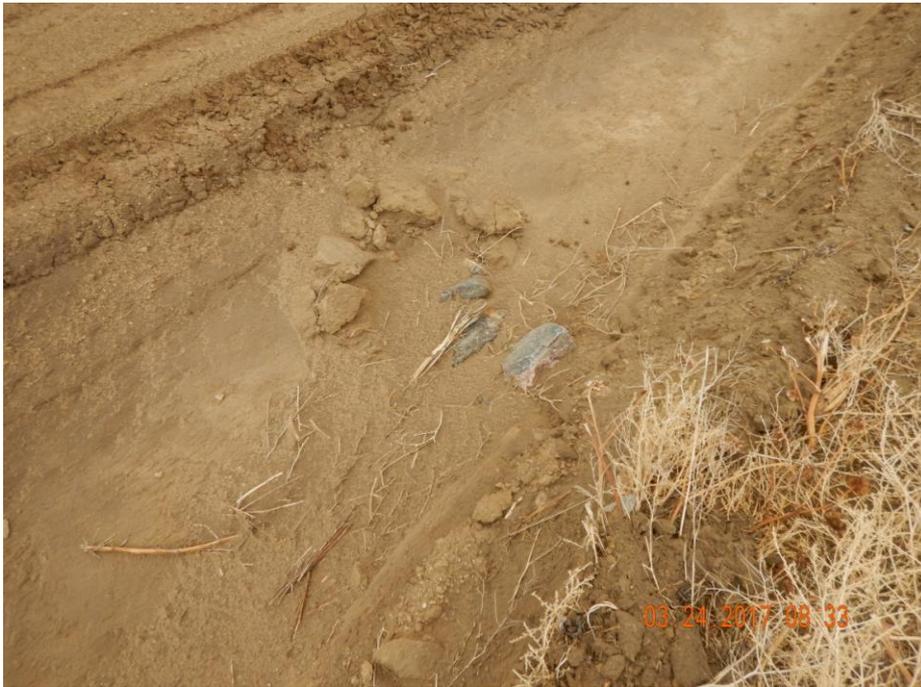
Photo 4: Photo taken from the west end of the location facing southwest. Photo shows rocks in the ditch used as a check-dam. The amount of aggregate and size used is insufficient and inadequate; check-dam has been improperly installed. Check-dam has been inundated with sediment and not in proper functioning condition.

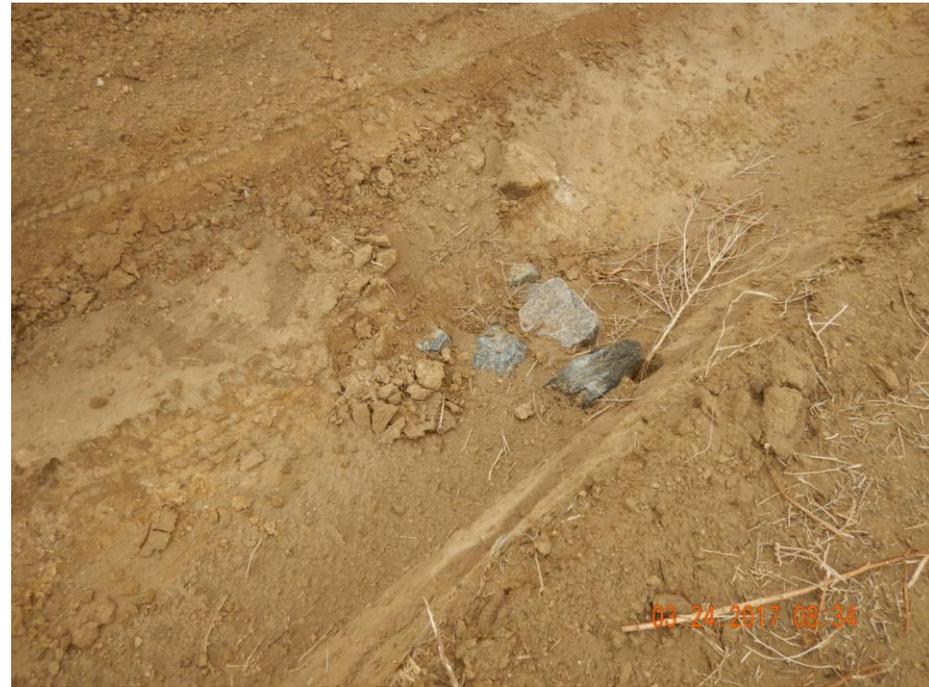
Photo 5: Photo taken from the west end of the location facing southwest. Photo shows rocks in the ditch used as a check-dam. The amount of aggregate and size used is insufficient and inadequate; check-dam has been improperly installed. Check-dam has been inundated with sediment and not in proper functioning condition.

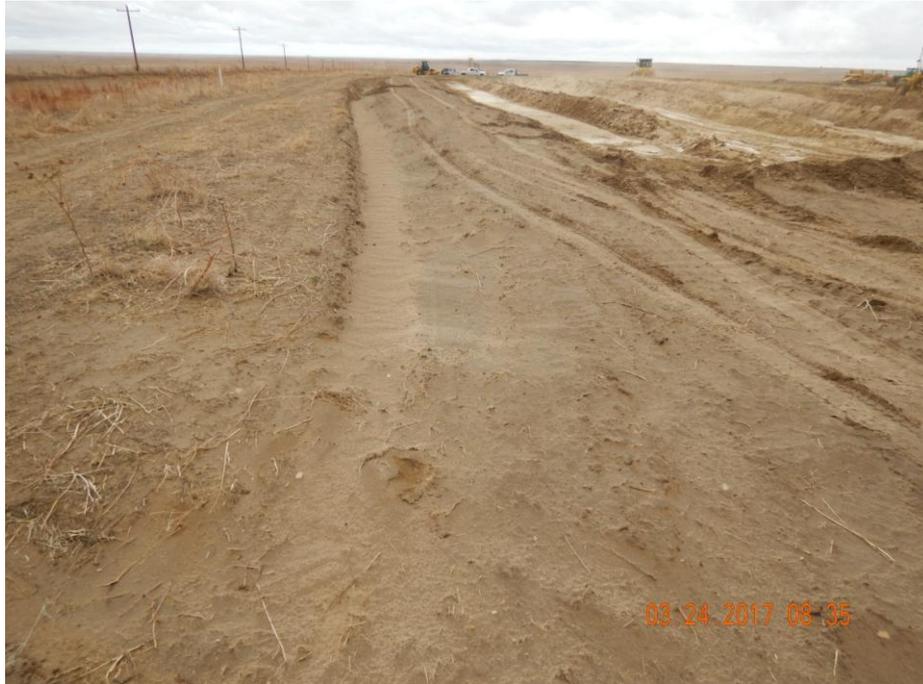
Photo 6: Photo taken from the southwest end of the location facing north. Photo shows stormwater and sediment control ditch along perimeter of the location. Ditch in its current condition is satisfactory as a temporary control for this stage of construction, however, ditch is incomplete in the southwest corner of the location, has not been consolidated and has been constructed with a steep grade. Alternative BMPs will need to be implemented or ditch will need to be upgraded once pad-construction activities have finished. CDOT recommends ditches be constructed with a grade of 2:1.

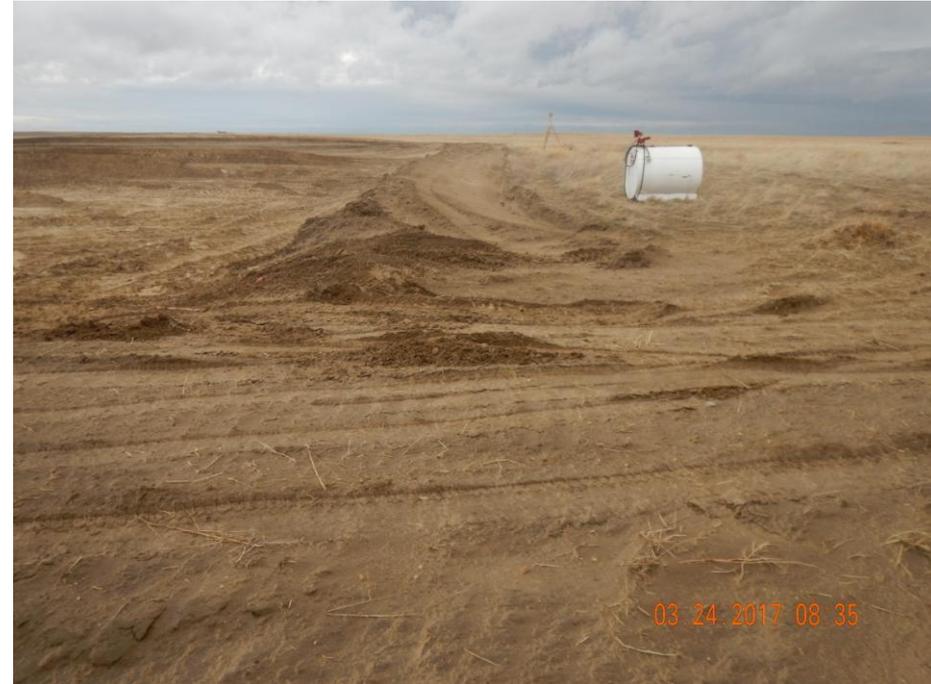
Photo 7: Photo taken from the southwest end of the location facing east. Photo shows stormwater and sediment control ditch along perimeter of the location. Ditch in its current condition is satisfactory as a temporary control for this stage of construction, however, ditch is incomplete in the southwest corner of the location, has not been consolidated and has been constructed with a steep grade. Alternative BMPs will need to be implemented or ditch will need to be upgraded once pad-construction activities have finished. CDOT recommends ditches be constructed with a grade of 2:1.

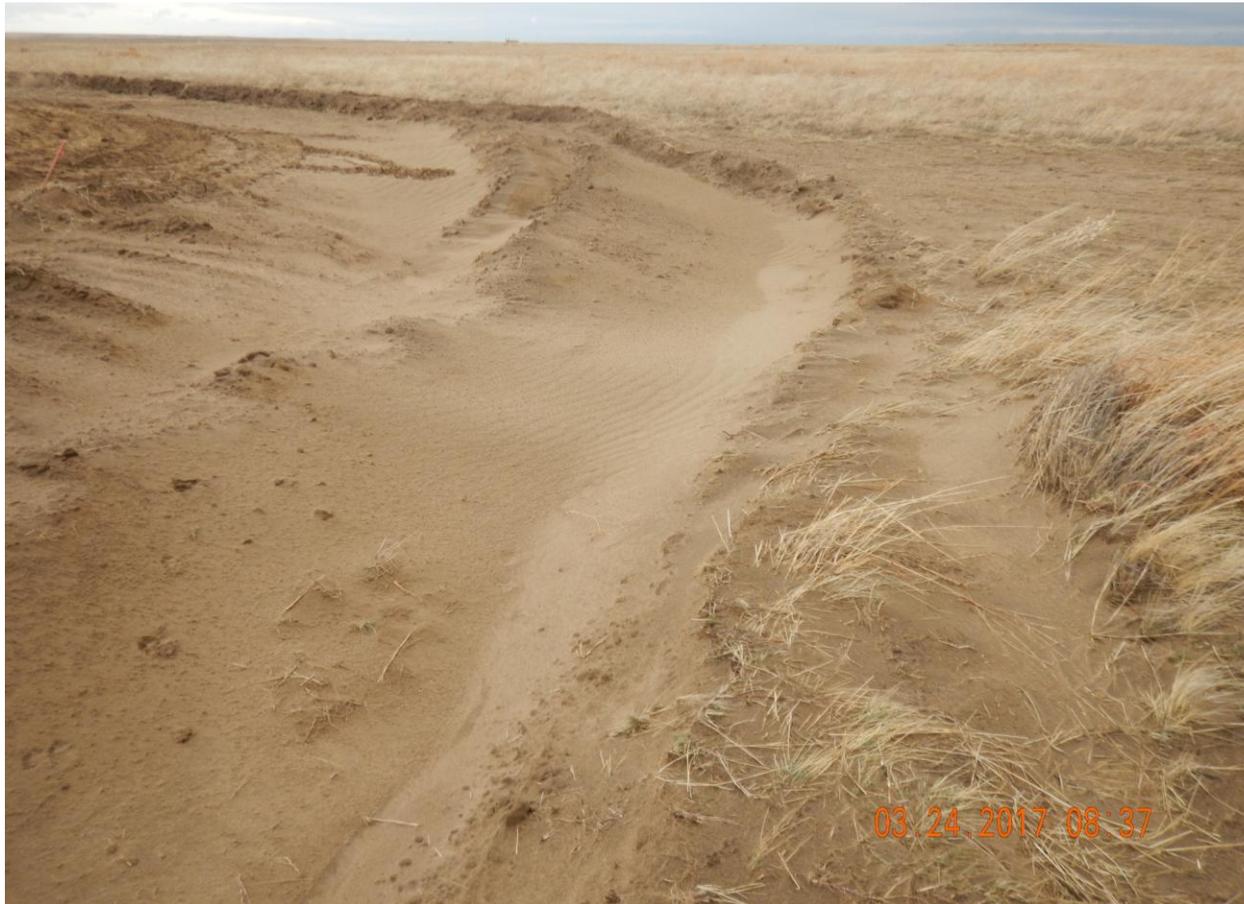
Photo 8: Photo taken from the southeast corner of the location. Photo shows stormwater and sediment control ditch appears shallowly constructed, has become inundated with sediment and requires maintenance.

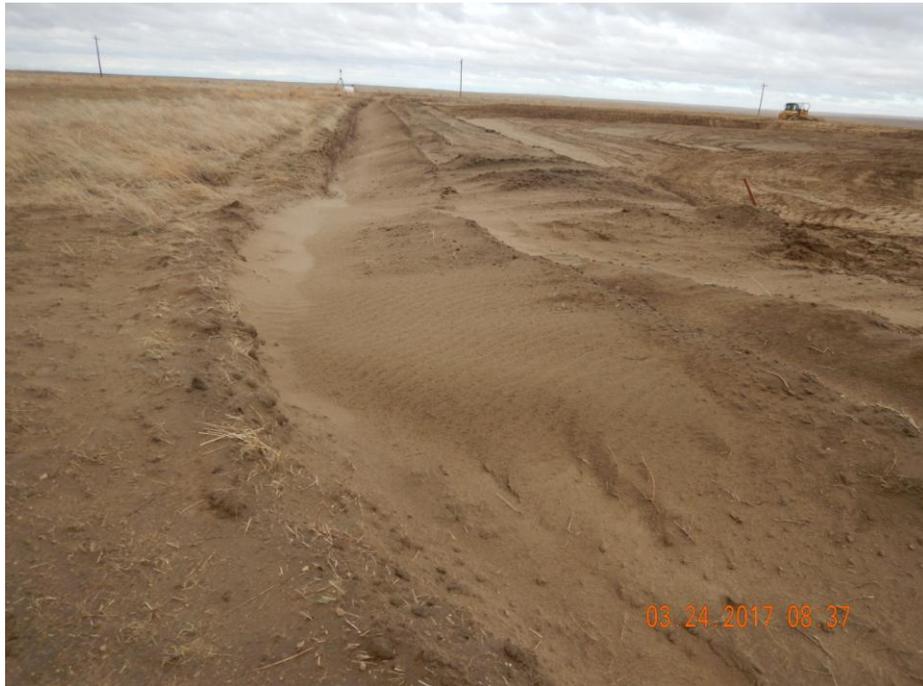
Photo 9: Photo taken from the southeast end of the location facing west. Photo shows stormwater and sediment control ditch appears shallowly constructed, has become inundated with sediment and requires maintenance.

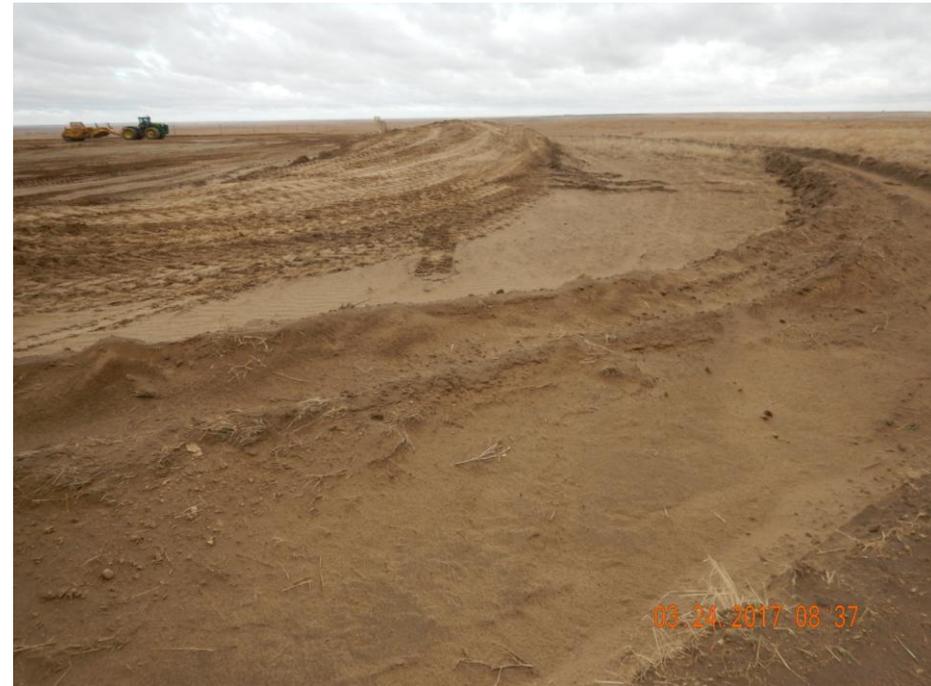
Photo 10: Photo taken from the southeast end of the location facing north. Photo shows stormwater and sediment control ditch along perimeter of the location. Ditch in its current condition is satisfactory as a temporary control for this stage of construction, however, ditch has not been consolidated and has been constructed with a steep grade. Alternative BMPs will need to be implemented or ditch will need to be upgraded once pad-construction activities have finished. CDOT recommends ditches be constructed with a grade of 2:1.

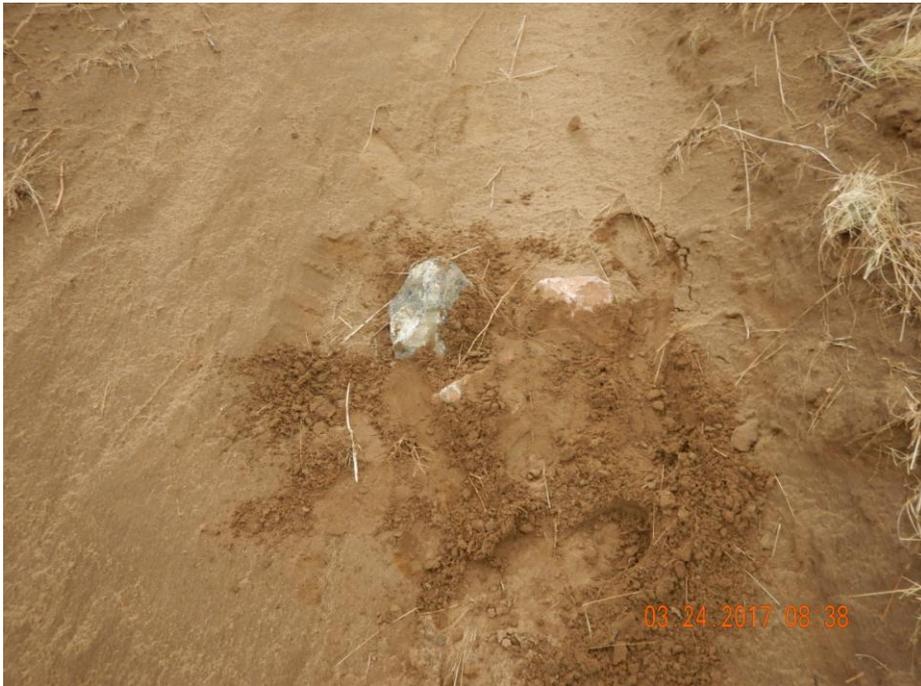
Photo 11: Photo taken from the east end of the location facing southwest. Photo shows rocks in the ditch used as a check-dam. The amount of aggregate and size used is insufficient and inadequate; check-dam has been improperly installed. Check-dam has been inundated with sediment and not in proper functioning condition.

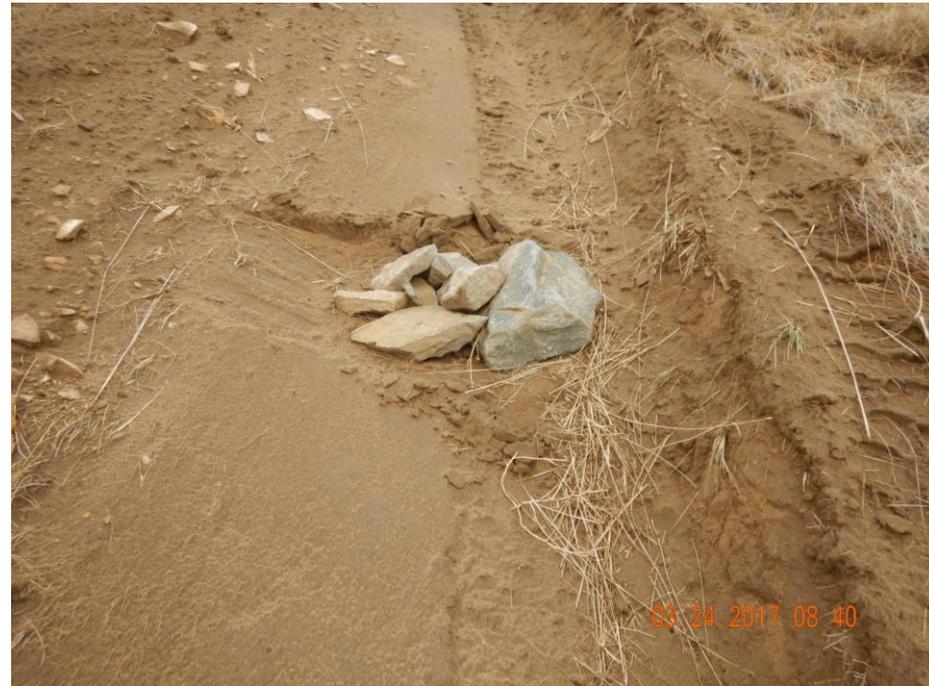
Photo 12: Photo taken from the west end of the location facing southwest. Photo shows rocks in the ditch used as a check-dam. The amount of aggregate and size used is insufficient and inadequate; check-dam has been improperly installed. Check-dam has been inundated with sediment and not in proper functioning condition.

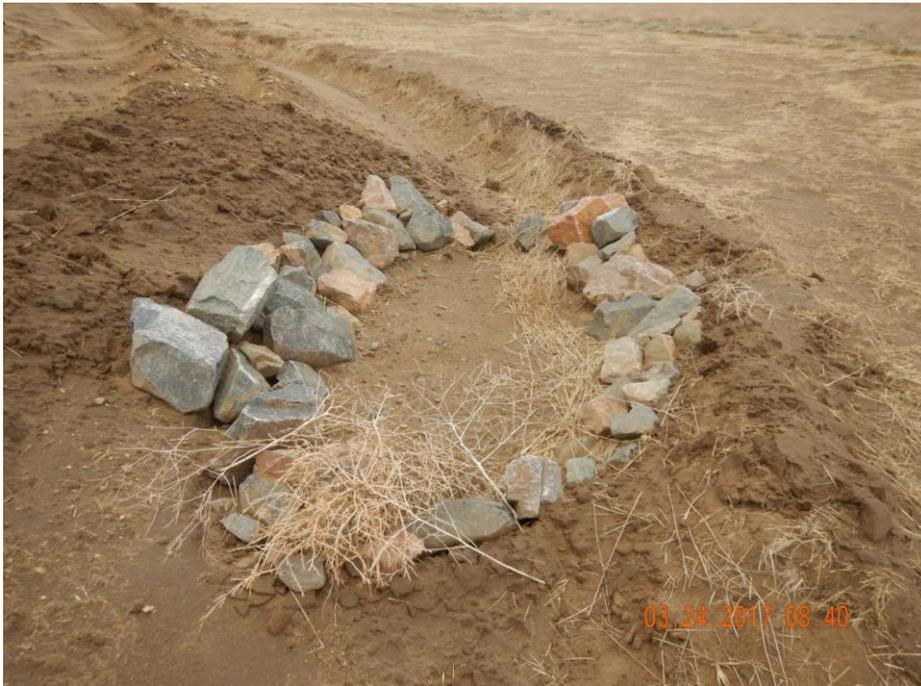
Photo 13: Photo taken from the northeast end of the location. Photo shows sediment trap BMP. BMP has filled with sediment and will require maintenance. The northeast end of the location appears to be the low end topographically. When a large stormwater event occurs, water will likely concentrate in this corner and flow out of the trap/ditch once capacity has been exceeded. Sediment trap does not have an adequate outlet or outlet protection to allow for proper stormwater discharge.

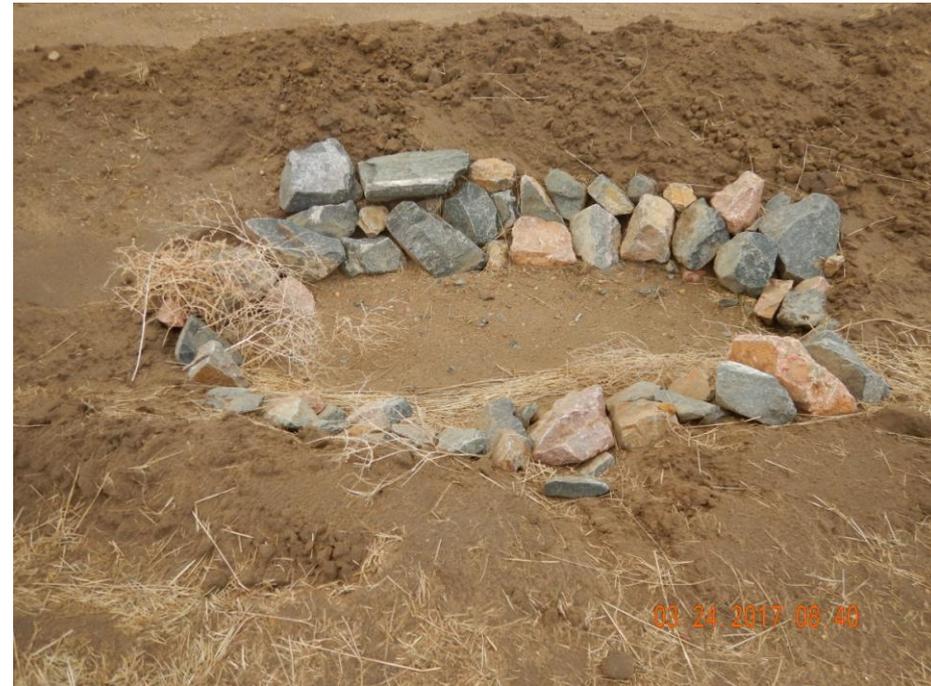
Photo 14: Photo taken from the northeast end of the location. Photo shows sediment trap BMP. BMP has filled with sediment and will require maintenance. The northeast end of the location appears to be the low end topographically. When a large stormwater event occurs, water will likely concentrate in this corner and flow out of the trap/ditch once capacity has been exceeded. Sediment trap does not have an adequate outlet or outlet protection to allow for proper stormwater discharge.

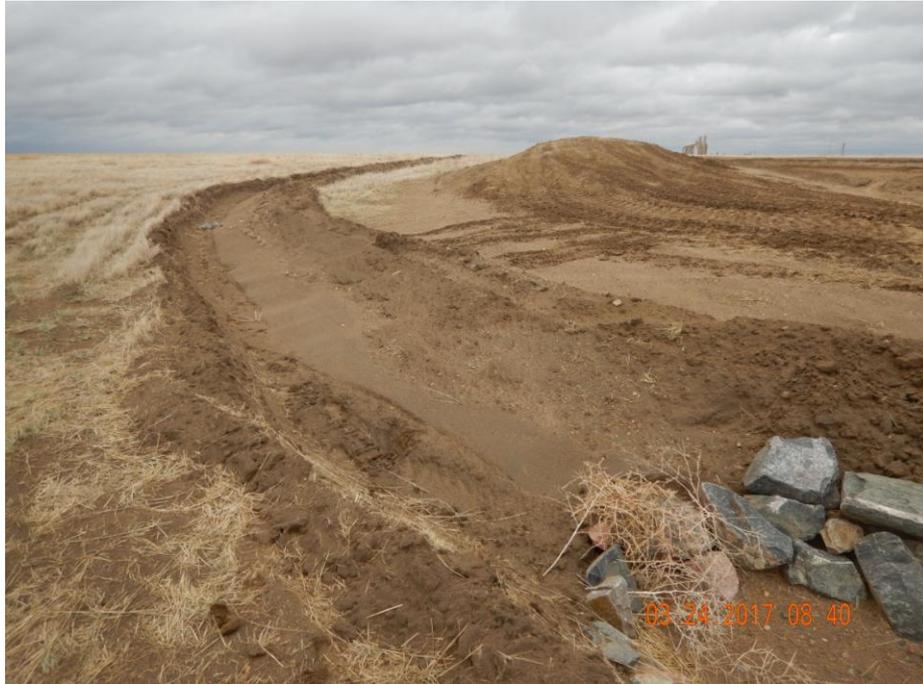
Photo 15: Photo taken from the northeast end of the location facing south. Photo shows stormwater and sediment control ditch along perimeter of the location. Ditch in its current condition is satisfactory as a temporary control for this stage of construction, however, ditch has not been consolidated and has been constructed with a steep grade. Alternative BMPs will need to be implemented or ditch will need to be upgraded once pad-construction activities have finished. CDOT recommends ditches be constructed with a grade of 2:1.

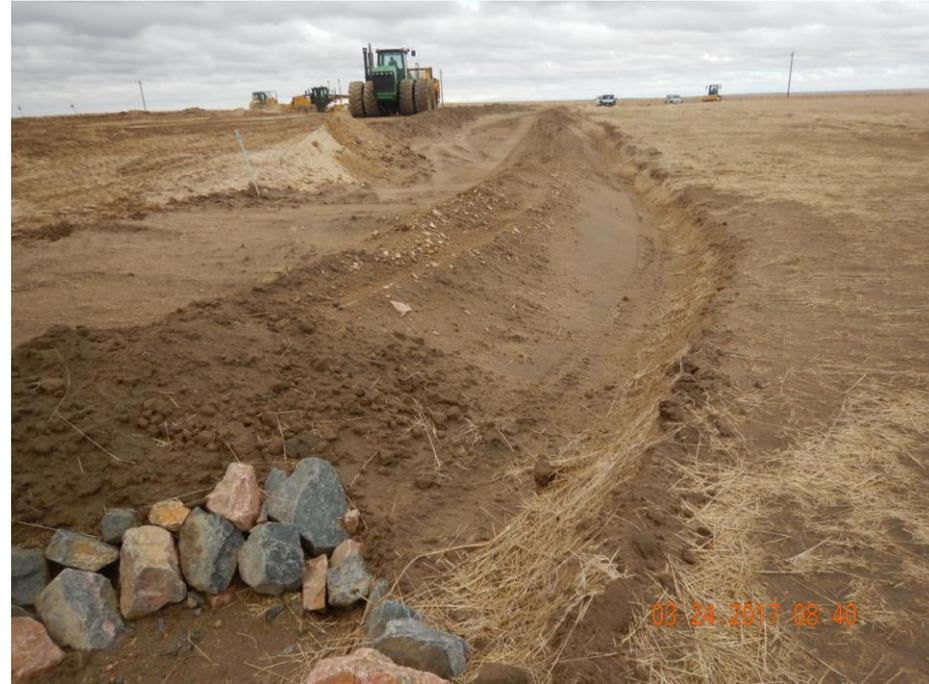
Photo 16: Photo taken from the northeast end of the location facing west. Photo shows stormwater and sediment control ditch along perimeter of the location. Ditch in its current condition is satisfactory as a temporary control for this stage of construction, however, ditch has not been consolidated and has been constructed with a steep grade. Alternative BMPs will need to be implemented or ditch will need to be upgraded once pad-construction activities have finished. CDOT recommends ditches be constructed with a grade of 2:1.

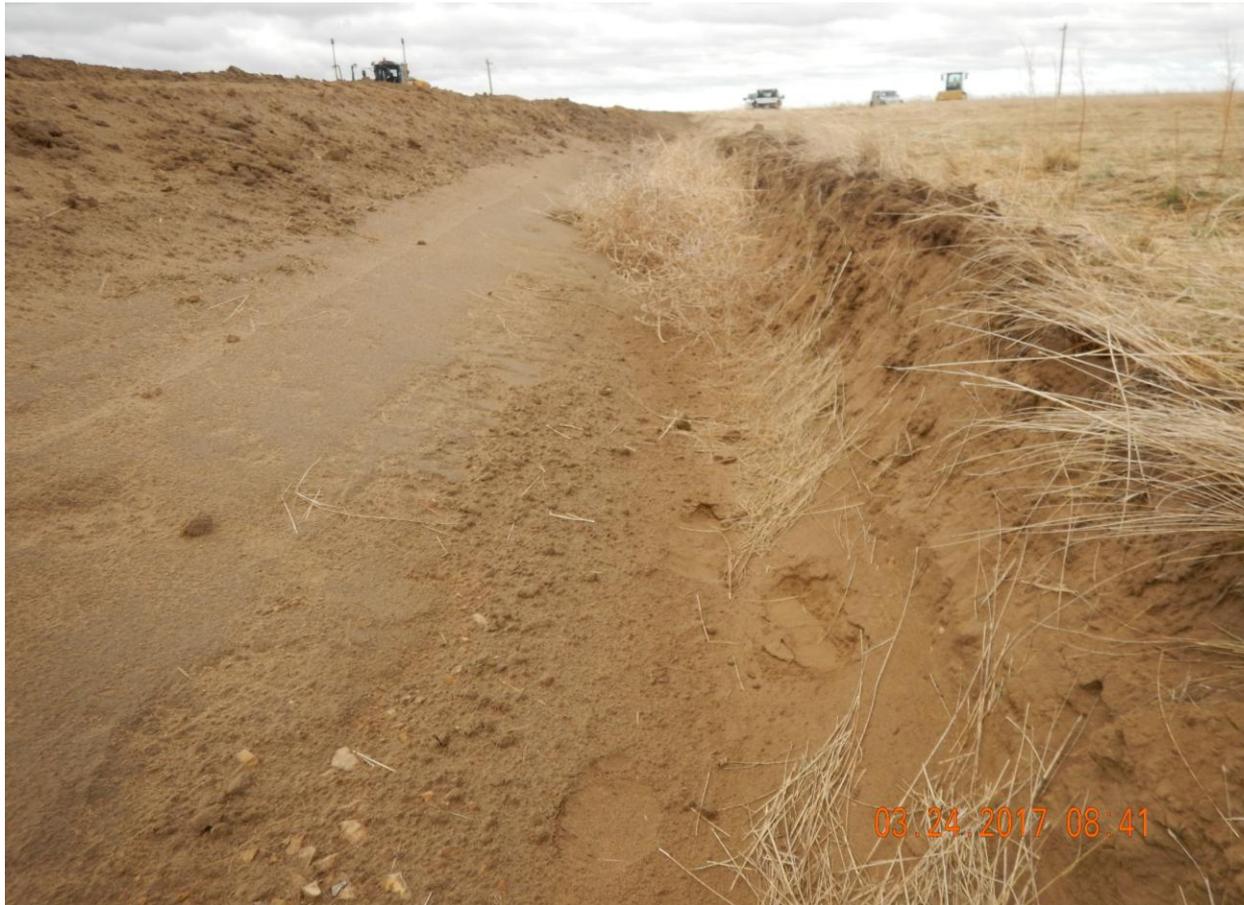
Photo 17: Photo taken from the north end of the location facing west. Photo shows stormwater and sediment control ditch along perimeter of the location. Photo shows ditch has not been consolidated and has been constructed with a steep grade. Alternative BMPs will need to be implemented or ditch will need to be upgraded once pad-construction activities have finished. CDOT recommends ditches be constructed with a grade of 2:1.

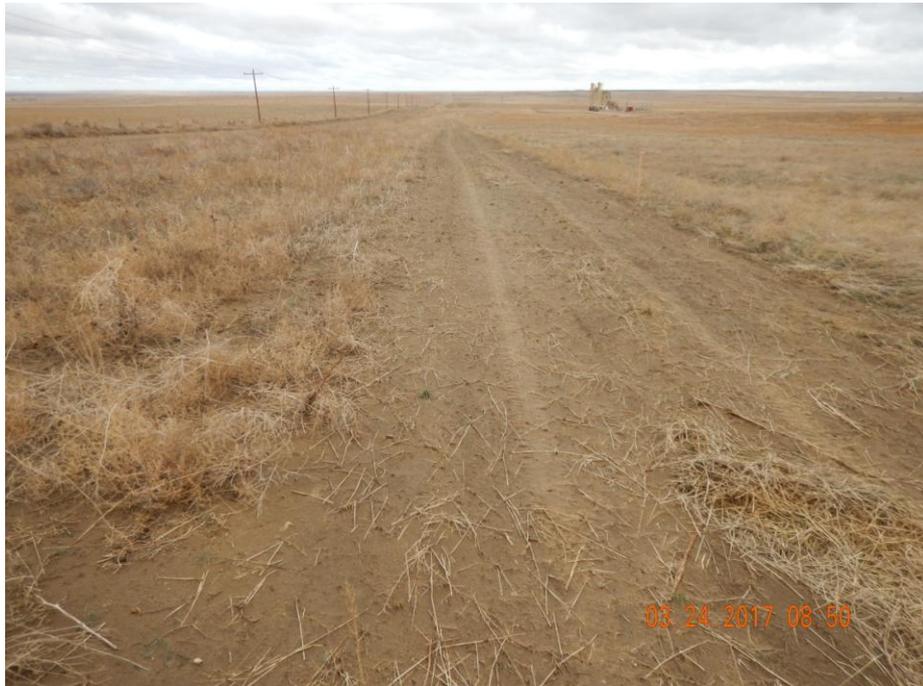
Photo 18: Photo taken from the access road leading north from the location. Photo shows no vehicle tracking BMPs has been implemented to mitigate sediment tracked from the construction site.

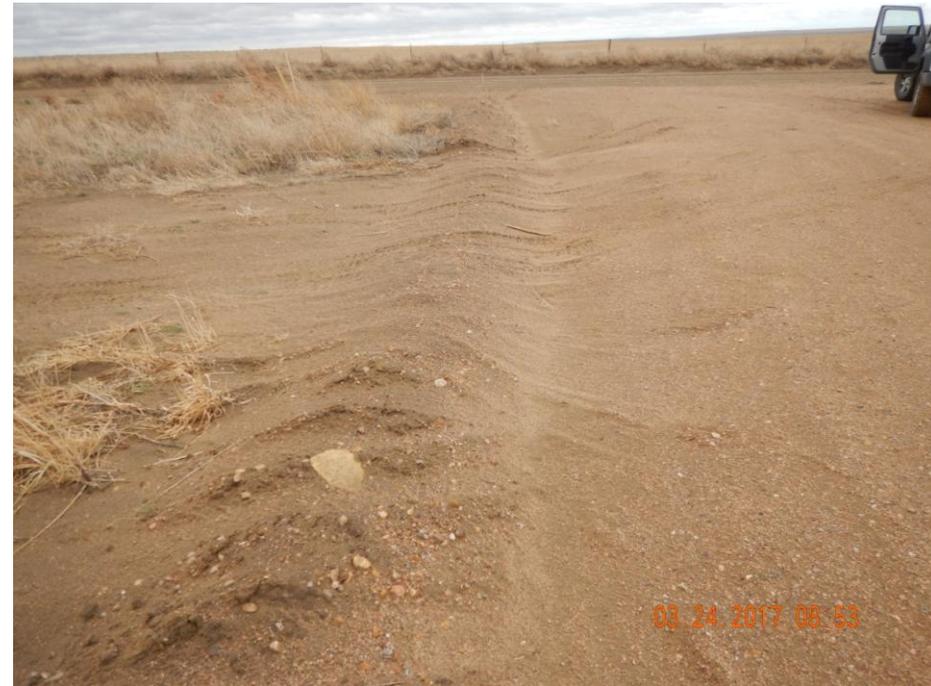
Photo 19: Photo taken from access road north of the location. Photo shows area where access road intersects a second location's access road. Photo shows no vehicle tracking BMPs has been implemented to mitigate sediment tracked from the construction site. In addition, vehicle traffic has traveled over the second access road's ditch BMP; equipment traffic should be kept off BMPs to ensure they function properly. Suggest using an alternative BMP (such as a culvert, cattle guard, ramp, etc...) to mobilize equipment over to mitigate potential negative impacts to stormwater BMPs.
