Inspection Photos
Location Name: State 36-3-9
API: 05-123-19794

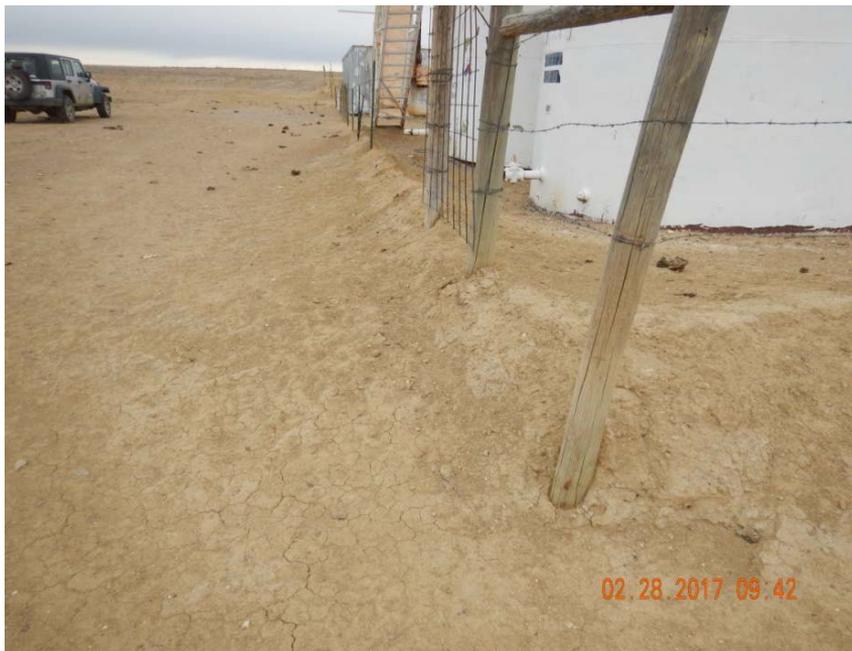
Photo from prior inspection by A Trujillo

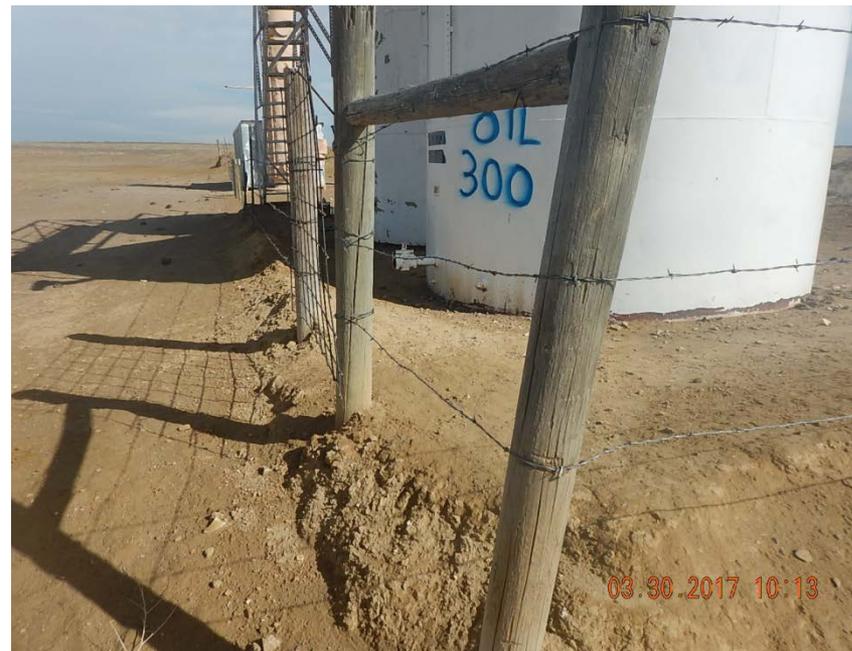
Photo 1: Berms low to nonexistent

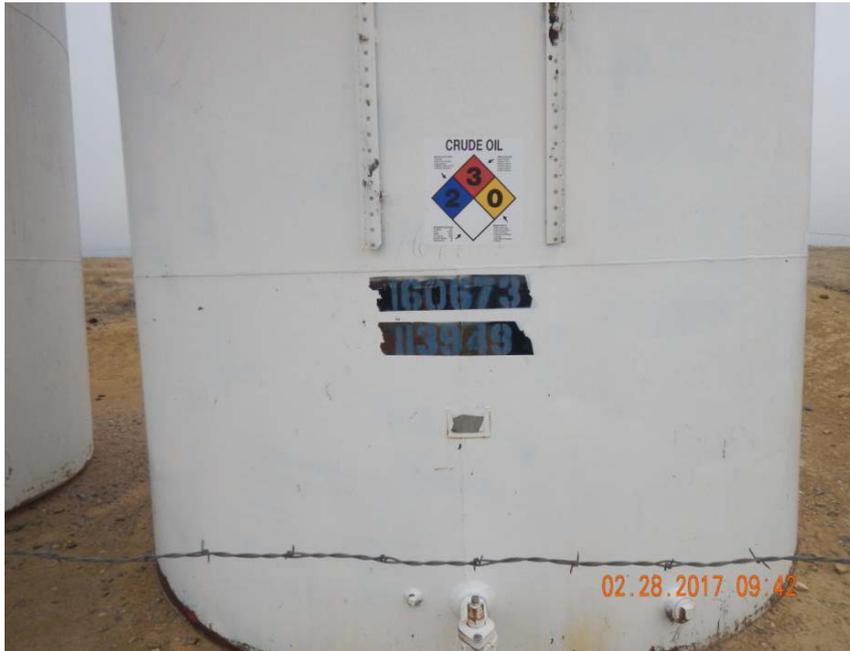
Photo from prior inspection by A Trujillo

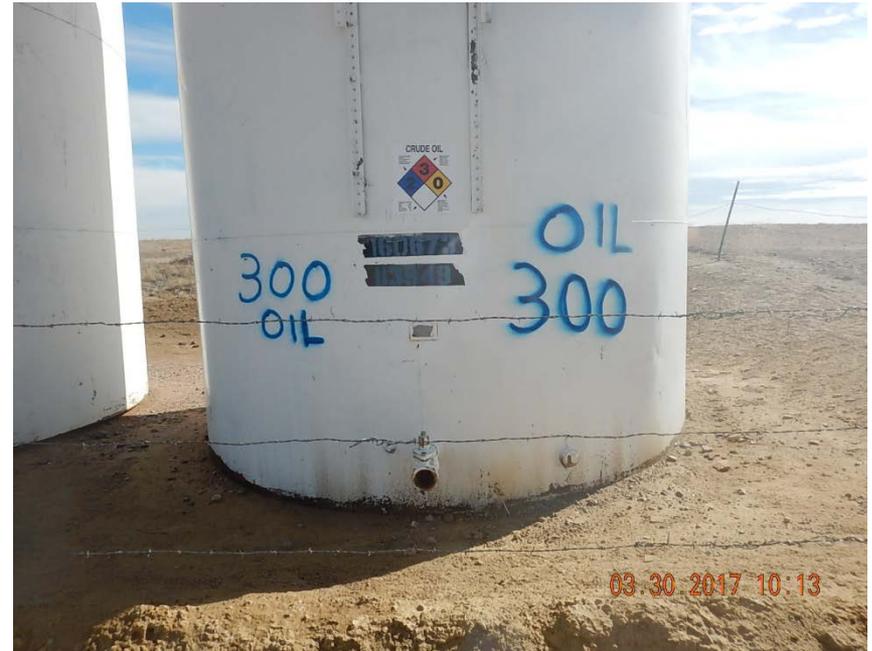
Photo 2: Tanks have been labeled with capacity

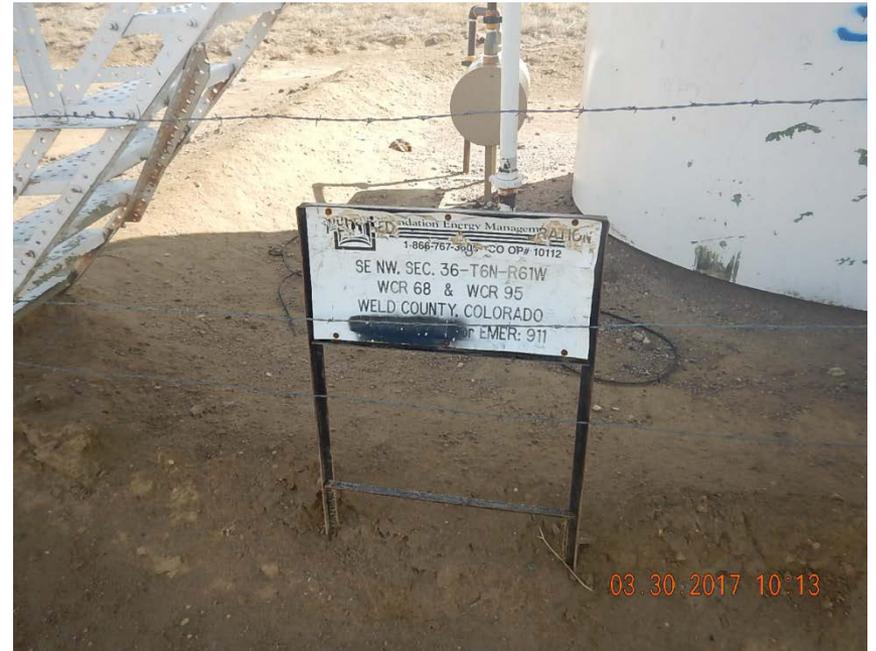
Photo 3: Sign illegible, does not mention state battery

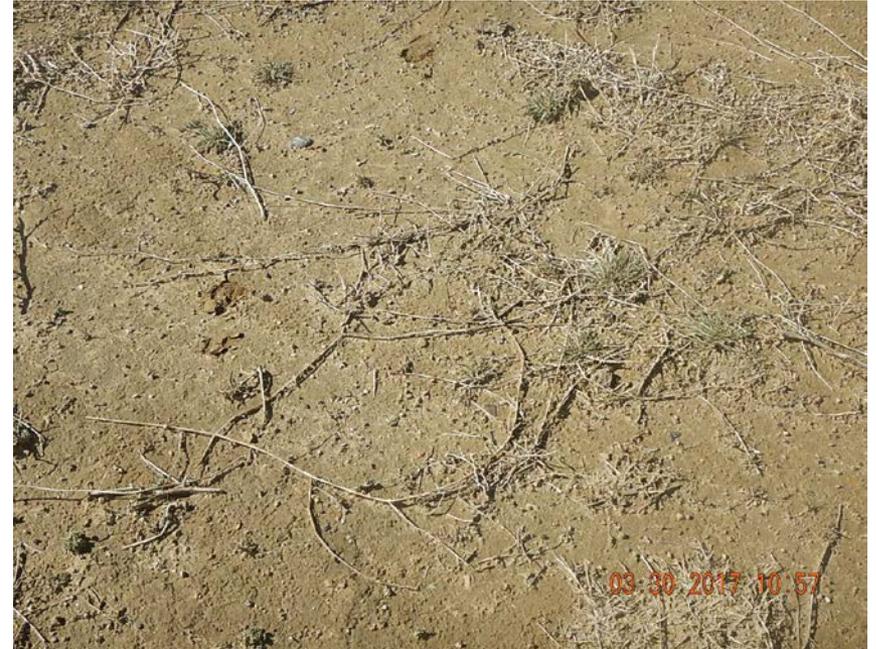
Photo 4: Weeds on location

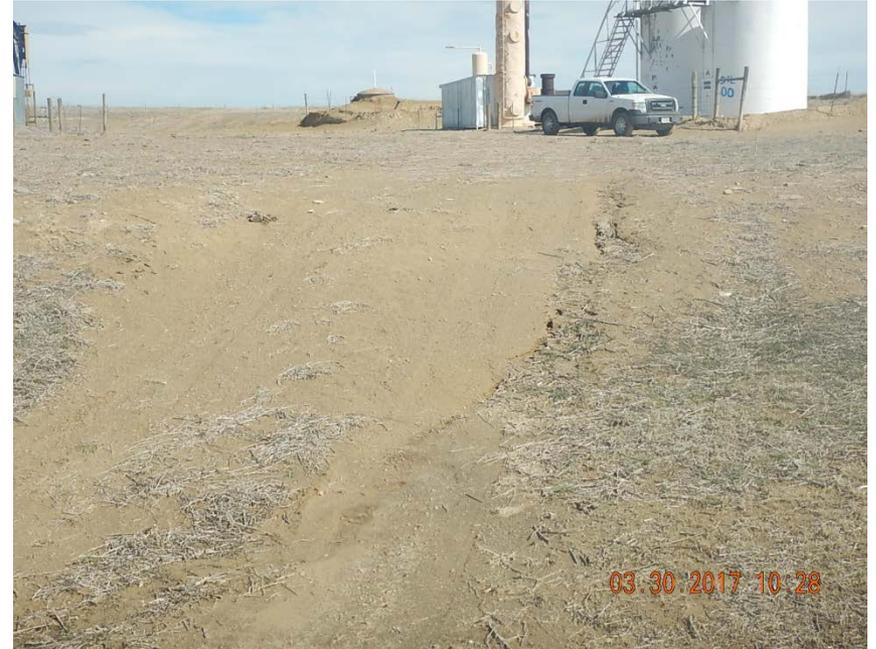
Photo 5: Stormwater runoff on SE corner of location

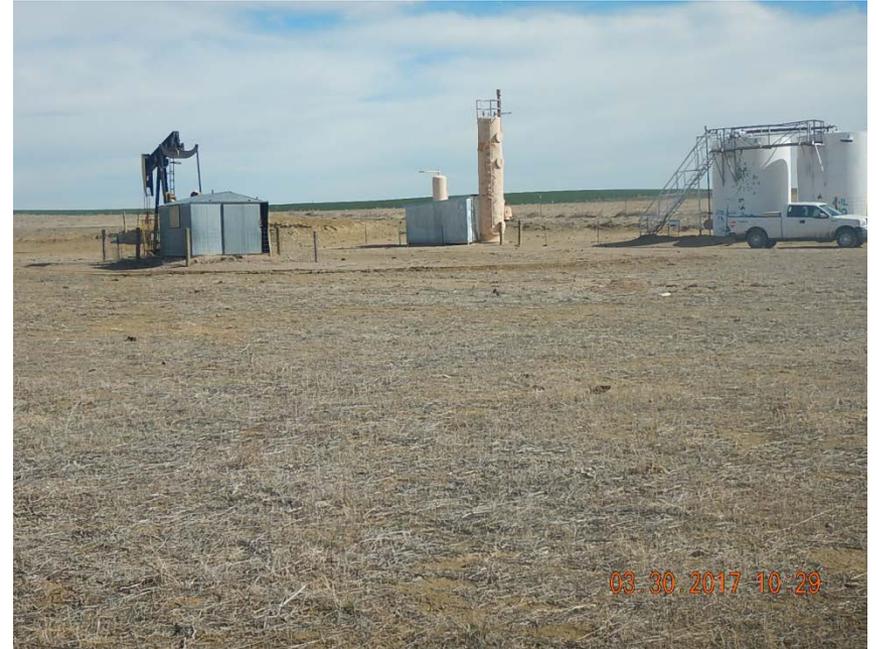
Photo 6: Site photo for reclamation

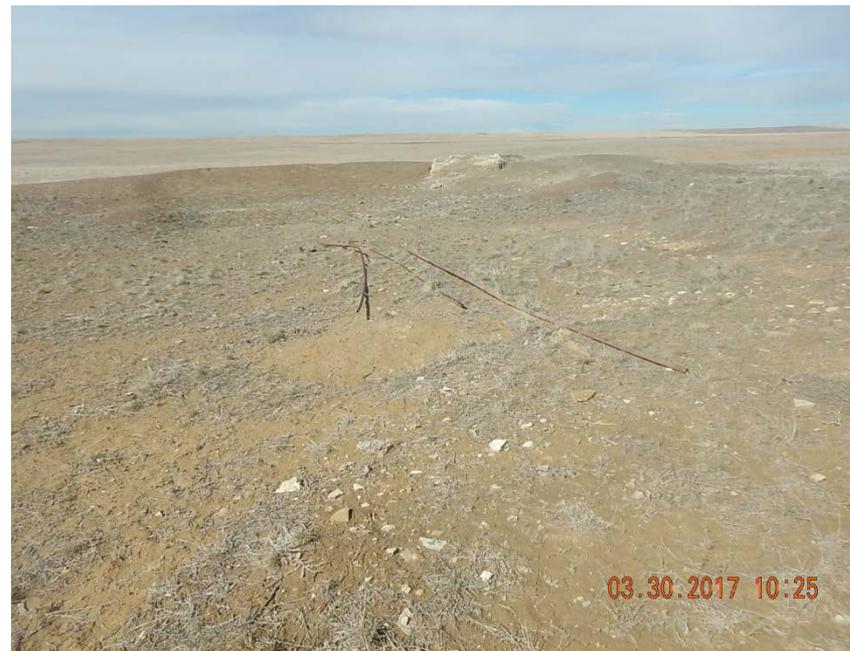
Photo 7: Unused rods

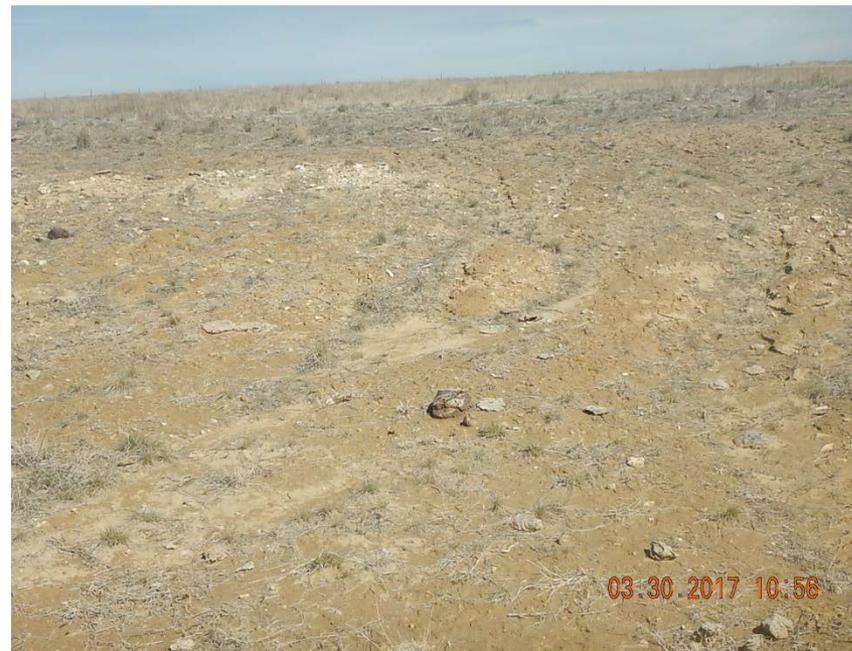
Photo 8: Stormwater erosion on N side of location, looking N

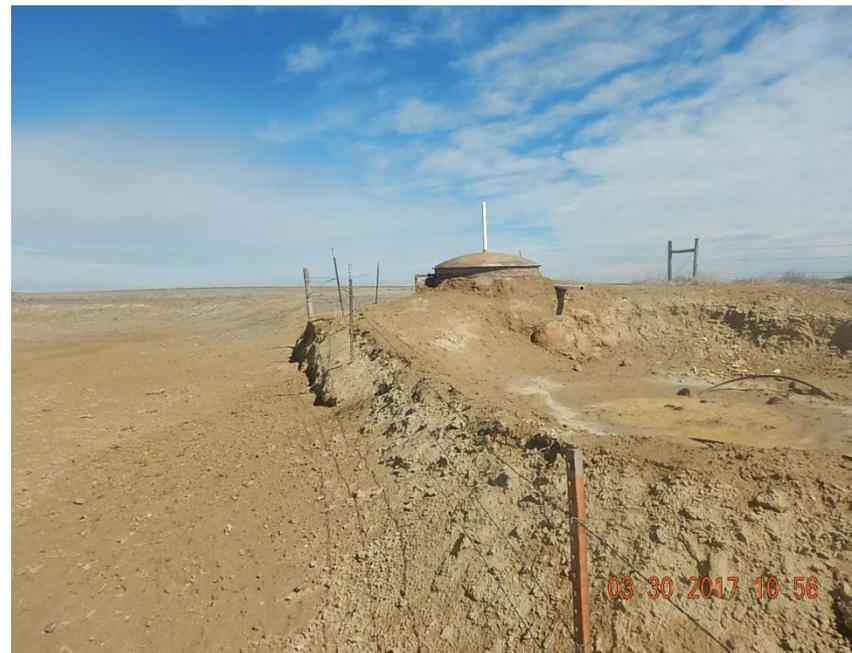
Photo 9: Unpermitted pit

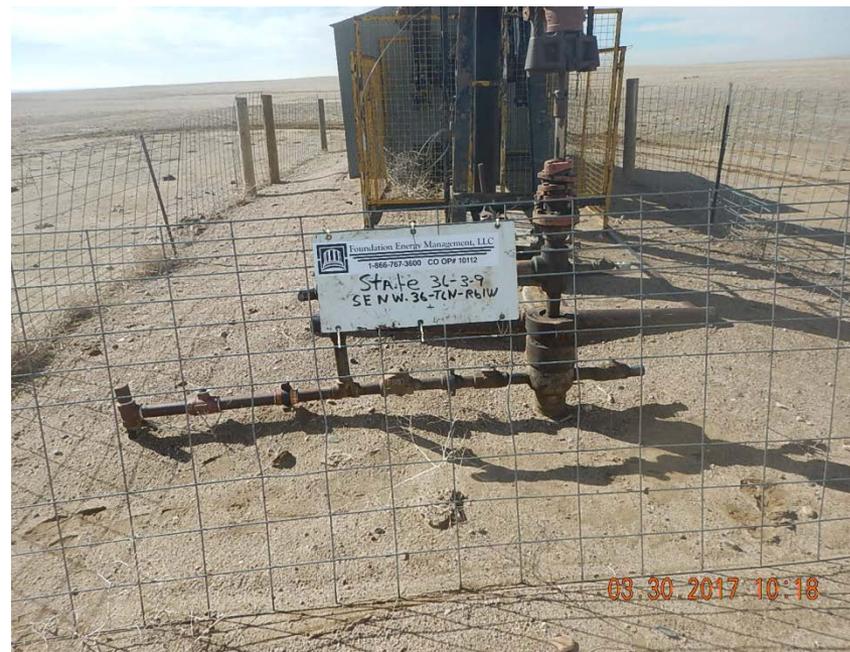
Photo 10: Wellhead sign

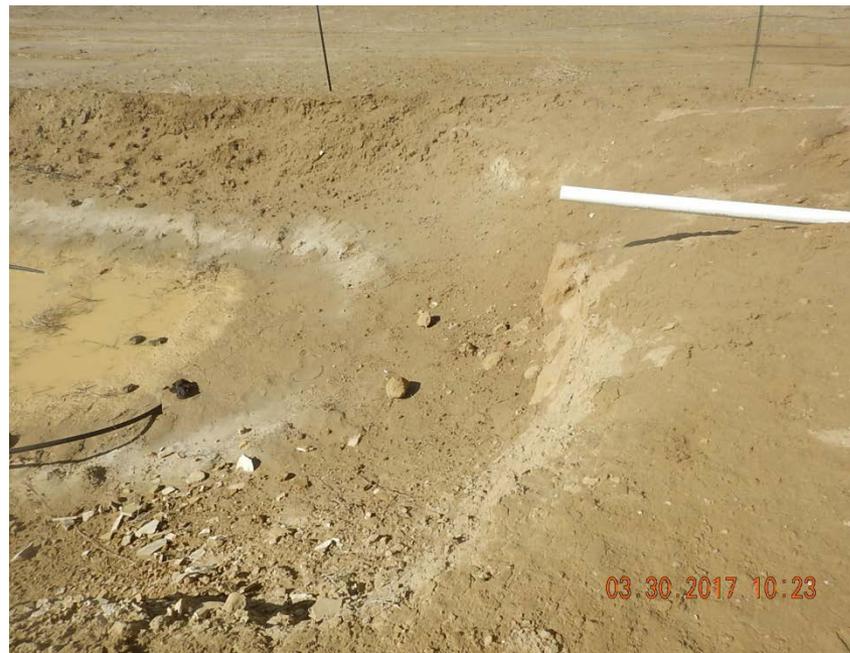
Photo 11: Stained soil has been addressed

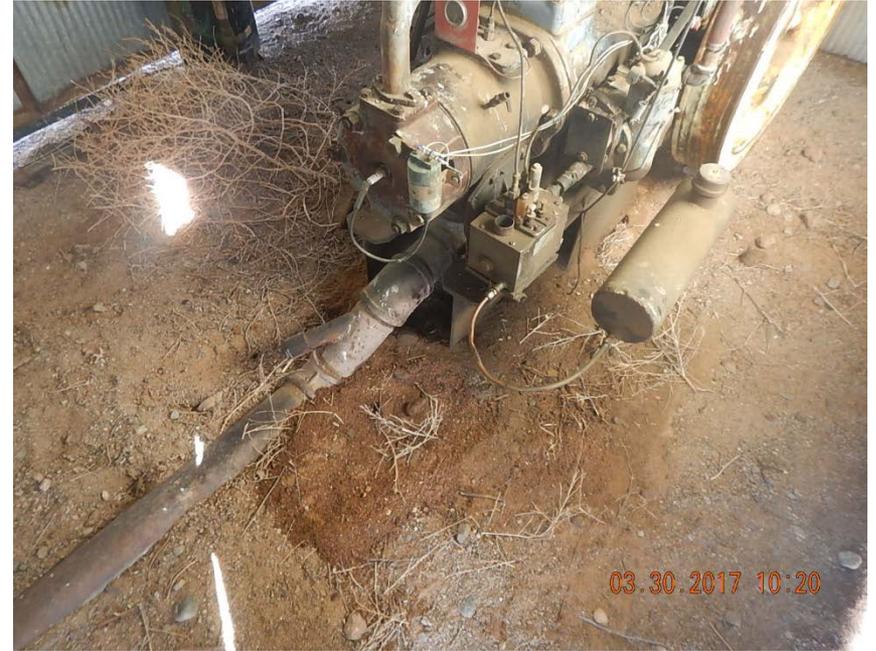
Photo 12: Stained soil has been addressed

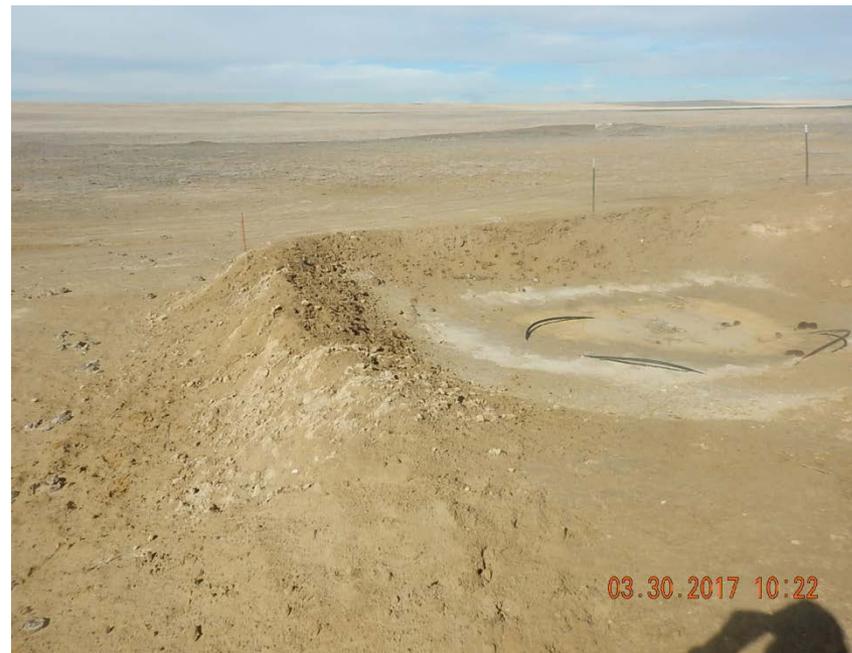
Photo 13: Pit wall built up, 2+ feet of freeboard

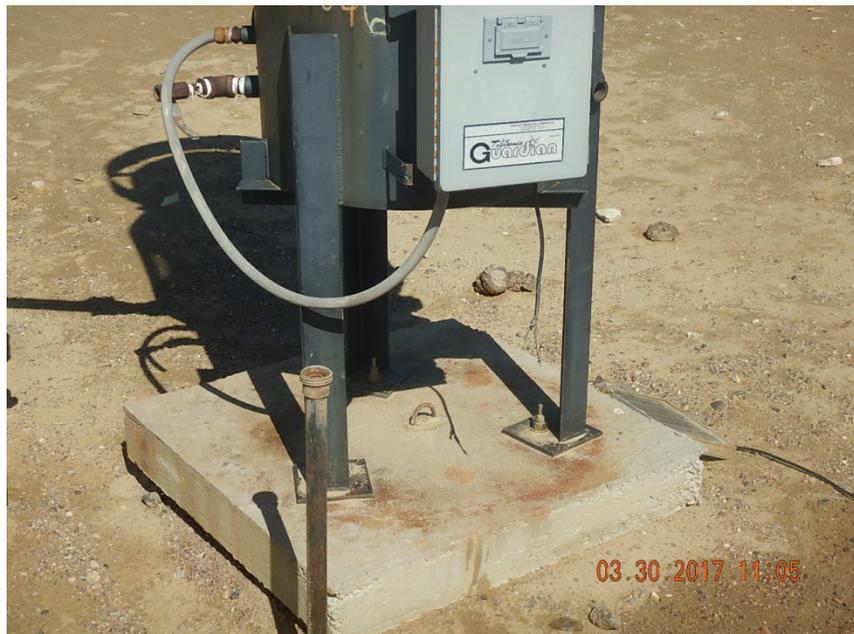
Photo 14: ECD disconnected from treating equipment

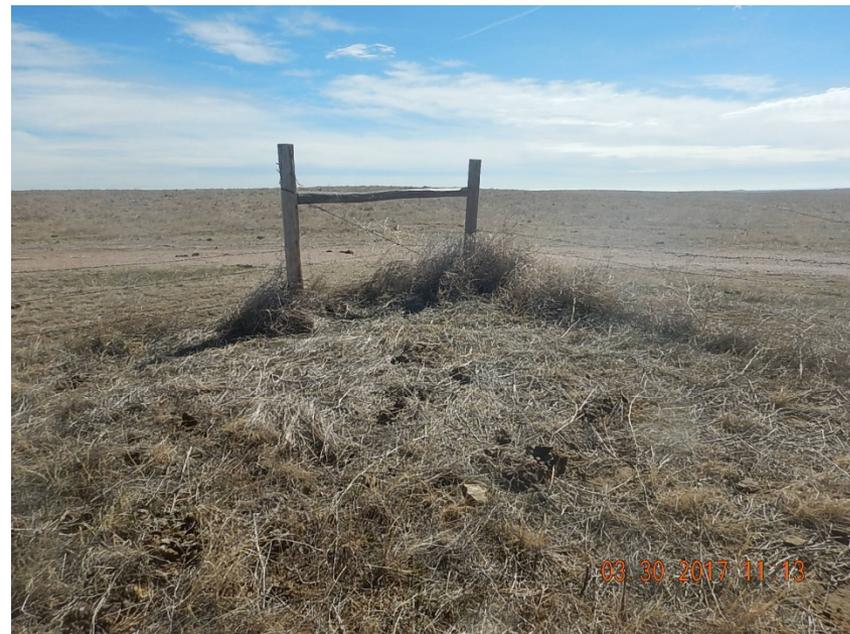
Photo 15: Low fence, manure inside tank battery

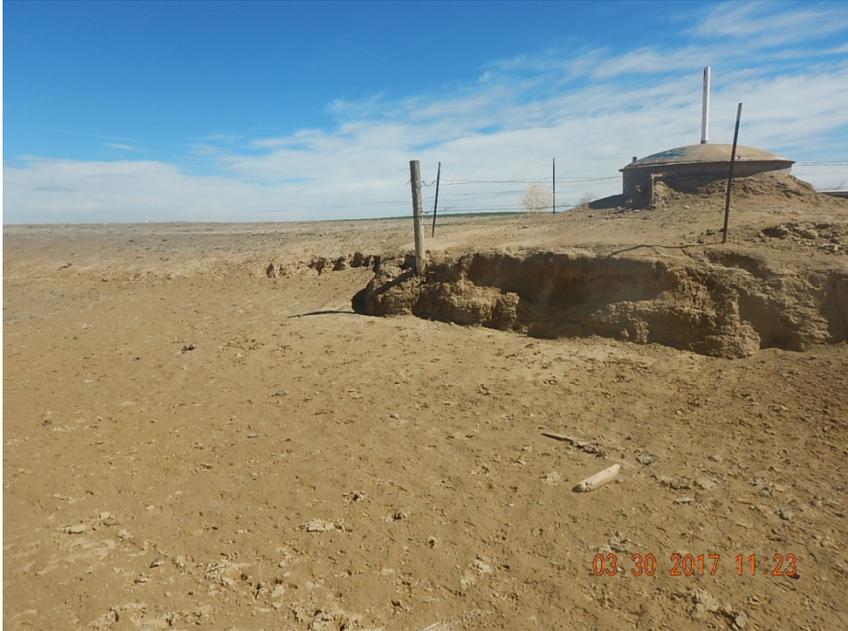
Photo 16: Fence post exposed on NW corner of pit
