# Construction and Stormwater Inspection

March 27, 2017

Operator: KERR MCGEE OIL & GAS ONSHORE LP  
#47120

Location ID: 331768

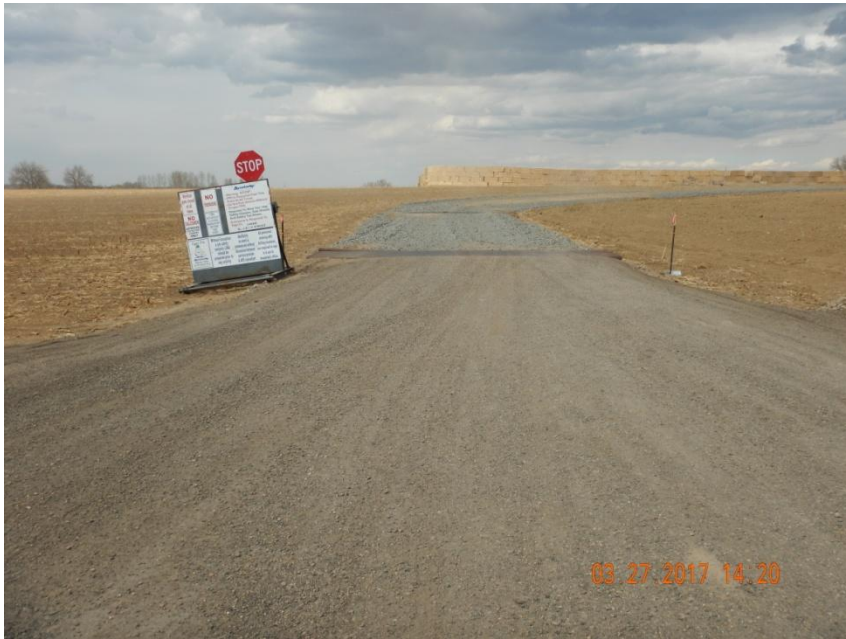
**Photo 1.** Photo taken from the entrance of location, facing North. Vehicle tracking pad installed and appears to be properly functioning.

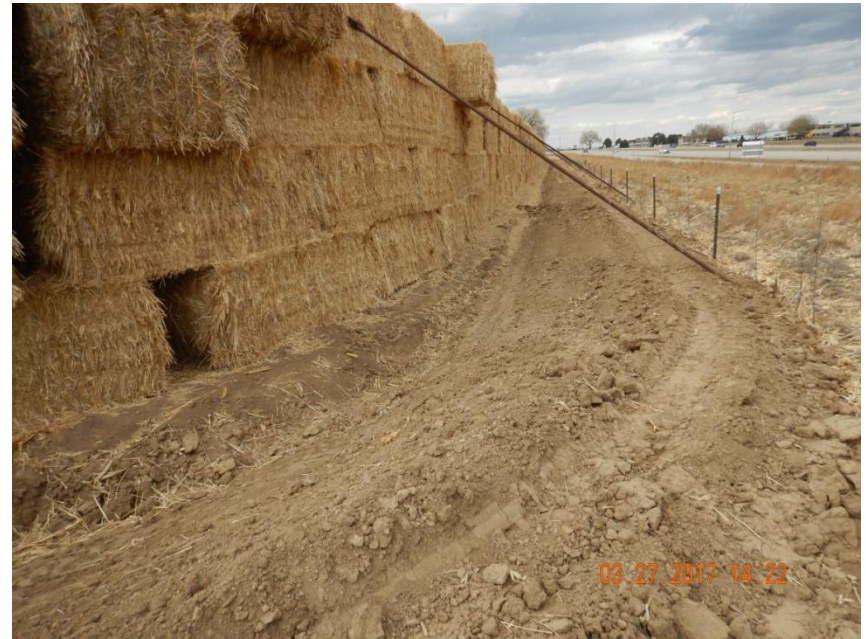
**Photo 2.** Photo taken from the southeast location, facing North. Ditch and berm BMP installed around perimeter of location.

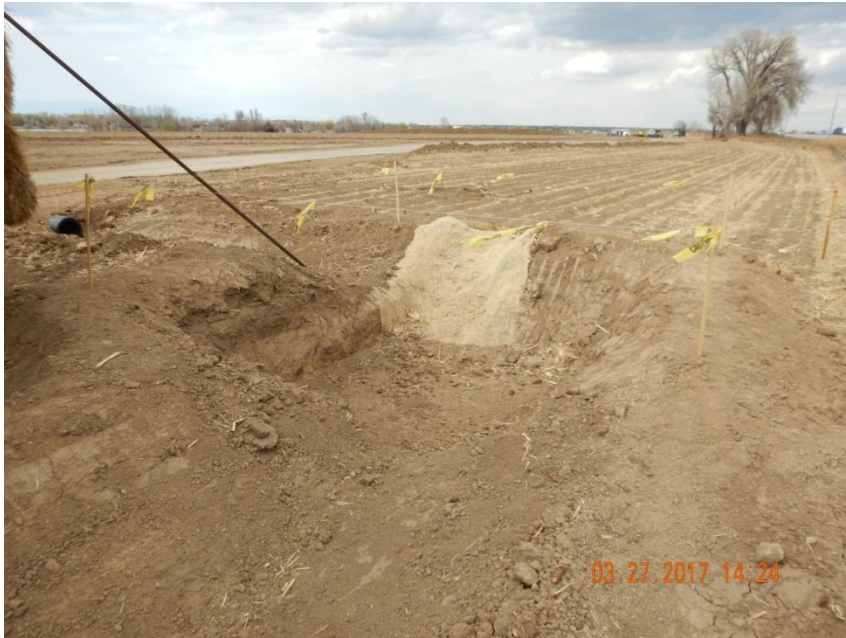
**Photo 3.** Photo taken from the northeast location, facing North. Sediment trap installed with outlet protection in the form of a blanket and wattle.

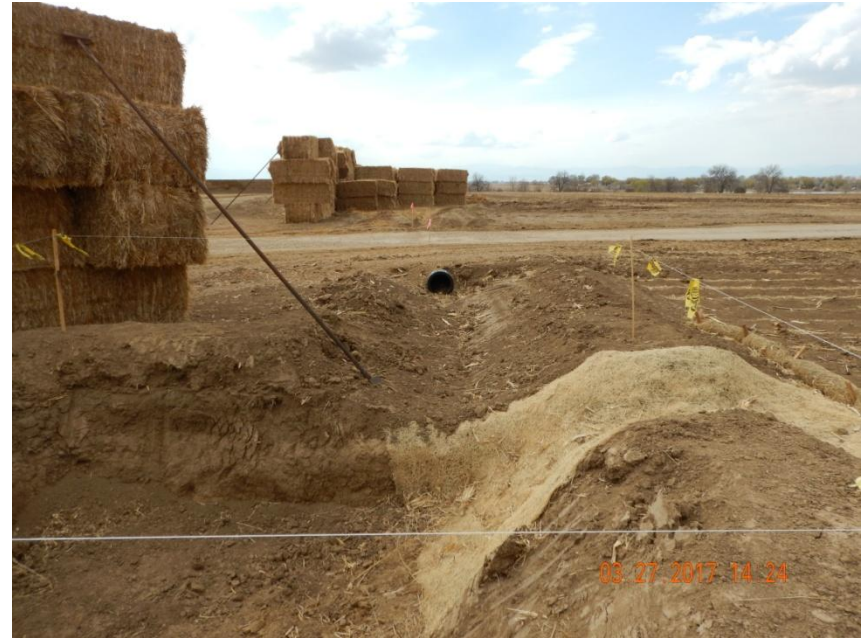
**Photo 4.** Photo taken from the northeast location, facing West. Culvert installed in conjunction with the ditch and berm BMP that is directed to the sediment trap.

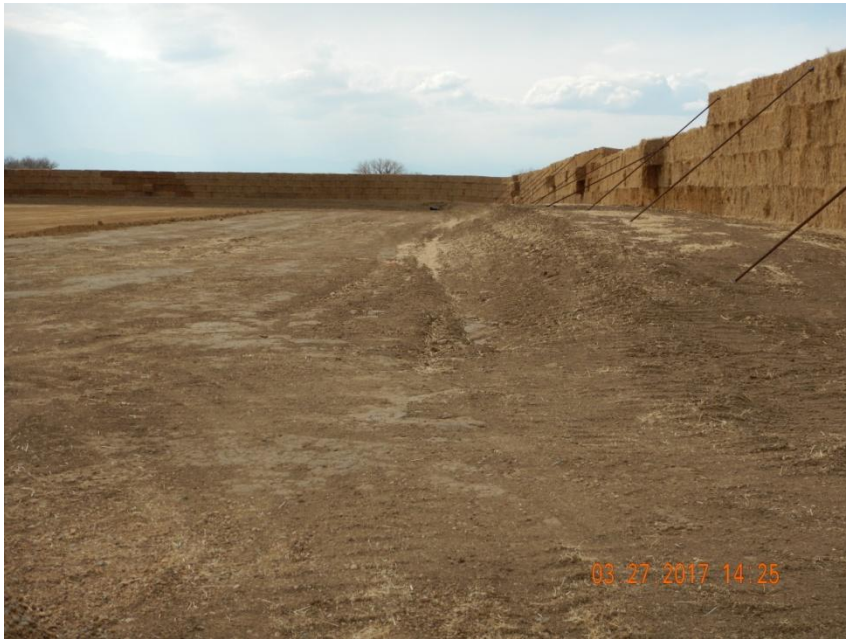
**Photo 5.** Photo taken from the northern production location, facing West. Topsoil salvaged and stored along the northern and western perimeter of the production location.

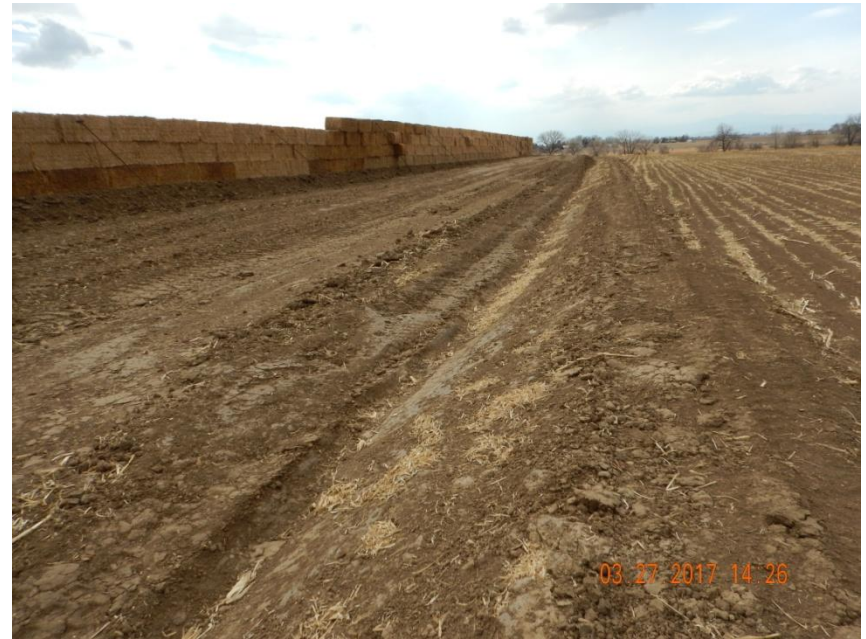
**Photo 6.** Photo taken from the northern location, facing West. Ditch and berm BMP installed around perimeter of location.

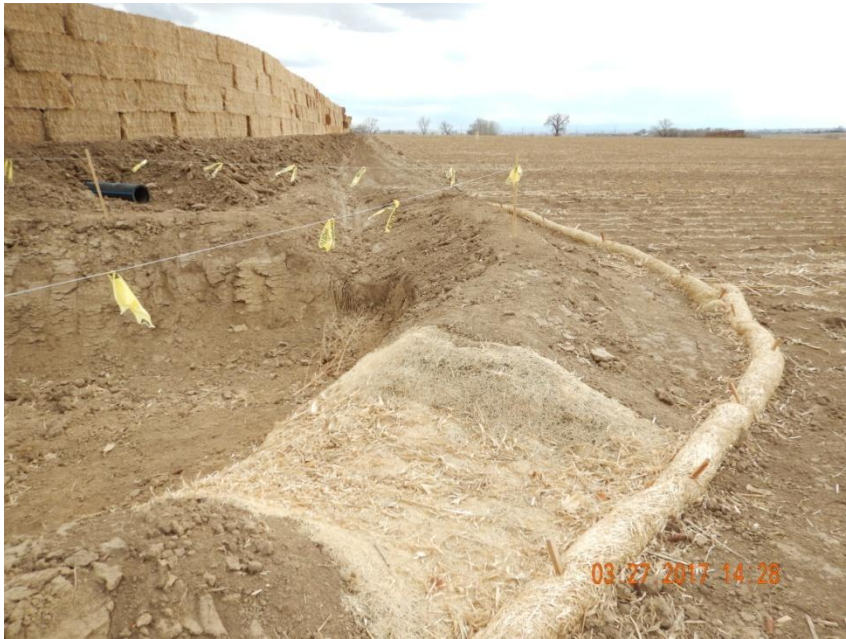
**Photo 7.** Photo taken from the northwest location, facing South. Sediment trap installed with outlet protection in the form of a blanket and wattle.

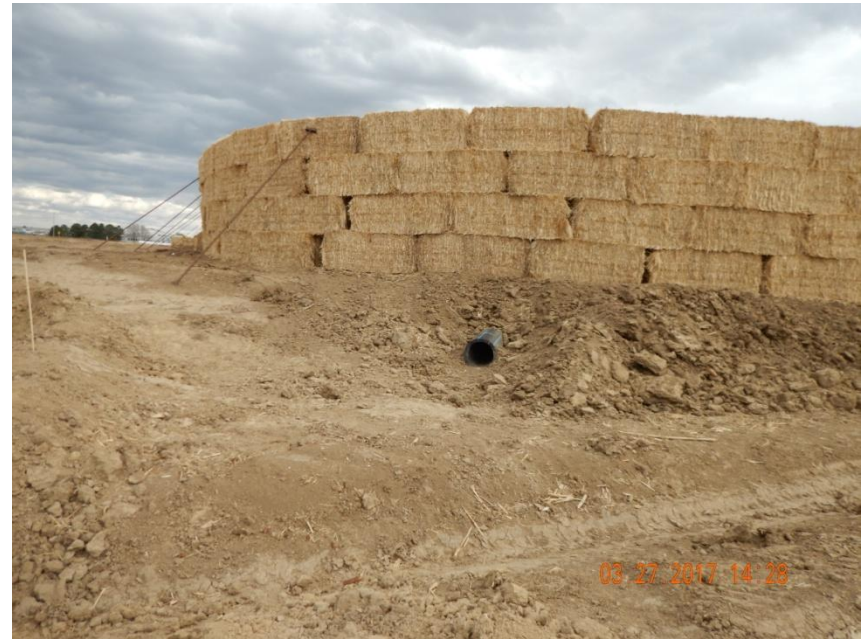
**Photo 8.** Photo taken from the northwest location, facing Southeast. Culvert has been installed directing stormwater runoff from the production area to the northwest sediment trap.

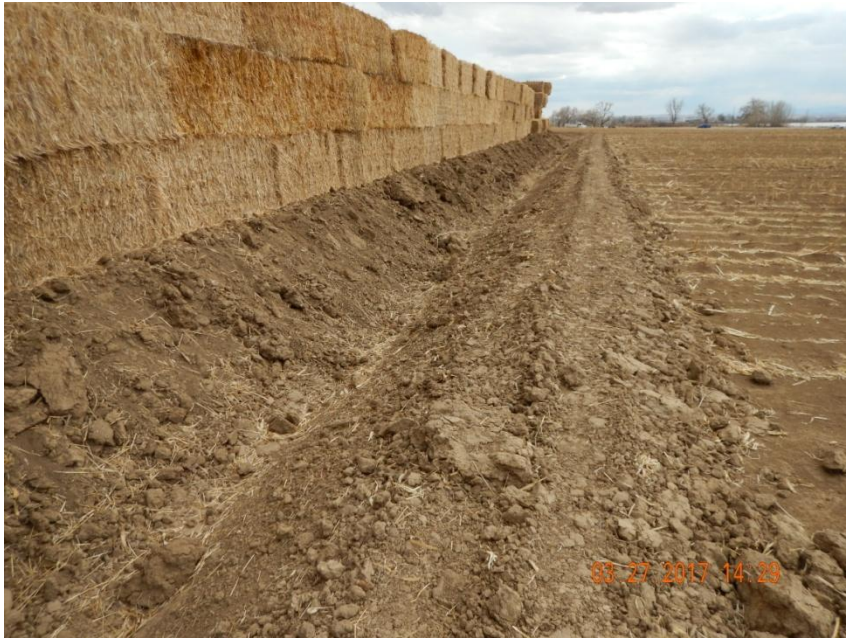
**Photo 9.** Photo taken from the western location, facing South. Ditch and berm BMP installed around perimeter of location.

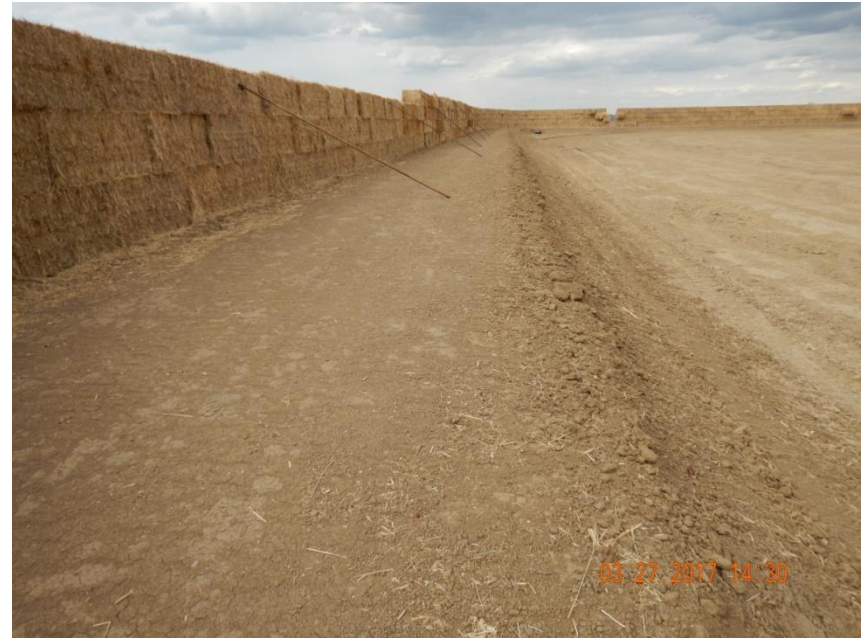
**Photo 10.** Photo taken from the western production location, facing North. Topsoil salvaged and stored along the northern and western perimeter of the production location.

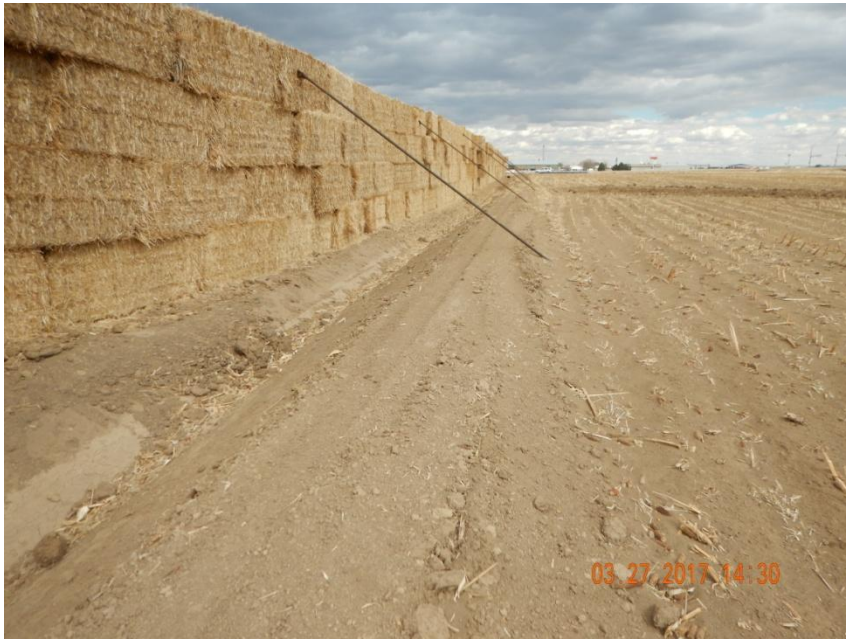
**Photo 11.** Photo taken from the southern location, facing East. Ditch and berm BMP installed around perimeter of location.
