Construction and Stormwater Inspection

March 27, 2017

Operator: KERR MCGEE OIL & GAS ONSHORE LP
#47120

Location ID: 446137

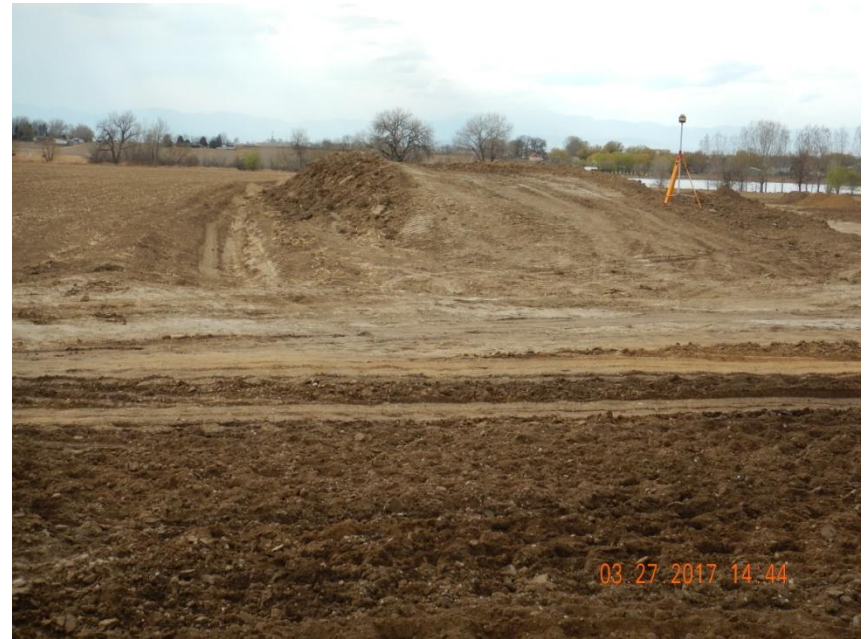
Photo 2. Photo taken from the southeast location, facing West. Ditch and berm BMP installed around north, west, and south perimeter of location. Topsoil stored along the southern perimeter of location.

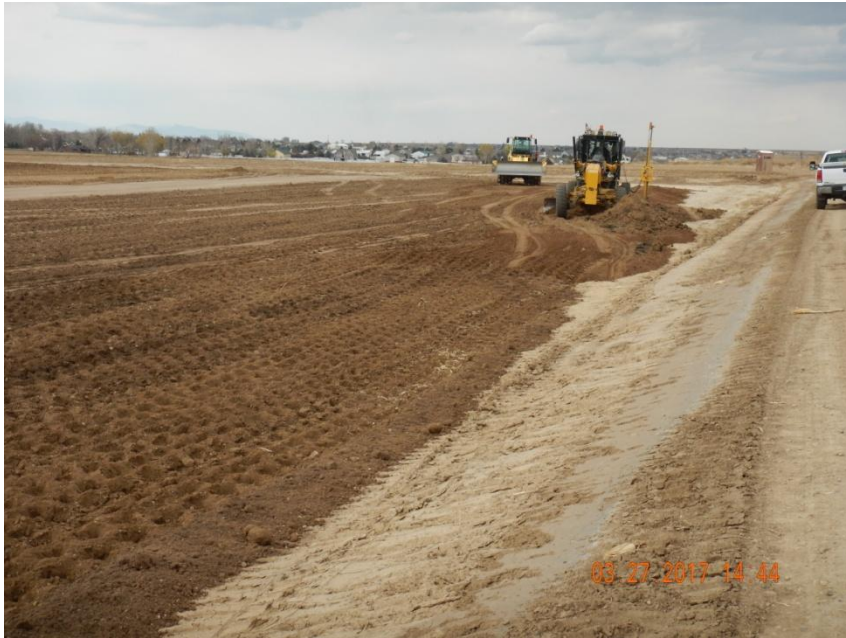
Photo 3. Photo taken from the southeast location, facing North. Cut slope appears to be temporarily stabilized but may need additional BMPs.

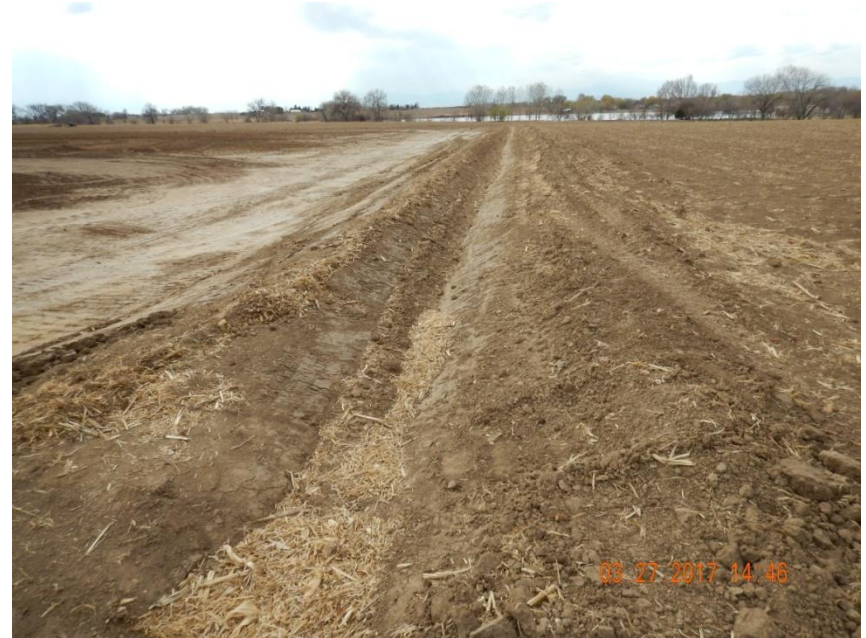
Photo 4. Photo taken from the northern location, facing West. Ditch and berm BMP installed around north, west, and south perimeter of location.

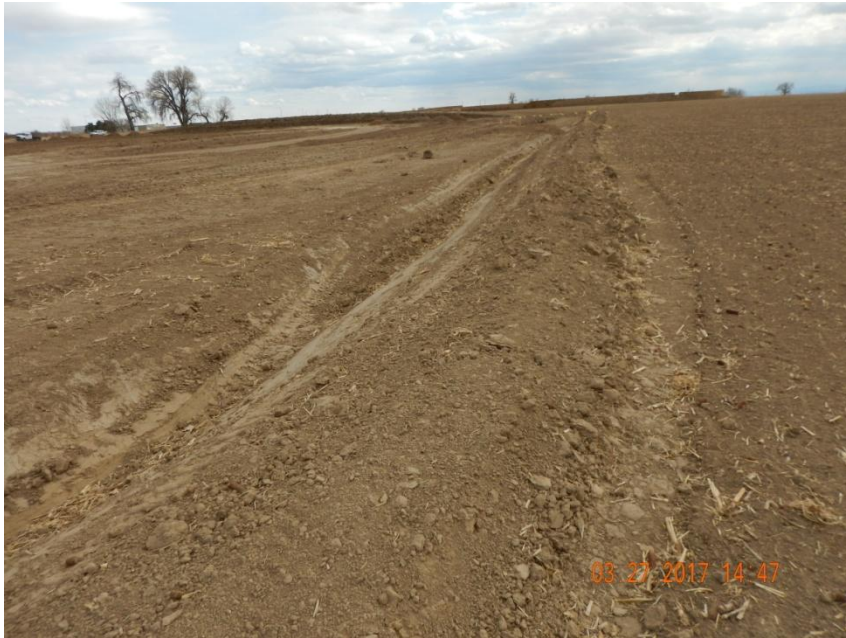
Photo 5. Photo taken from the northwest location, facing South. Ditch and berm BMP installed around north, west, and south perimeter of location.

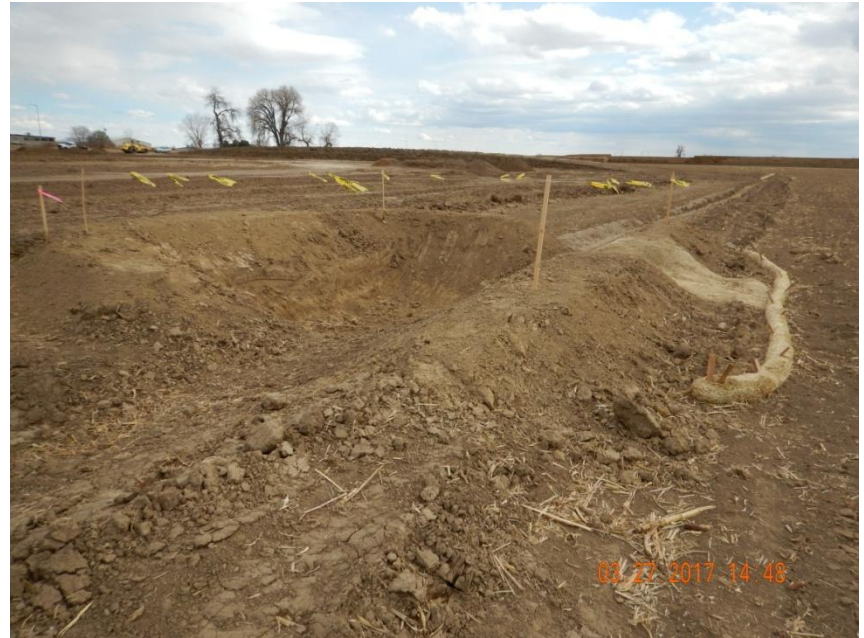
Photo 6. Photo taken from the western location, facing South. Sediment trap installed with outlet protection in the form of a blanket and wattle.

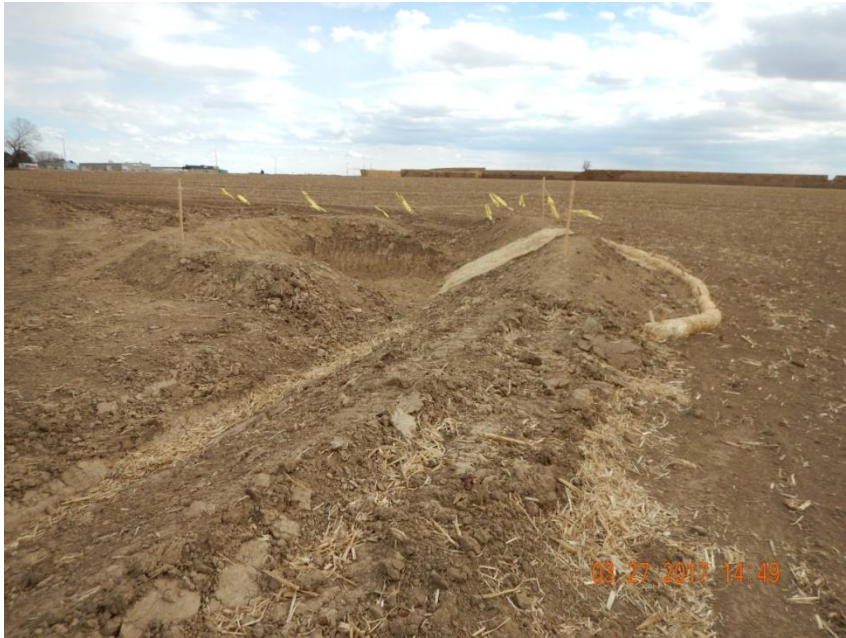
Photo 7. Photo taken from the southwest location, facing South. Sediment trap installed with outlet protection in the form of a blanket and wattle.

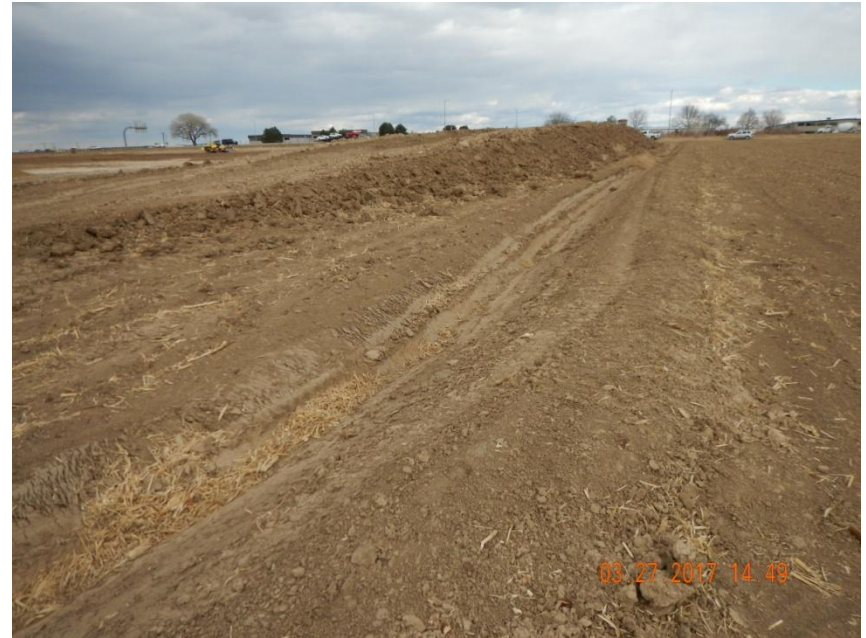
Photo 8. Photo taken from the southern location, facing East. Ditch and berm BMP installed around north, west, and south perimeter of location.
