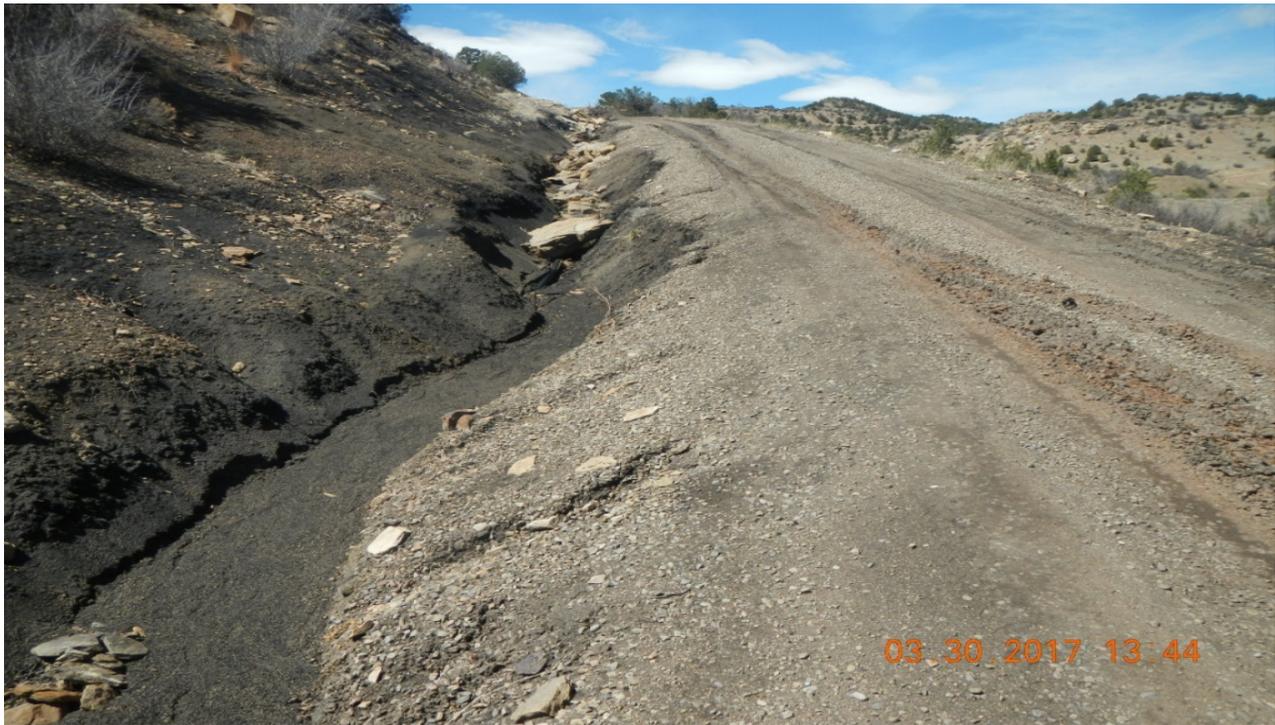
photo 1: Facing northwest, there are signs of erosion occurring along the side of the access road.

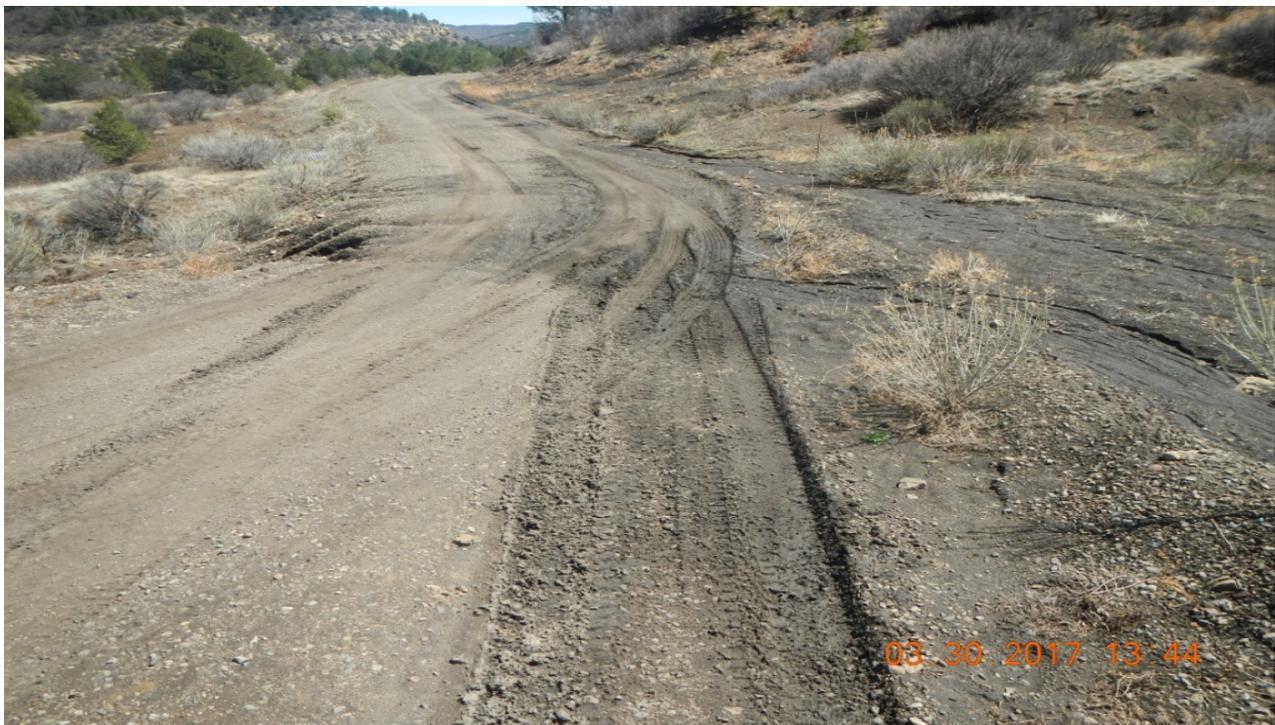
photo 2: Facing southeast, erosion occurring in photo 1 is depositing sediment in this area and stormwater is flowing across the road causing erosion.

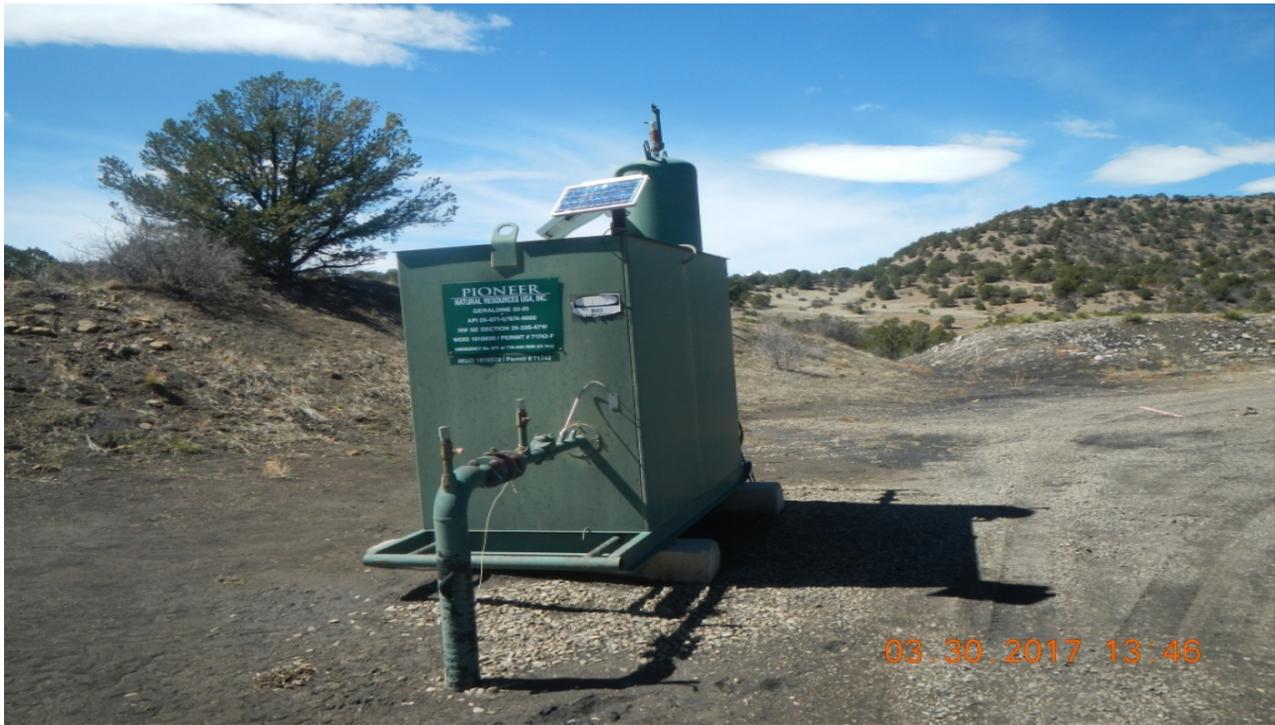
photo 3: Well sign is adequate.

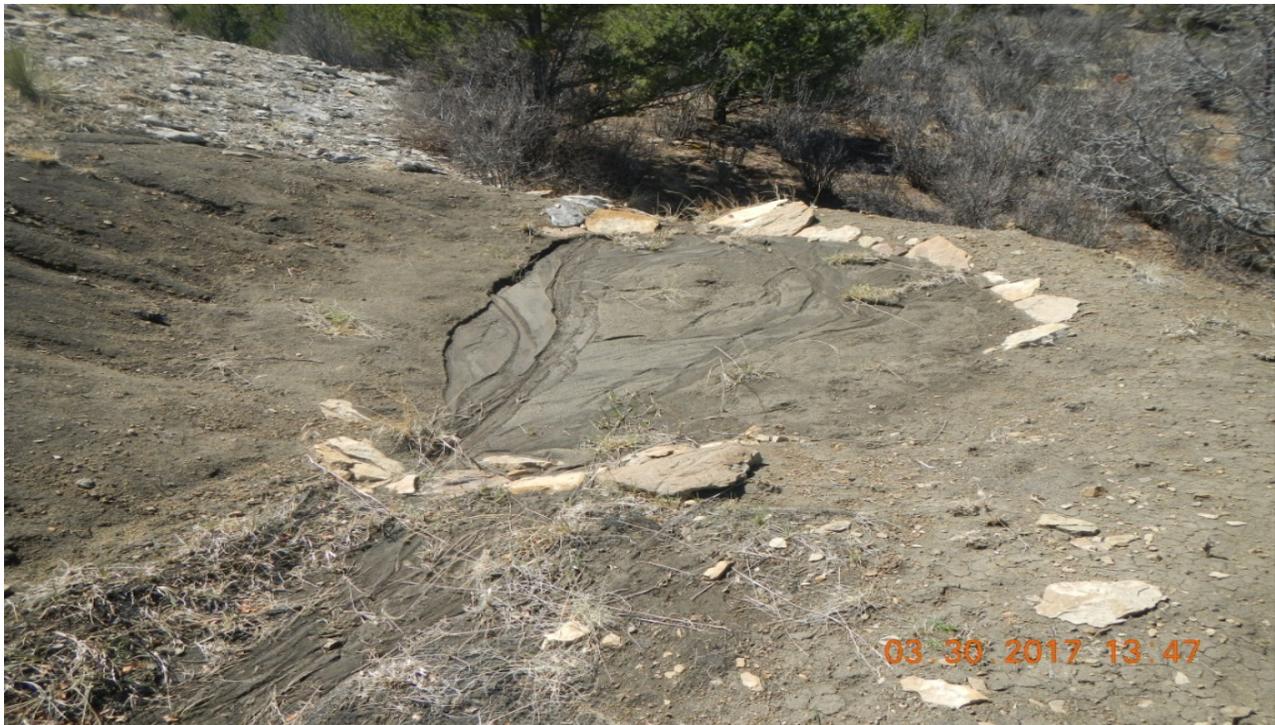
photo 4: The sediment trap at the northwest side of the location is full of sediment.

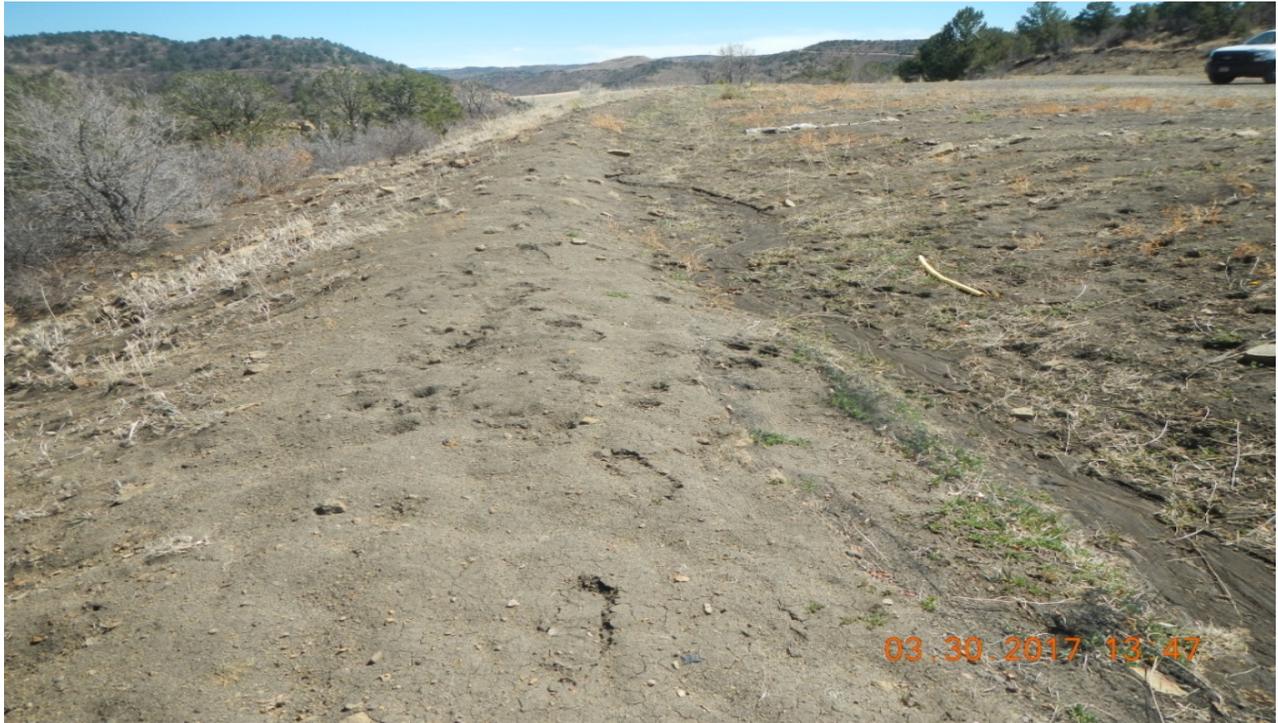
photo 5: Facing southeast at the location. There are areas where vegetation has not established and soils are not stabilized.

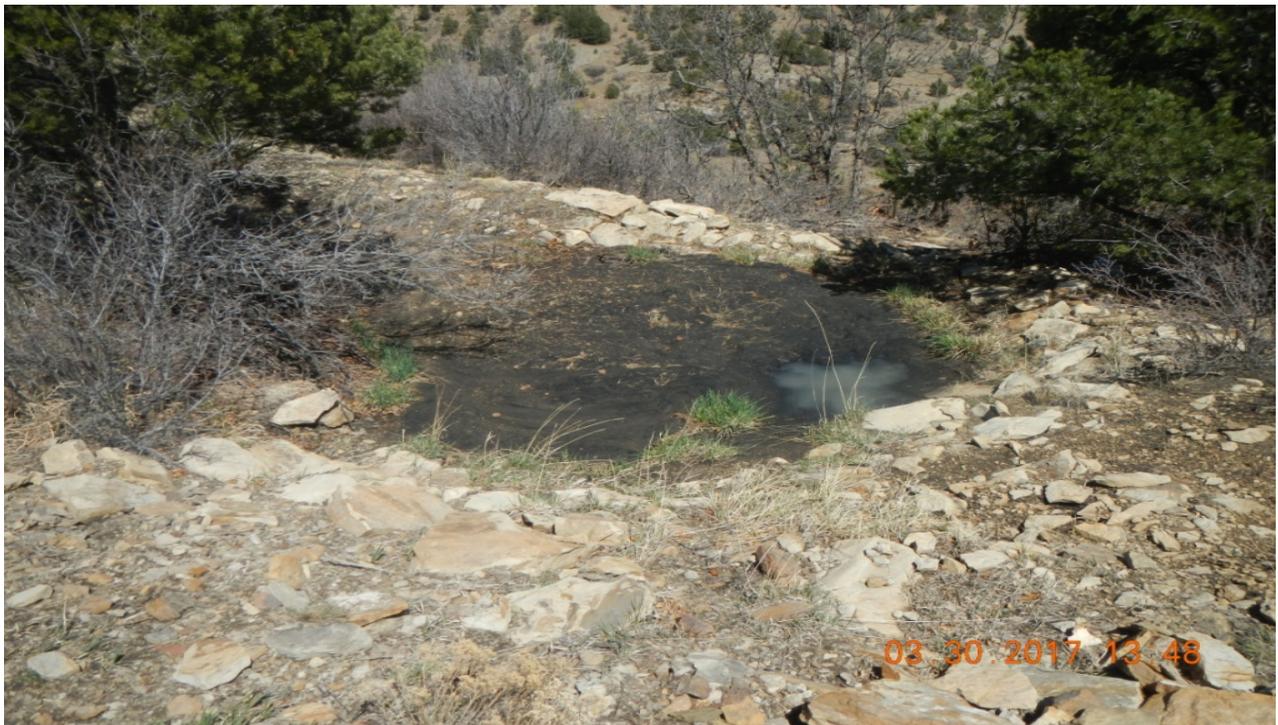
photo 6: Sediment trap at the east side of the location is full of sediment.
