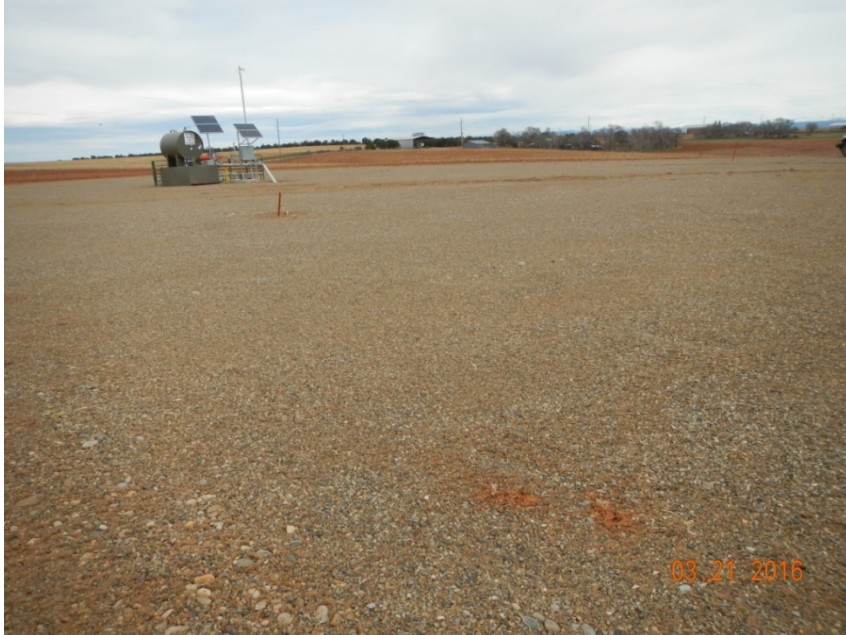
Photo 1: View of the project area from the southwestern corner facing center.

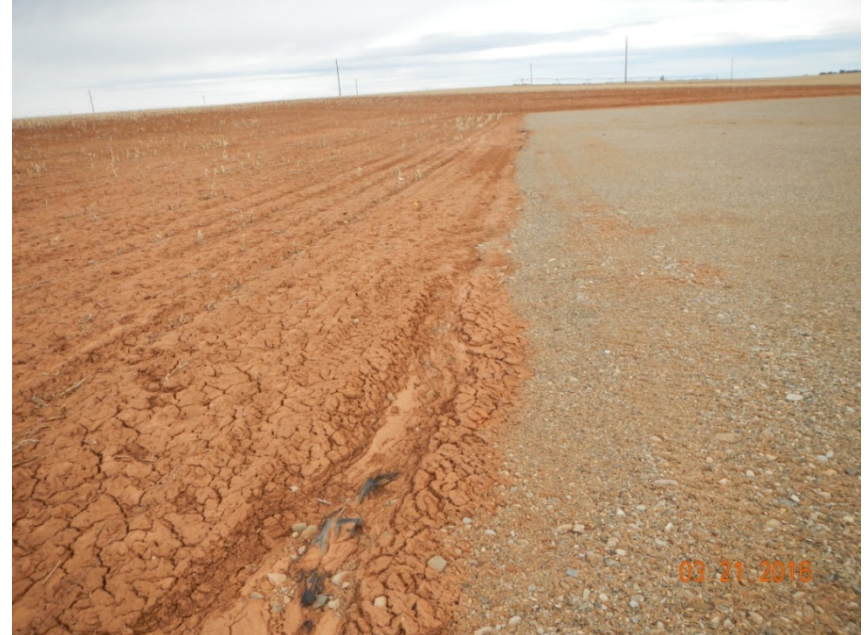
Photo 2: View of the western portion of the project area from the southwestern corner facing northward. Surrounding field and interim reclamation areas are not vegetated at this time.

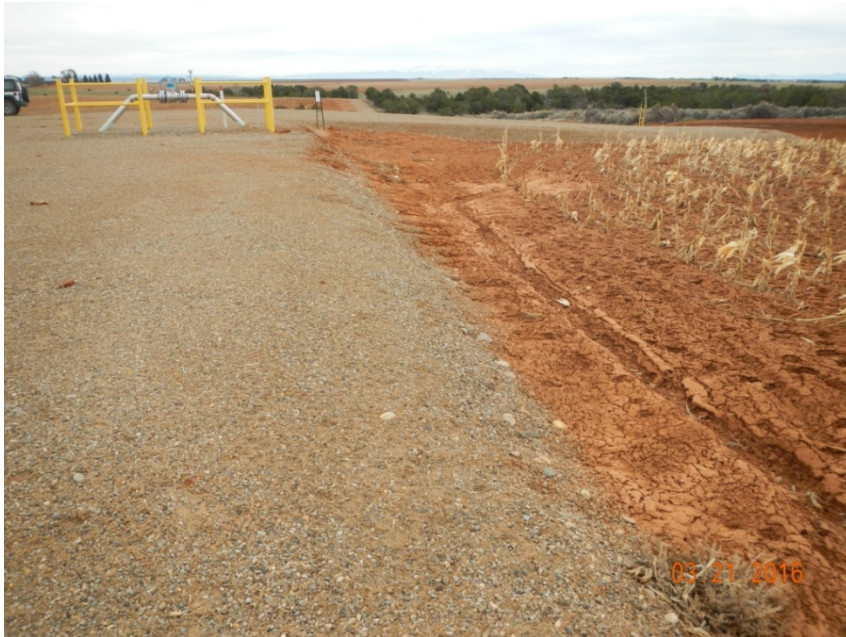
Photo 3: View of the southern portion of the project area from the southwestern corner facing eastward.

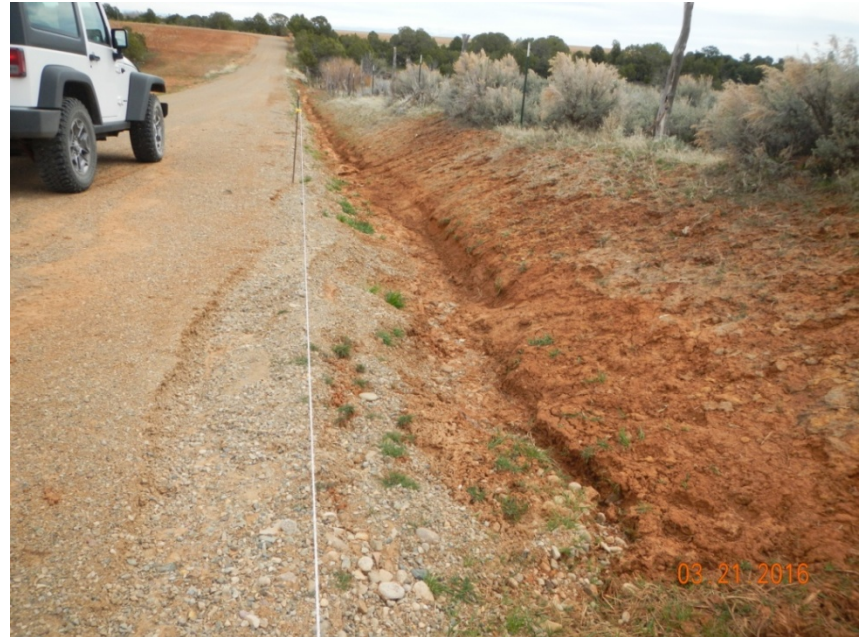
Photo 4: View of area where stormwater erosion is occurring along the southern edge of the access road.

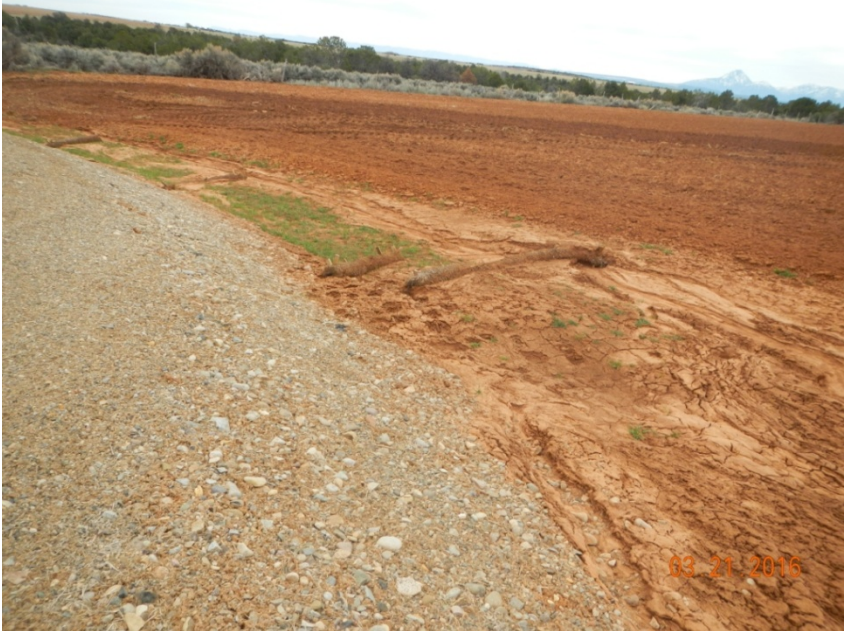
Photo 5: Another view of where erosion is occurring along the access road where wattles are no longer functioning.
