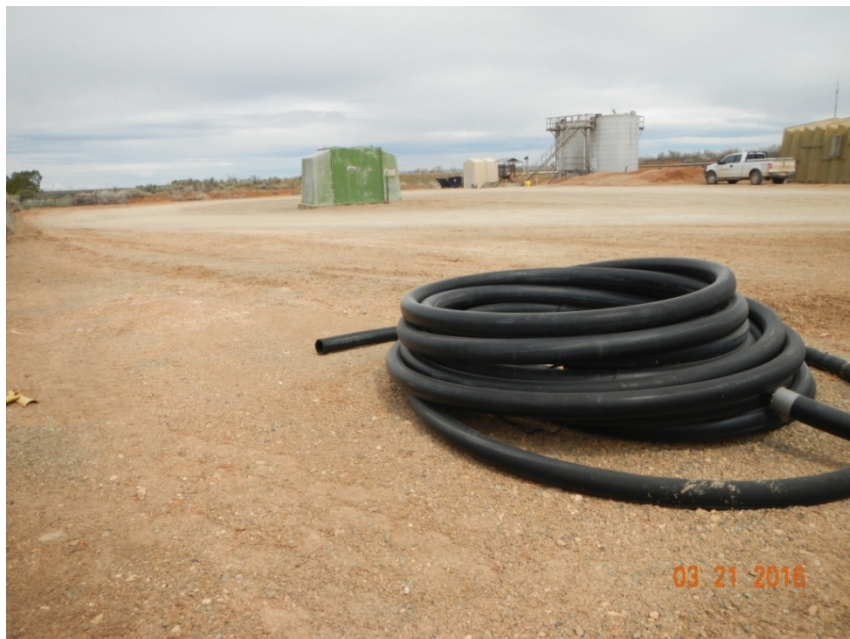
**Photo 1:** View of the project area from the southwestern corner facing center. Unused pipe should be removed.

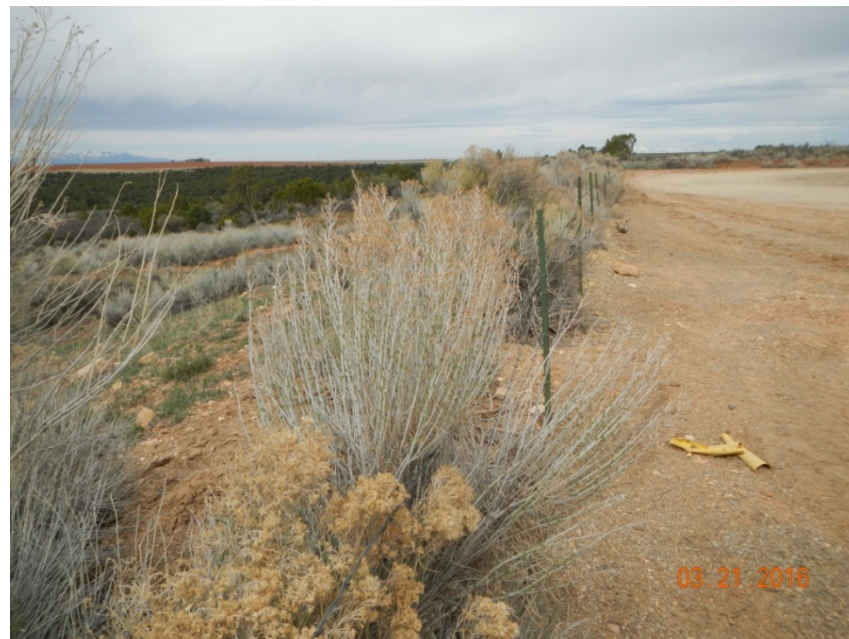
**Photo 2:** View of the western portion of the project area from the southwestern corner facing northward. Revegetation is largely comprised shrubs such rubber rabbitbrush (*Chrysothamnus nauseosus*) and big sagebrush (*Artemisia tridentata*).

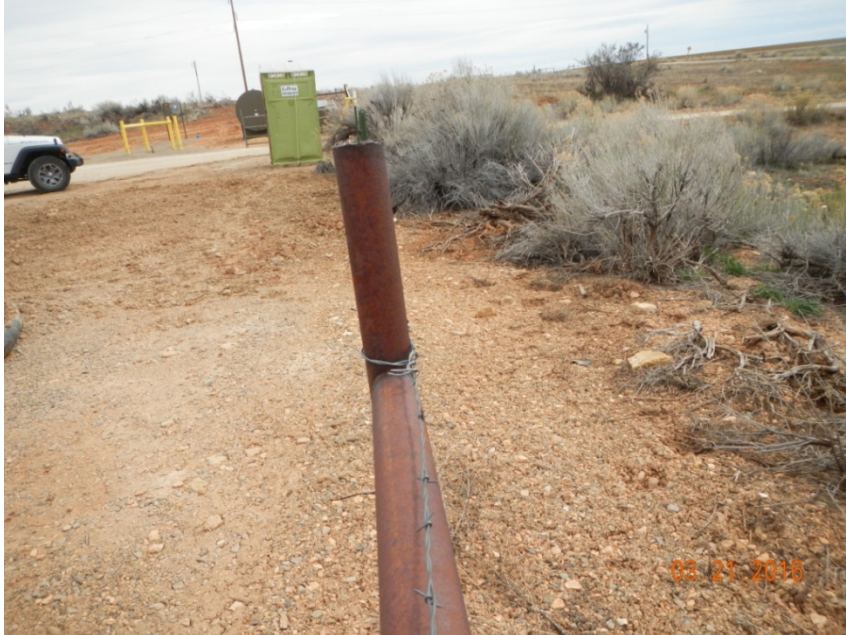
**Photo 3: View of the southern portion of the project area from the southwestern corner facing eastward.**

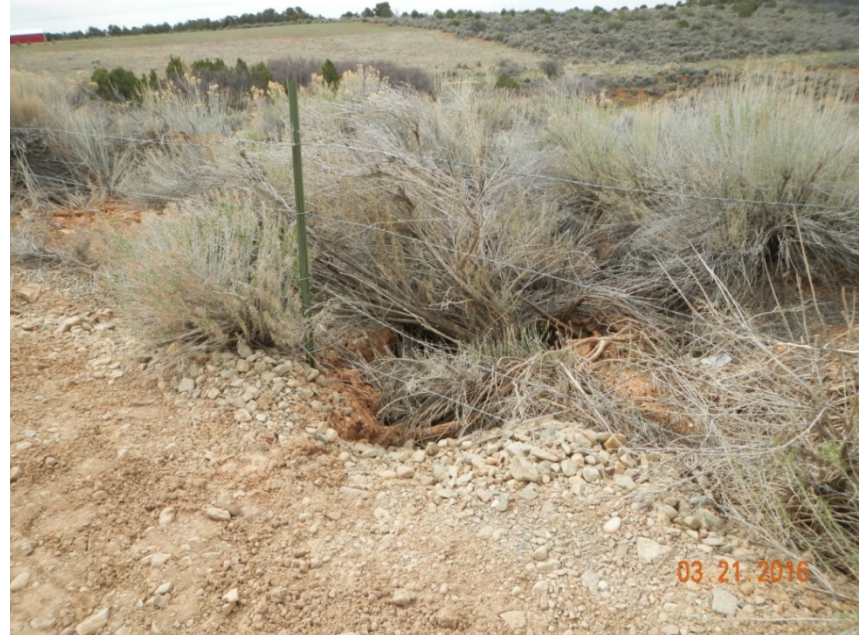
**Photo 4: View of area where it appears erosion is occurring within the western portion of the project area.**

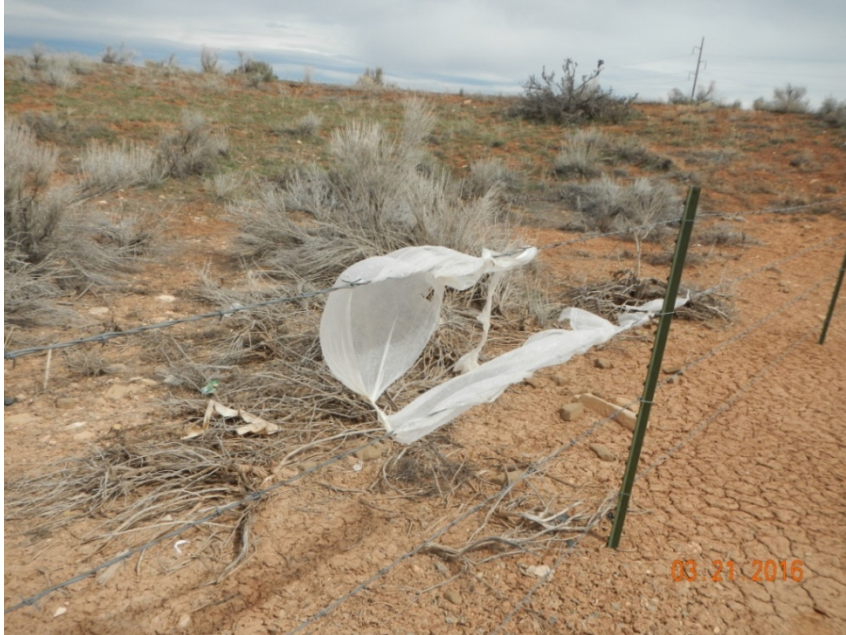
**Photo 5: View of trash on the fence and within the northern revegetation area.**
