Inspection Photos

03/31/2017

Operator: Whiting Oil and Gas #96155

Location ID: 444465

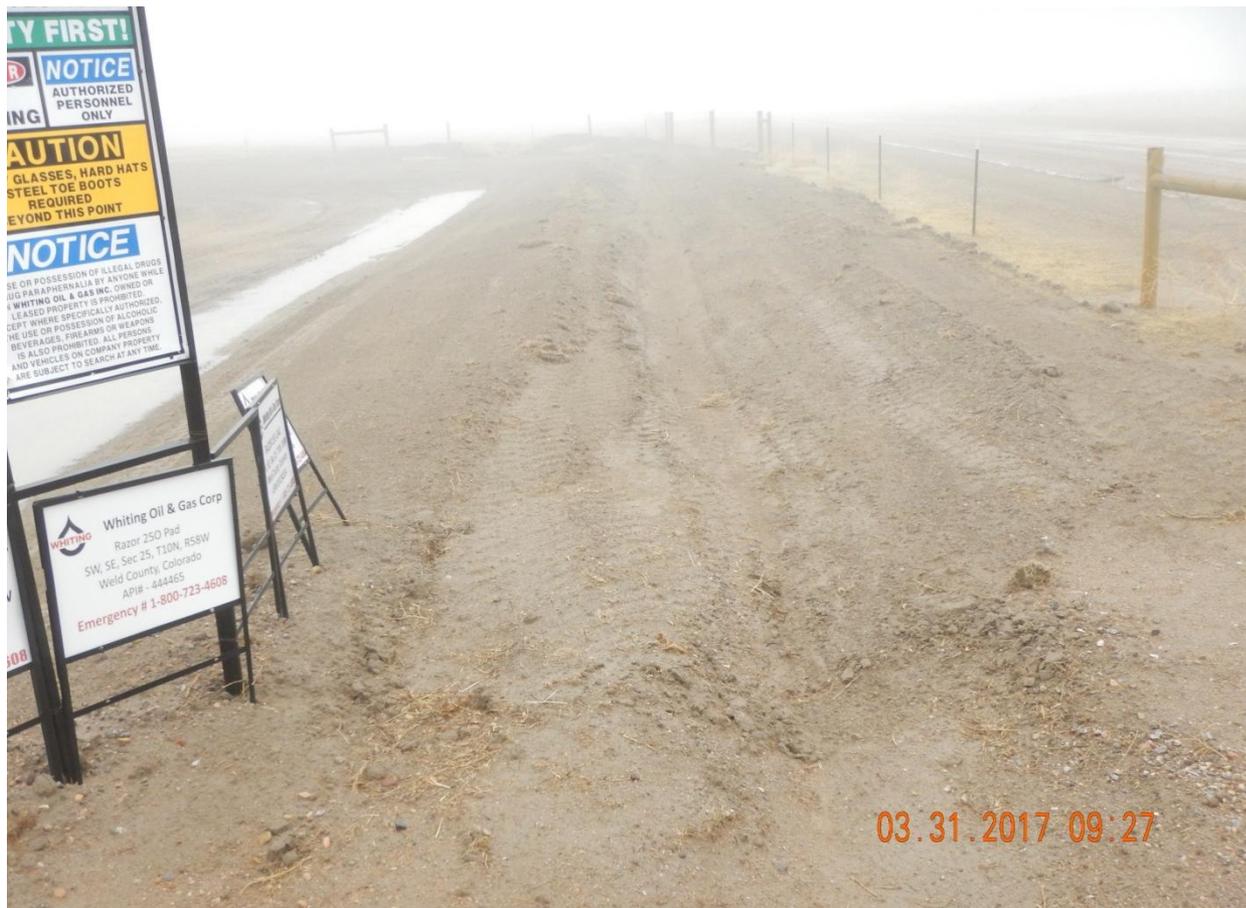
Photo 1: Photo taken from the north end of the location, facing west. Photo shows stormwater ditch along perimeter of the location

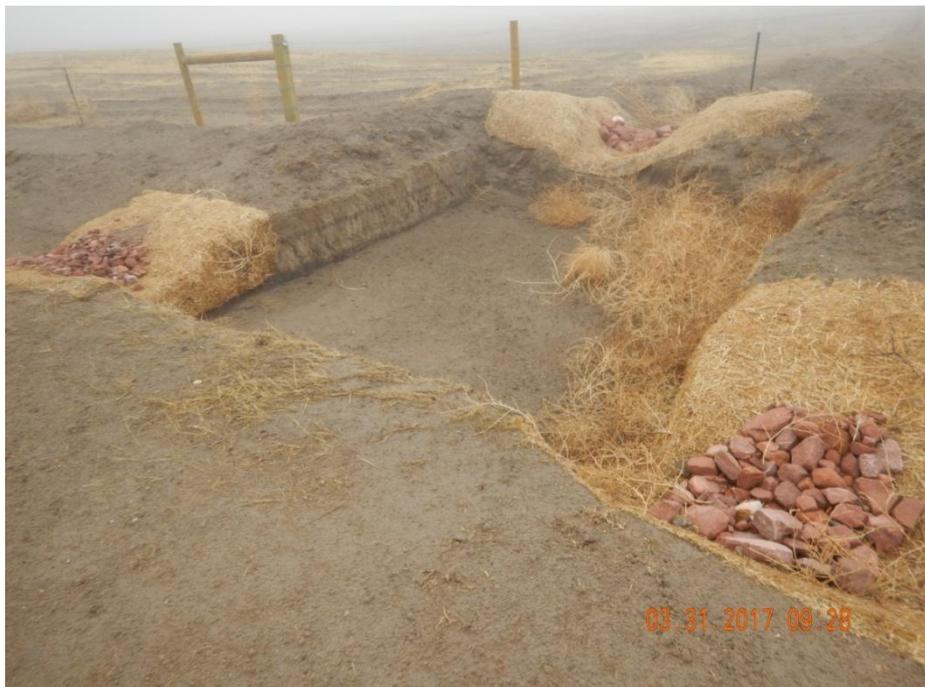
Photo 2: Photo taken from the northwest end of the location, facing south. Photo shows sediment trap has had additional inlet and outlet protection implemented and appears to be sufficient and in proper functioning condition.

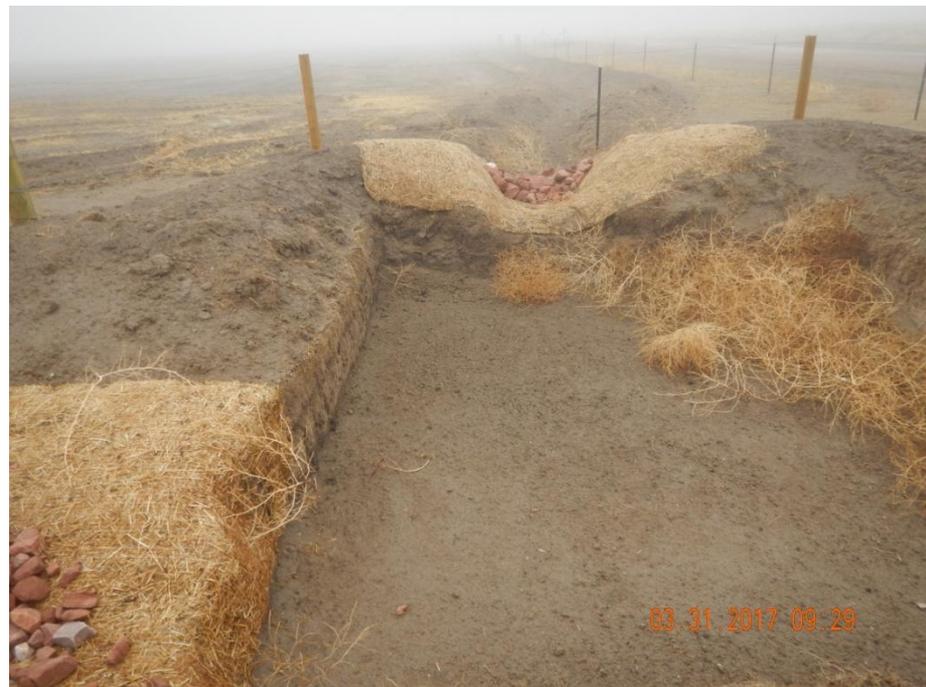
Photo 3: Photo taken from the northwest end of the location, facing south. Photo shows sediment trap has had additional inlet and outlet protection implemented and appears to be sufficient and in proper functioning condition.

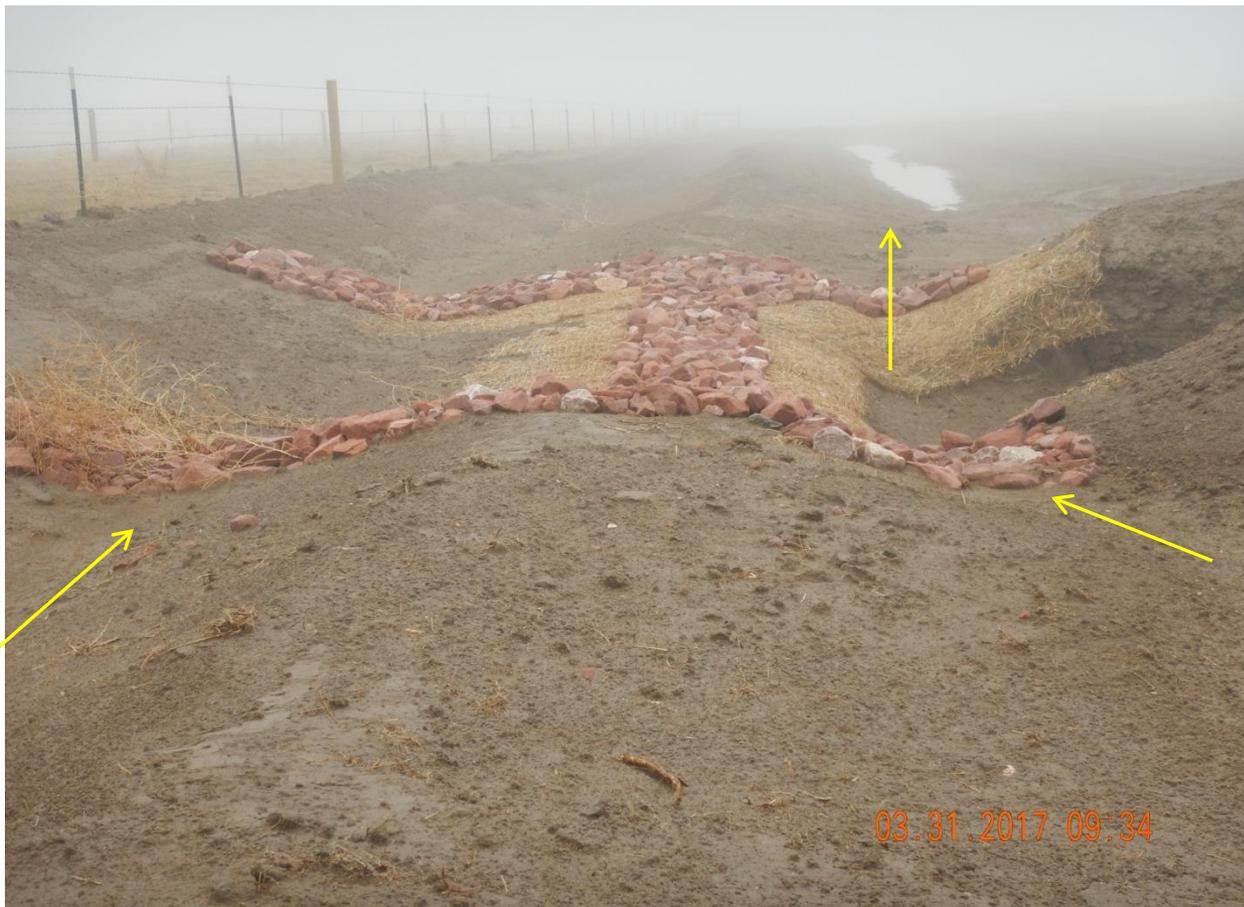
Photo 4: Photo taken from the south end of the location facing west. Photo shows sediment trap has had additional inlet and outlet protection implemented, however trap has been constructed in such a manner that stormwater would more likely flow from the ditch into the trap, rather than the trap into ditch. Also, it appears once trap has reached capacity, stormwater will likely flow out onto the location and pond to the west. Stormwater flow represented by yellow arrows. Trap does not appear to have been constructed with proper planning or good engineering practices to protect the site during inclement weather conditions

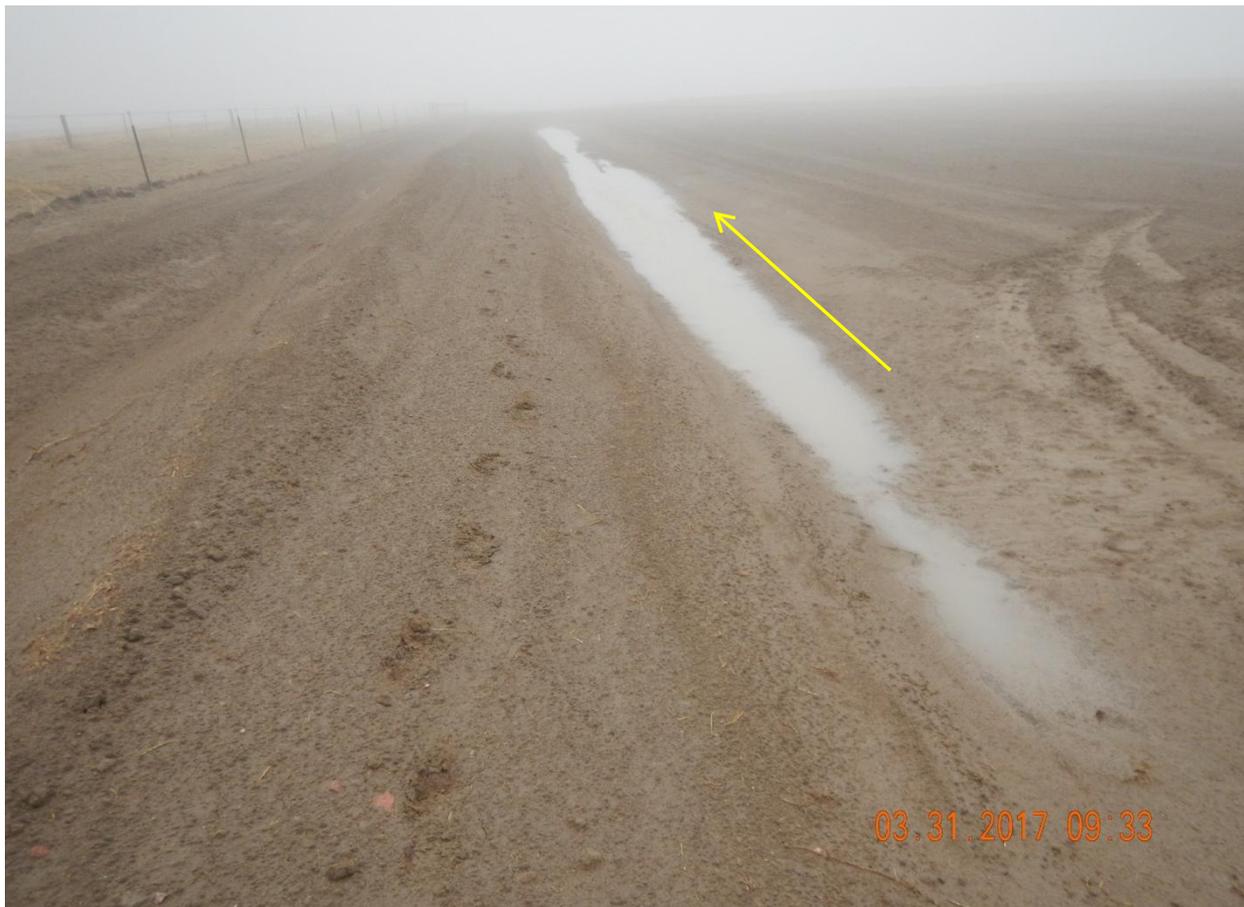
Photo 5: Photo taken to the west of the sediment trap seen in photo 4. Photo shows area on the southwest end of the location where water appears to concentrate and pond. Once trap has reached capacity, stormwater will likely flow out onto the location and pond here.

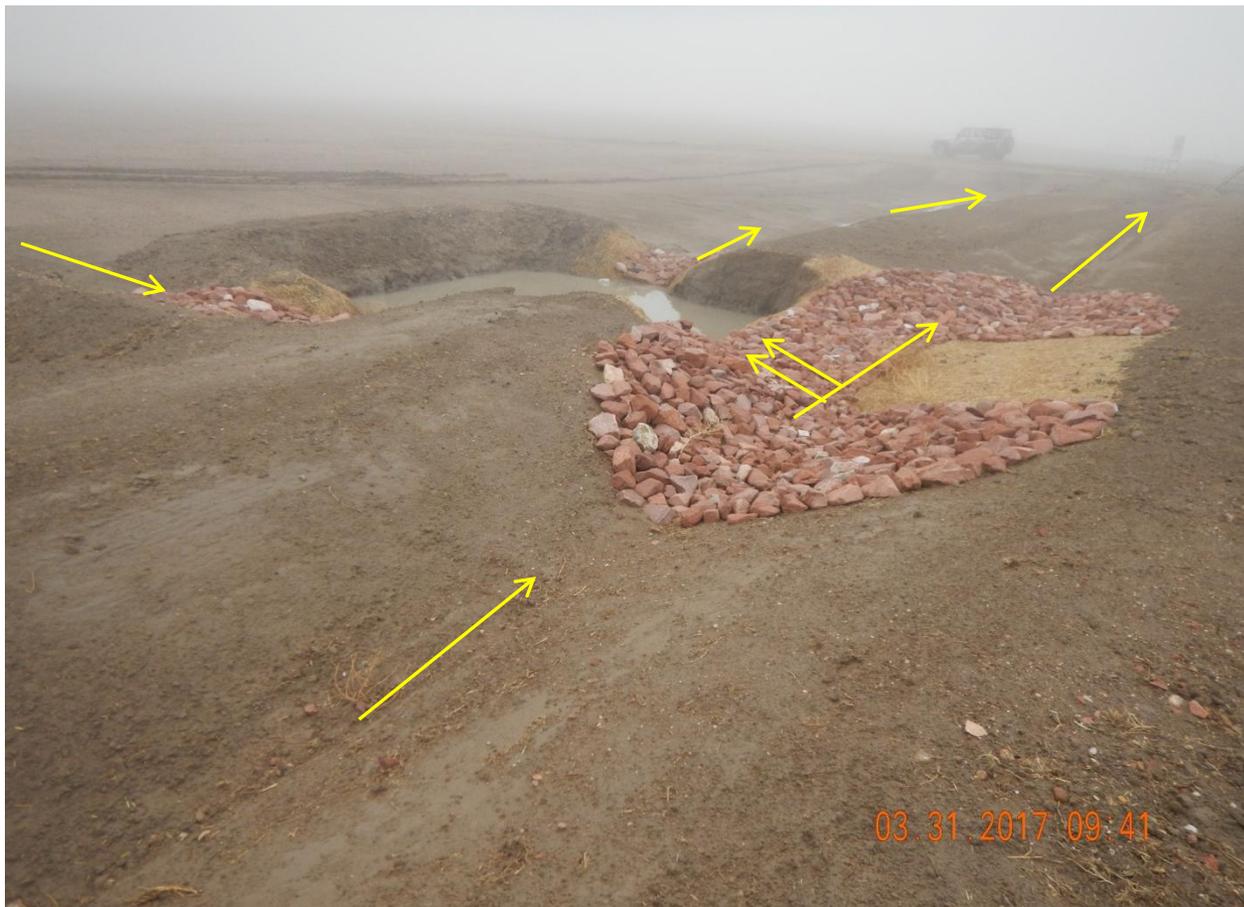
Photo 6: Photo taken from the north end of the location facing west. Photo shows sediment trap has had additional inlet and outlet protection implemented, however trap has been constructed in such a manner that stormwater would more likely flow from the ditch into the trap, rather than the trap into ditch. Also, it appears once trap has reached capacity, stormwater will likely flow out onto the location and pond to the west. Stormwater flow represented by yellow arrows. Trap does not appear to have been constructed with proper planning or good engineering practices to protect the site during inclement weather conditions

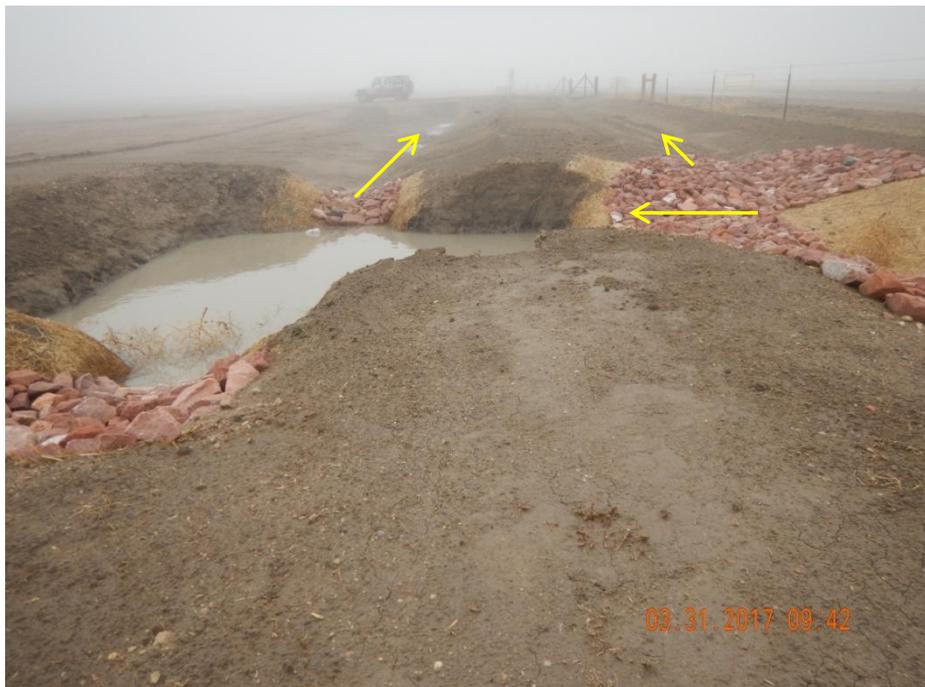
Photo 7: Photo taken from sediment trap on the north end of the location, facing west. Photo shows trap appears to have been constructed in such a manner that stormwater would more likely flow from the ditch into the trap, rather than the trap into ditch. It also appears once trap has reached capacity, stormwater will likely flow out onto the location and pond to the west. Stormwater flow represented by yellow arrows

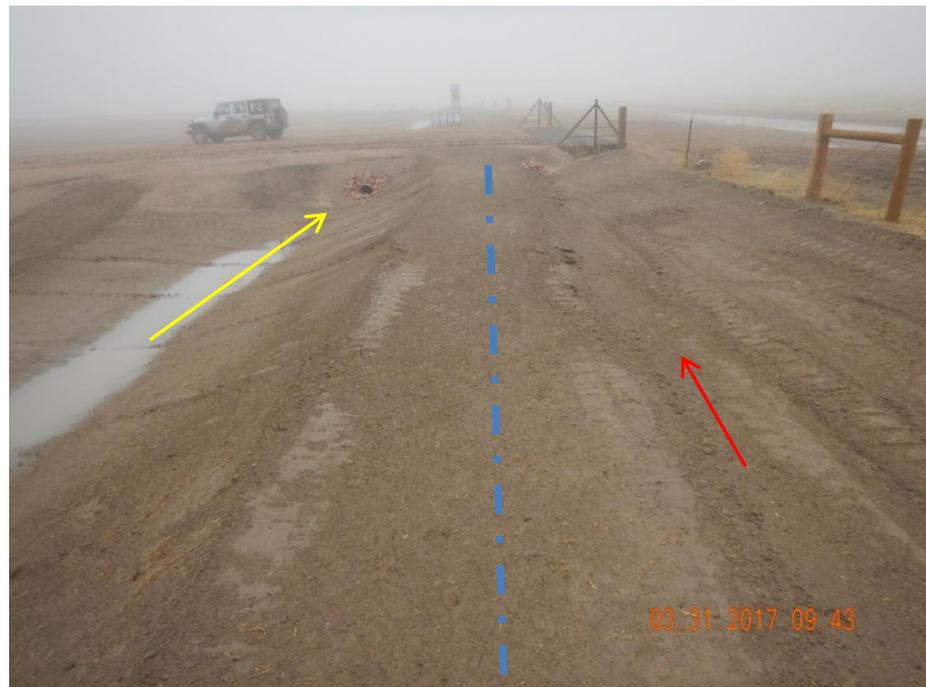
Photo 8: Photo taken from top of berm (blue line) between ditch on the north end of the location and the pad. Arrow in yellows shows likely stormwater flow and ponding once sediment trap has reached capacity. Red arrow represents stormwater flow within ditch.

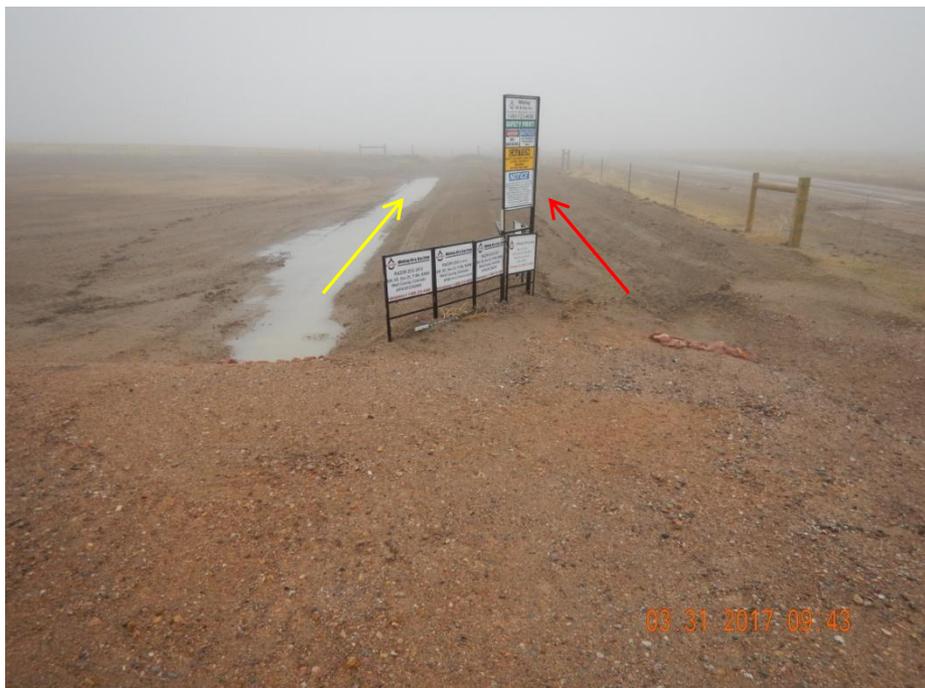
Photo 9: Photo taken access road above the culvert seen in photo 8.(blue line) on the north end of the location and the pad. Arrow in yellow shows area of stormwater flow and ponding once sediment trap has reached capacity. Red arrow represents stormwater flow within ditch.

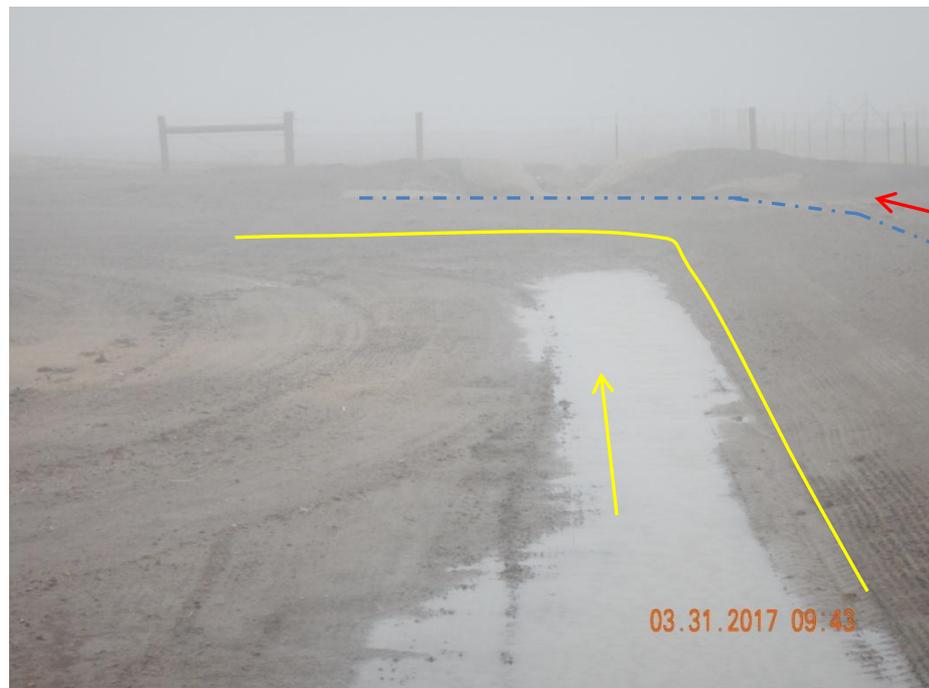
Photo 10: Photo taken from the northwest end of the location, facing west. Photo shows areas (yellow arrow/line) of stormwater flow and ponding once sediment trap has reached capacity. Red arrow represents stormwater flow within ditch. Berm separating stormwater ditch and pad represented by blue line.
