# Inspection Photos

Operator: Whiting Oil and Gas #96155

Location ID: 444471

Inspection Doc. Number: 682501845

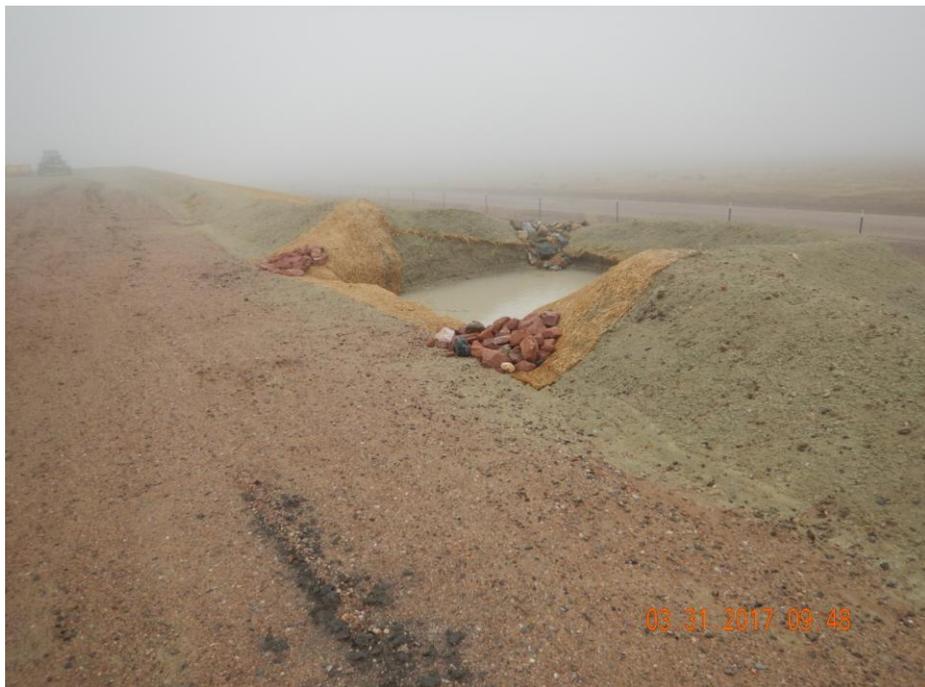
**Photo 1:** Photo taken from the north end of the location, facing west. Photo shows additional inlet protection has been installed on sediment trap.

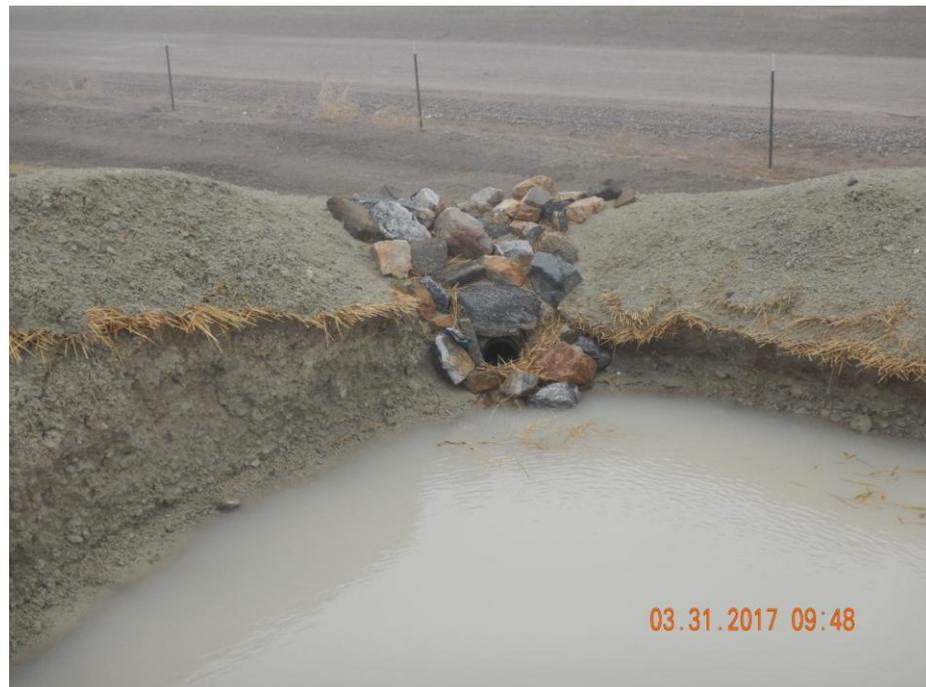
**Photo 2:** Photo taken from the north end of the location. Photo shows additional outlet drain constructed into sediment trap.

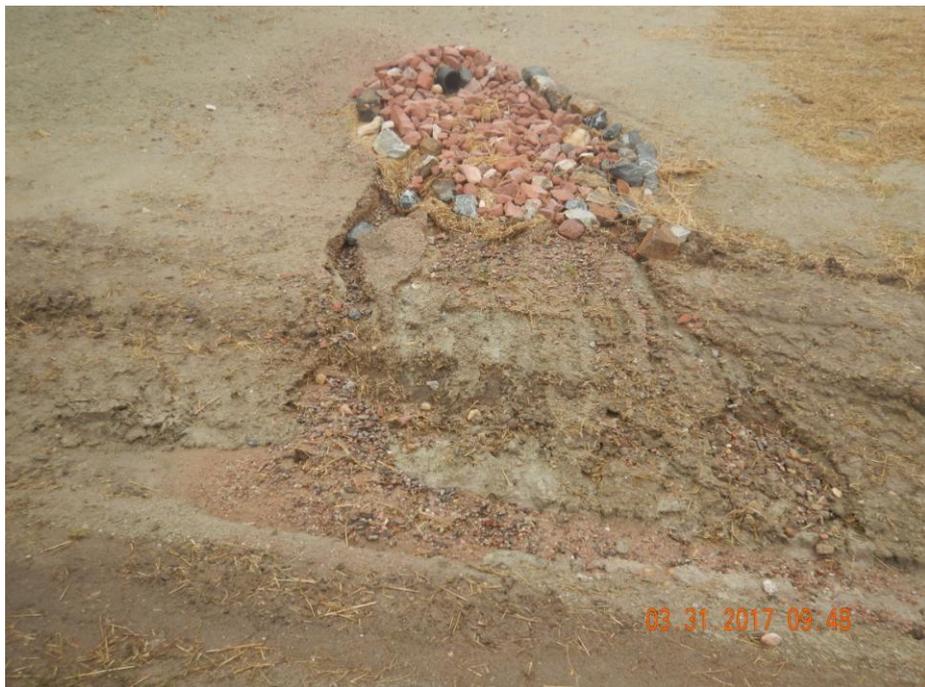
**Photo 3:** Photo taken from the outlet of the sediment trap on the north end of the location. Photo shows that outlet armoring from the drain was insufficient as stormwater erosion leading into the ditch is evident.

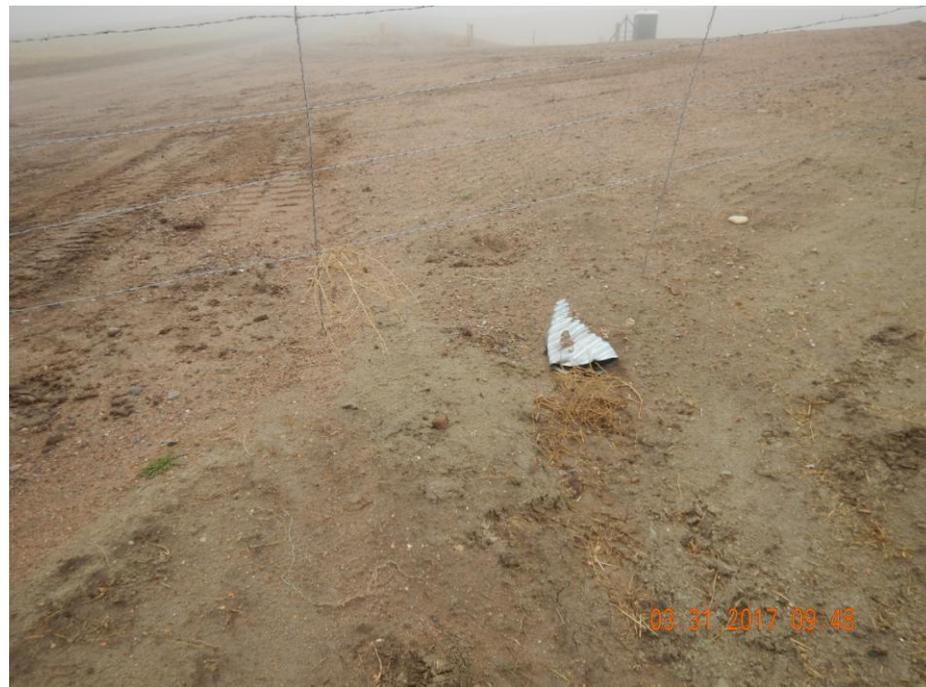
**Photo 4:** Photo taken from the access road on the north end of the location. Photo shows culvert has been smashed and in need of maintenance.

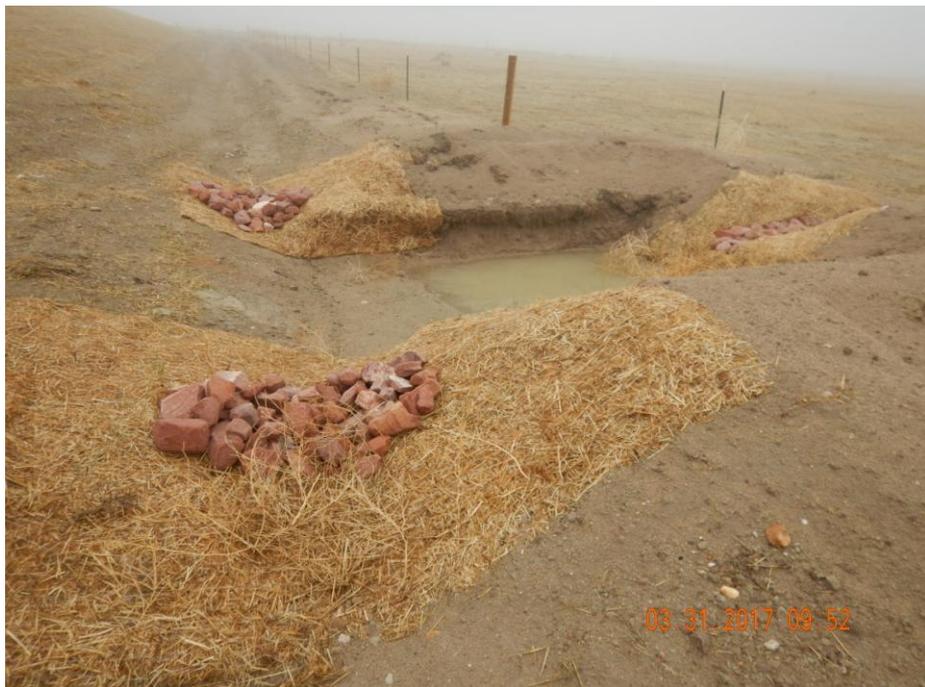
**Photo 5:** Photo taken from the northwest end of the location. Photo shows that additional inlet and outlet protection has been installed on the sediment traps.

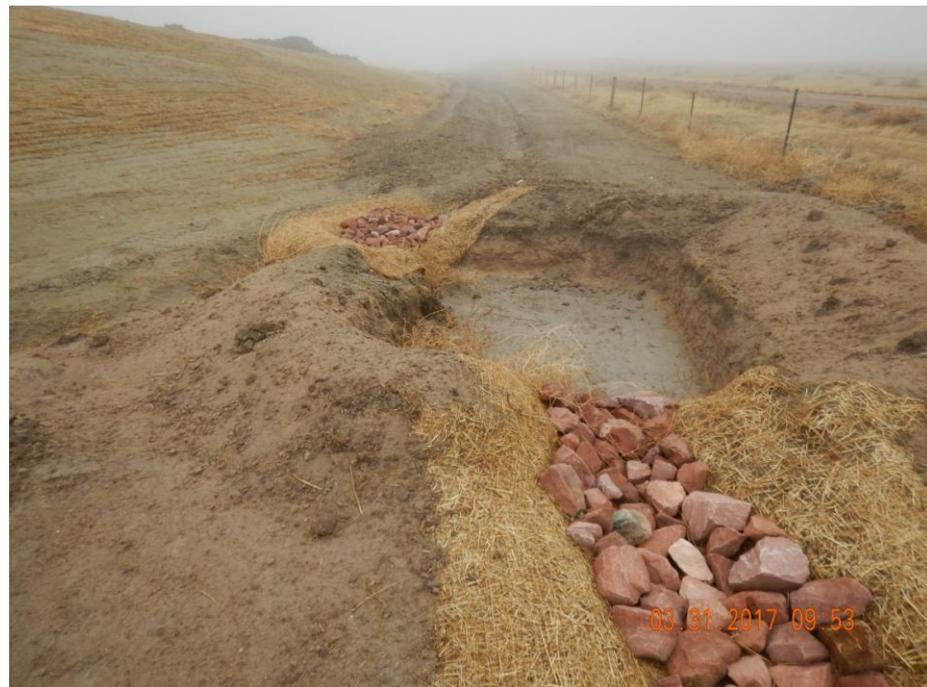
**Photo 6:** Photo taken from the southwest corner of the location, facing east. Photo shows a stormwater and sediment trap has been constructed on this corner of the location. Trap appears to be in proper functioning condition.

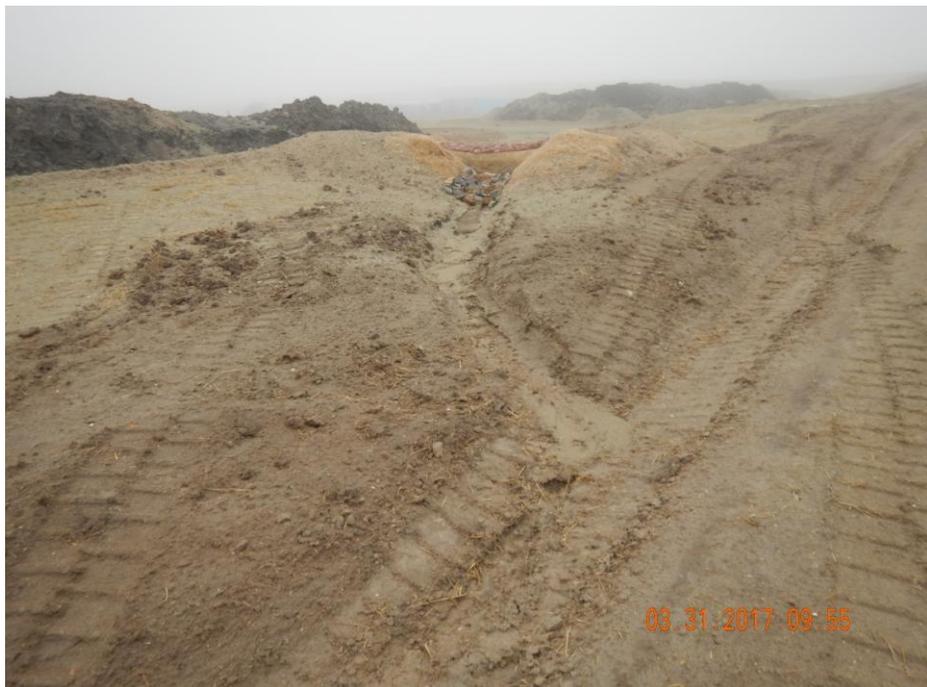
**Photo 7:** Photo taken from the outlet of the sediment trap on the south end of the location. Photo shows that outlet armoring appears insufficient as stormwater erosion leading into the ditch is evident.

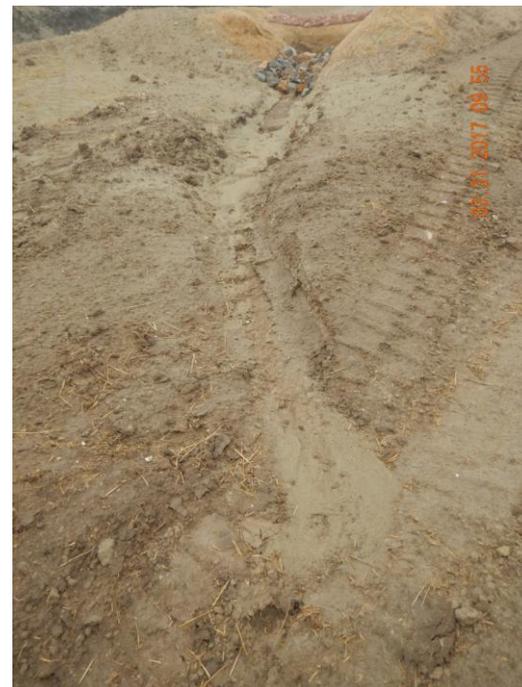
**Photo 8:** Photo taken from the outlet of the sediment trap on the south end of the location. Photo shows that outlet armoring appears insufficient as stormwater erosion leading into the ditch is evident.

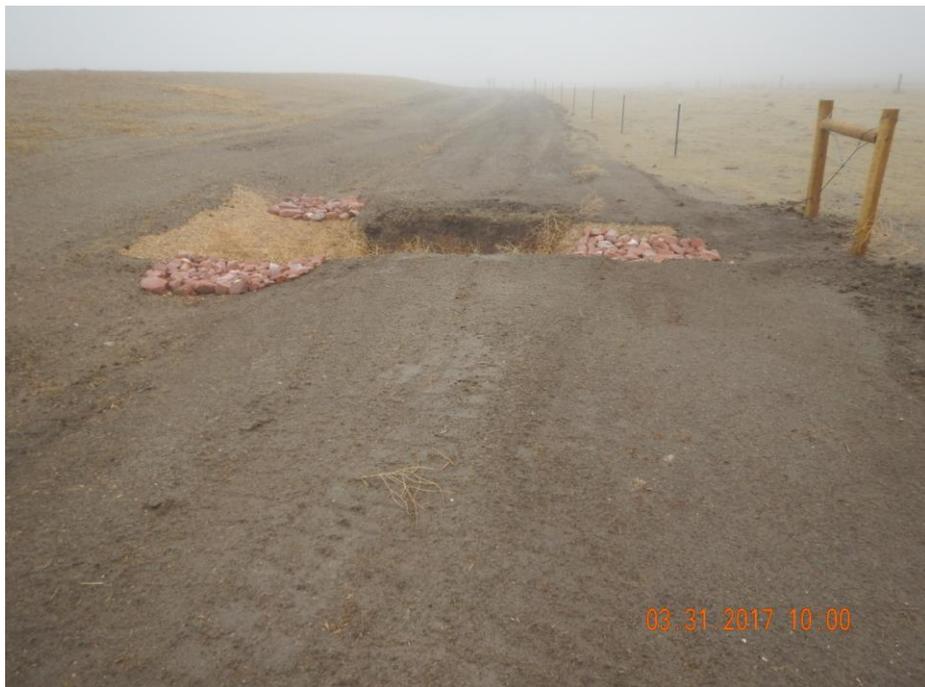
**Photo 9:** Photo taken from the east end of the location. Photo shows additional inlet and outlet protection has been installed on sediment trap.

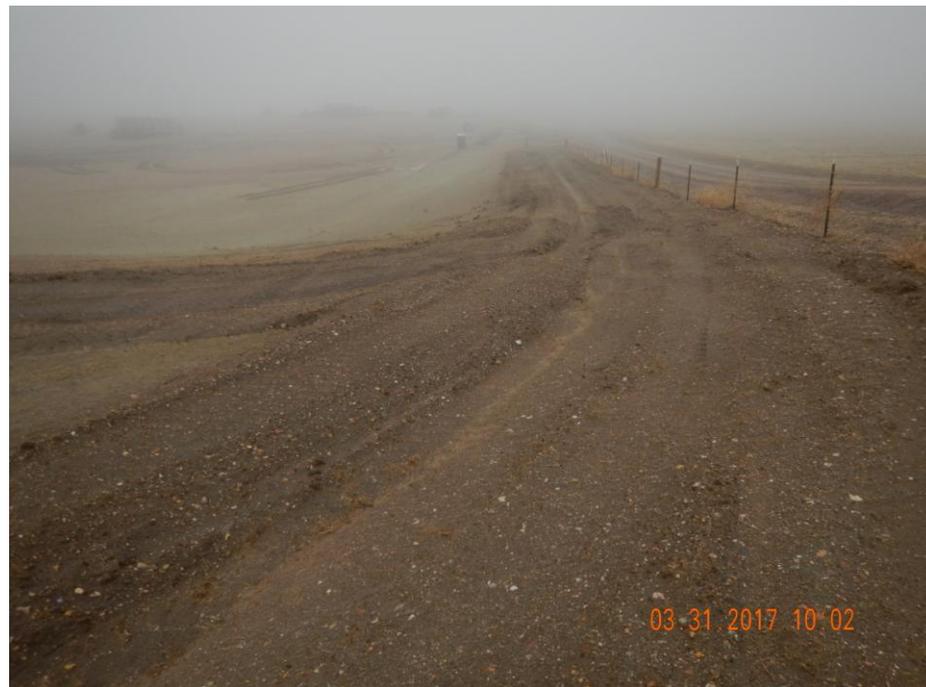
**Photo 10:** Photo taken from the northeast corner of the location, facing west. Photo shows example of an area of ditch with long stretches of downward slope without controls to mitigate stormwater velocity.
