Stormwater Inspection

April 3, 2017

Operator: BONANZA CREEK ENERGY OPERATING
COMPANY LLC - #8960

Location Name: State Crow Valley #41-21-
20XRLNB

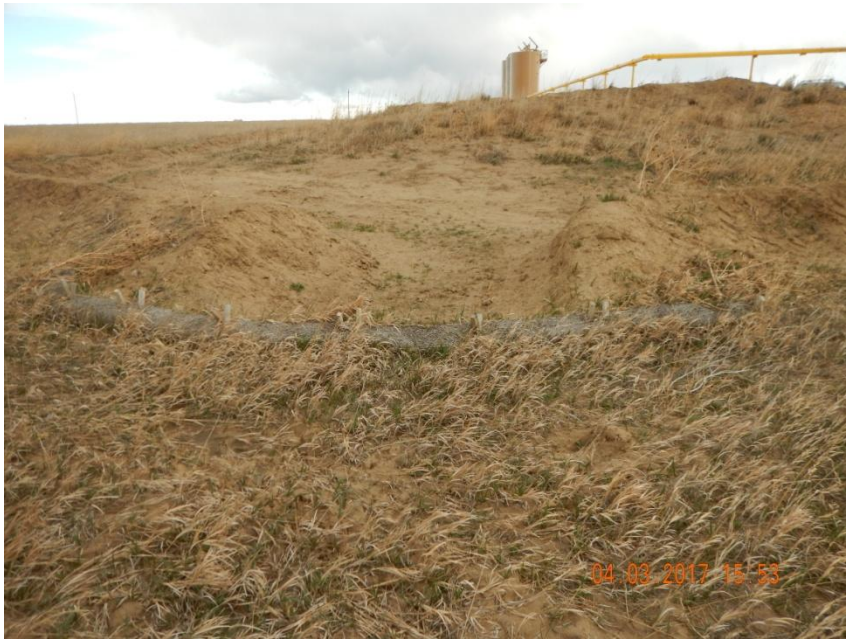
Photo 1. Photo taken from the northern sediment trap along the northwest location, facing East. Minor repairs were made to the sediment trap which may be insufficient to prevent sediment laden stormwater runoff from leaving location.

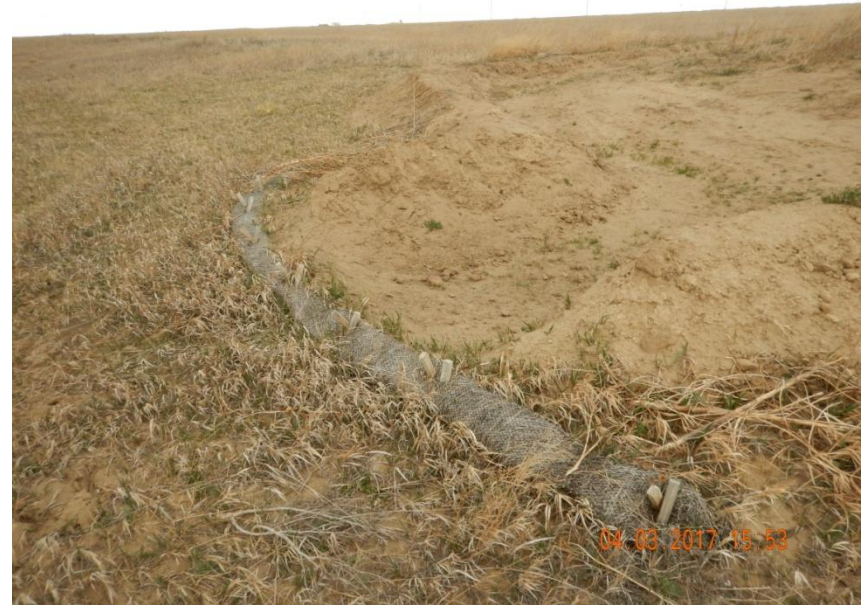
Photo 2. Photo taken from the northern sediment trap along the northwest location, facing North. Minor repairs were made to the sediment trap which may be insufficient to prevent sediment laden stormwater runoff from leaving location.

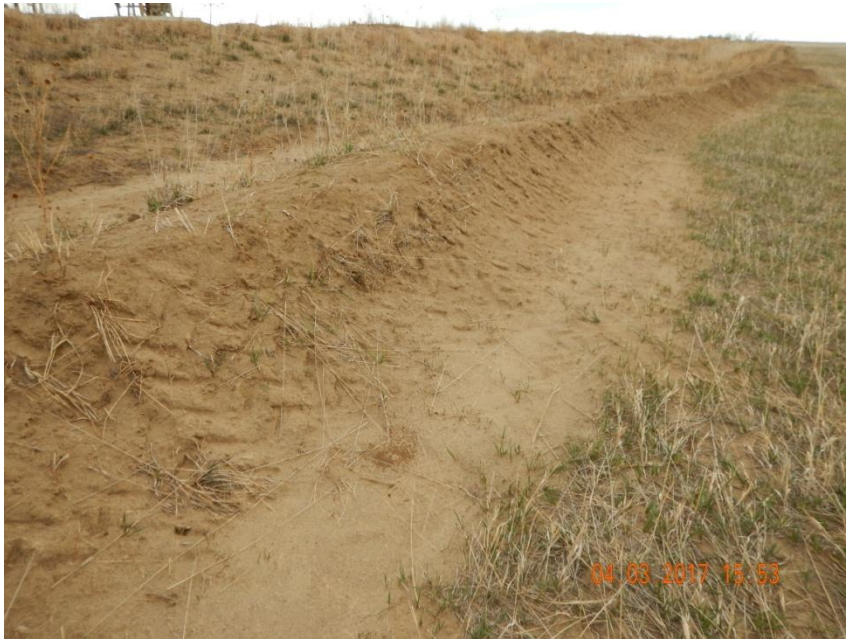
Photo 3. Photo taken of the northwestern location, facing South. Berm BMP has been repaired and built up higher.

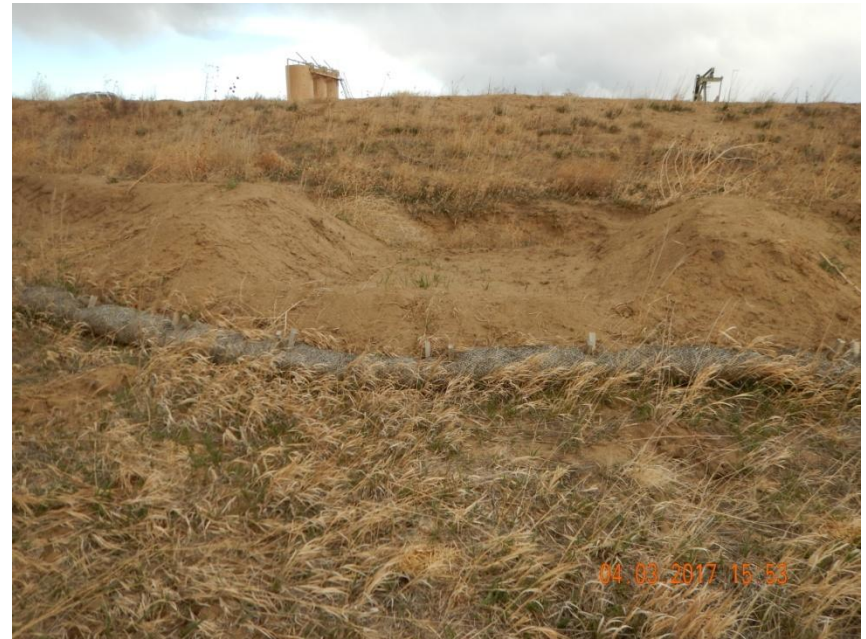
Photo 4. Photo taken from the southern sediment trap along the western location, facing East. Minor repairs were made to the sediment trap which may be insufficient to prevent sediment laden stormwater runoff from leaving location.

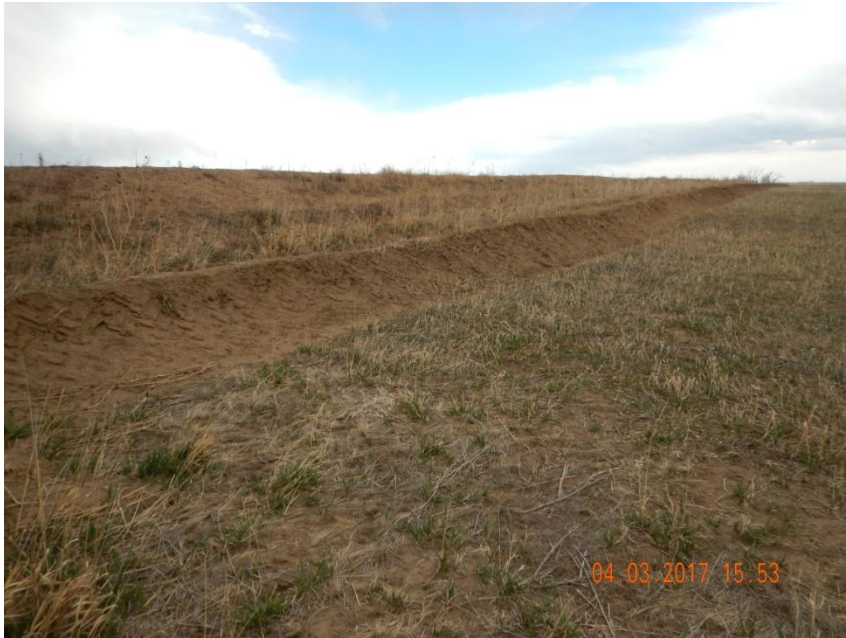
Photo 5. Photo taken of the western location, facing Southeast. Berm BMP has been repaired and built up higher.

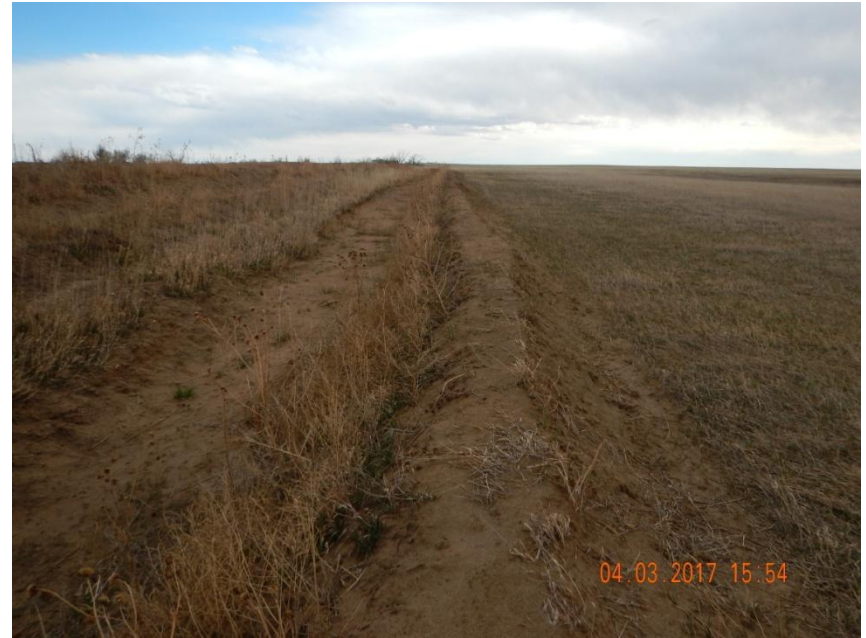
Photo 6. Photo taken of the southwestern location, facing South. Berm BMP has been repaired and built up higher.
