Reclamation Inspection

April 3, 2017

Operator: BONANZA CREEK ENERGY OPERATING
COMPANY LLC - #8960

API: 05-123-40540

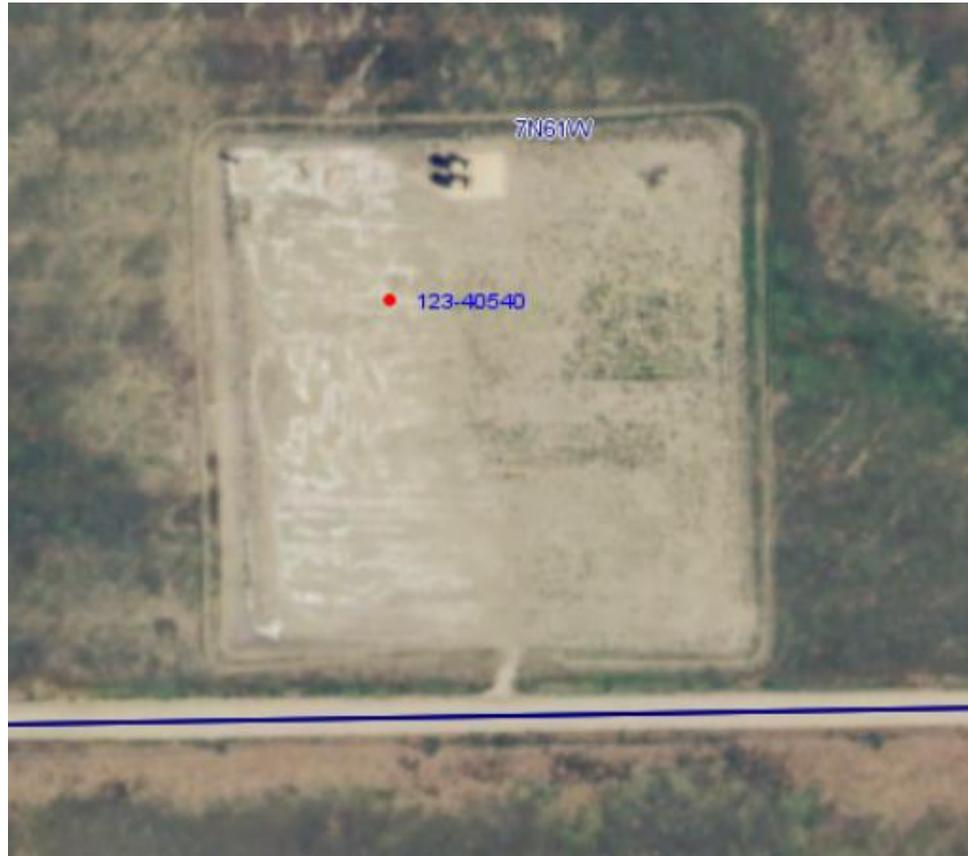
COGCC GISOnline database aerial imagery taken in 2015. Based off aerial imagery, it appears equipment may have been on location but currently no equipment was found on location. Based off the COGCC database, this location has never been drilled.

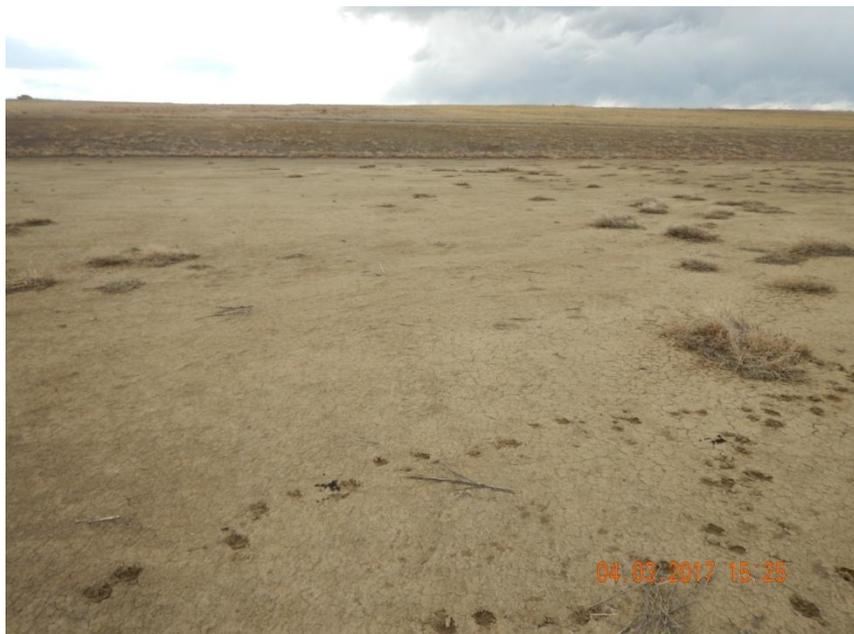
Photo 1. Photo taken from the proposed well location, facing West. Location has been built but has not been drilled. Weedy, annual vegetation was apparent throughout the location with large bare spaces with no vegetation.

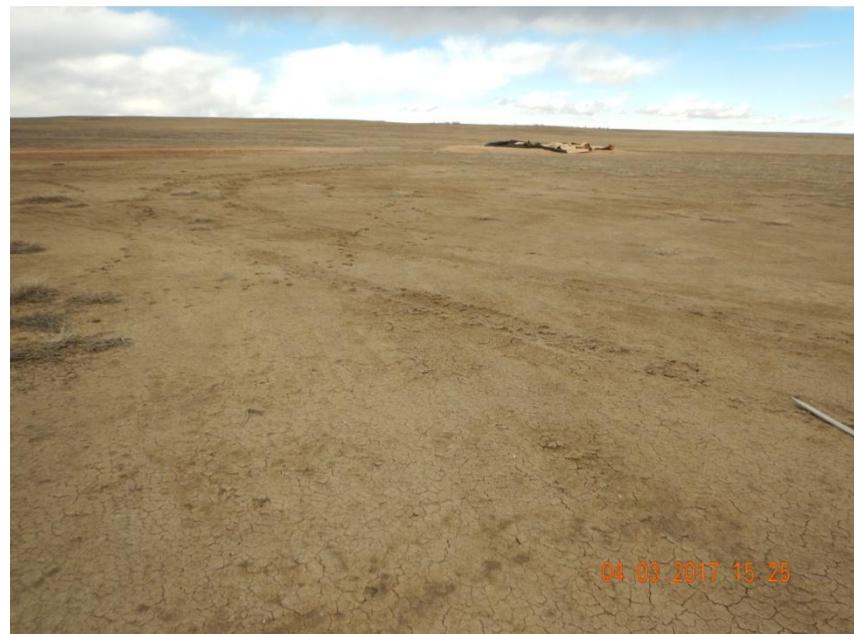
Photo 2. Photo taken from the proposed well location, facing North. Location has been built but has not been drilled. Weedy, annual vegetation was apparent throughout the location with large bare spaces with no vegetation.

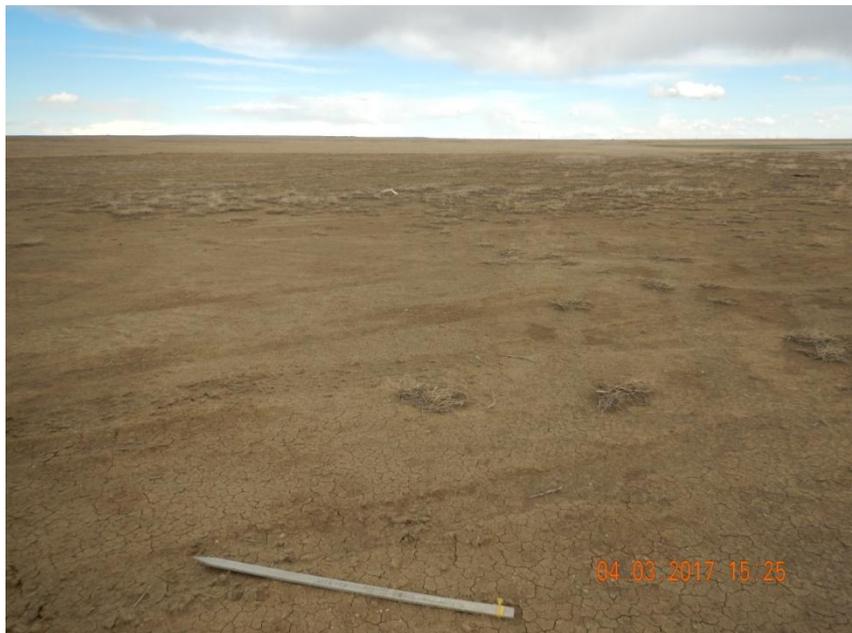
Photo 3. Photo taken from the proposed well location, facing East. Location has been built but has not been drilled. Weedy, annual vegetation was apparent throughout the location with large bare spaces with no vegetation.

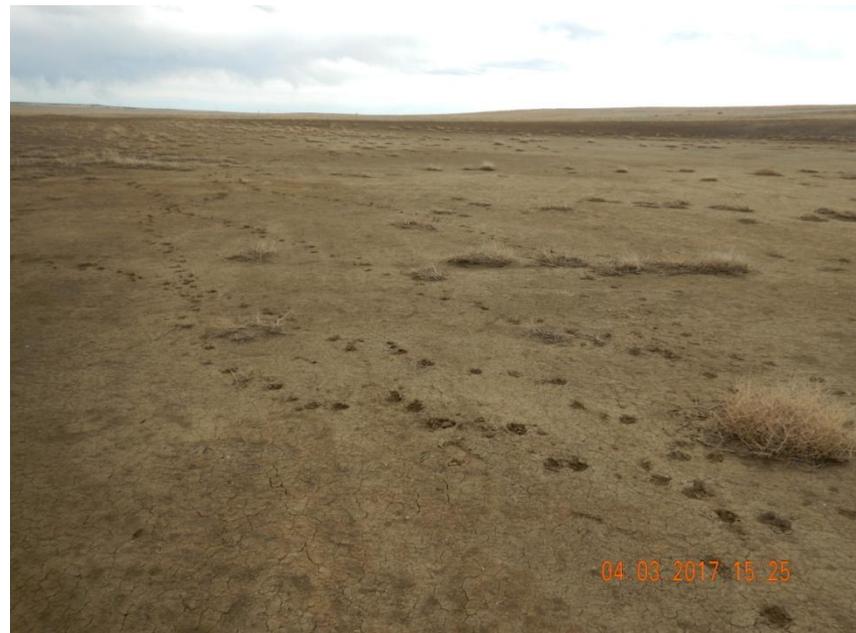
Photo 4. Photo taken from the proposed well location, facing South. Location has been built but has not been drilled. Weedy, annual vegetation was apparent throughout the location with large bare spaces with no vegetation.

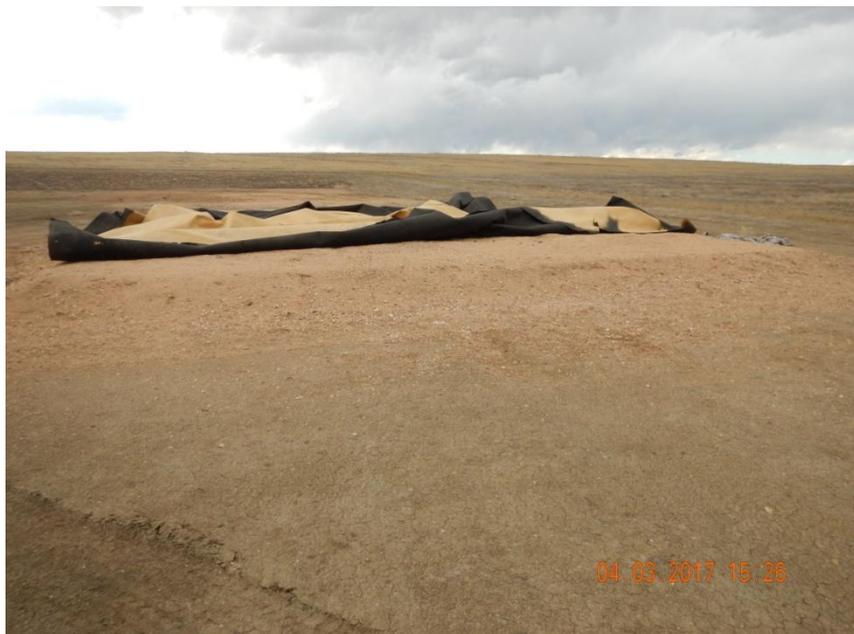
Photo 5. Photo taken from the northern location, facing West. Debris has been left on location from where potential equipment was on location.

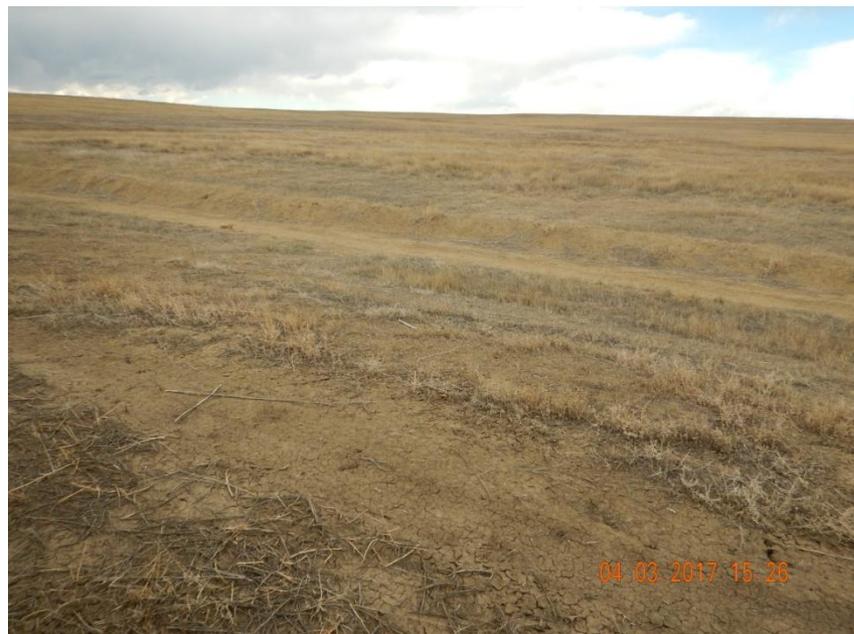
Photo 6. Photo taken from the northern location, facing Northwest. A ditch and berm BMP has been installed around the location perimeter. Minor rill erosion was observed along the fill slopes.

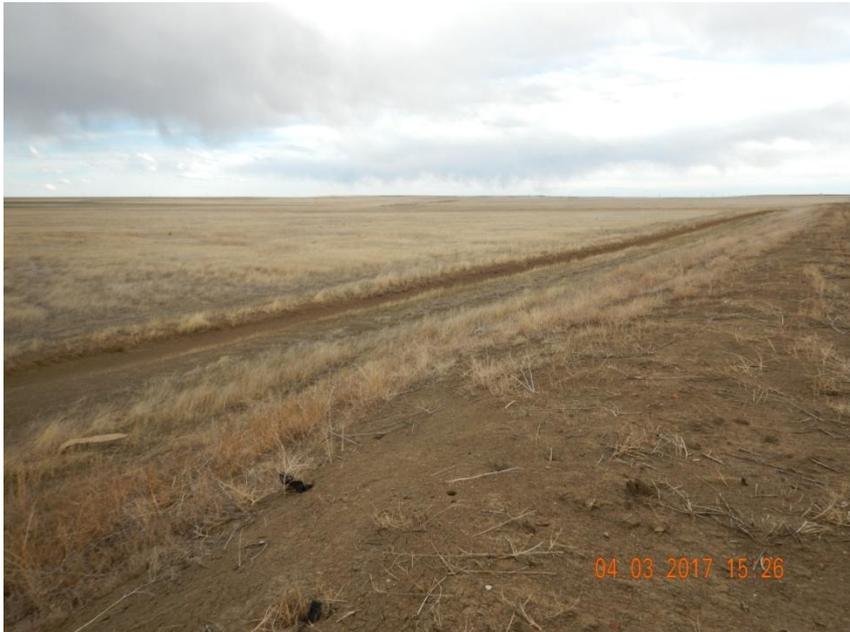
Photo 7. Photo taken from the eastern location, facing Southeast. A ditch and berm BMP has been installed around the location perimeter. Minor rill erosion was observed along the fill slopes.

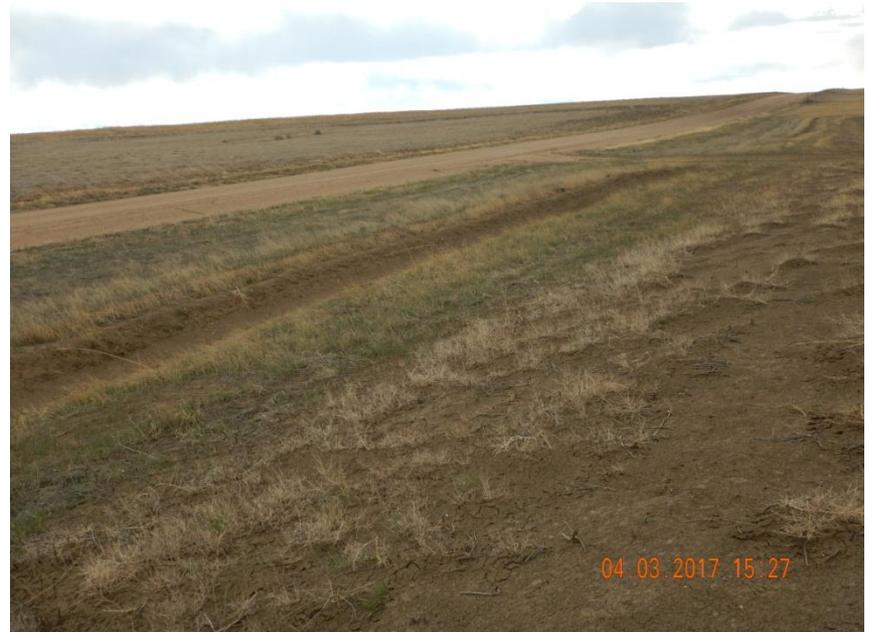
Photo 8. Photo taken from the southern location, facing Southwest. A ditch and berm BMP has been installed around the location perimeter. Minor rill erosion was observed along the fill slopes.
