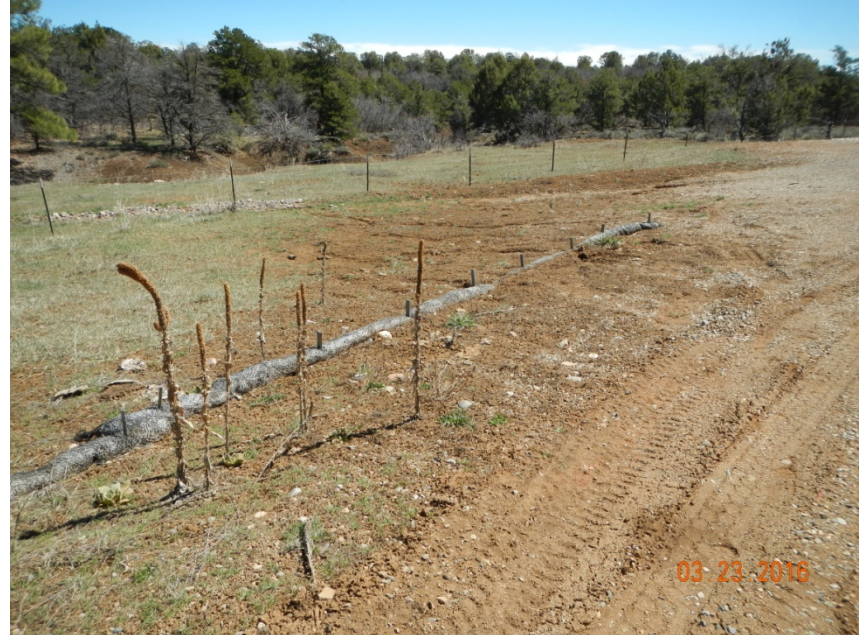
**Photo 4: View of area in the eastern portion of the interim reclamation area that is eroding and needs stabilization.**

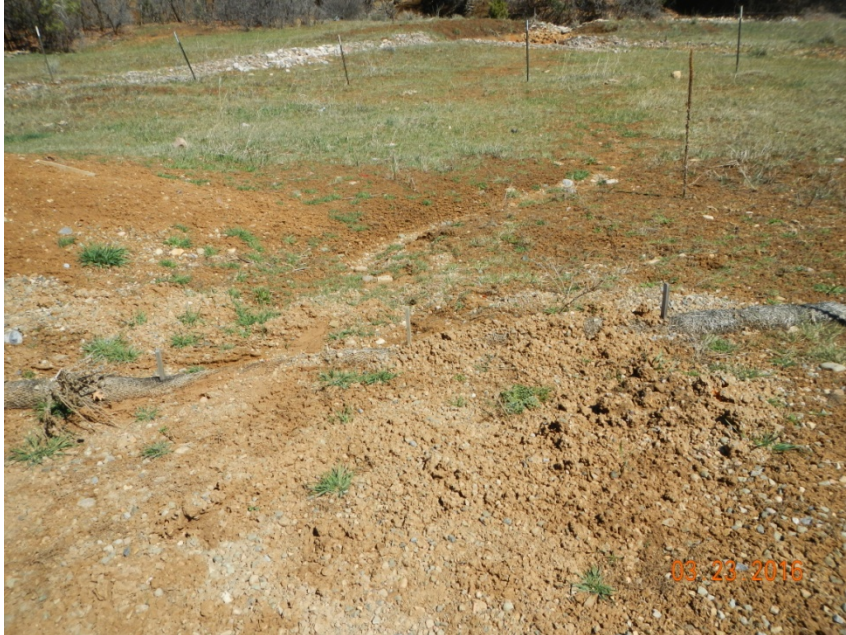
**Photo 5: View of wattles in the eastern portion of the project area that are not functioning.**

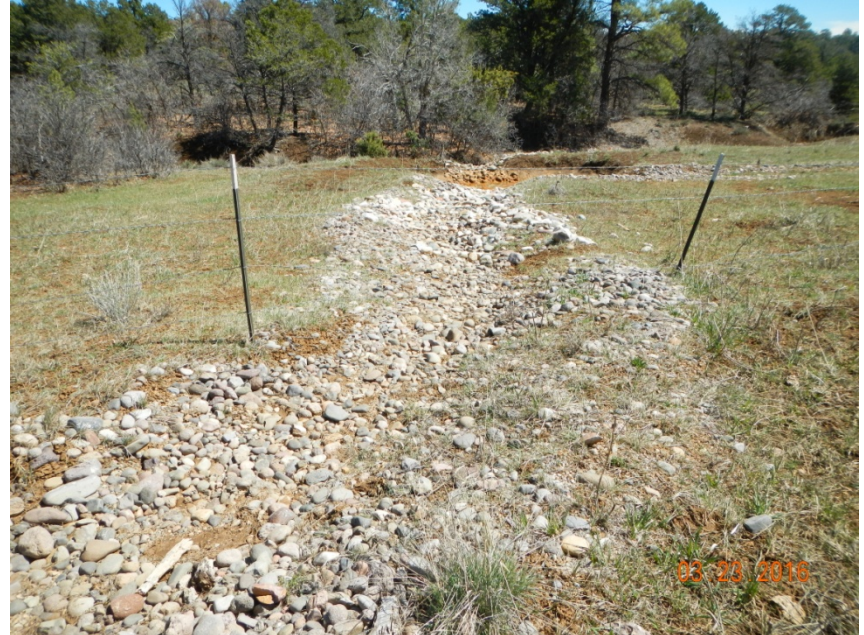
**Photo 6: View of stormwater controls and drainage to a silt trap at the edge of the project area.**

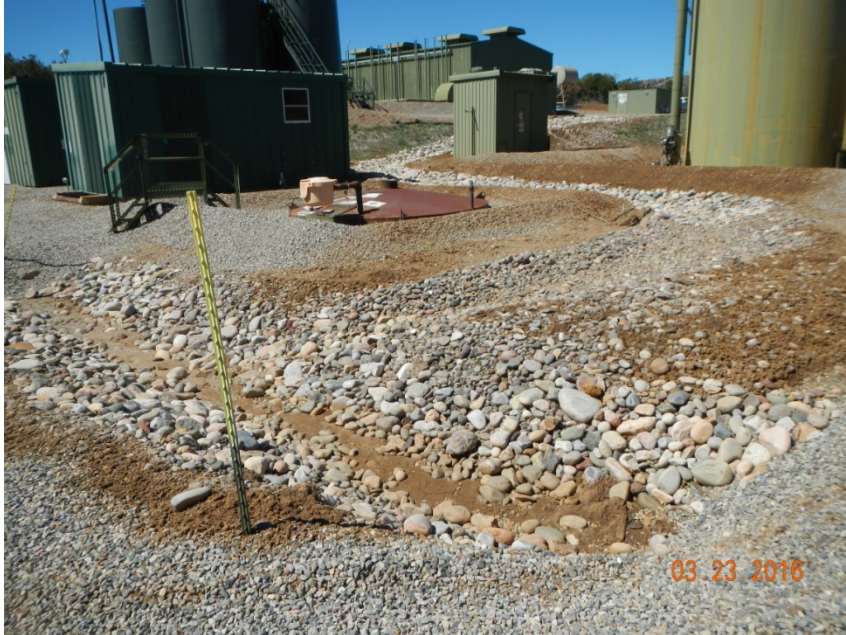
**Photo 7: View of stormwater management in the northwestern portion of the project area that appears to be functioning.**
