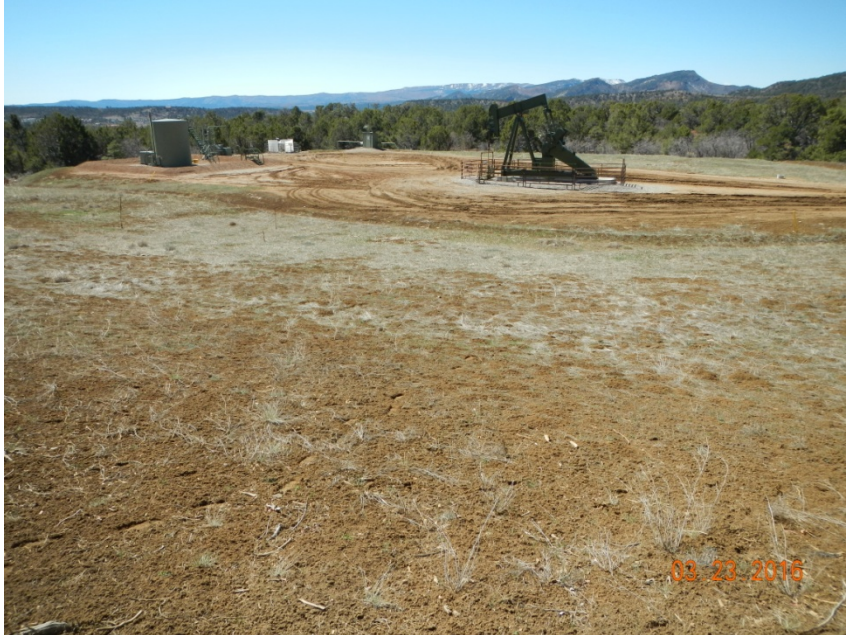
**Photo 1: View of the project area from the northeastern corner facing center.**

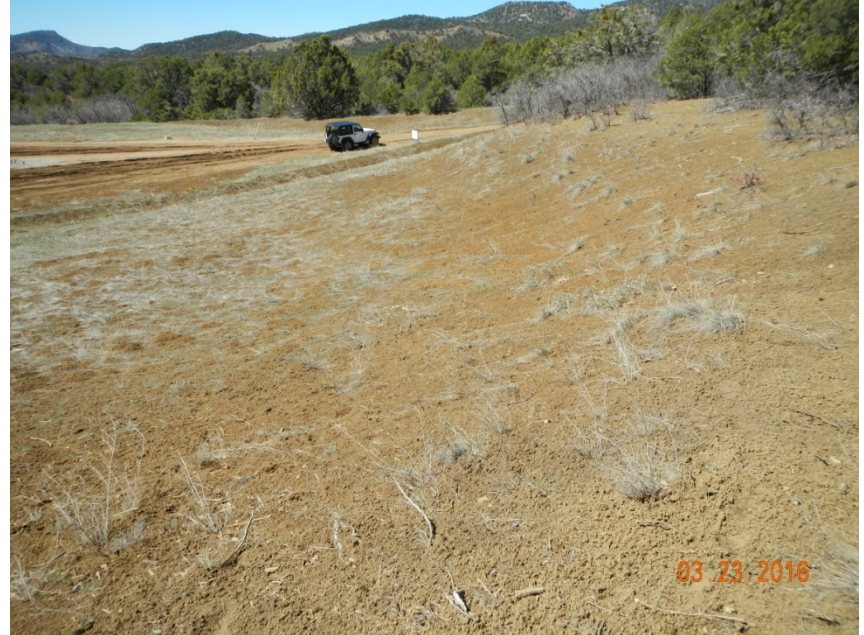
**Photo 2: View of the northern portion of the project area from the northeastern corner facing westward.**

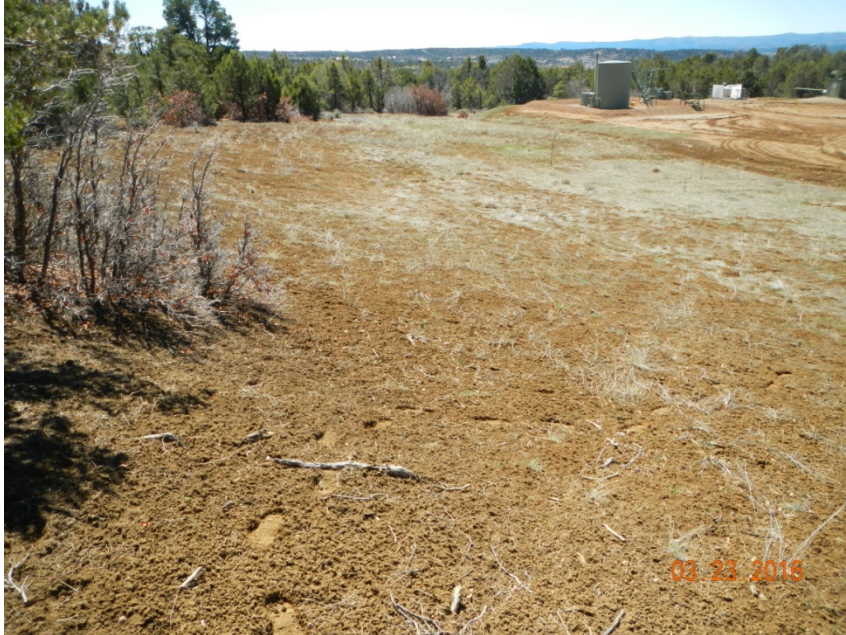
**Photo 3: View of the eastern portion of the project area from the northeastern corner facing southward. Revegetation is sparse in this portion of the interim reclamation area and largely comprised of Indian ricegrass (*Achnatherum hymenoides*) and smooth brome (*Bromus inermis*).**

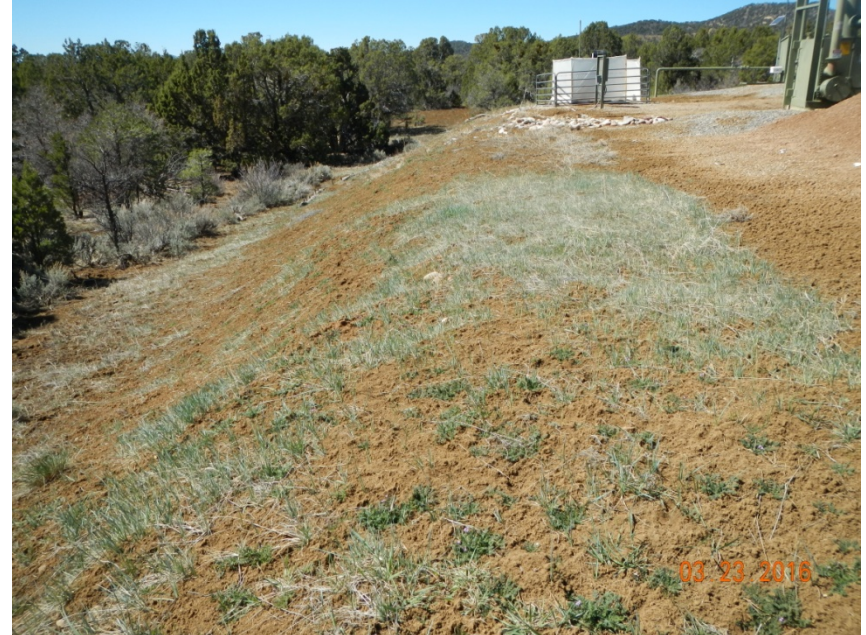
**Photo 4: View of the southern portion of the project area from the southeastern corner facing westward.**

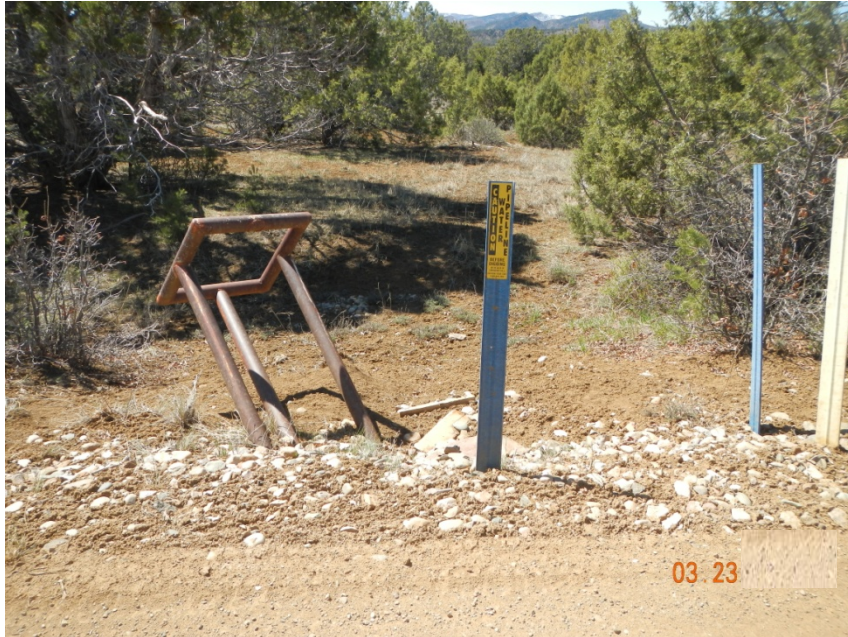
**Photo 9: View of pipe barricade that looks like it's been knocked over.**
