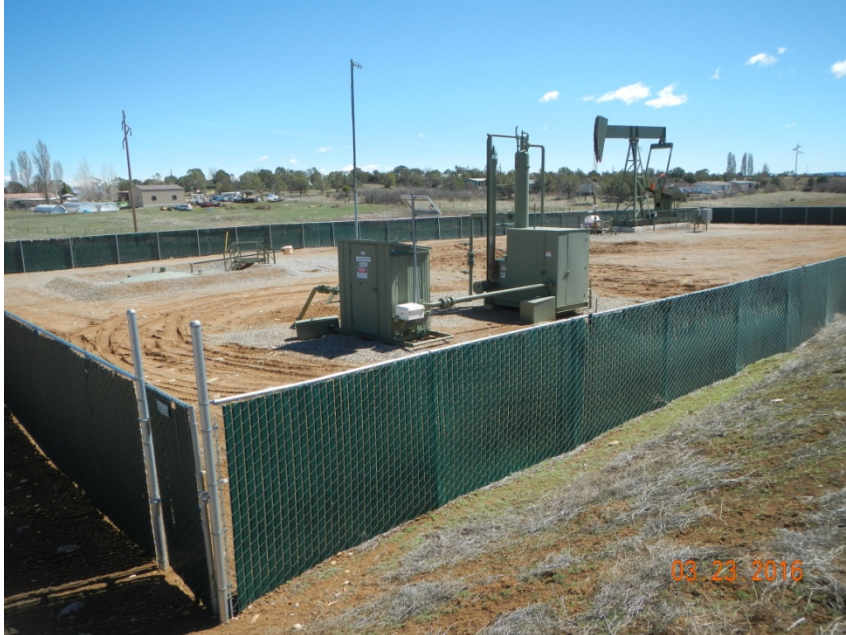
Photo 1: View of the project area from the southeastern corner facing center.

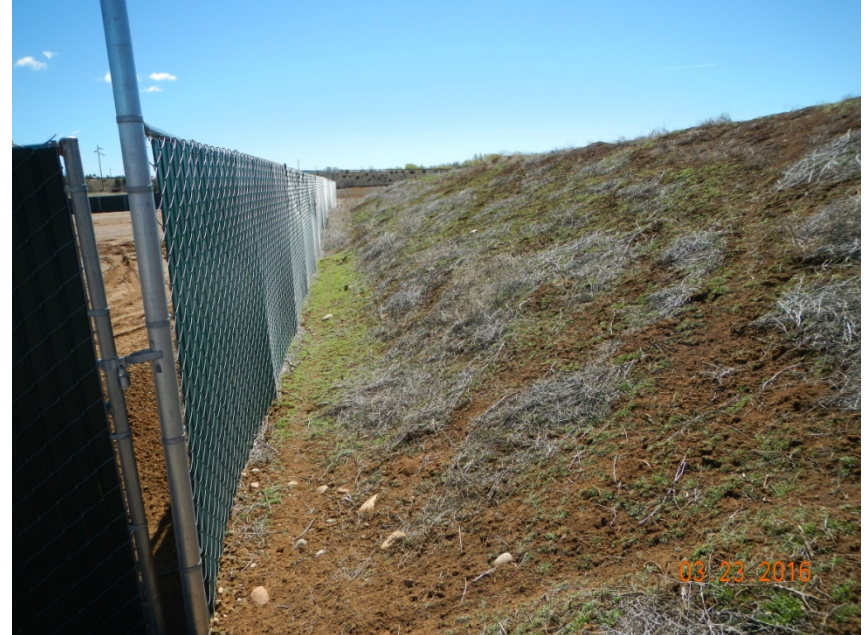
Photo 2: View of the western portion of the project area from the northwestern corner facing southward. Revegetation is sparse and consistent with surrounding degraded field.

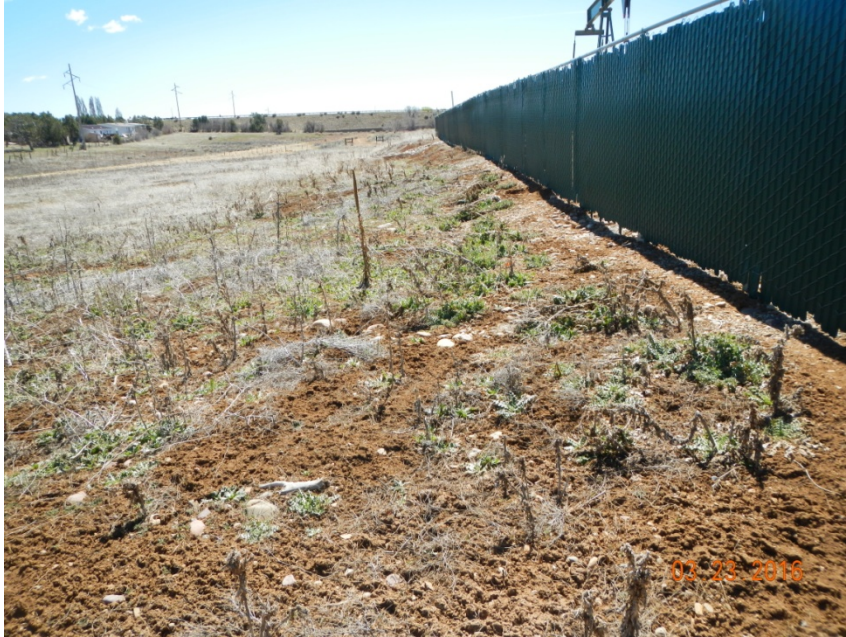
Photo 3: View of the eastern portion of the project area from the northeastern edge facing southward. Musk thistles (*Carduus nutans*) are present in the foreground.

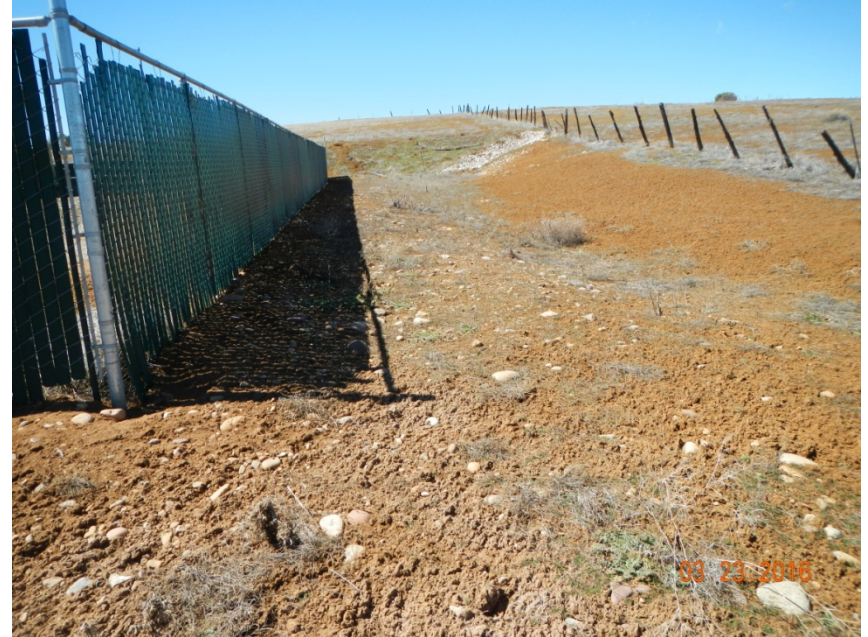
Photo 4: View of the northern portion of the project area from the northeastern corner facing westward.

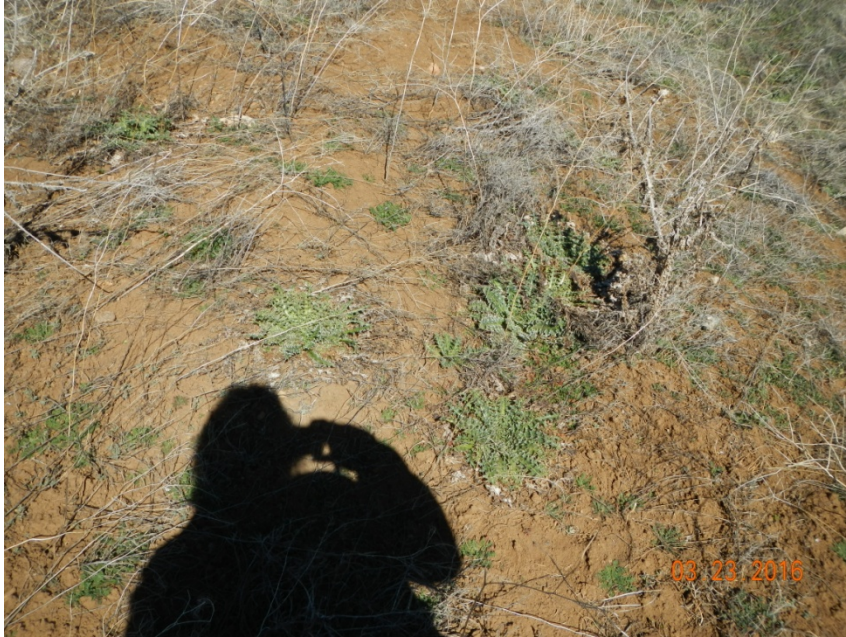
Photo 5: Another view of musk thistles within the interim reclamation area.

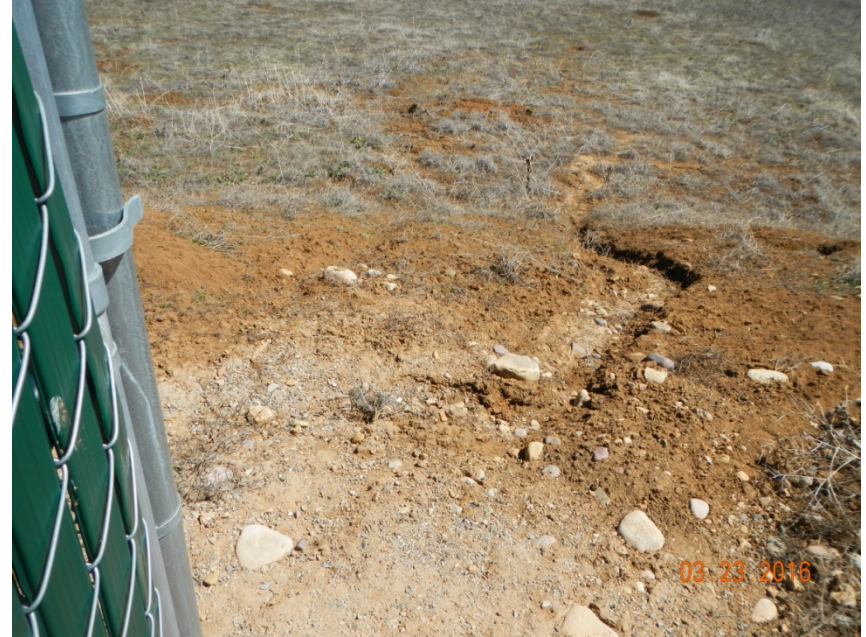
Photo 6: View of erosional channels in the southeastern corner of the project area.

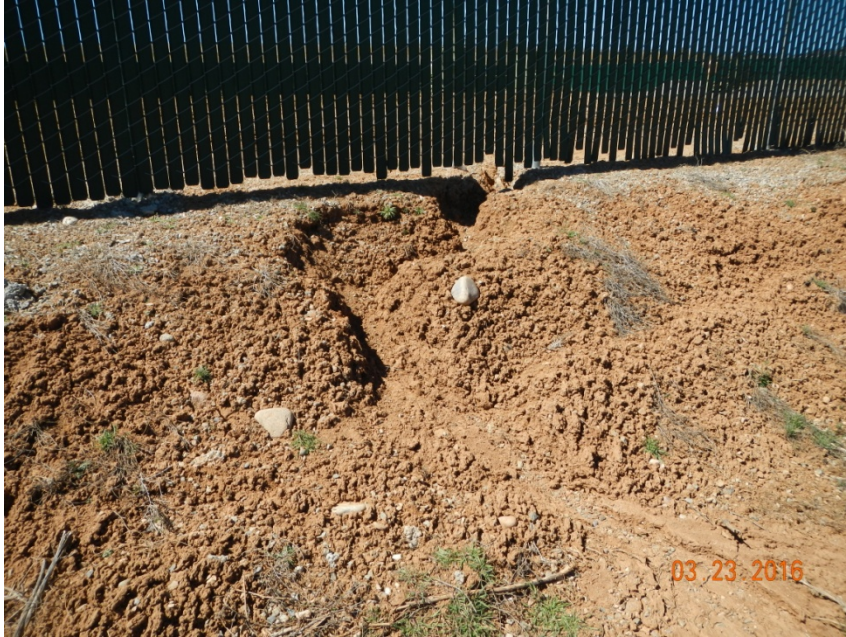
Photo 7: View of erosional channel forming within the eastern portion of the project area.

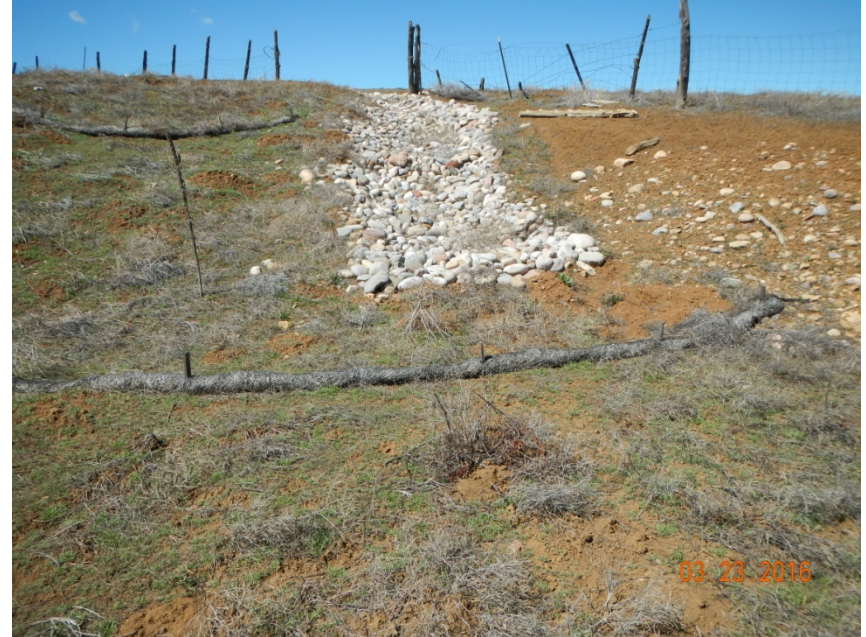
Photo 8: View of stormwater controls in the northwestern portion of the project area appear to be functioning.
