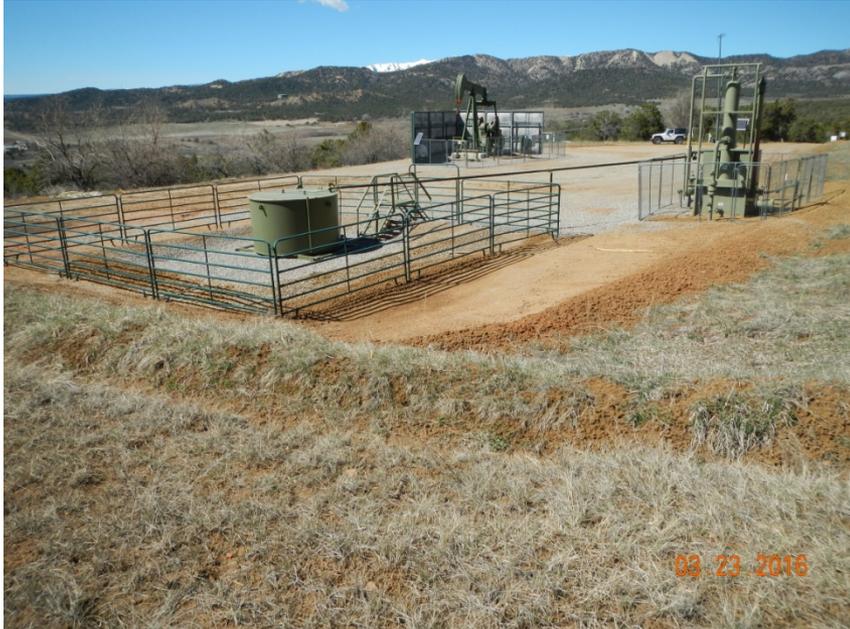
**Photo 1:** View of the project area from the southeastern corner facing center.

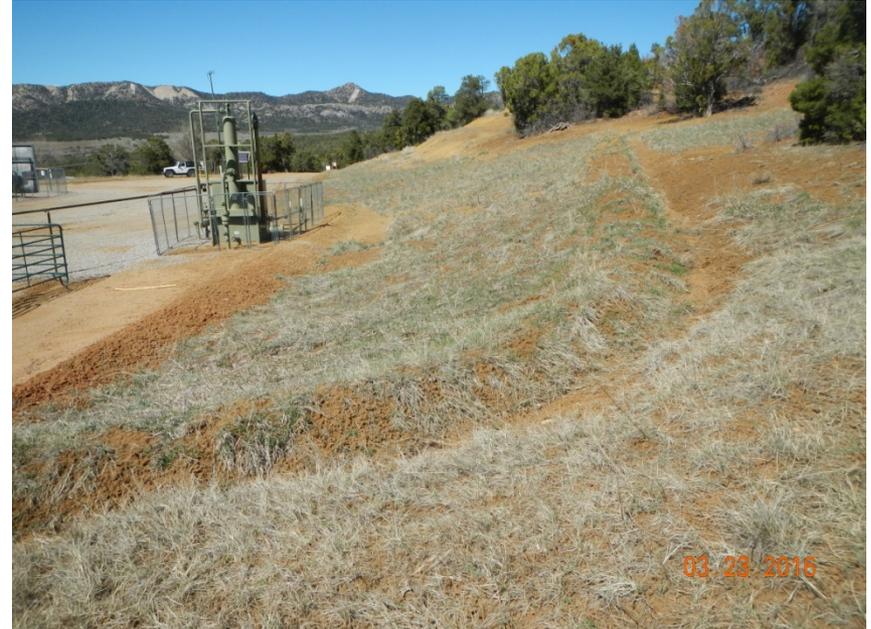
**Photo 2:** View of the eastern portion of the project area from the southeastern corner facing northward. Revegetation is progressing and largely comprised of smooth brome (*Bromus inermis*).

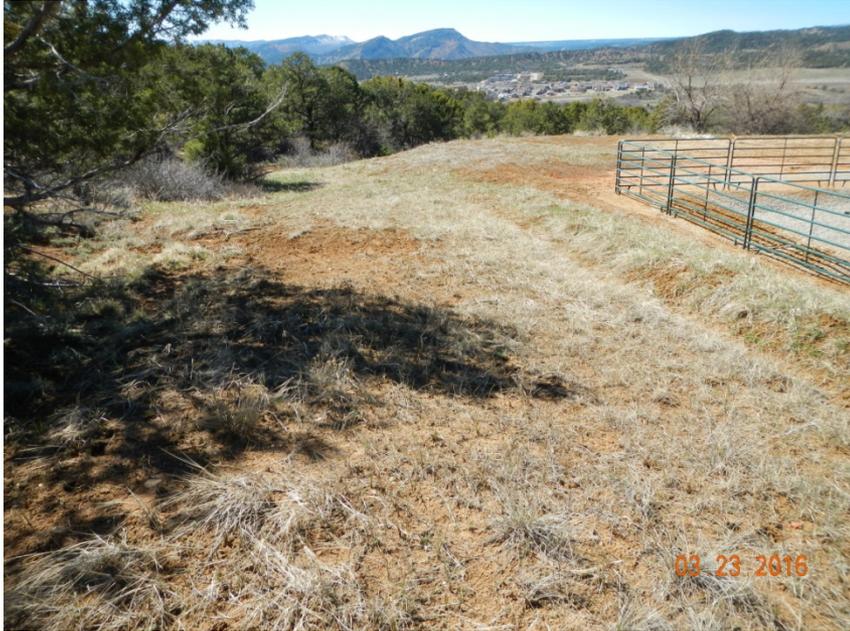
**Photo 3: View of the southern portion of the project area from the southeastern edge facing westward.**

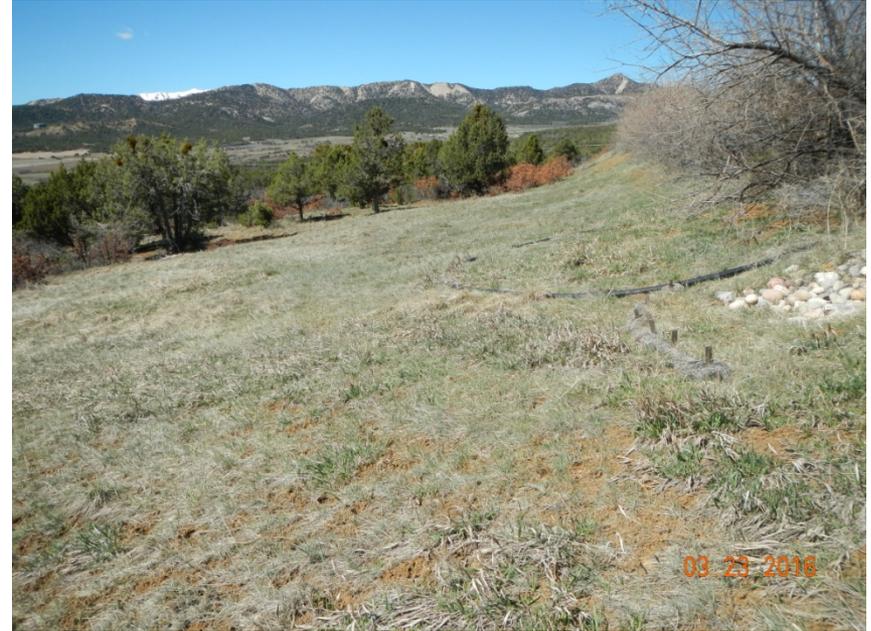
**Photo 4: View of the northern portion of the project area from the northeastern corner facing westward. Russian olive (*Eleagnus angustifolia*) trees appear to have been planted on the western edge of the working area.**

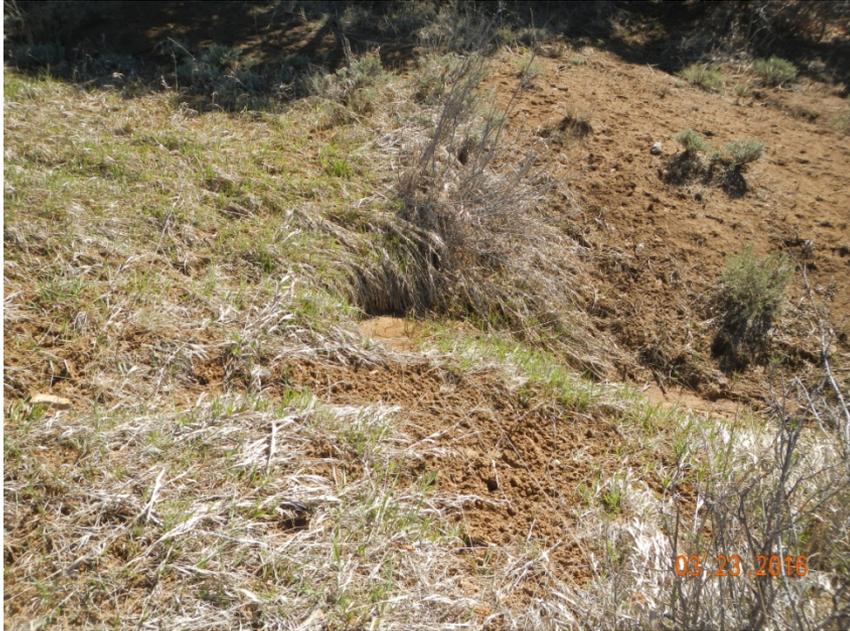
**Photo 5: View of headcut forming along the southern diversion in the project area. This should be carefully monitored and repaired if erosion worsens.**

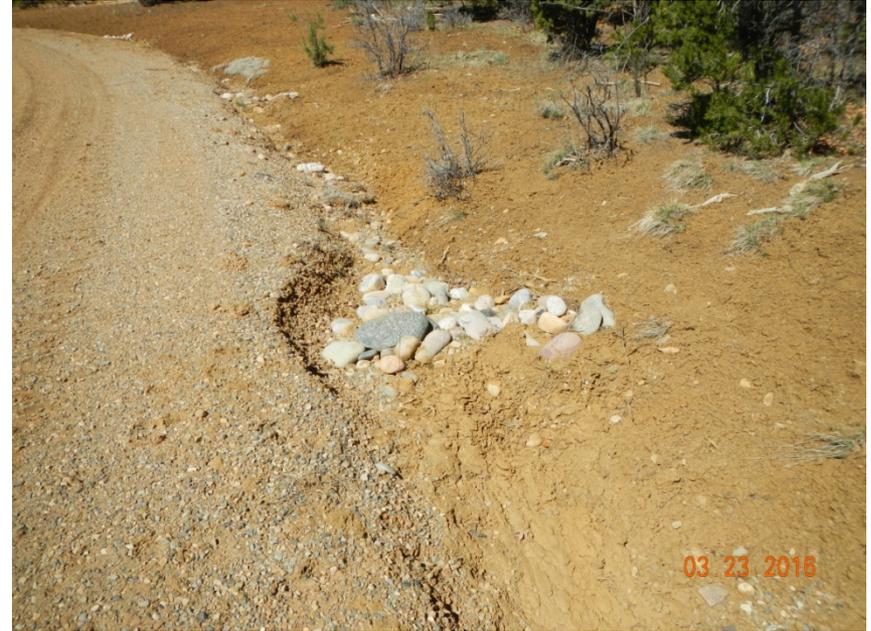
**Photo 6: View of cobble check dam along the access road that is full of sediment and eroding where stormwater flows around the dam.**
