Stormwater Inspection

April 6, 2017

Operator: BURLINGTON RESOURCES OIL & GAS LP
#26580

Location Name: Montezuma 4-64 18-13 #4H

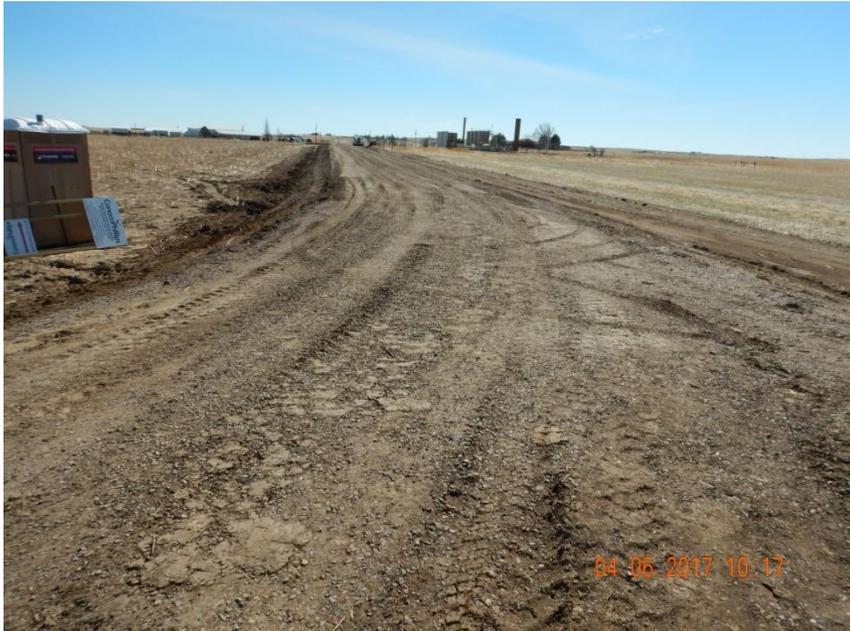
Photo 1. Photo taken from the entrance of location, facing East. Access road into entrance has been constructed.

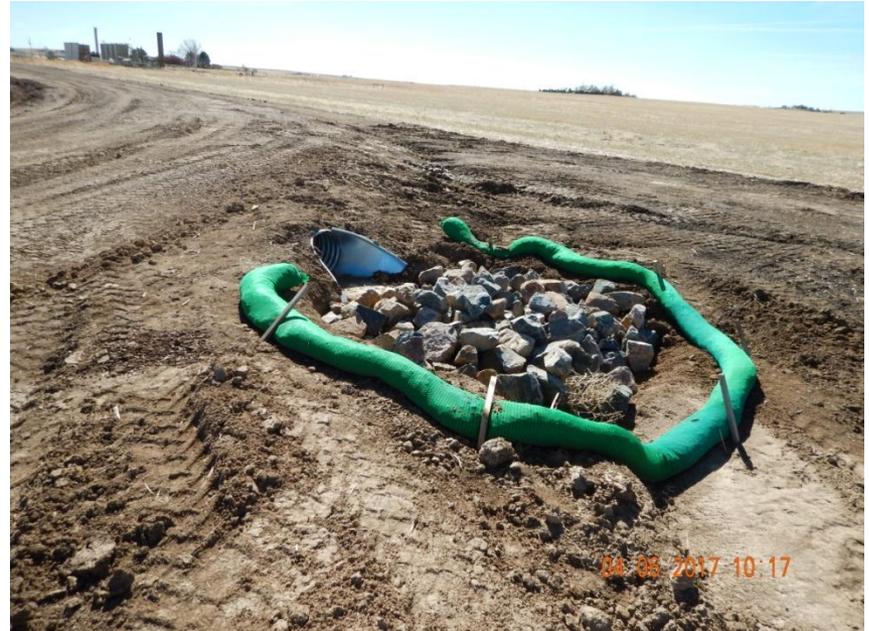
Photo 2. Photo taken from the southeast location, facing Southeast. A stabilized outlet has been installed with a filter wattle.

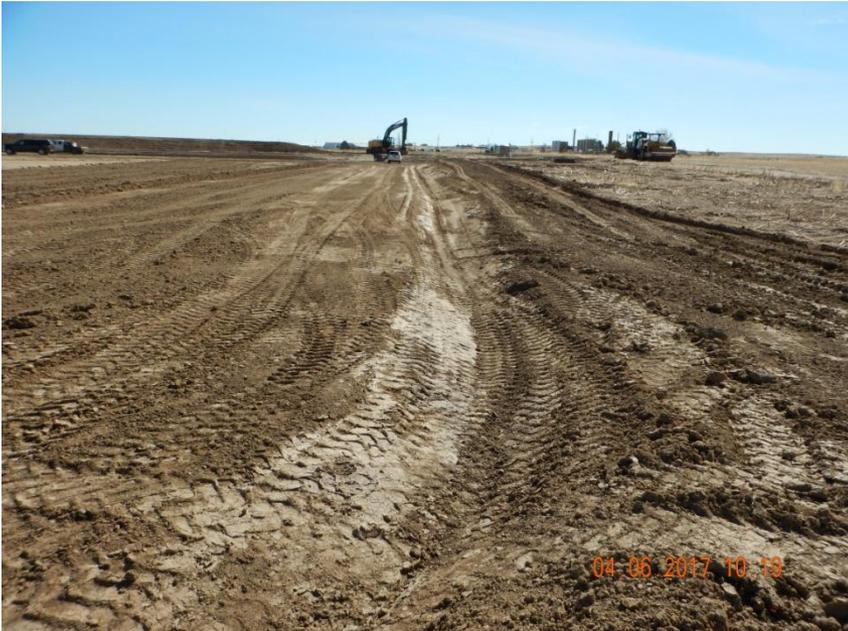
Photo 3. Photo taken from the southwest production area, facing East. Diversion ditch installed in conjunction with a sediment trap.

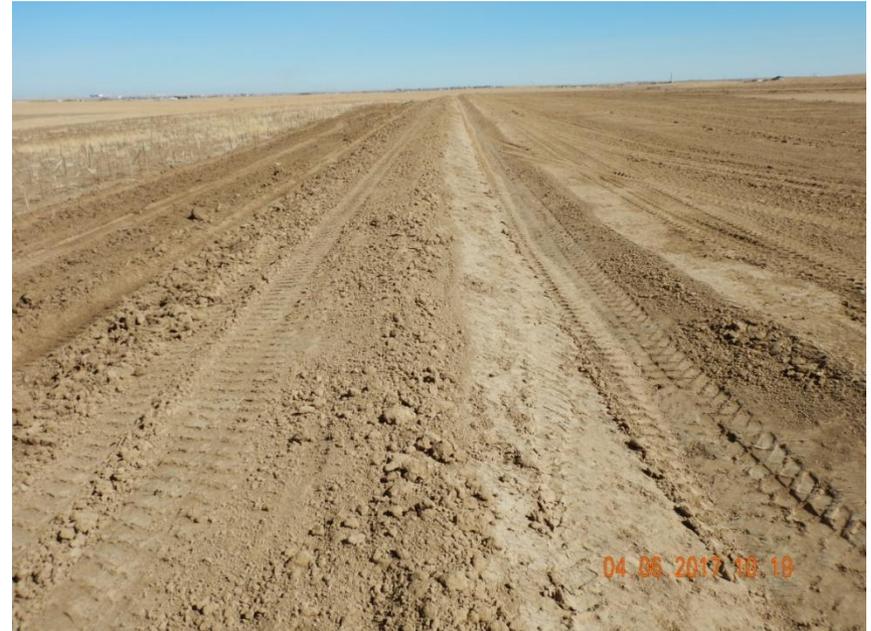
Photo 4. Photo taken from the western production area, facing East. Diversion ditch installed in conjunction with a sediment trap. Operator said that filtrex will be installed along the western disturbance area.

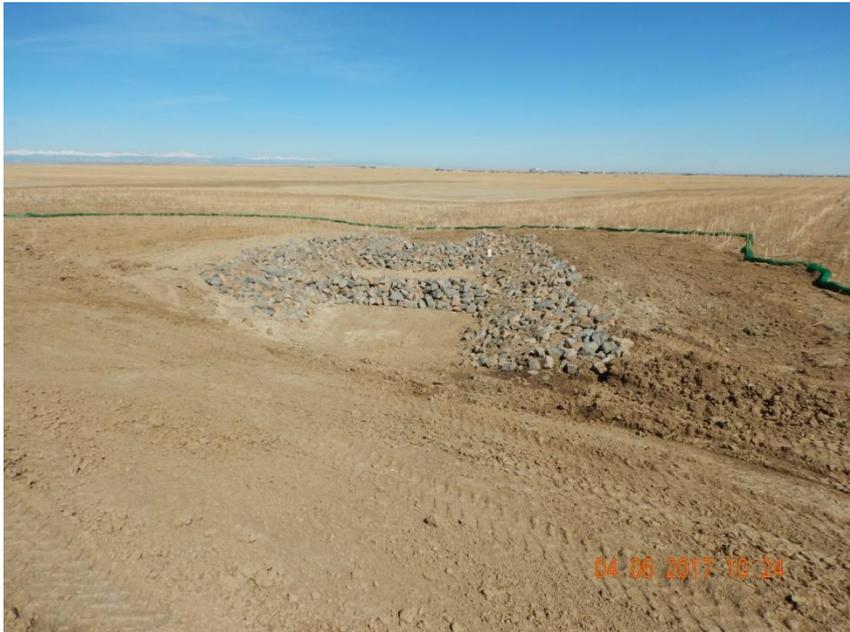
Photo 5. Photo taken from the northwest location, facing Northwest. Sediment trap has been installed in conjunction with diversion ditches and filtrex installed along the outer perimeter of the disturbance area.

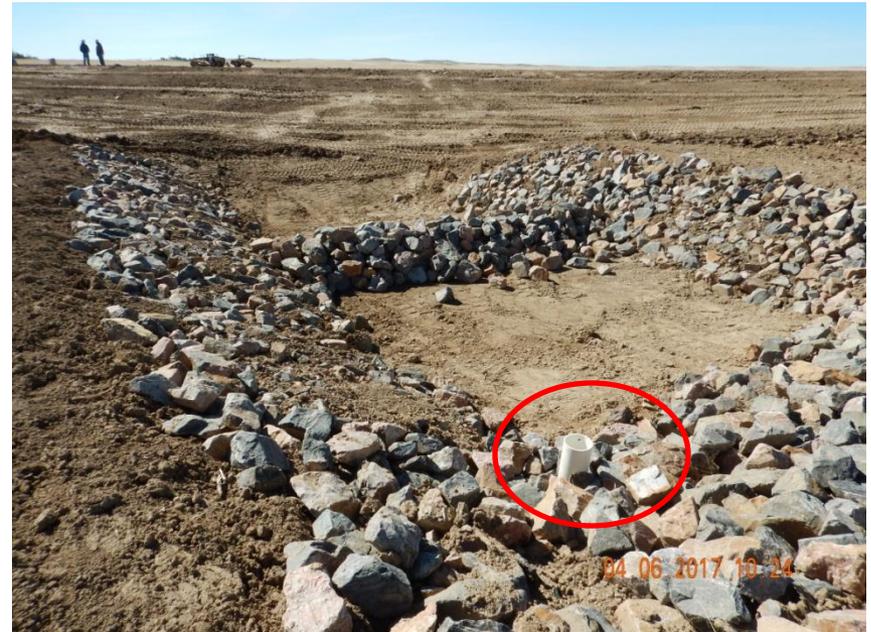
Photo 6. Photo taken from the sediment trap, facing South. Sediment trap has been installed with a stabilized outfall and principle outlet.

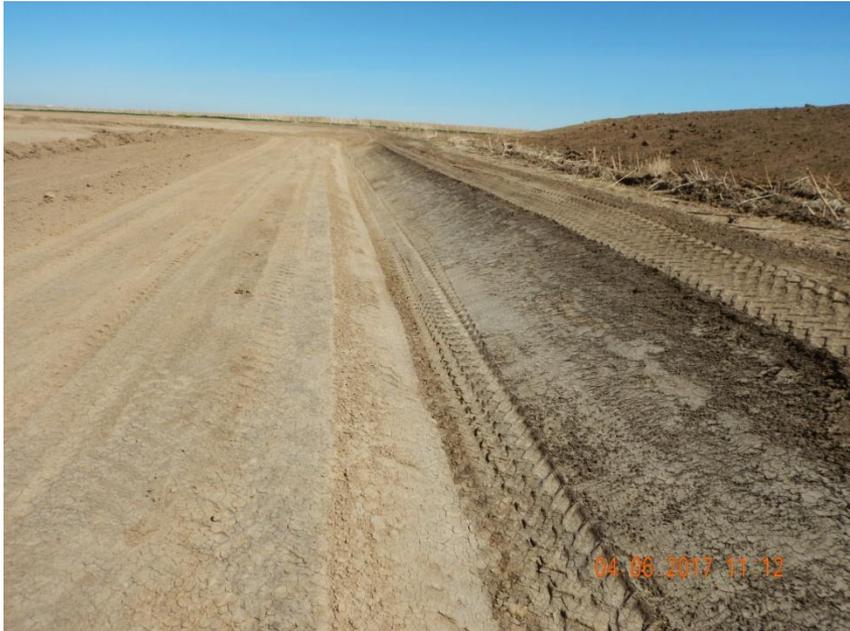
Photo 7. Photo taken from the eastern production area, facing North. Diversion ditch has been installed in conjunction with a sediment trap.

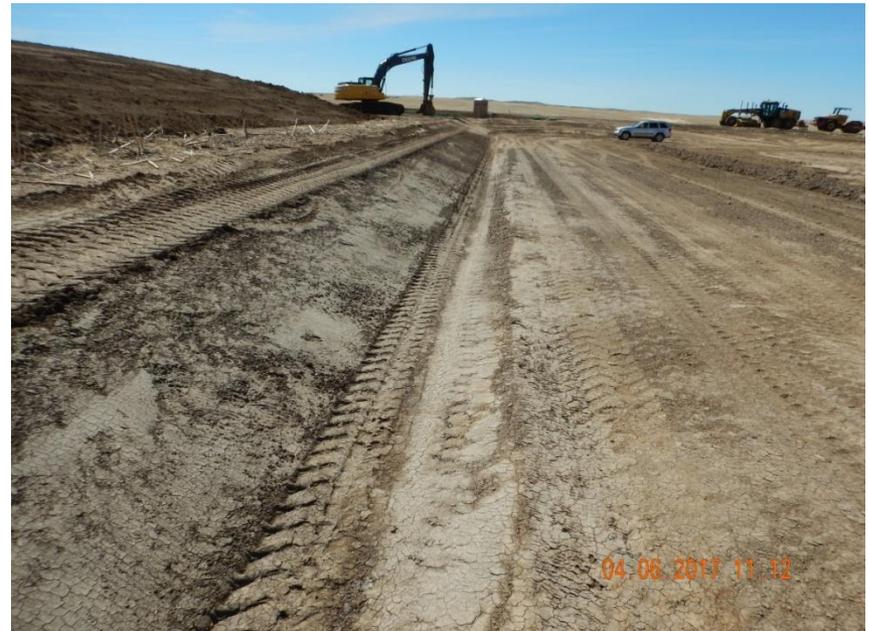
Photo 8. Photo taken from the eastern production area, facing South. Diversion ditch has been installed in conjunction with a sediment trap.

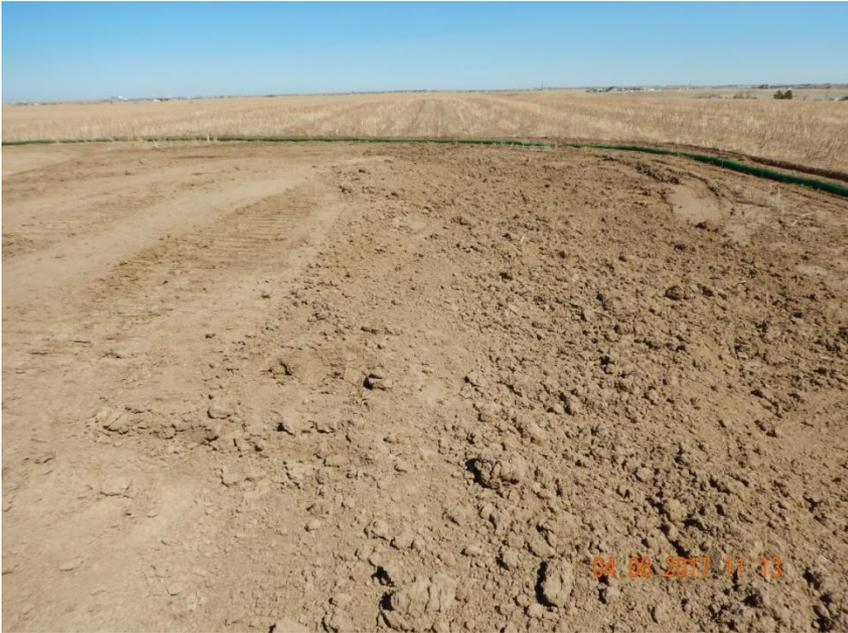
Photo 9. Photo taken from the topsoil stockpile along the eastern location, facing North. Filtrex has been installed along the toe of the topsoil stockpile with a diversion ditch to the outside to control run-on.

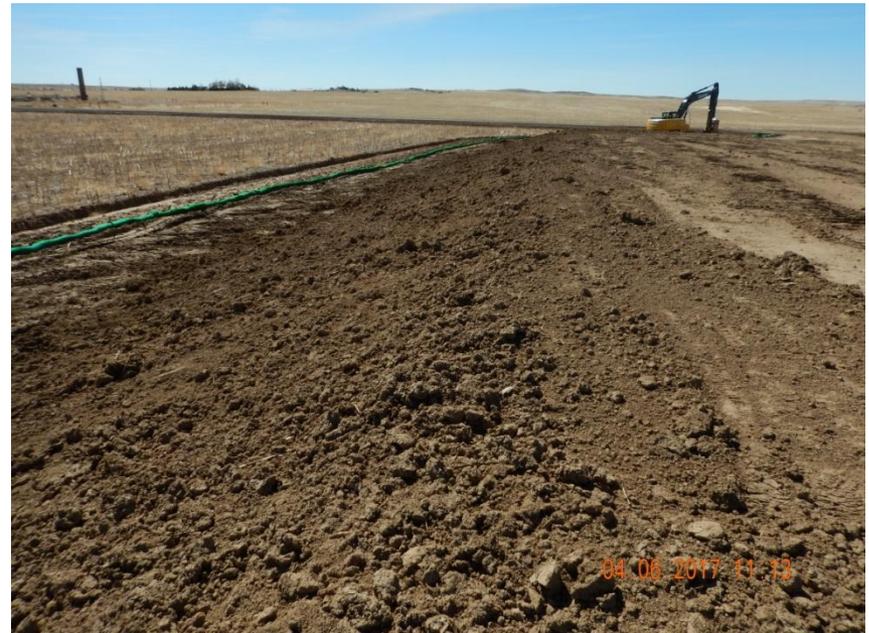
Photo 10. Photo taken from the topsoil stockpile along the eastern location, facing South. Filtrex has been installed along the toe of the topsoil stockpile with a diversion ditch to the outside to control run-on.
