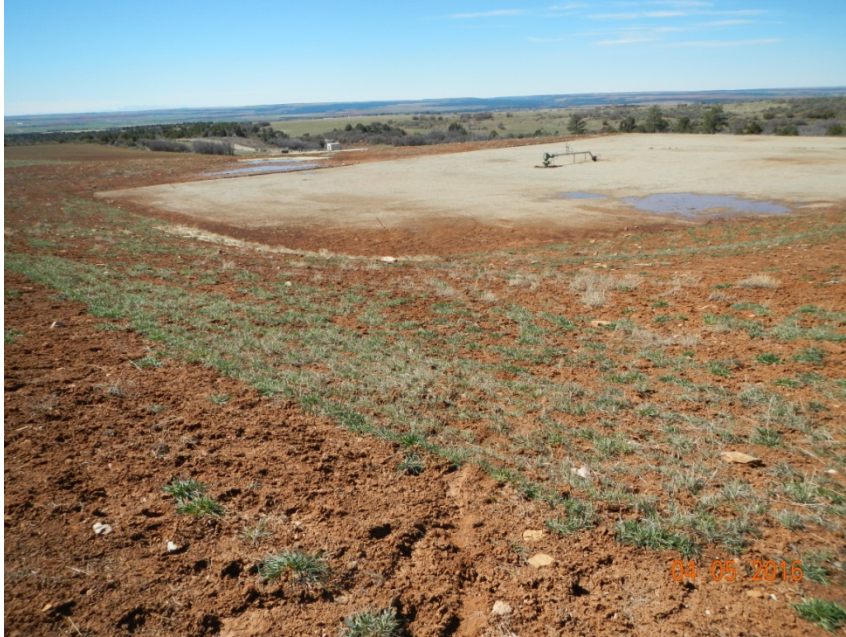
Photo 1: View of the project area from the northeastern corner facing center.

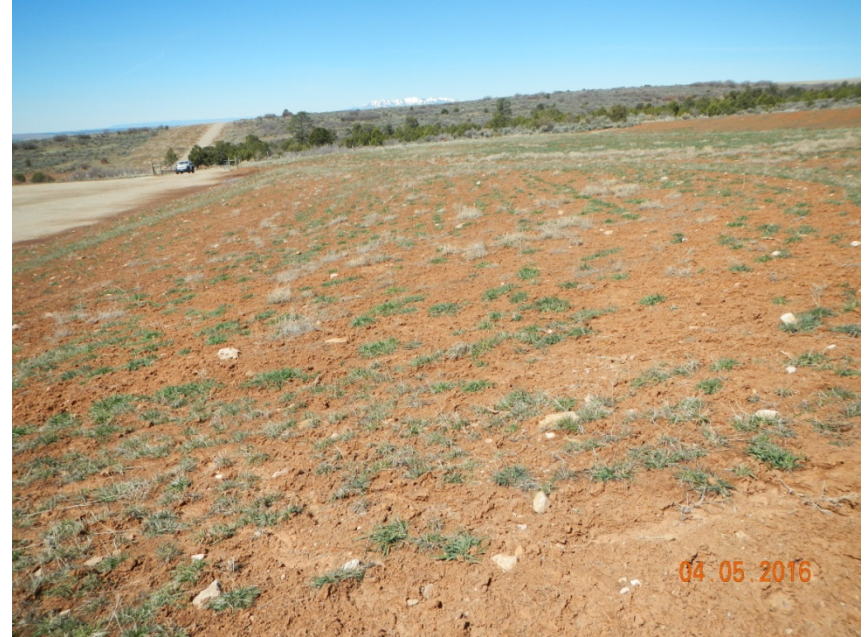
Photo 2: View of the northern portion of the project area from the northeastern corner facing westward. Most of the revegetation is not in identifiable form but is largely comprised of grasses such as intermediate wheatgrass (*Thinopyron intermedium*).

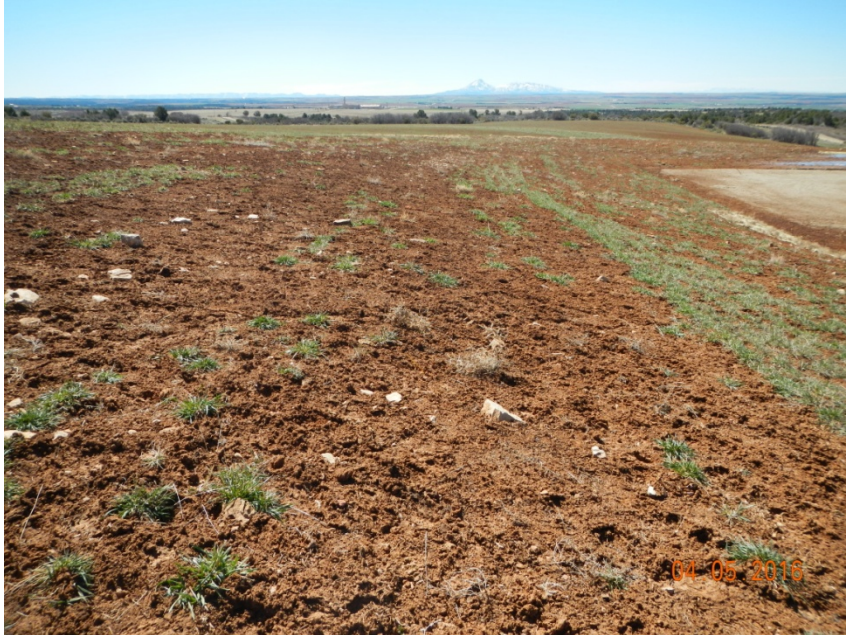
Photo 3: View of the eastern portion of the project area from the northeastern corner facing southward.

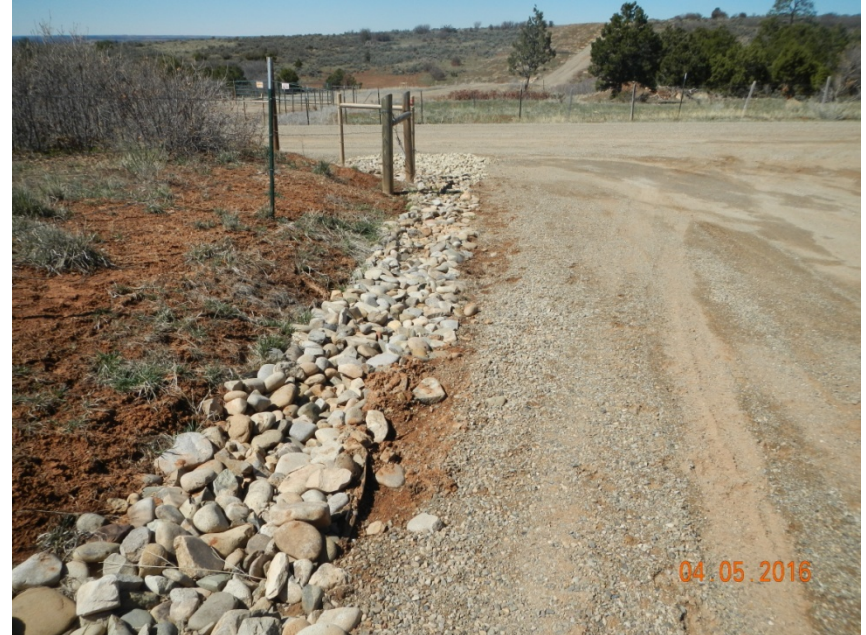
Photo 4: View cobble run-down along the access that appears to be functioning.

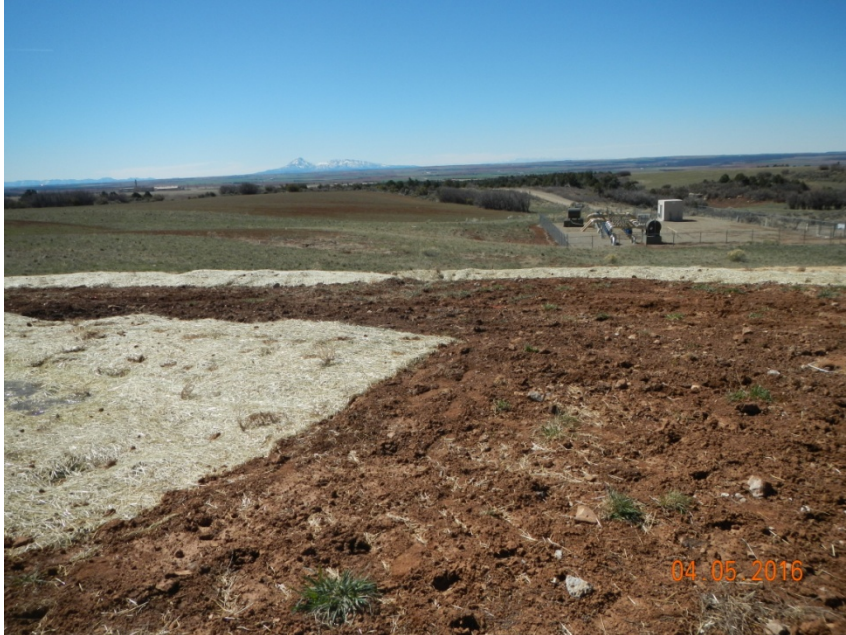
Photo 5: View of stormwater controls newly installed within the southern portion of the project area. Appear to be functioning at this time. Area is recently seeded.

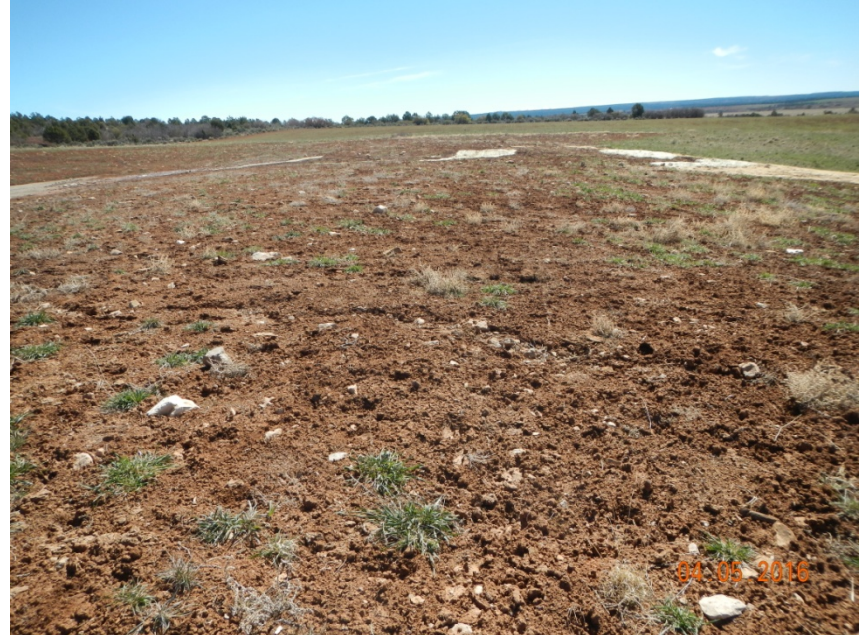
Photo 6: View of the southern portion of the project area from the southwestern corner facing eastward.
