April 6, 2017

COLORADO
Oil & Gas Conservation
Commission
Department of Natural Resources

Inspection Photos: Gunderson Loc#449070

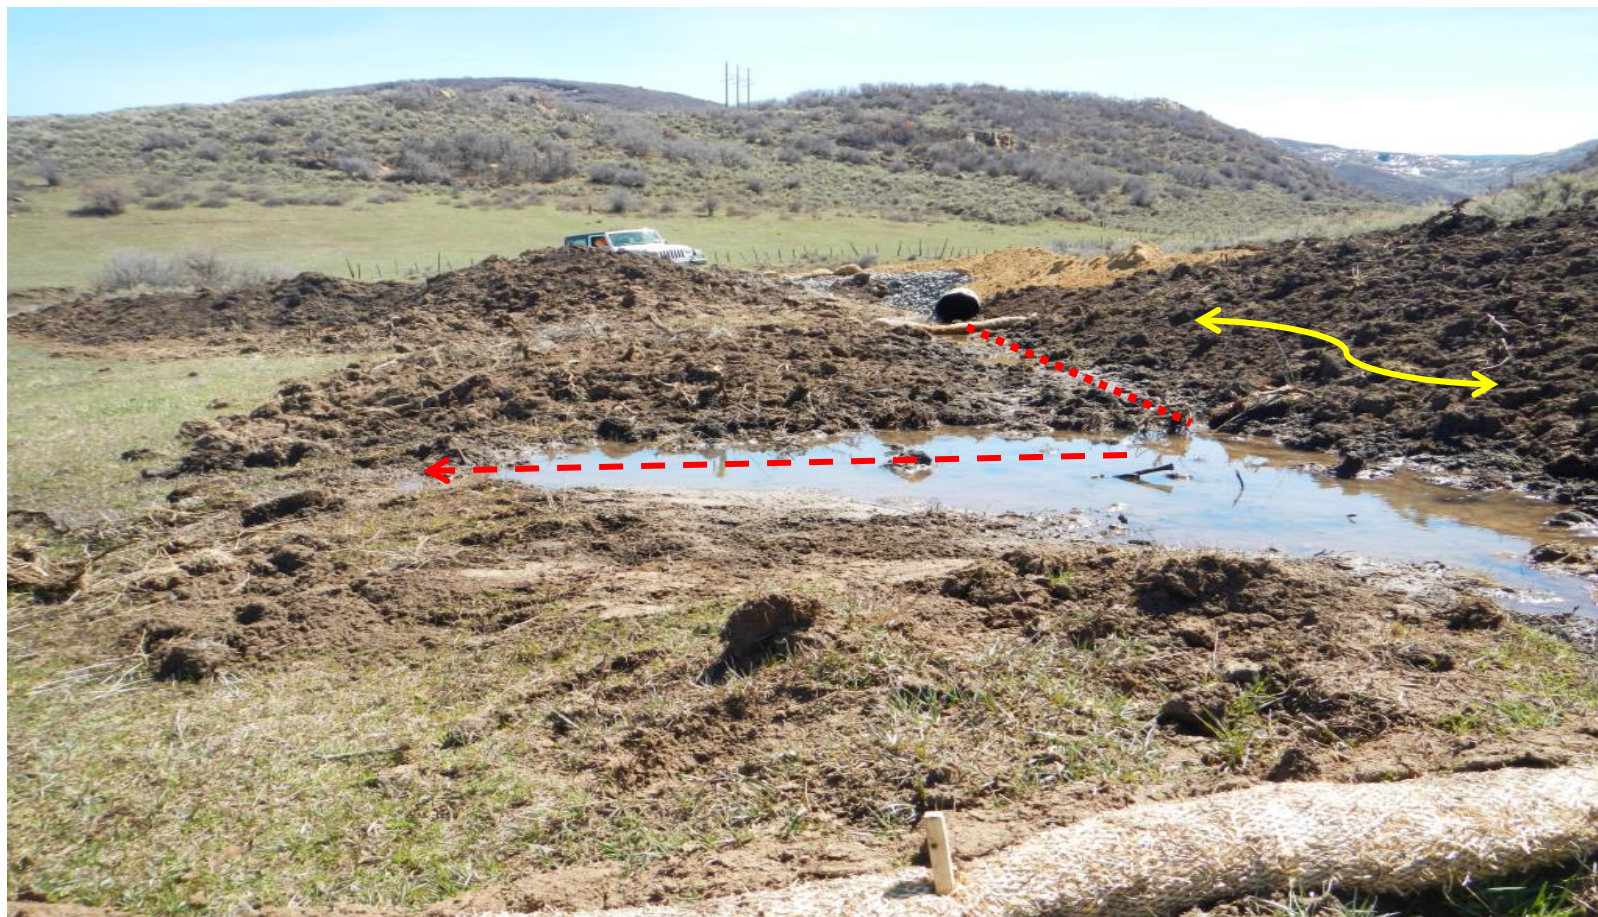
Photo#1: View from base of Access Rd Fill slope & irrigation ditch to SE. Jeep is at aprox take off point of Access Rd from Local Rd. Irrigation ditch water flows (indicated by red arrow) from Culvert & then is diverted out & flows to BMPs in Photos 2&3. Note loose soil in and along both sides of ditch Access Rd Fill Slope indicated by yellow arrow.

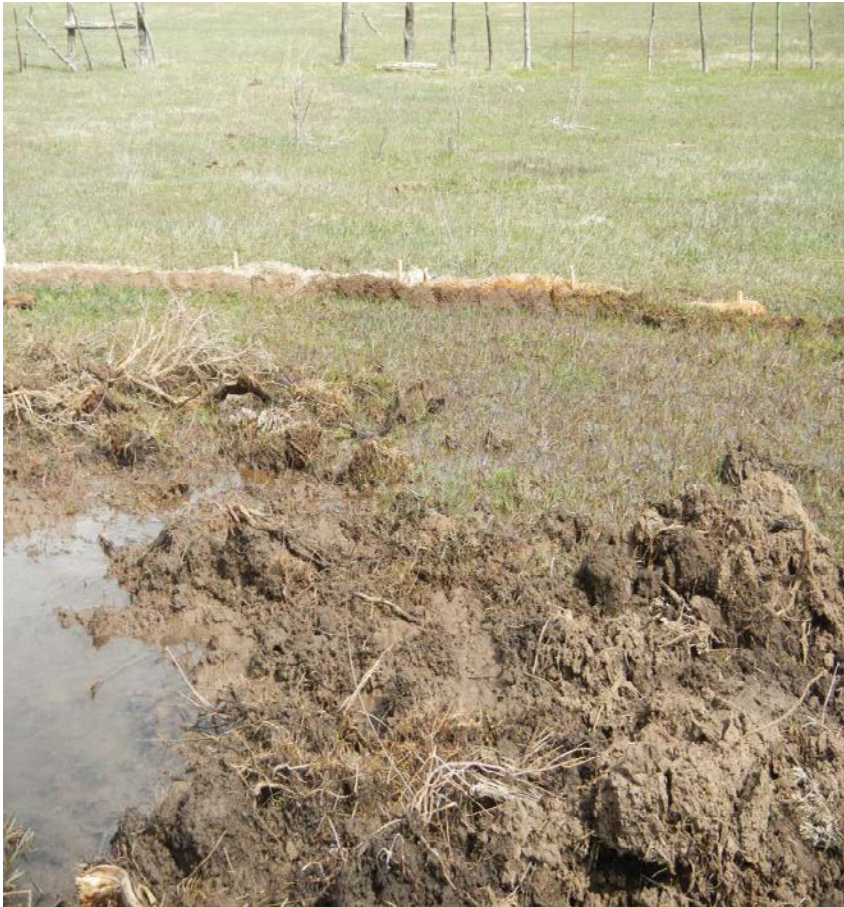
Photo#2:

Views of Insufficient BMP receiving discharged water from photo #1. Increased ditch flow or Precipitation event would soon overwhelm structure.

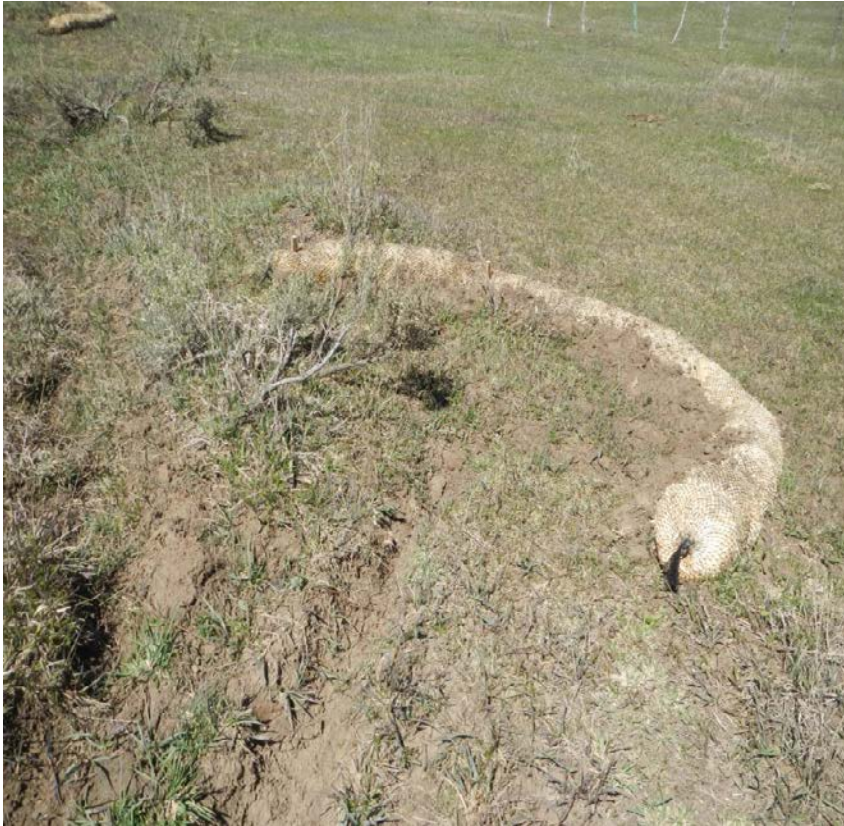
Photo#4:

Two BMPs installed further NW along ditch from photo #3 also appear insufficient to handle sediment migration from loose soil in Access Rd Fill slope.

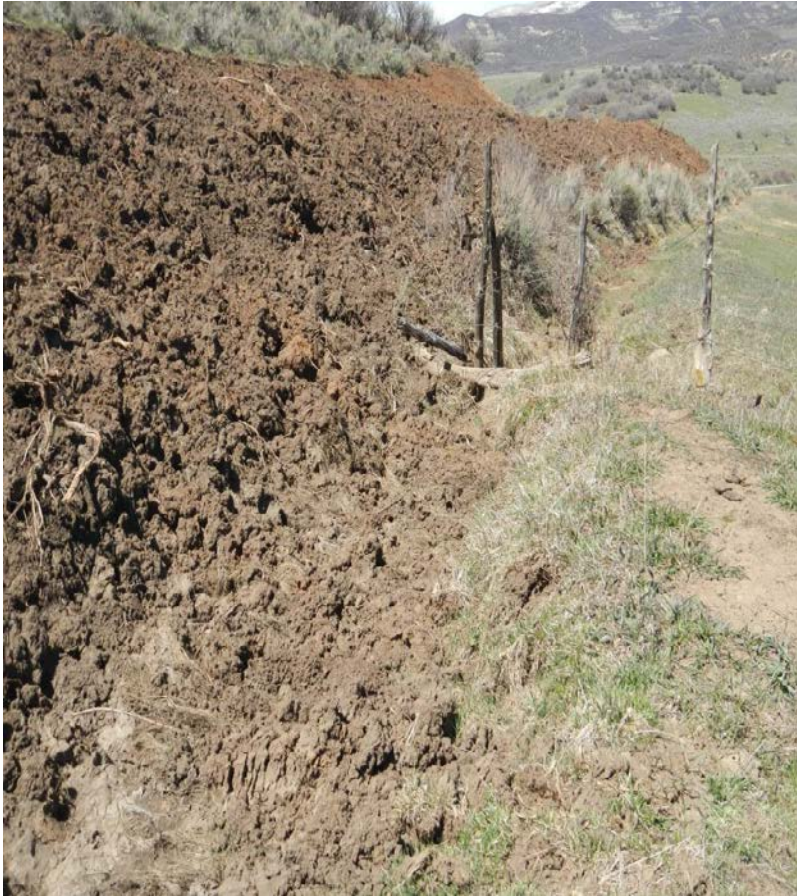
Photo#6:

In some areas along Access Rd Fill slope, soil fills in irrigation ditch which runs along base (photo#6); in others ditch maybe being presumed by operator to be perimeter BMP for Fill Slope(photo#7): In both areas; sufficient BMPs need to be Installed in accordance with Good Engineering Practices along base of all Access Rd Fill Slope.
