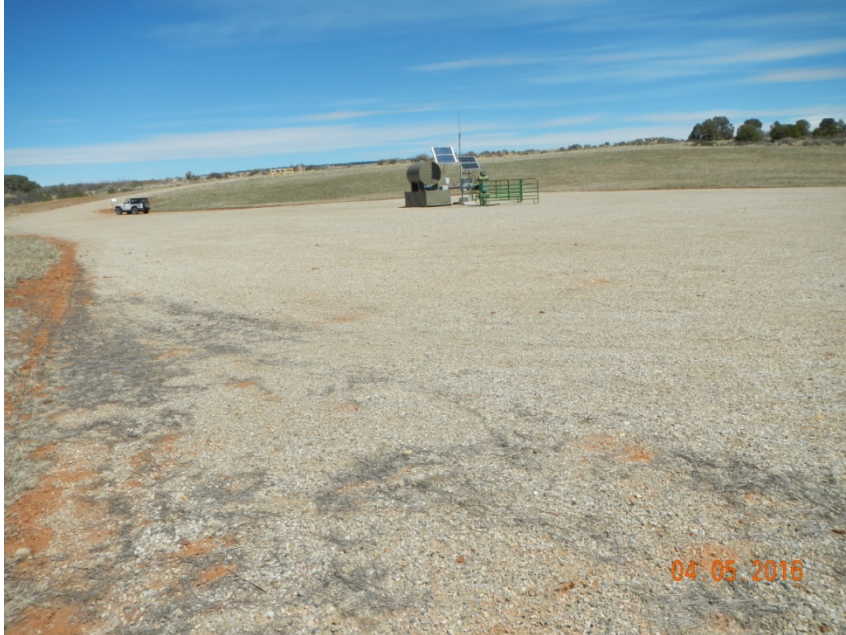
Photo 1: View of the project area from the southwestern corner facing center.

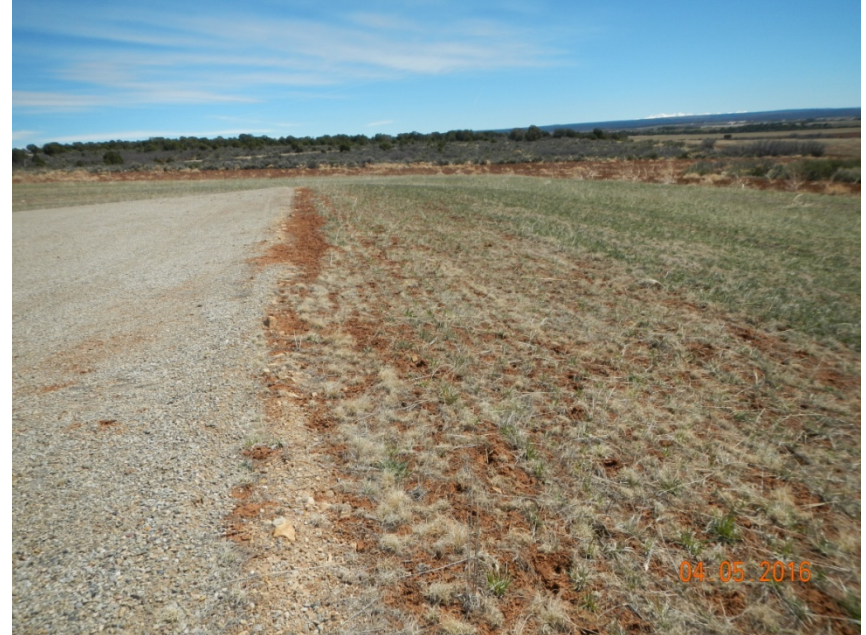
Photo 2: View of the southern portion of the project area from the southwestern corner facing eastward. Revegetation within the project area is progressing with grasses such as blue grama (*Bouteloua gracilis*), and western wheatgrass (*Pascopyrum smithii*), and others not in identifiable form.

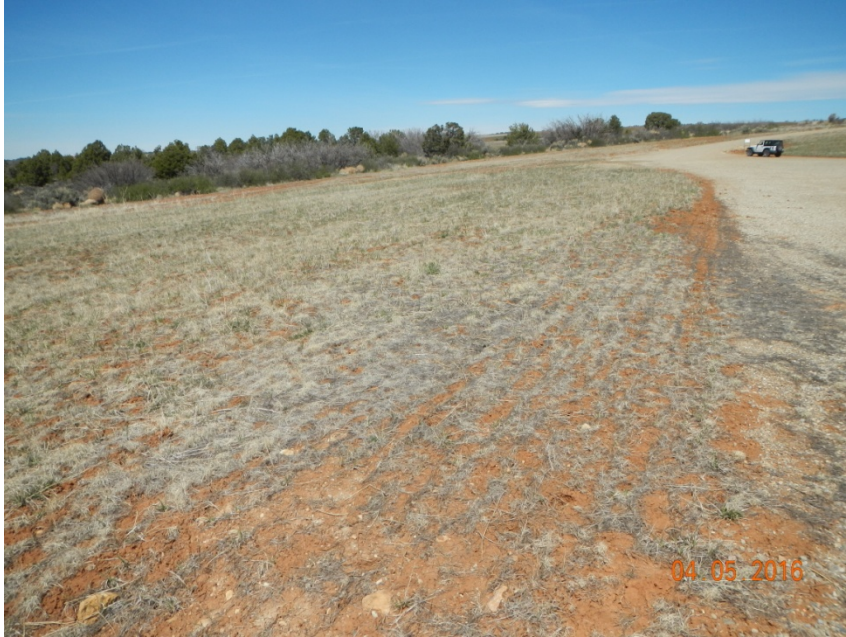
Photo 3: View of the western portion of the project area from the southwestern corner facing northward.

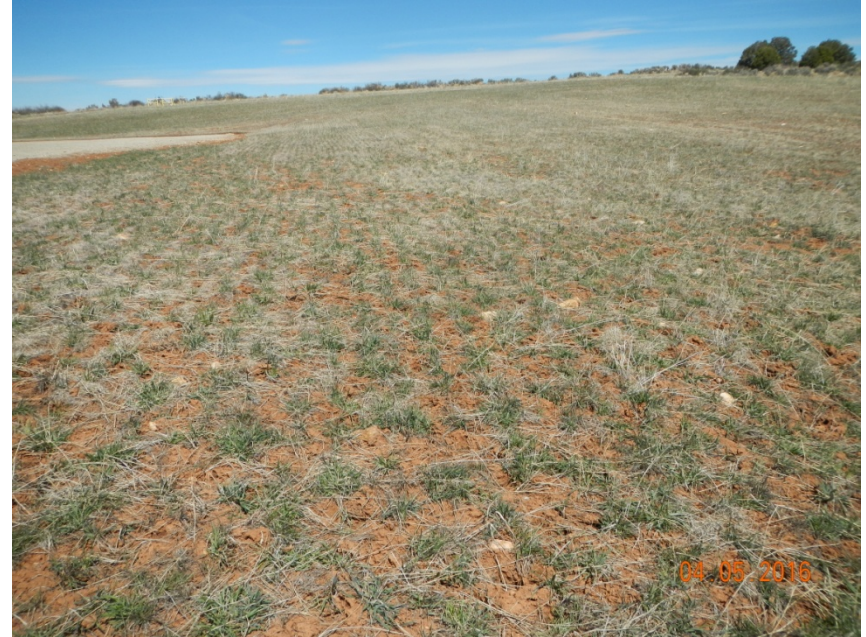
Photo 4: View of the eastern portion of the interim reclamation area from the southeastern corner facing northward.

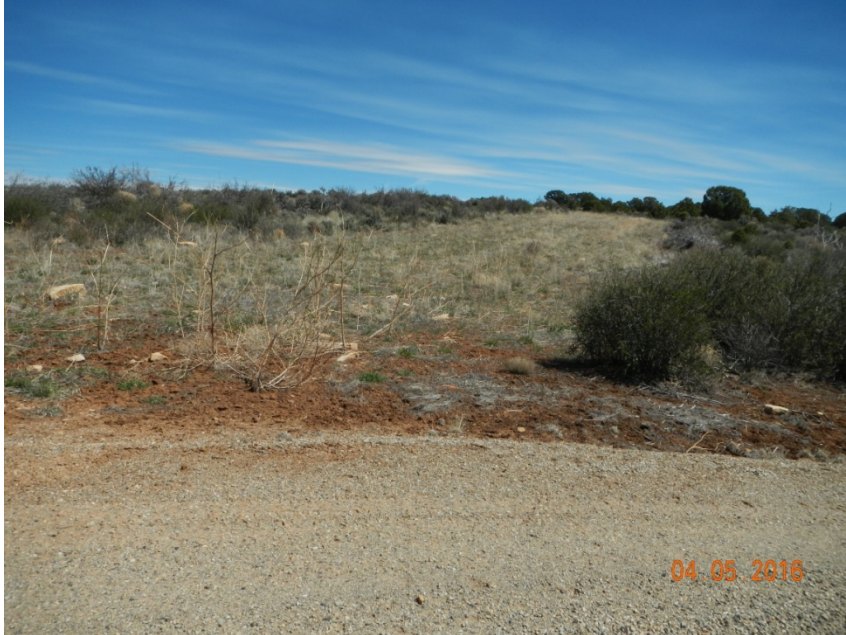
Photo 5: View of flowline alignment, revegetation appears to be progressing.

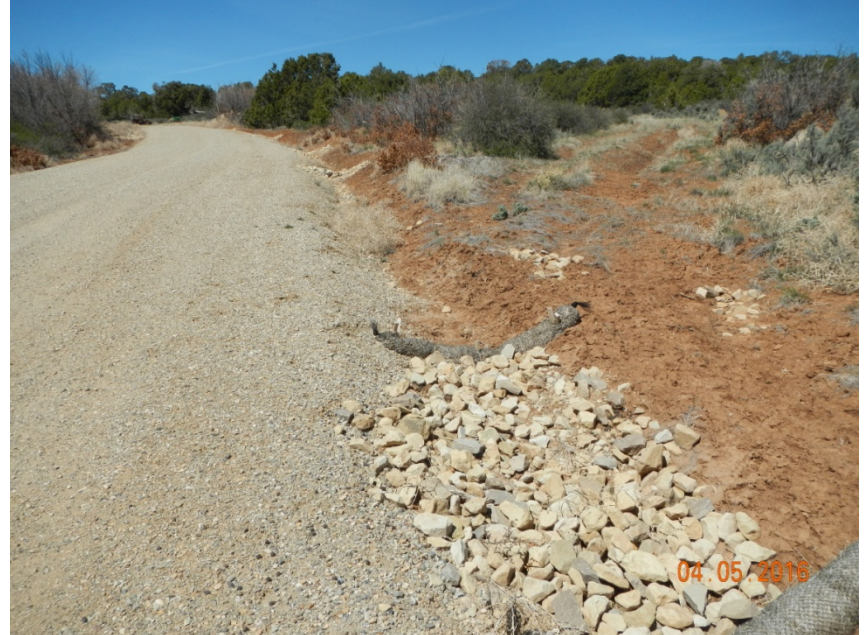
Photo 6: View of stormwater controls along the access road, appear to be functioning.
