Stormwater Inspection

April 3, 2017

Operator: NOBLE ENERGY INC- #100322

Location ID: 445257

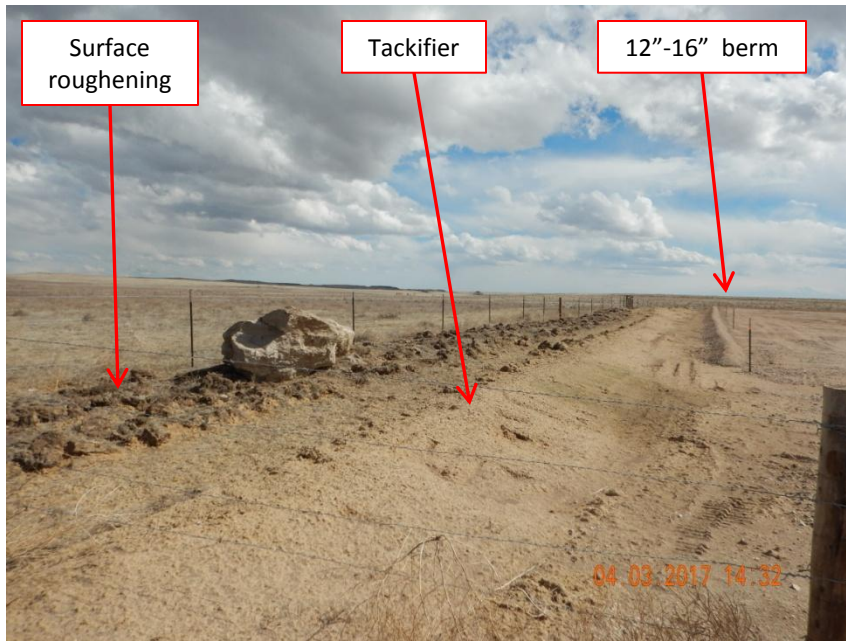
Photo 1. Photo taken from the northeast location, facing South. Surface roughening has been installed along the perimeter of the location, in conjunction with a tackifier along portions of the fill slope. A 12"-16" berm has been installed along the production area.

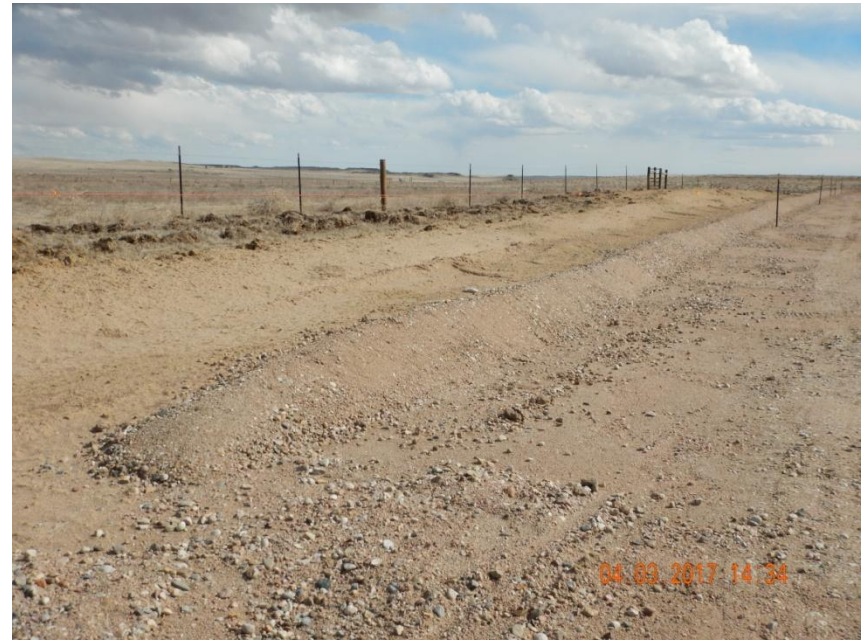
Photo 2. Photo taken from the northeast location, facing Southeast. Photo illustrates current stormwater BMPs.

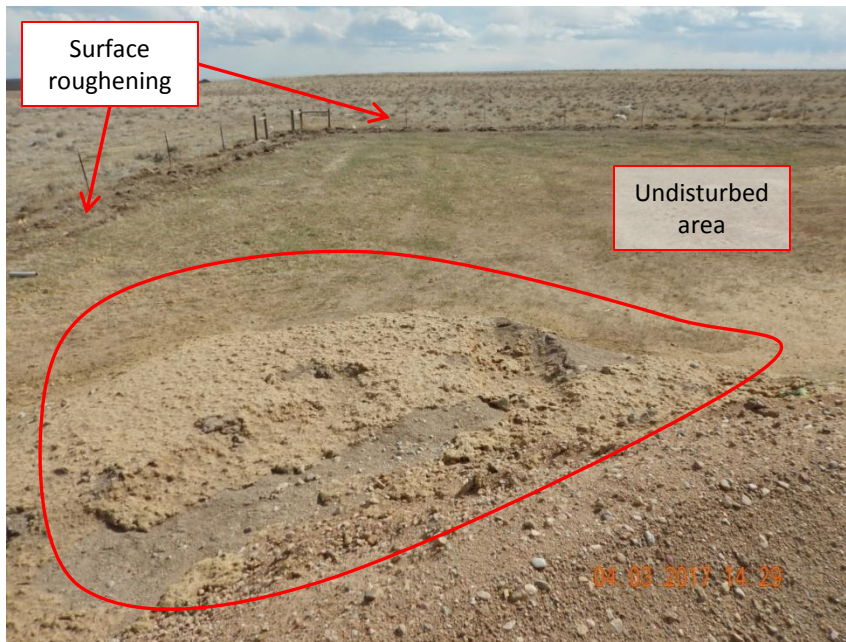
Photo 3. Photo taken from the southeast location, facing South. Surface roughening has been installed along the location perimeter. A large undisturbed, vegetated area exists between the production area and the temporary BMP- surface roughening. A portion of the fill slope does not appear to be stabilized.

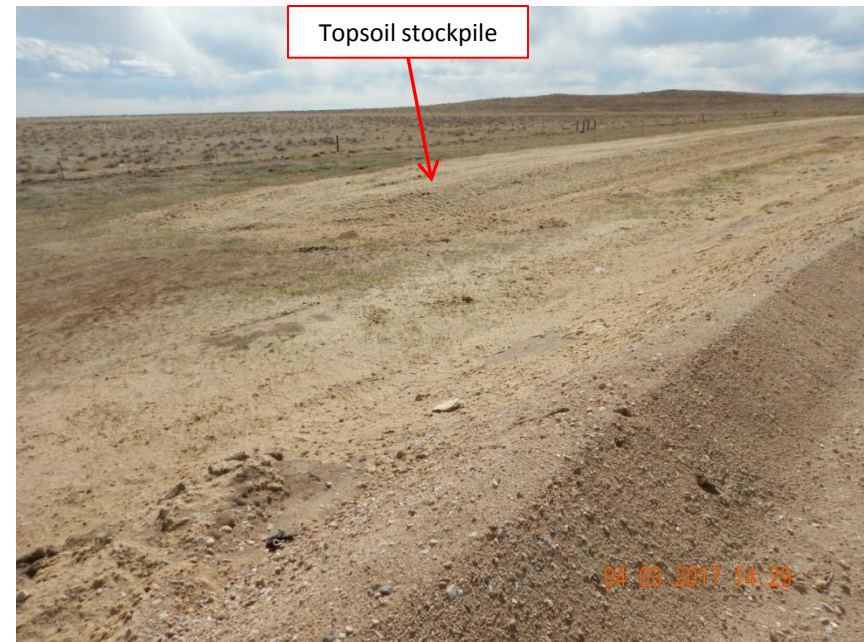
Photo 4. Photo taken from the southeast location, facing Southwest. Topsoil stockpile has been stored along the southern location and a tackifier applied.

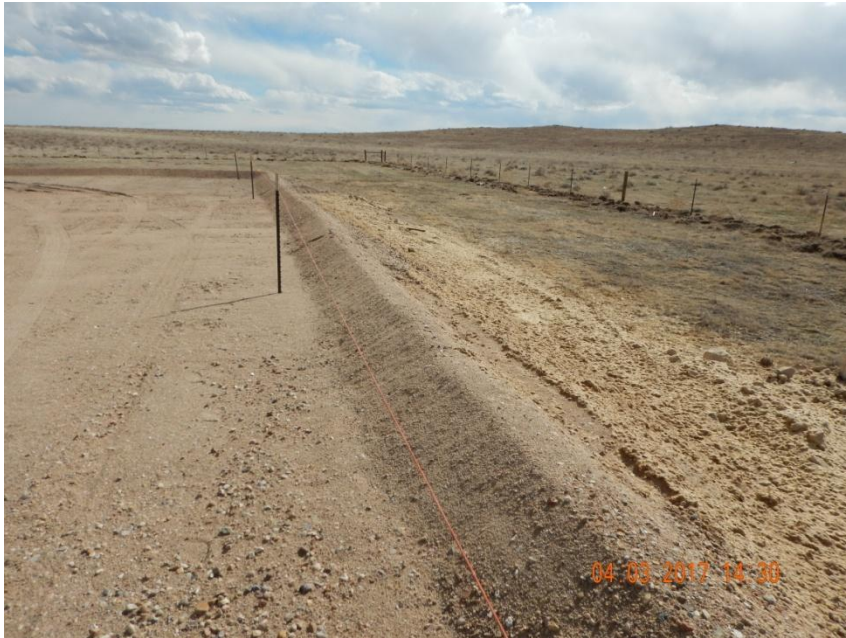
Photo 5. Photo taken from the western location, facing South. Surface roughening has been installed along the perimeter of the location, in conjunction with a tackifier along portions of the fill slope. A 12"-16" berm has been installed along the production area.
