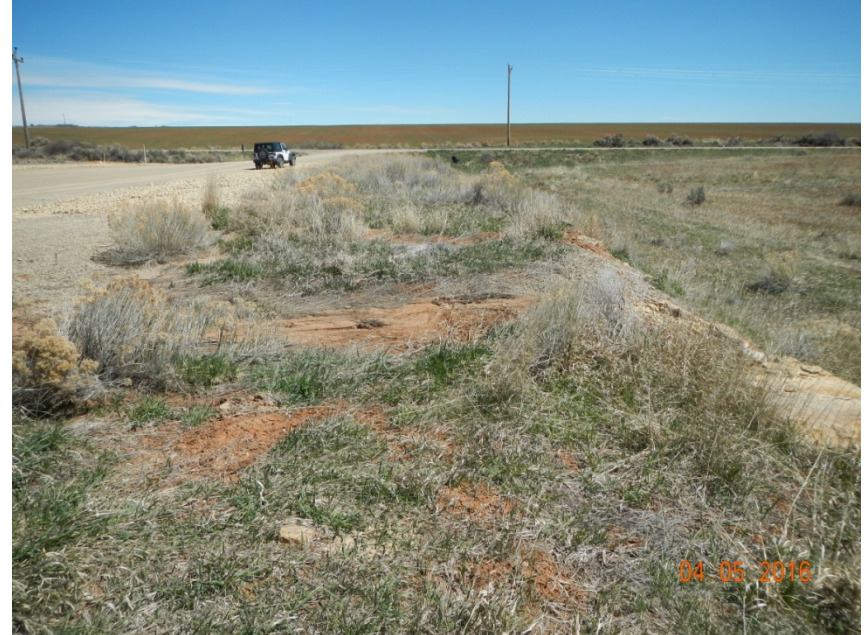
Photo 2: View of the southern portion of the project area from the southwestern corner facing eastward. Revegetation within the project area is progressing with grasses and shrubs such as smooth brome (*Bromus inermis*) and rubber rabbitbrush (*Chrysothamnus nauseosus*).

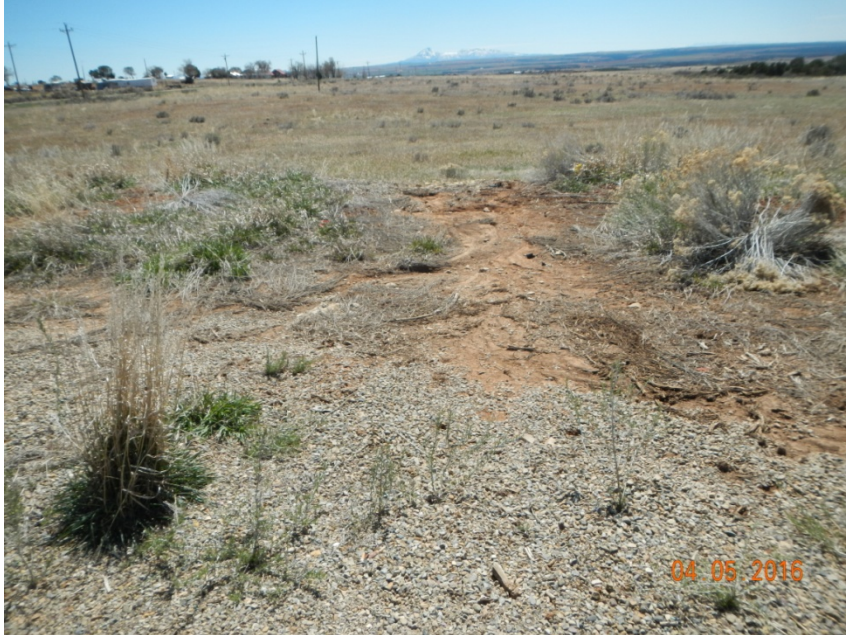
Photo 5: View of area where concentrated stormwater flows off of the southern edge of the well pad.

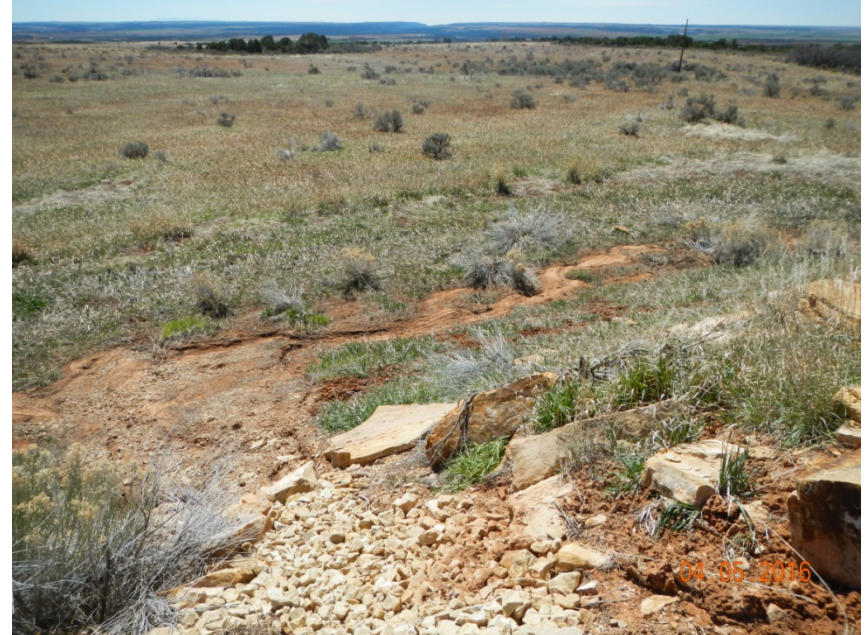
Photo 6: View of sediment deposition downstream of erosion occurring in Photo 5.
