Inspection Photos
Location Name: Myers F-1
API: 05-123-10334

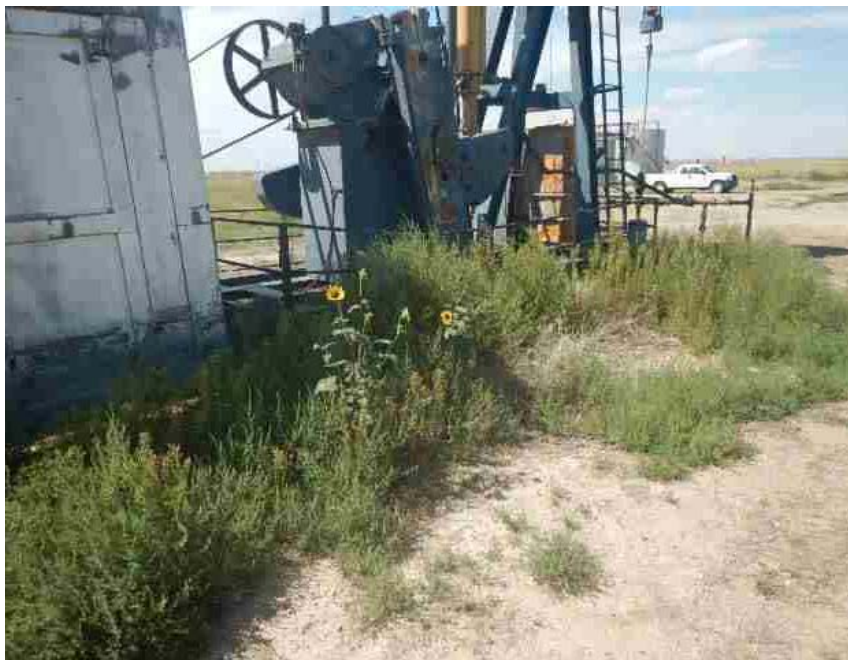
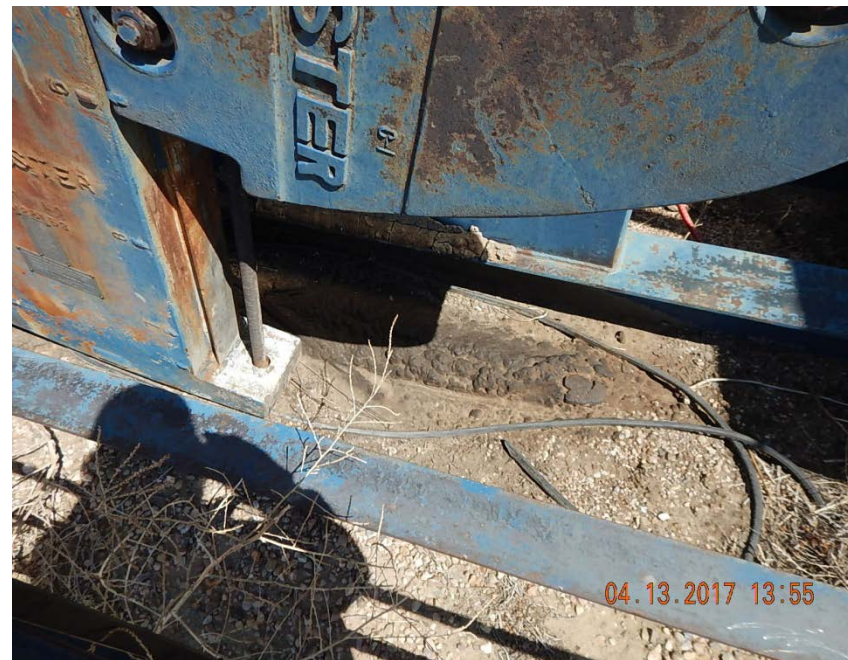
Photo from prior inspection for comparison

Photo 1: Weeds controlled at pump jack, stained soil at pump jack

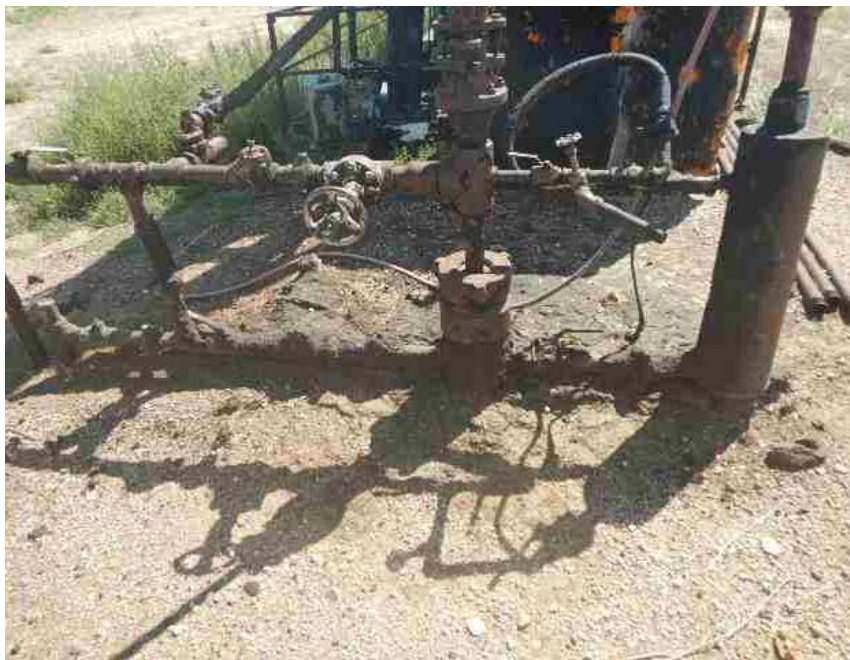
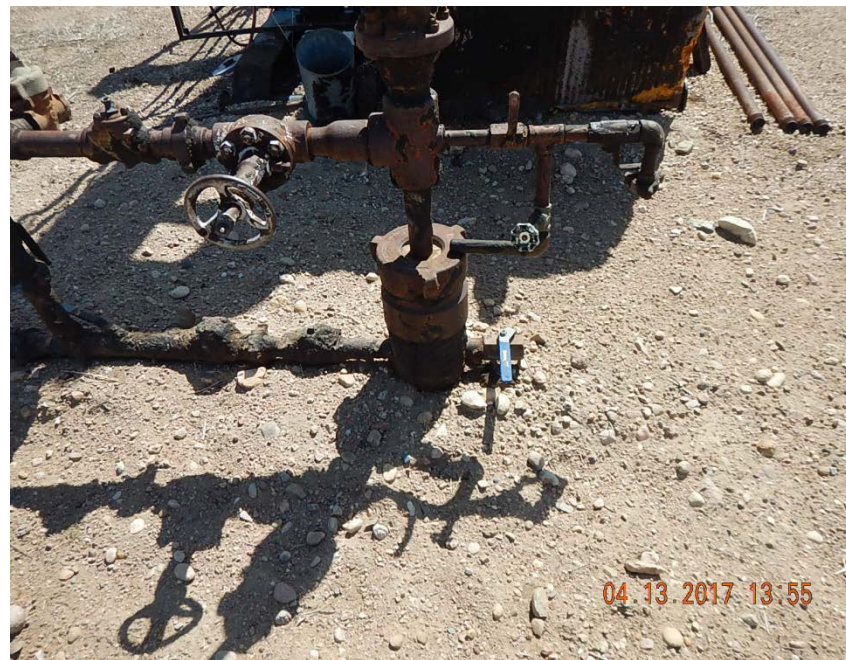
Photo from prior inspection for comparison

Photo 2: Stained soil at wellhead removed.

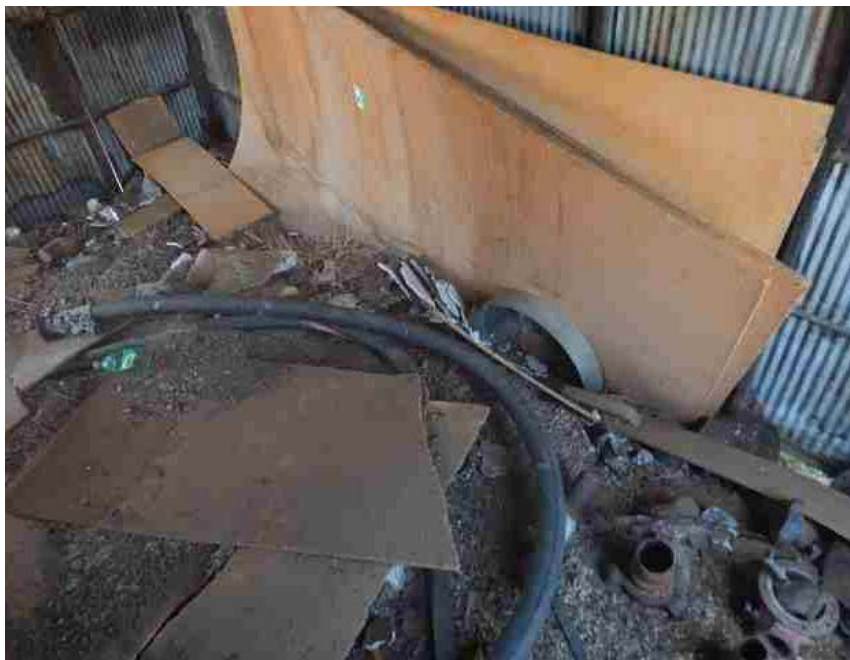
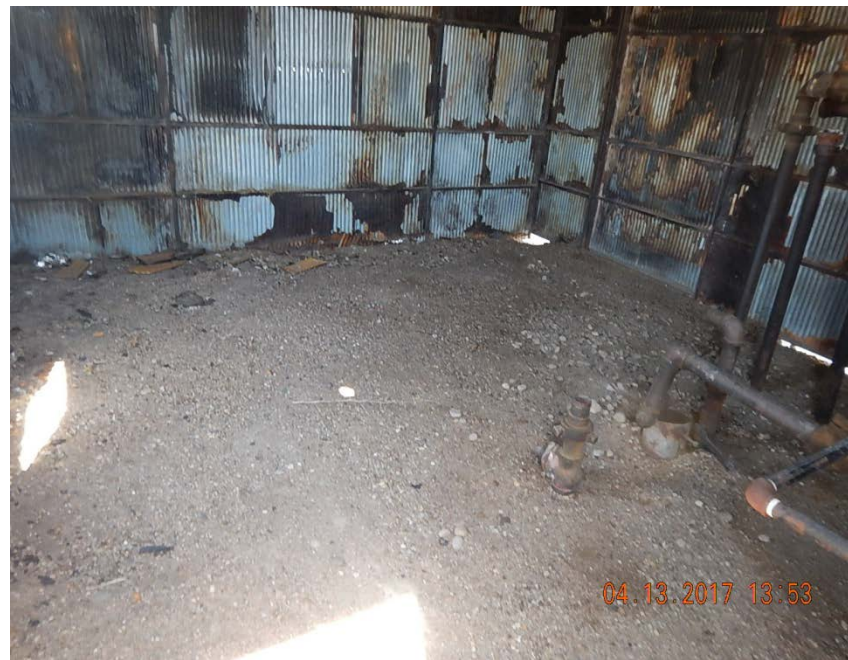
Photo from prior inspection for comparison

Photo 3: Debris removed from treater house

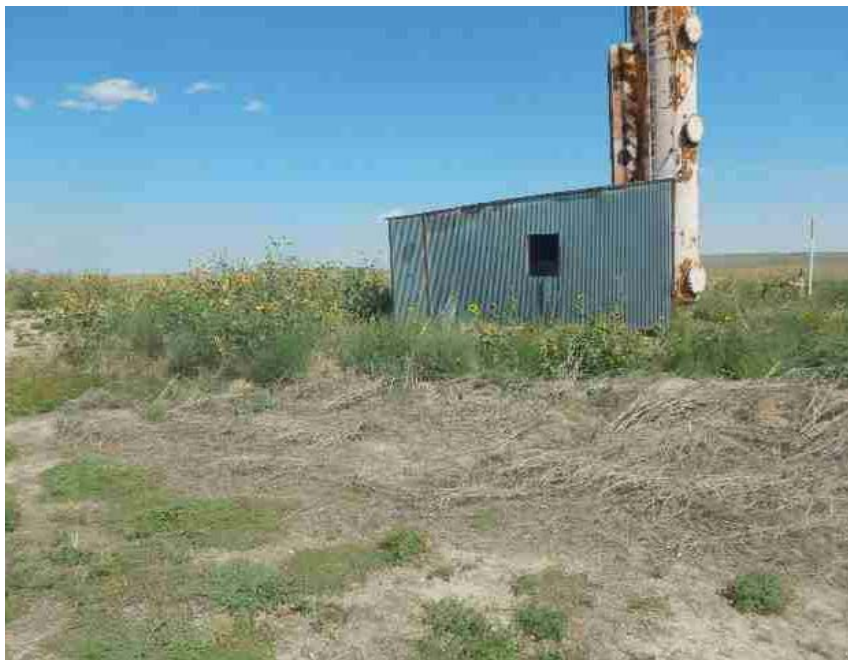
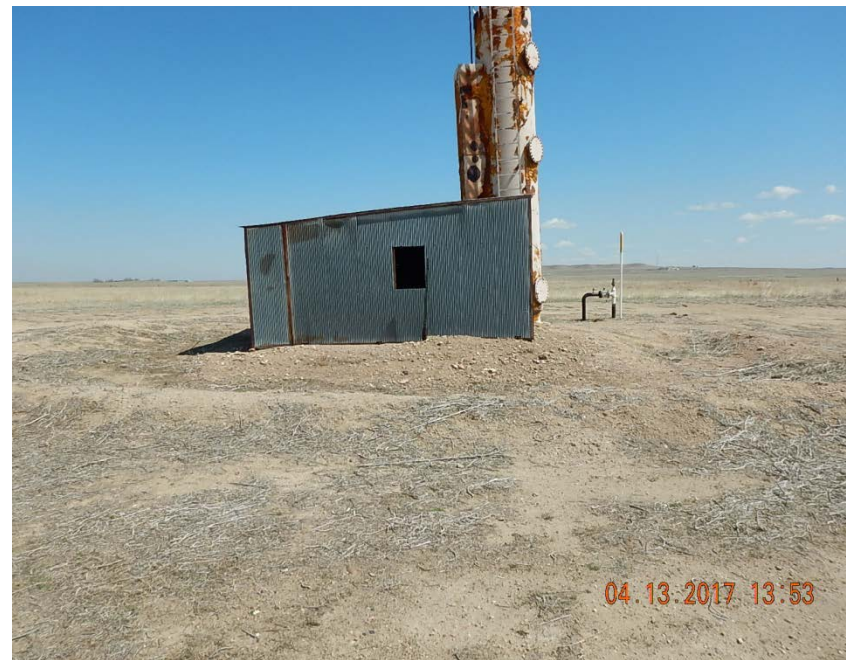
Photo from prior inspection for comparison

Photo 4: Weeds controlled at treater

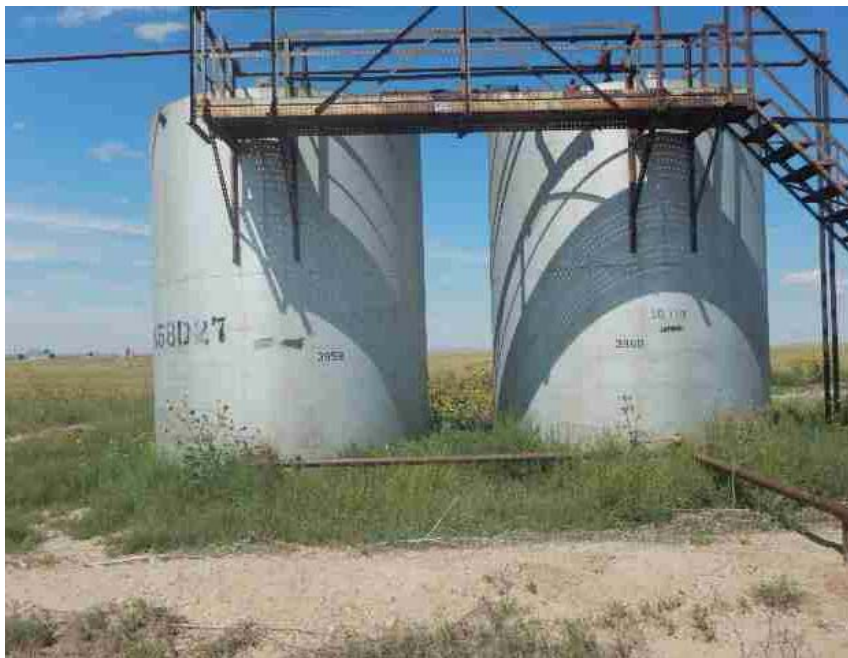
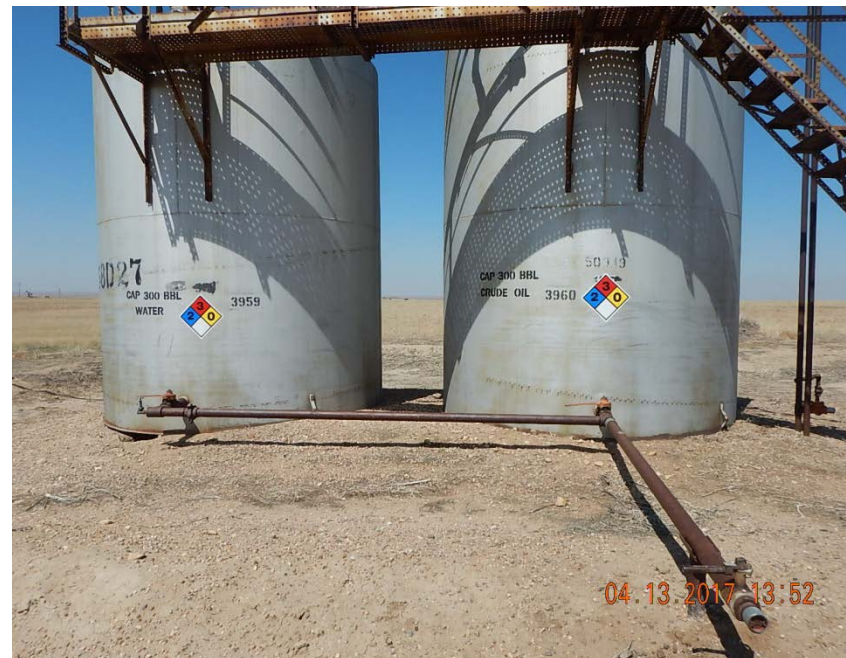
Photo from prior inspection for comparison

Photo 5: Tanks are placarded, stenciled

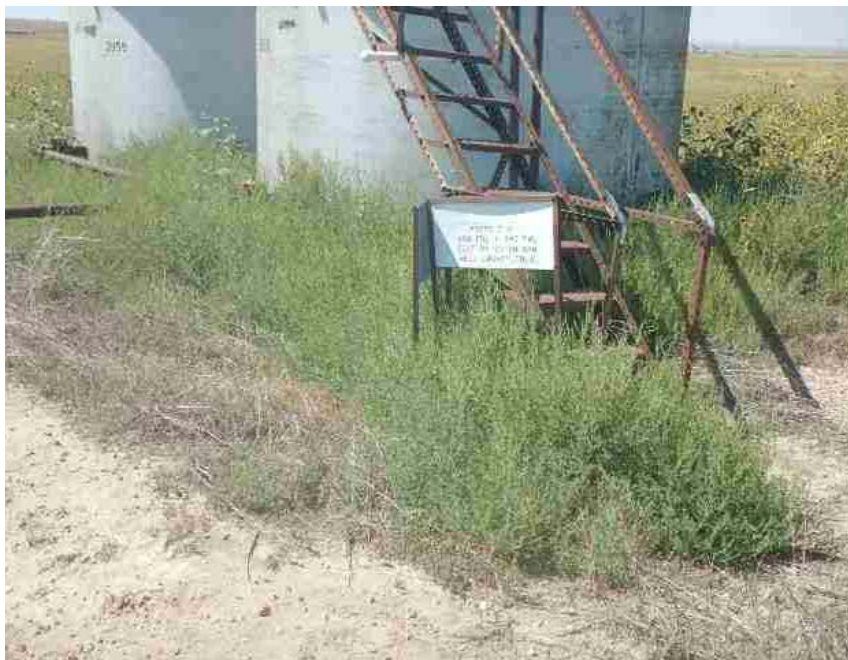
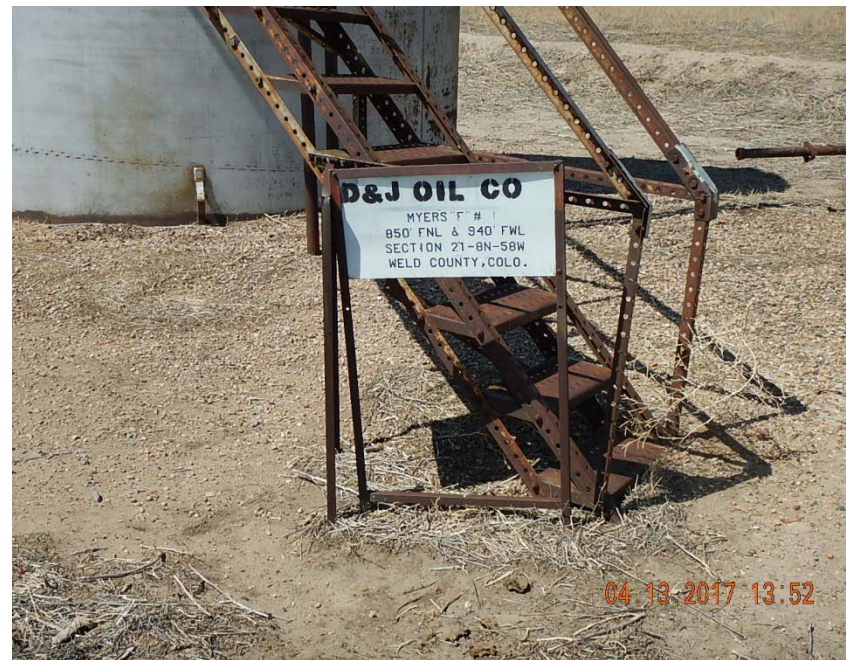
Photo from prior inspection for comparison

Photo 6: Weeds removed, operator on sign, no emergency contact number

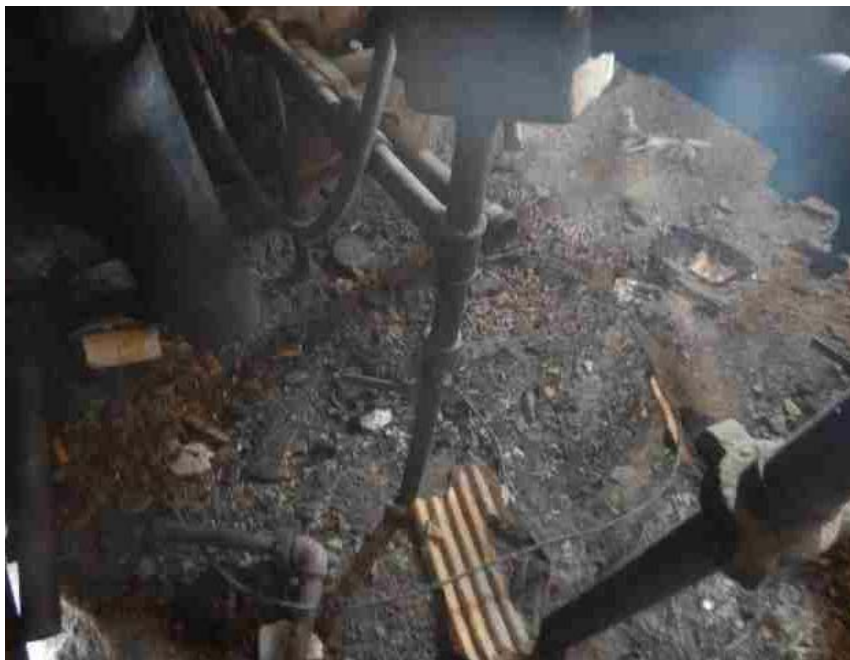
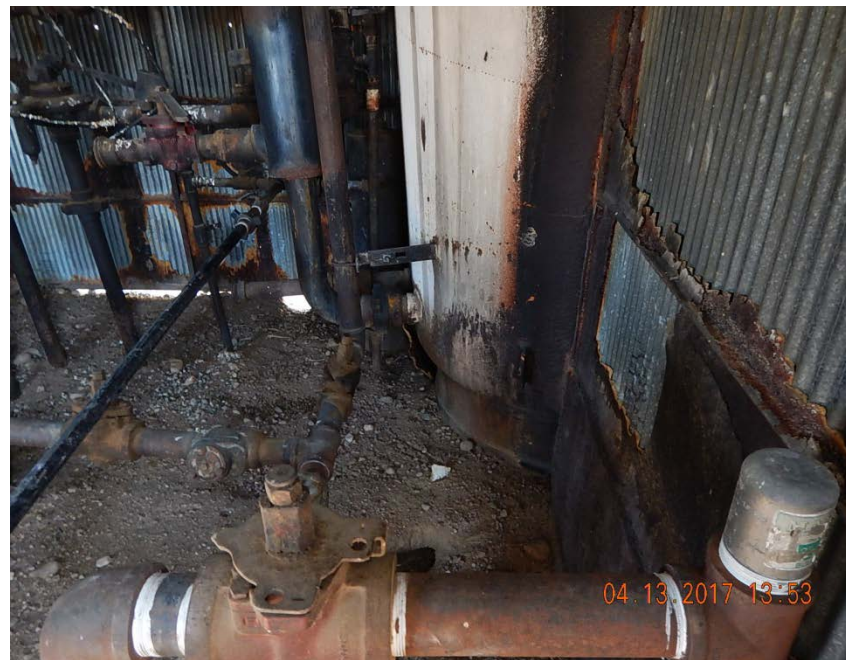
Photo from prior inspection for comparison

Photo 7: Stained soil removed

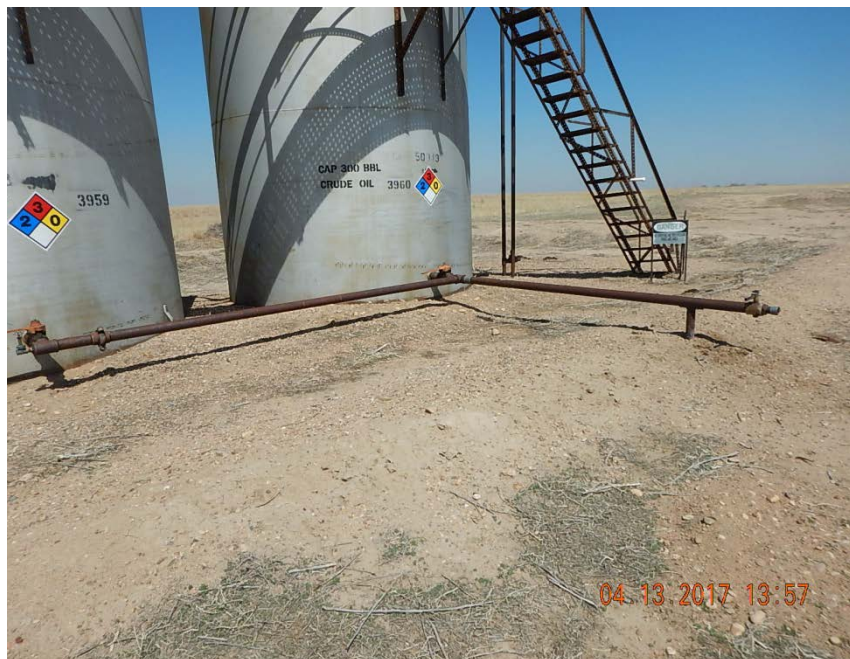
Photo 8: Low berms at tank battery
