Interim Reclamation Inspection

April 12, 2017

Operator: CRESTONE PEAK RESOURCES OPERATING LLC- # 10633

Location ID: 336360

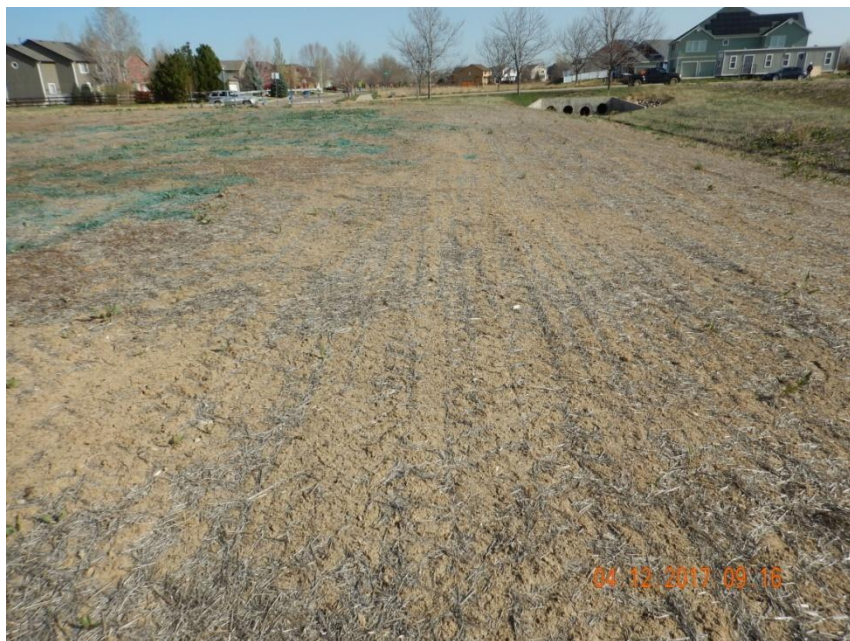
Photo 1. Photo taken from the eastern location, facing North. Little, to no, germination of grass species observed along the eastern interim area. Appears weed management is being conducted to control a Rumex species, likely Curly dock.

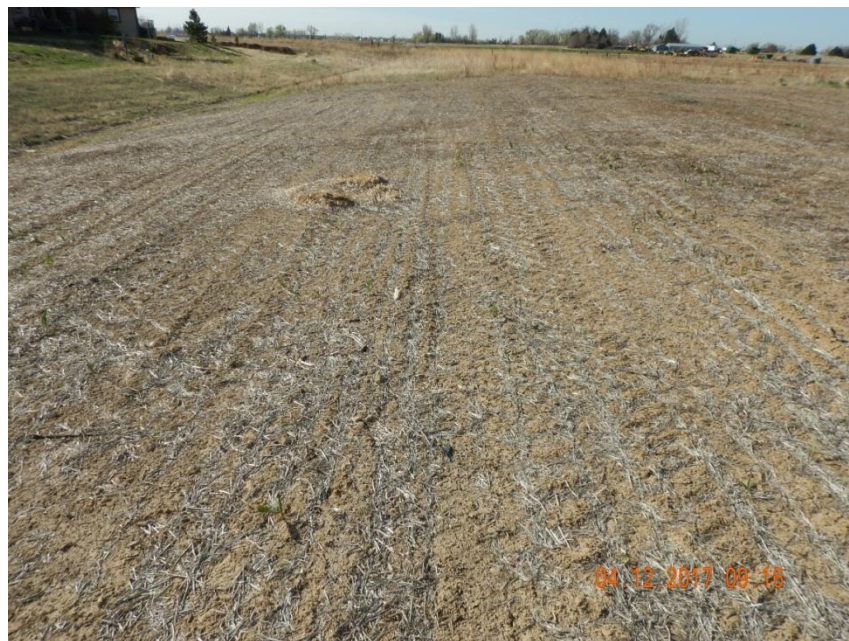
Photo 2. Photo taken from the eastern location, facing South. Little, to no, germination of grass species observed along the eastern interim area.

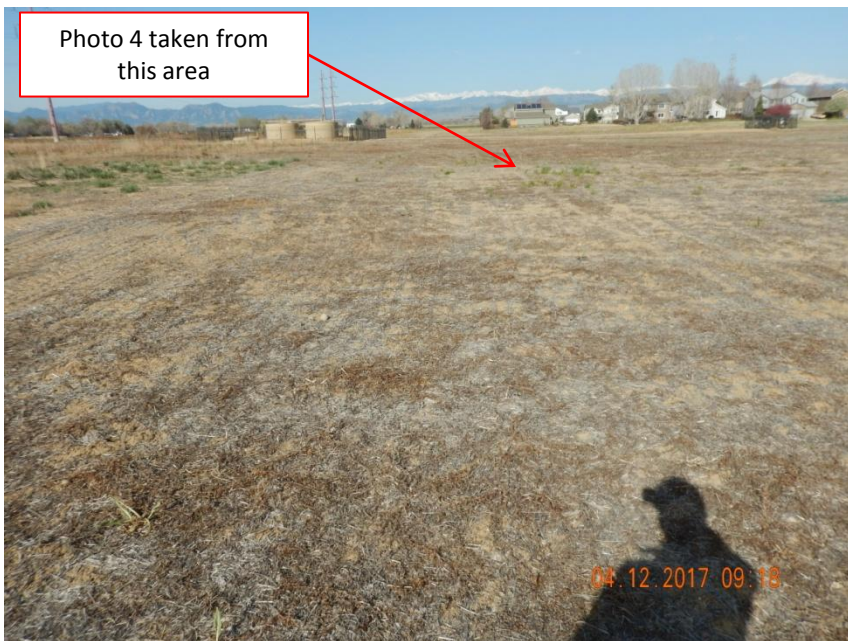
Photo 3. Photo taken from the southeast location, facing West. Little, to no, germination of grass species observed along the southeastern interim area.

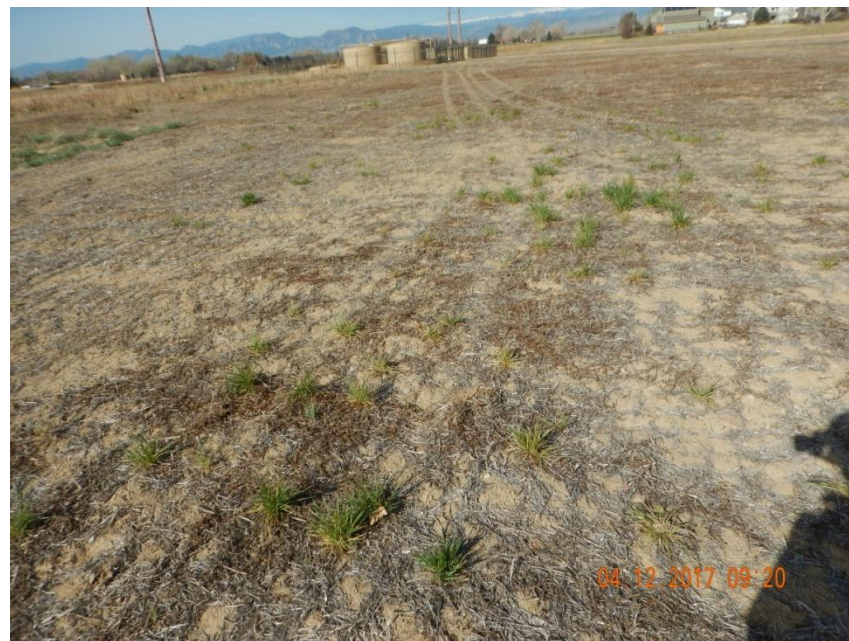
Photo 4. Photo taken from the southeastern location, facing West. A patch of germinating grass species observed but confined to a relatively small area.

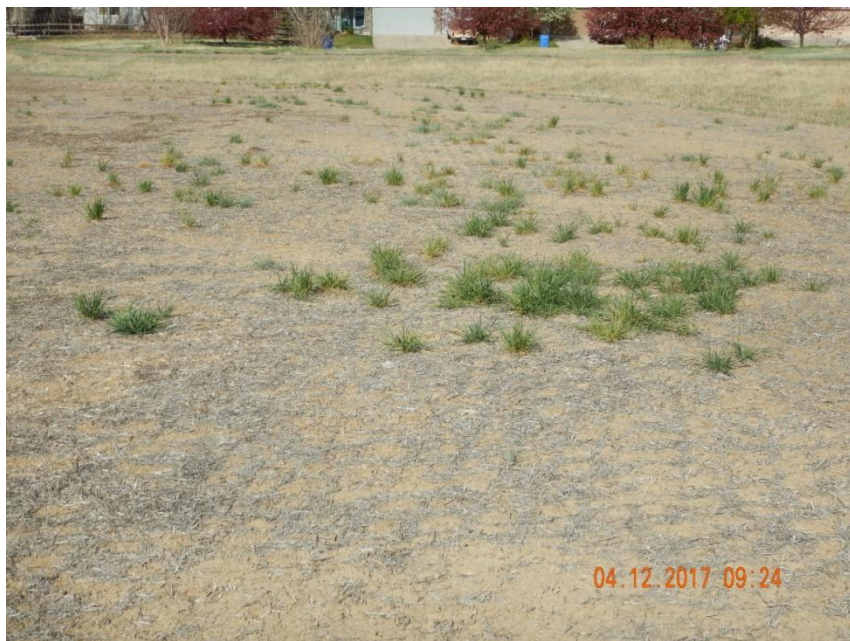
Photo 5. Photo taken from the northern location, facing West. Germination of grass species evident along the northern perimeter but still sparse growth that is not uniform.

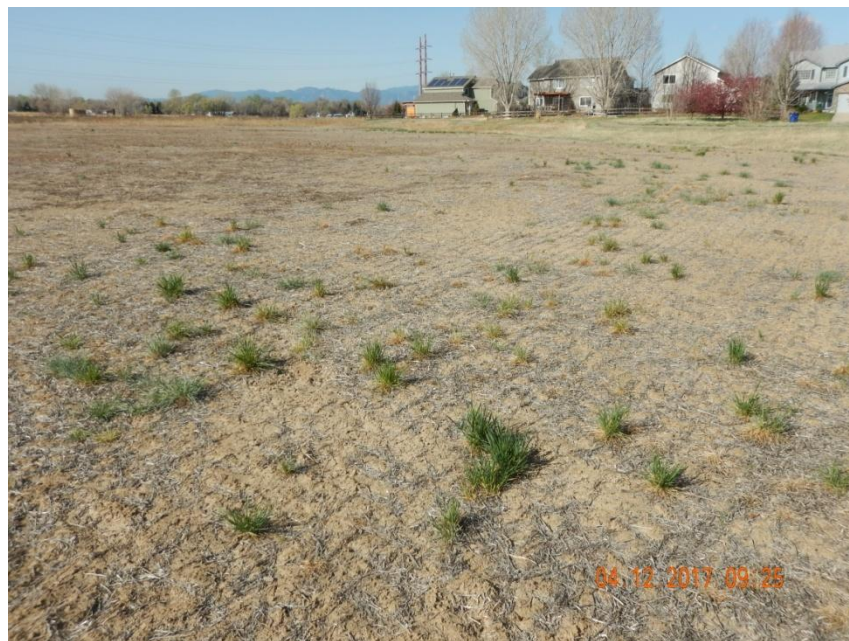
Photo 6. Photo taken from the northern location, facing Southwest. Germination of grass species evident along the northern perimeter but a notable difference in germination of grass species where field bindweed was previously growing and sprayed with a herbicide.

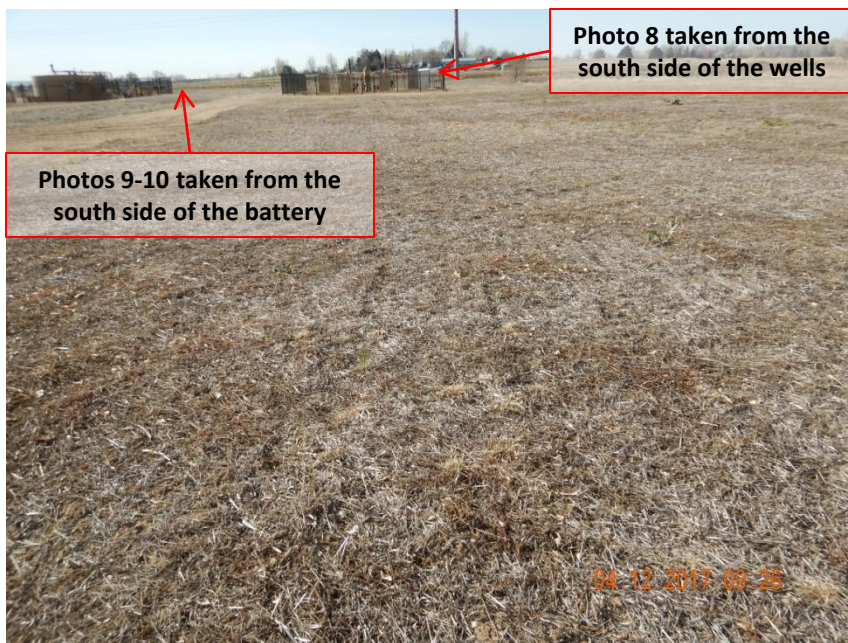
Photo 7. Photo taken from the northern location, facing South. Little, to no, germination of grass species observed along this interim area.

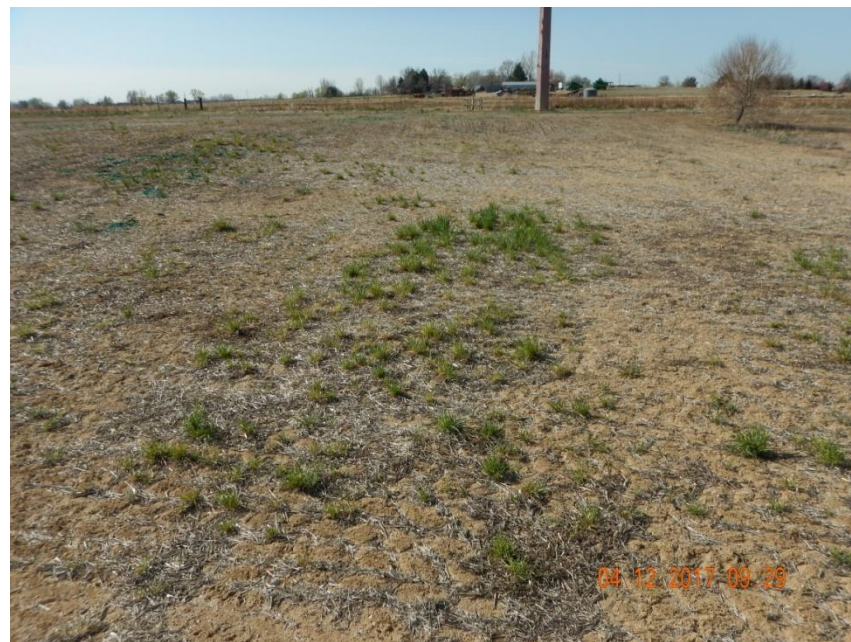
Photo 8. Photo taken from the southern location just south of the wells, facing South. A patch of germinating grass species observed.

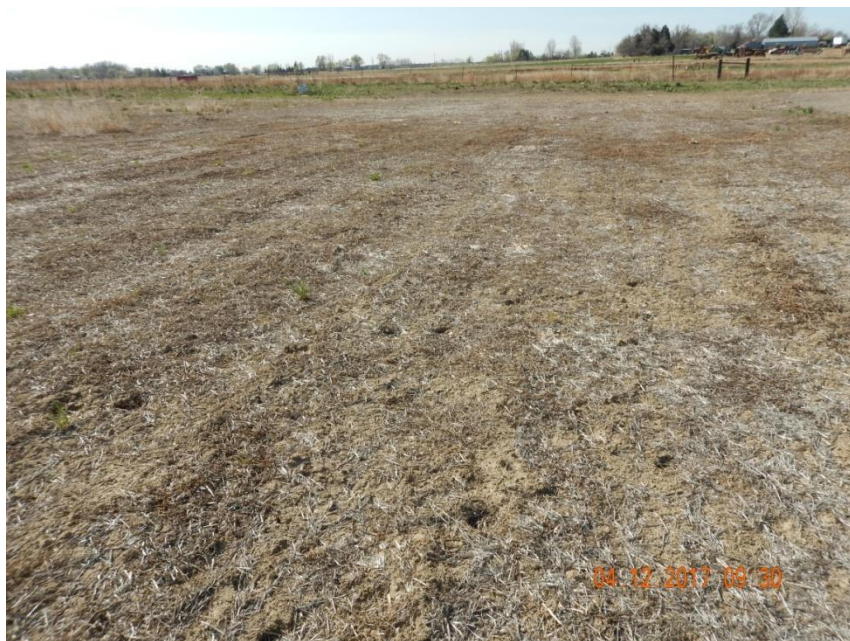
Photo 9. Photo taken from the southern location just south of the battery, facing South. Little, to no, germination of grass species observed along this interim area.

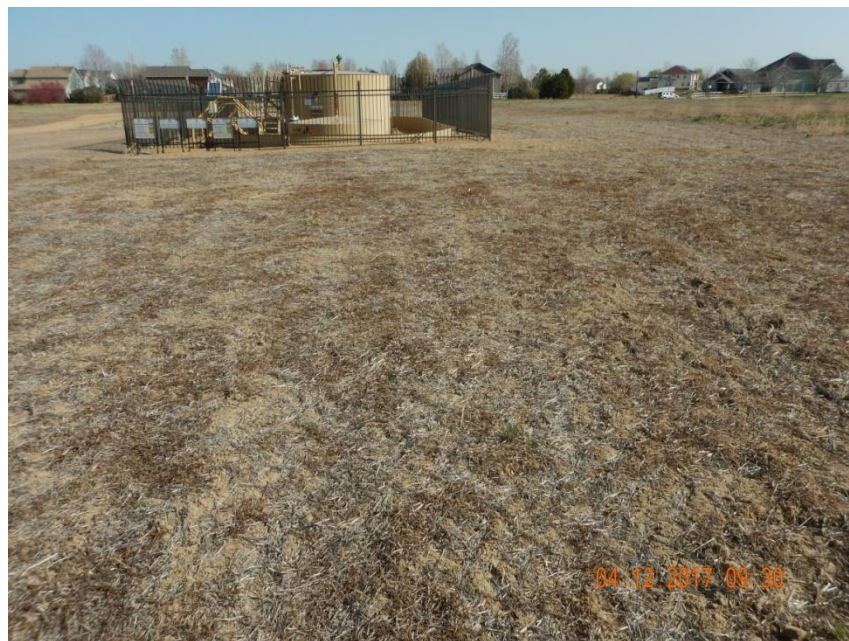
Photo 10. Photo taken from the southern location just south of the battery, facing North. Little, to no, germination of grass species observed along this interim area.

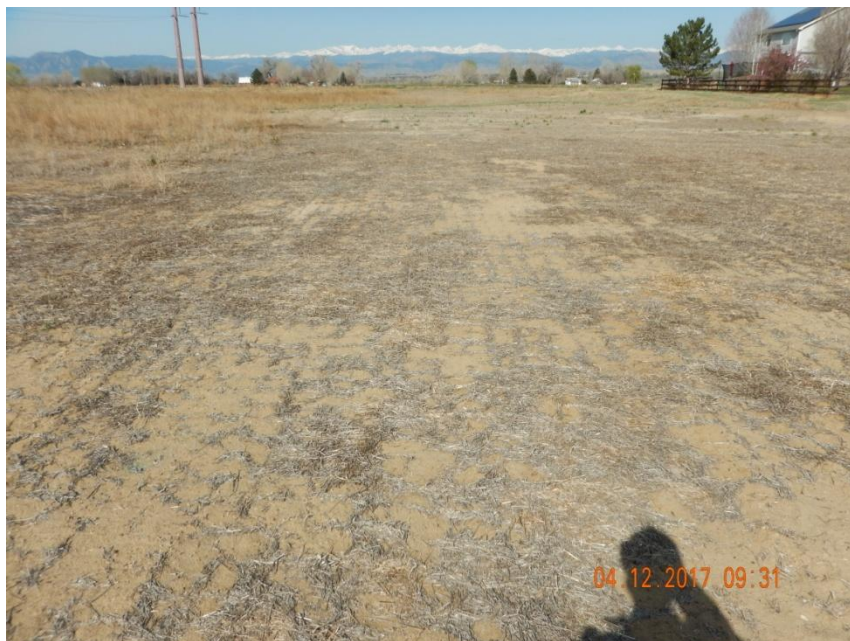
Photo 11. Photo taken from the southern location, facing West. Little, to no, germination of grass species observed along this interim area.

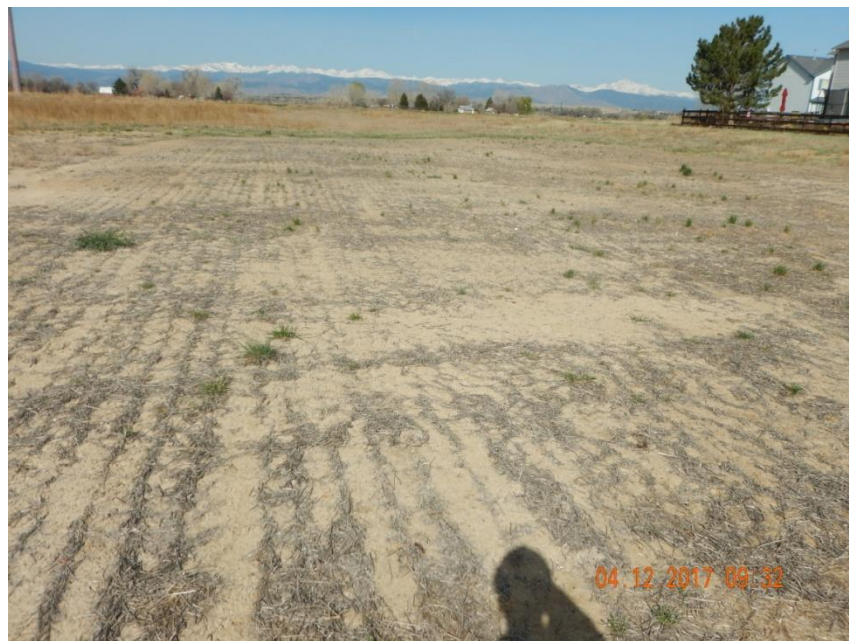
Photo 12. Photo taken from the western location, facing West. Little, to sparse, germination of grass species observed along this interim area.

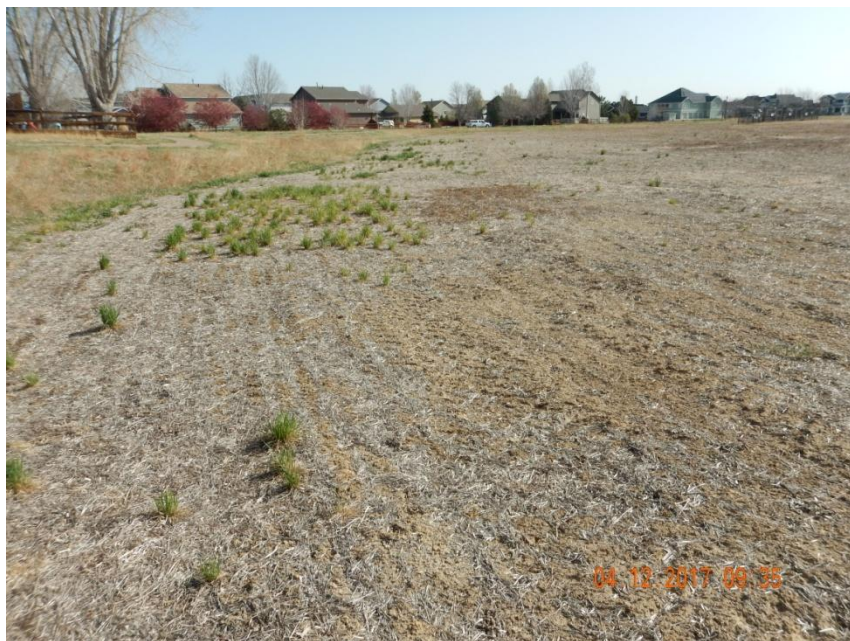
Photo 13. Photo taken from the western location, facing North. Germination of grass species evident along the western perimeter but still sparse growth that is not uniform.

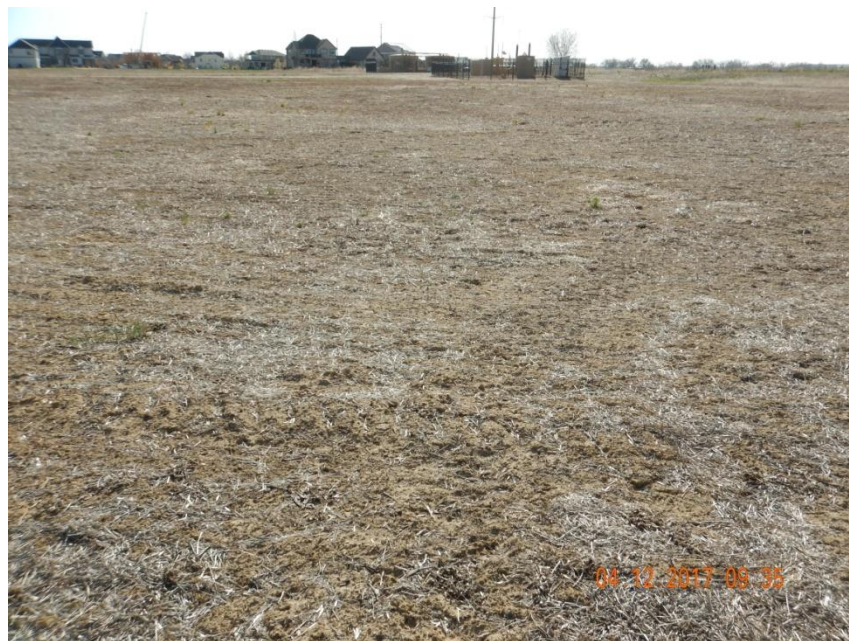
Photo 14. Photo taken from the western location, facing East. Little, to no, germination of grass species observed along this interim area.

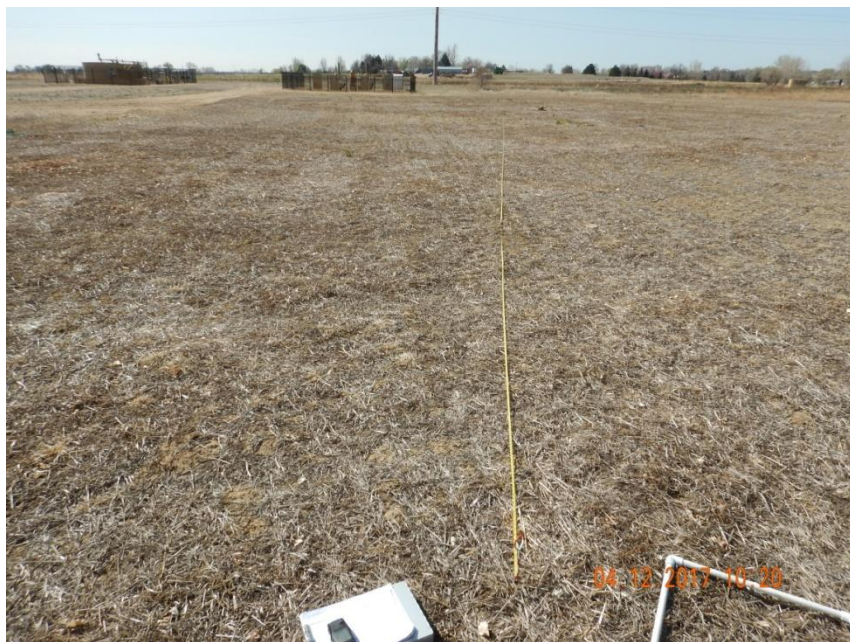
Photo 15. Photo taken from the start of transect Location #1: 40.06024, -105.06689 @180° from the north, facing South. A total of zero (0) grass species were detected during the assessment along this transect.

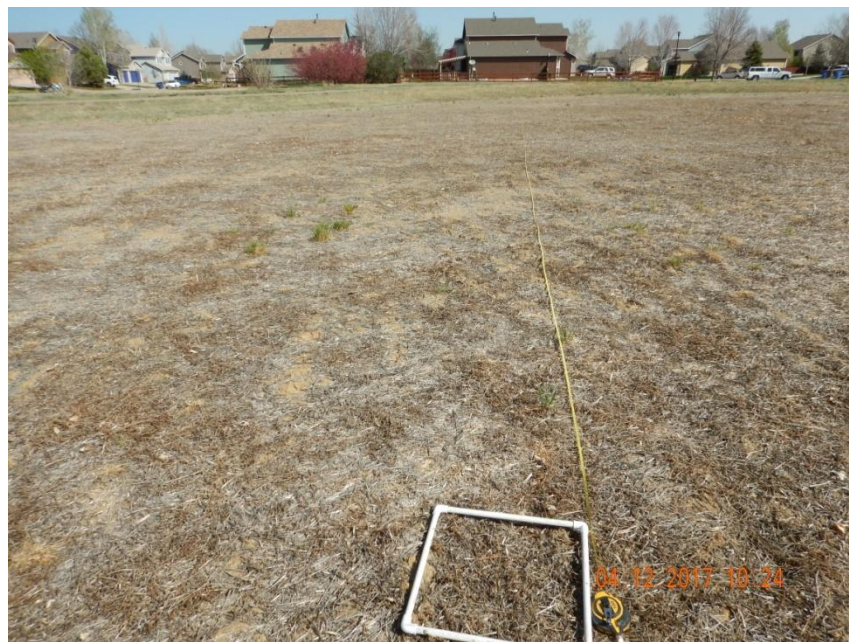
Photo 16. Photo taken from the end of transect Location #1 from the south, facing North. Again, a total of zero (0) grass species were detected during the assessment along this transect.

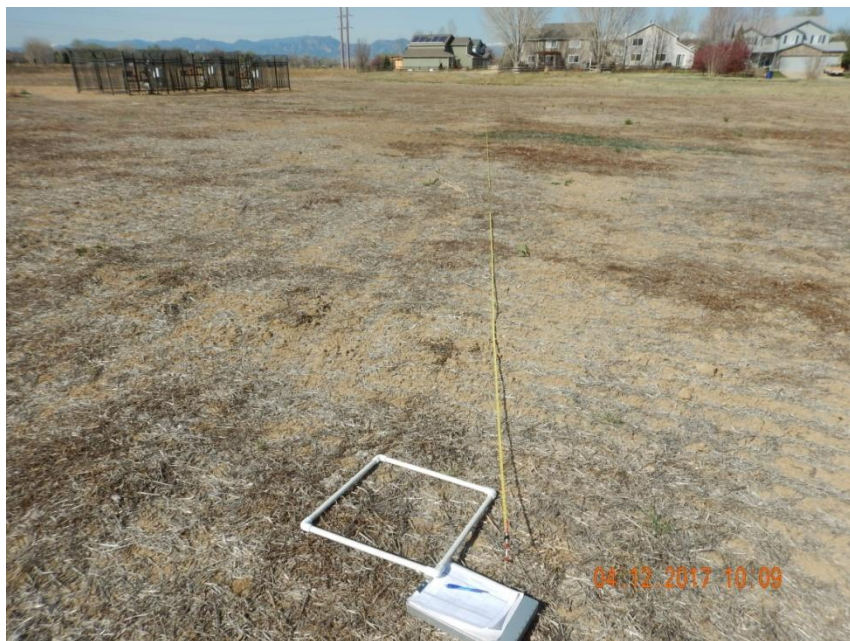
Photo 17. Photo taken from the start of transect Location #2: 40.06031, -105.06626 @250° from the east, facing West. A total of three (3) grass species were detected during the assessment along this transect.

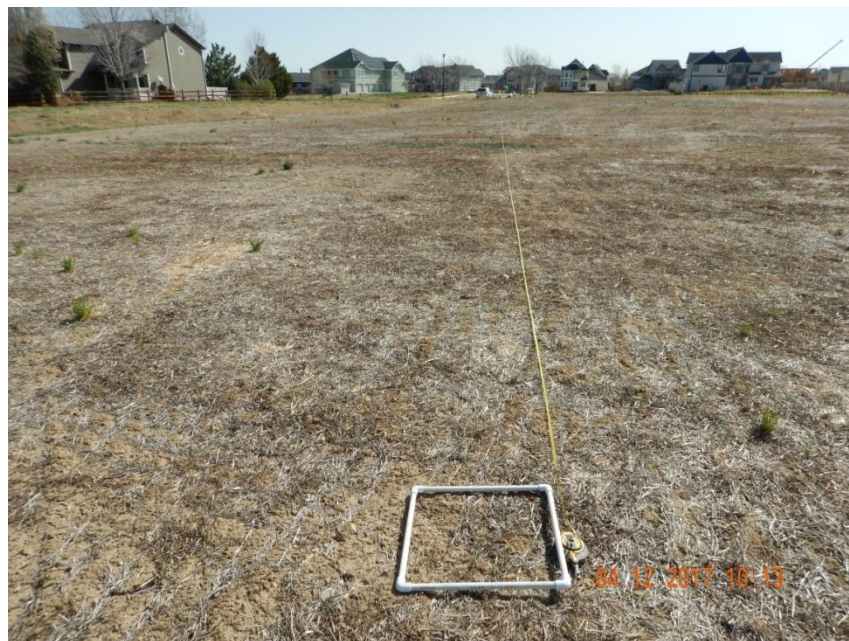
Photo 18. Photo taken from the end of transect Location #2 from the west, facing East. Again, a total of three (3) grass species were detected during the assessment along this transect.

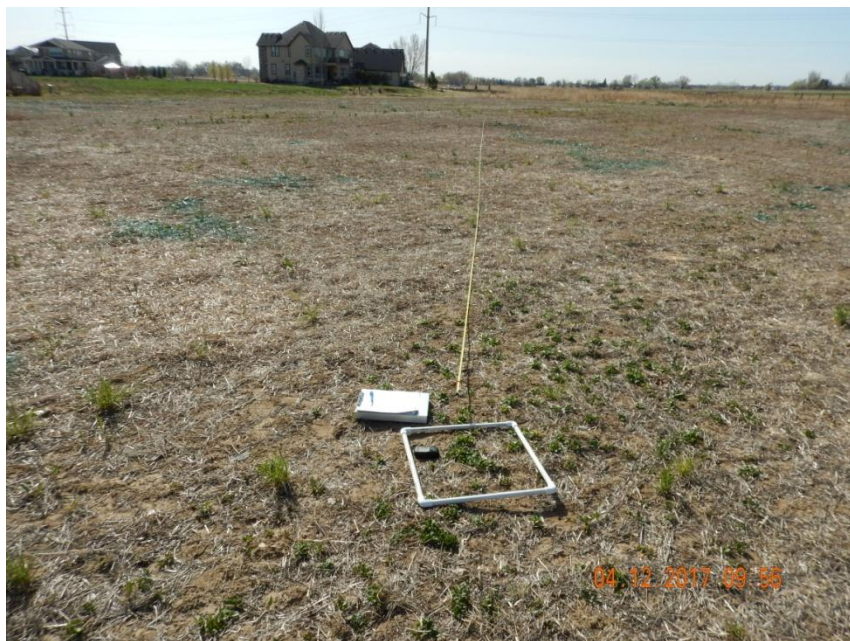
Photo 19. Photo taken from the start of transect Location #3: 40.06023, -105.06581 @145° from the north, facing South. A total of nine (9) grass species were detected during the assessment along this transect. A small patch of field bindweed was observed at the start of the transect.

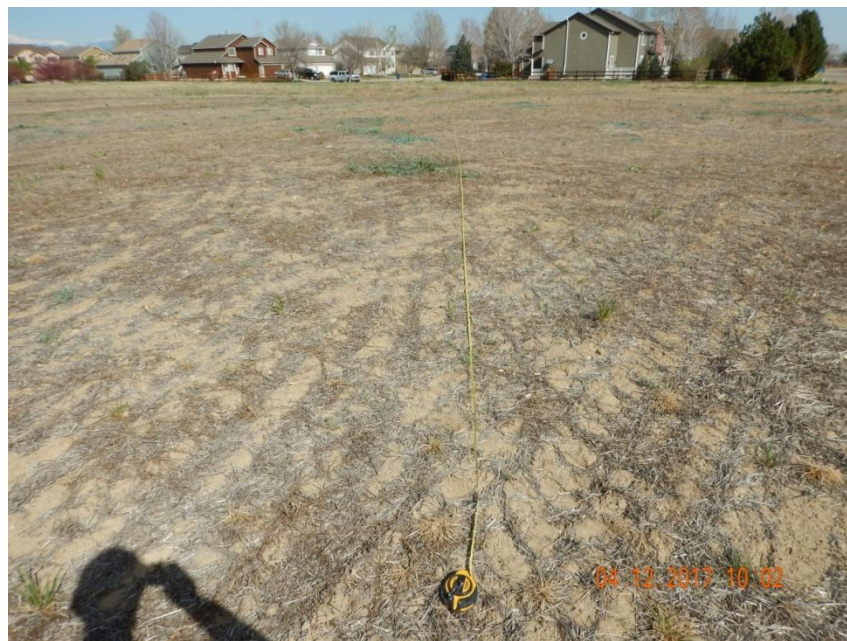
Photo 20. Photo taken from the end of transect Location #3 from the south, facing North. Again, a total of nine (9) grass species were detected during the assessment along this transect.

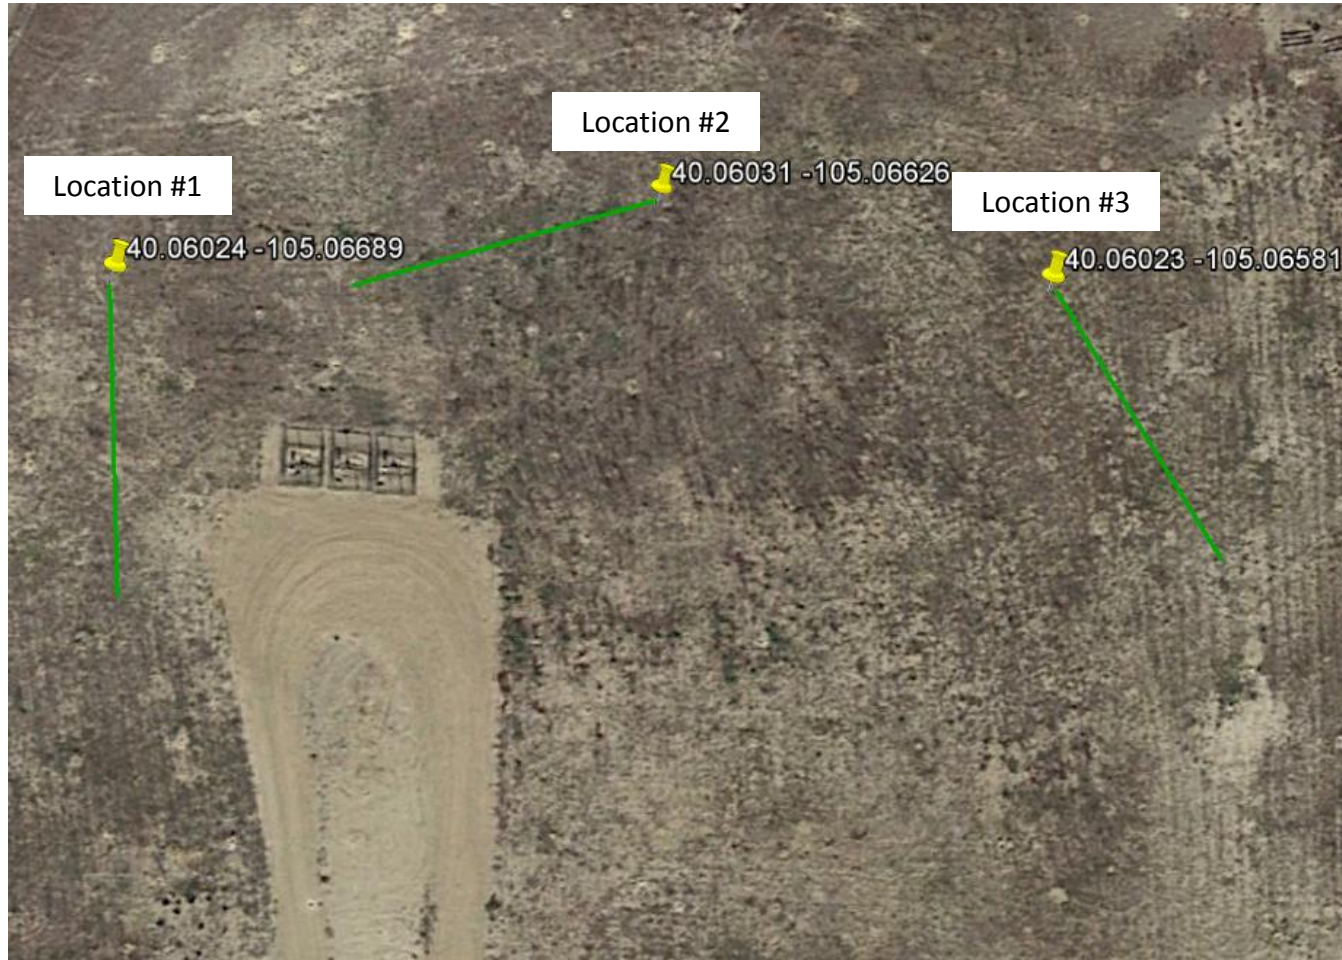
Note the transect lines (green lines) are not to scale but an approximate direction indicating where the transect was performed. These same three locations and bearings were used in the 2016 germination assessment. In 2016, a total of 67 seedlings were counted. During this inspection, a total of 12 individuals were counted.
