Inspection Photos  
Location Name: Tow Creek 11-13  
API: 05-107-06051

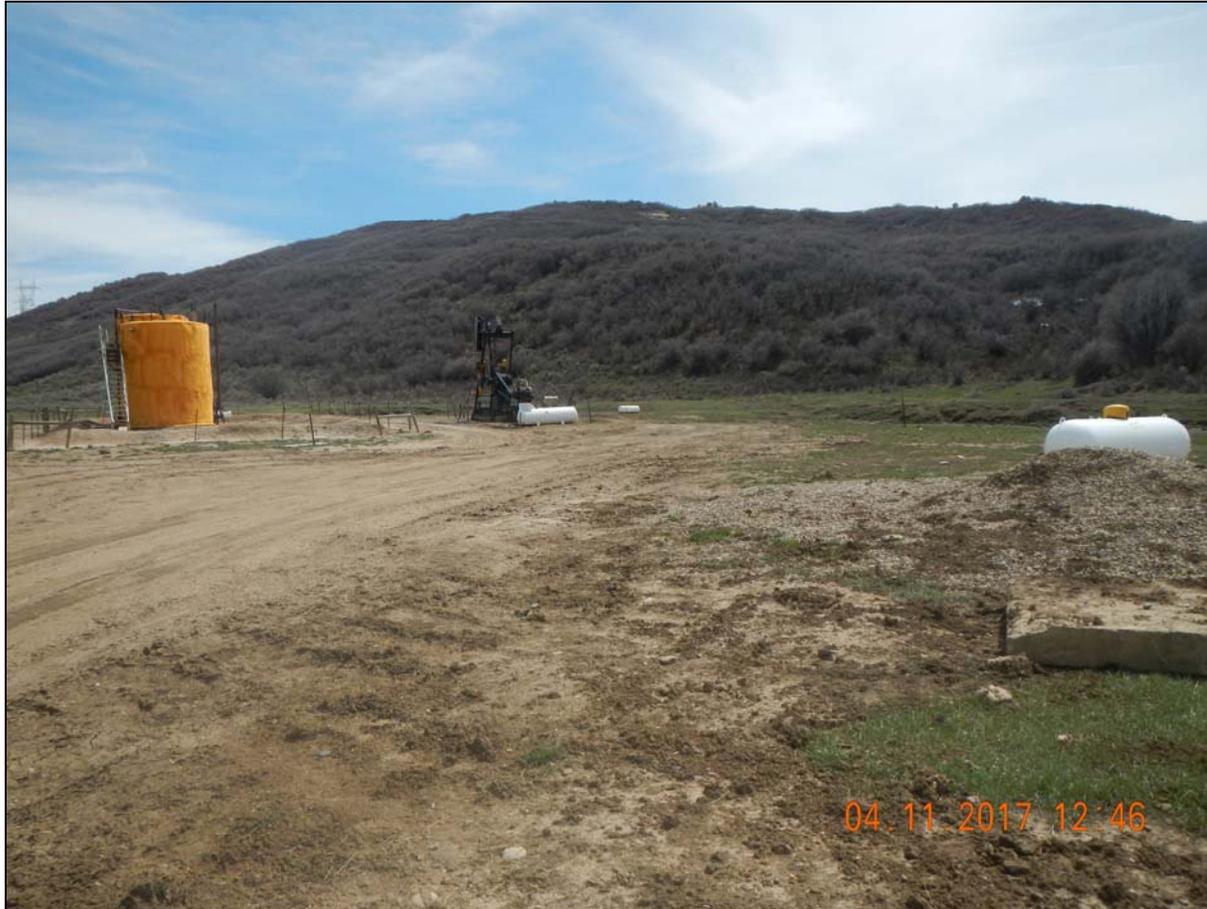
**Photo 1. View at entrance to location facing southeast. 1 of 3 unlabeled propane tanks visible in foreground.**

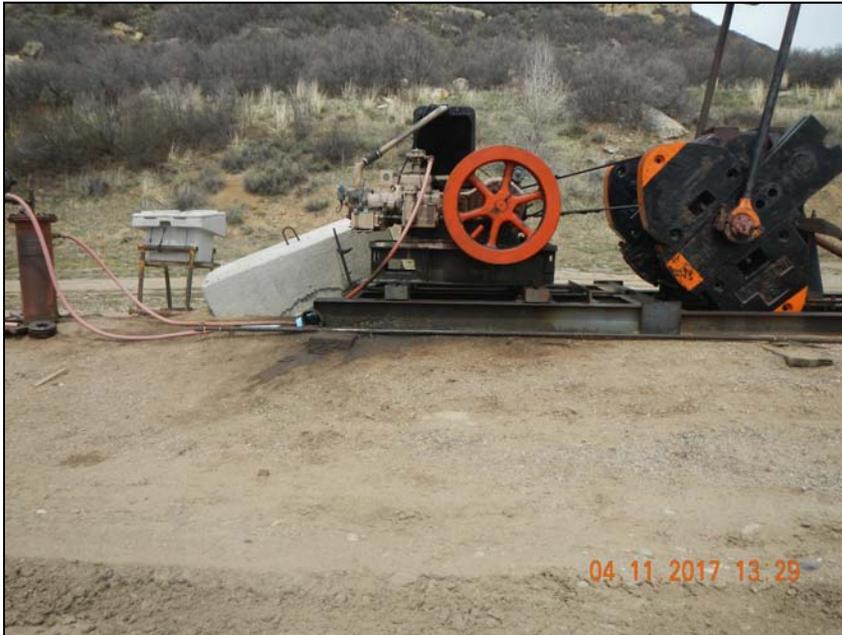
Photo 2. Stained soil at pump jack exhaust.

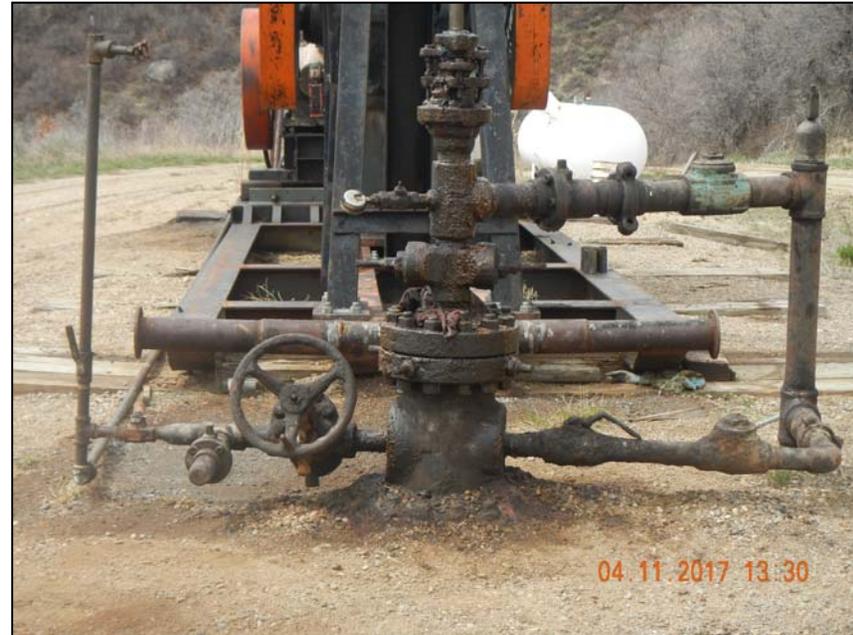
Photo 3. Stained soil at wellhead.
