Construction and Stormwater Inspection

April 7, 2017

Operator: KERR MCGEE OIL & GAS ONSHORE LP
#47120

Location ID: 330770

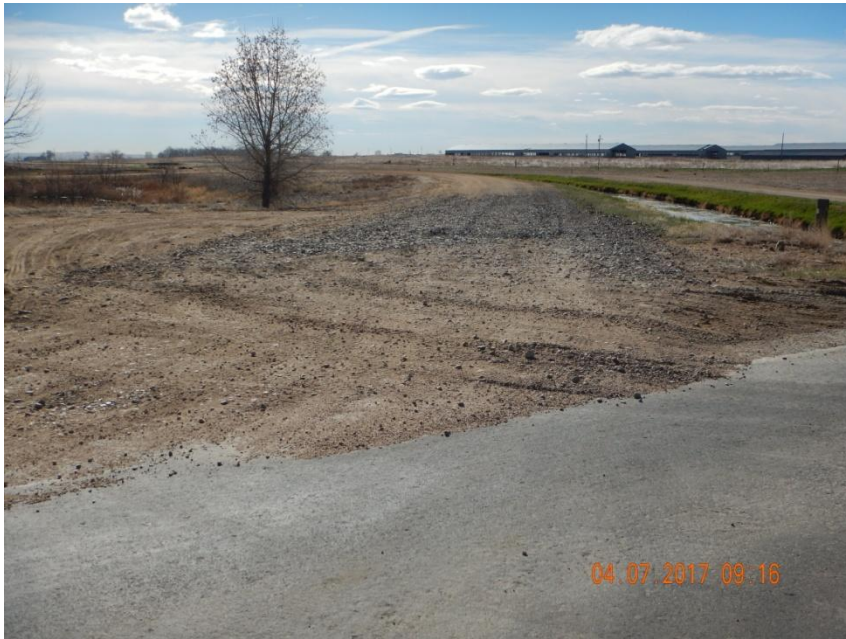
Photo 1. Photo taken from the entrance of location, facing East. Vehicle tracking pad installed but does not appear to be a sufficient amount of material. Monitor vehicle tracking and potential sediment discharge.

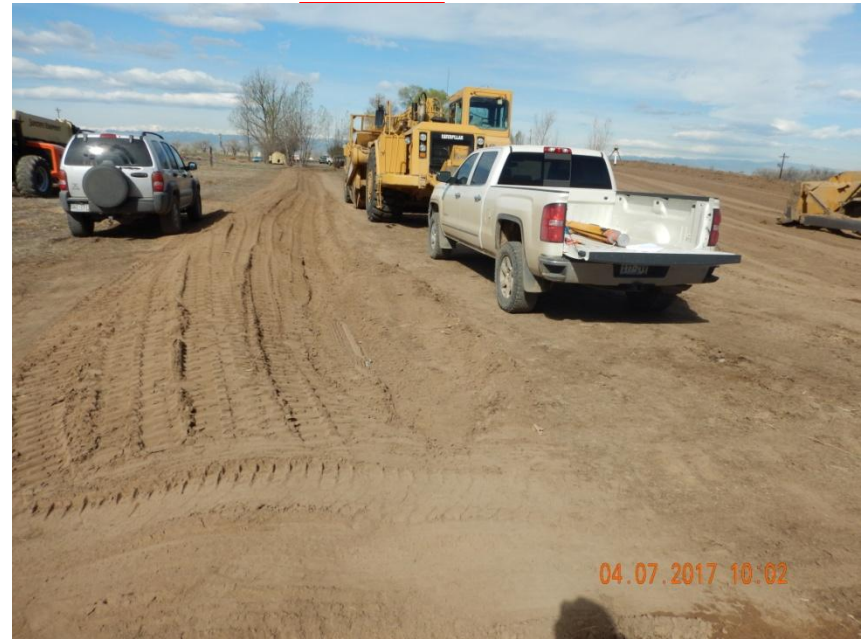
Photo 2. Photo taken from the southeastern location, facing West. Ditch and berm BMP installed around the perimeter of location. Also, location is dominated by sandy soils so a tackifier is recommended to stabilize all disturbed areas to control for wind erosion.

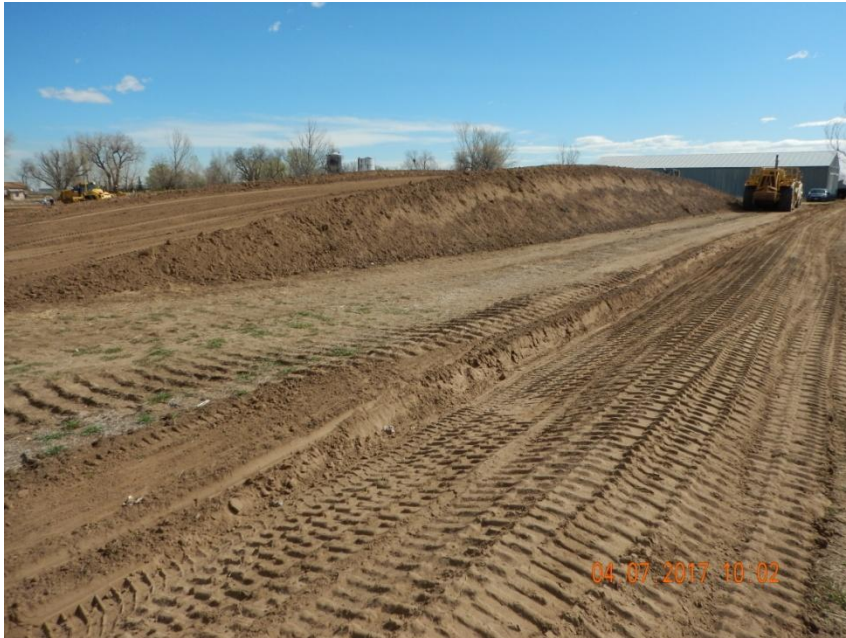
Photo 3. Photo taken from the southern location, facing Northeast. Topsoil stockpile stored along the southern perimeter of the location.

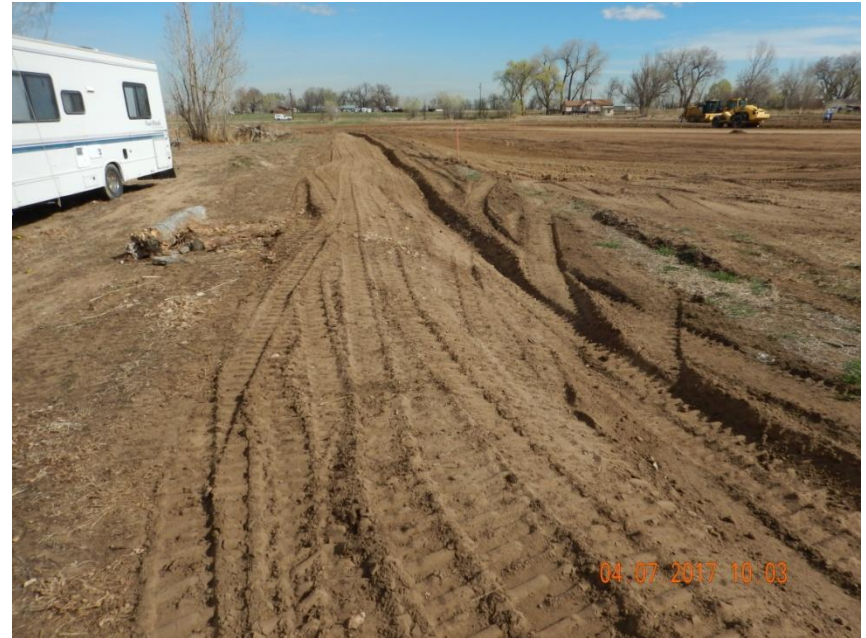
Photo 4. Photo taken from the southwest location, facing North. Ditch and berm BMP installed around the perimeter of location. Also, location is dominated by sandy soils so a tackifier is recommended to stabilize all disturbed areas to control for wind erosion.

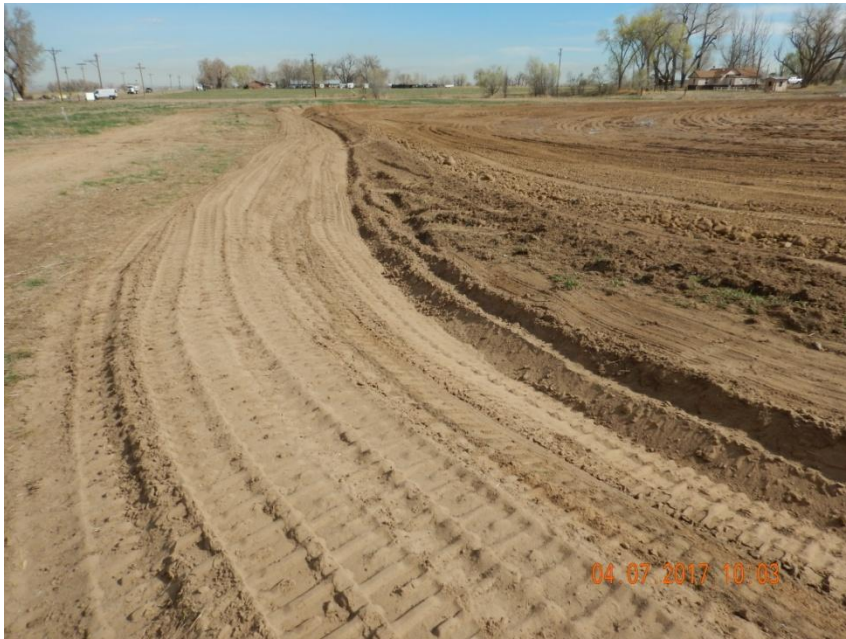
Photo 5. Photo taken from the western location, facing North. Ditch and berm BMP installed around the perimeter of location. Also, location is dominated by sandy soils so a tackifier is recommended to stabilize all disturbed areas to control for wind erosion.

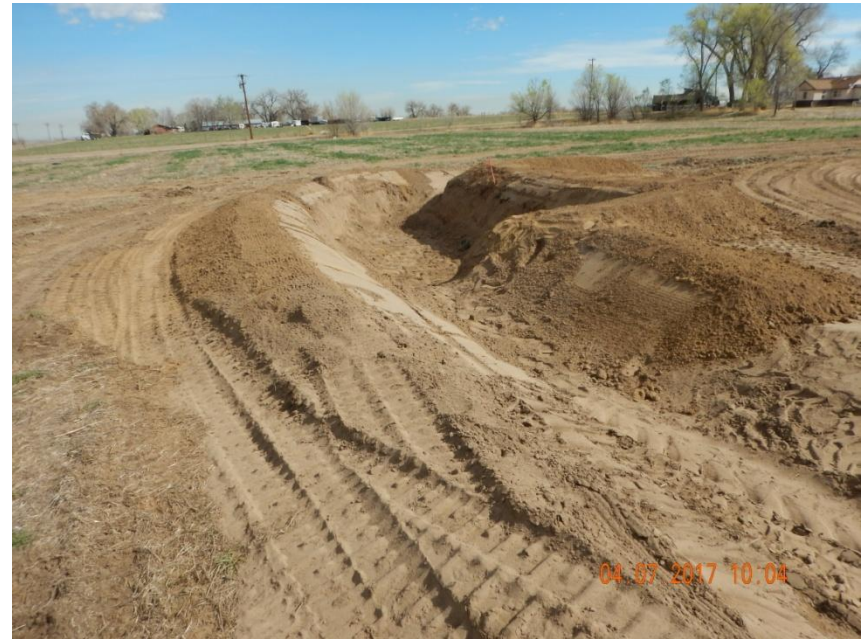
Photo 6. Photo taken from the northwest location, facing North. Sediment trap installed and IN-PROCESS of being completed (i.e., outlet still needs to be stabilized). Also, location is dominated by sandy soils so a tackifier is recommended to stabilize all disturbed areas to control for wind erosion.

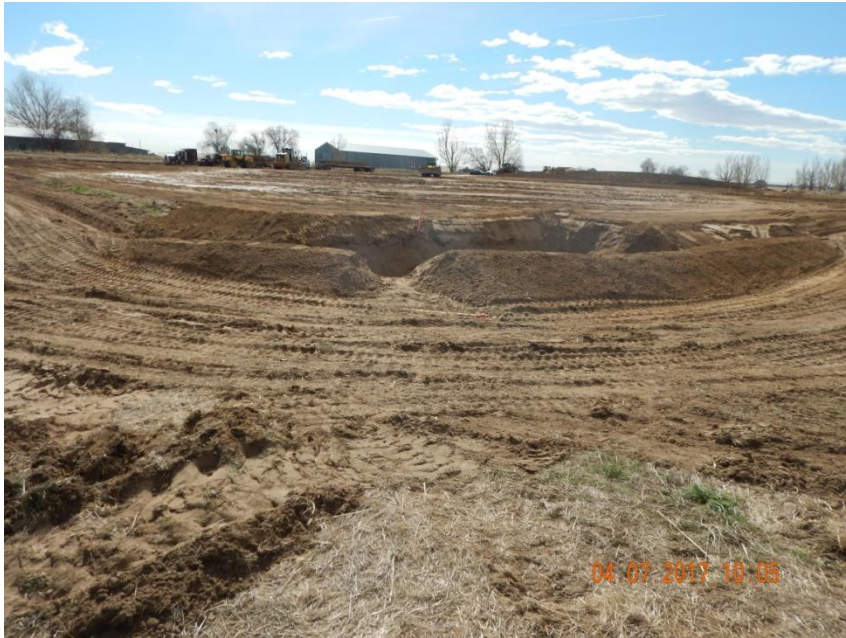
Photo 7. Photo taken sediment trap, facing Southeast. Sediment trap installed and IN-PROCESS of being completed (i.e., outlet still needs to be stabilized).

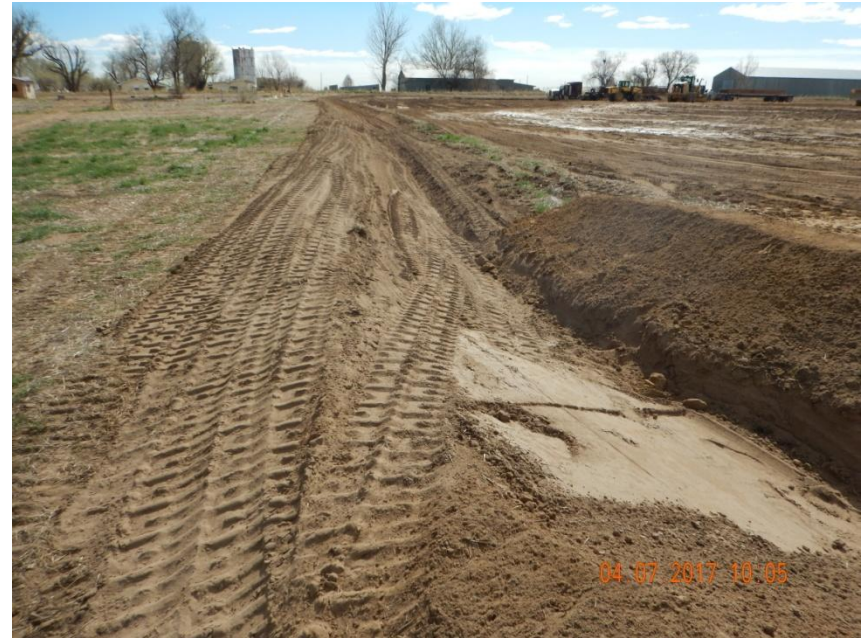
Photo 8. Photo taken from the northwest location, facing East. Ditch and berm BMP installed around the perimeter of location. Also, location is dominated by sandy soils so a tackifier is recommended to stabilize all disturbed areas to control for wind erosion.

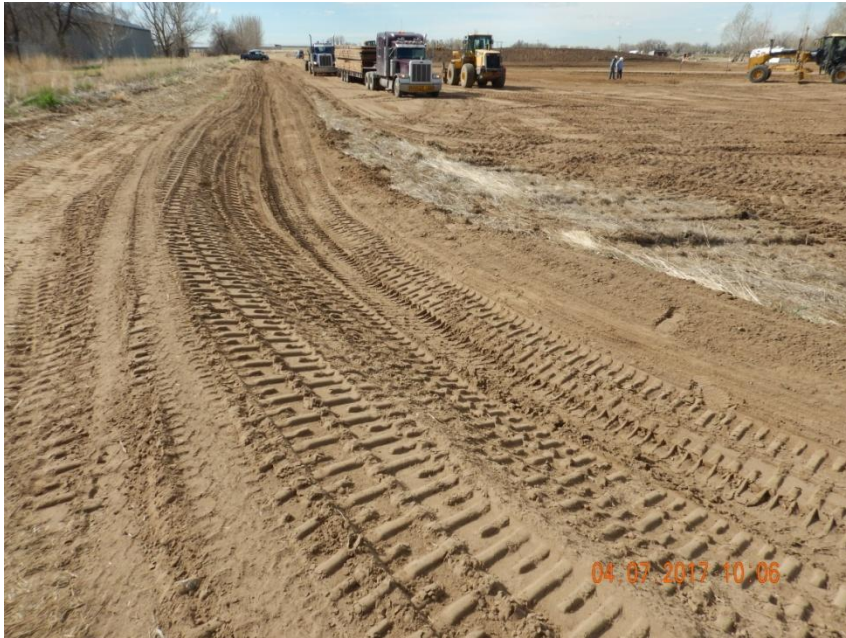
Photo 9. Photo taken from the northeast location, facing South. Ditch and berm BMP installed around the perimeter of location. Also, location is dominated by sandy soils so a tackifier is recommended to stabilize all disturbed areas to control for wind erosion.

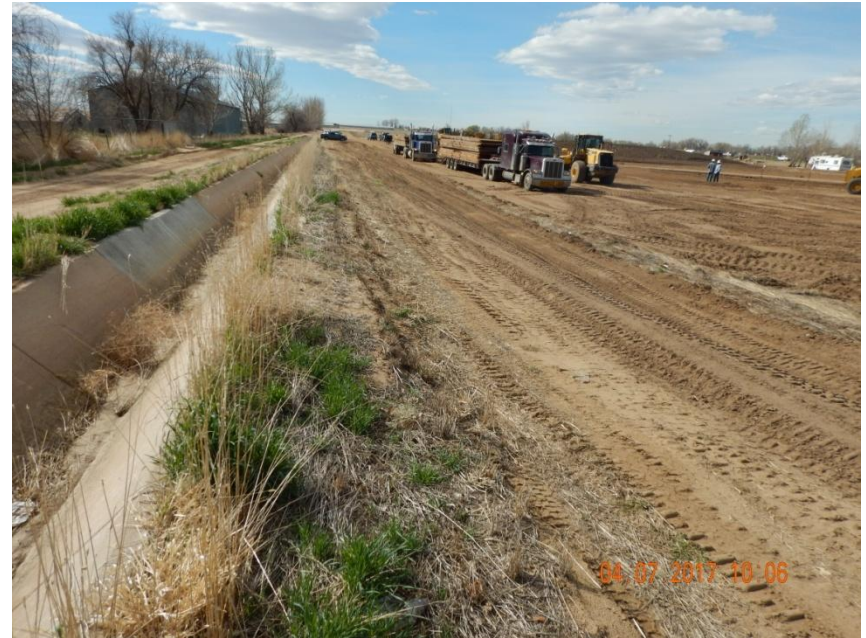
Photo 10. Photo taken from the eastern location, facing South. Existing irrigation ditch travels south, east of location.
