# Construction and Stormwater Inspection

April 7, 2017

Operator: KERR MCGEE OIL & GAS ONSHORE LP  
#47120

Location ID: 330811

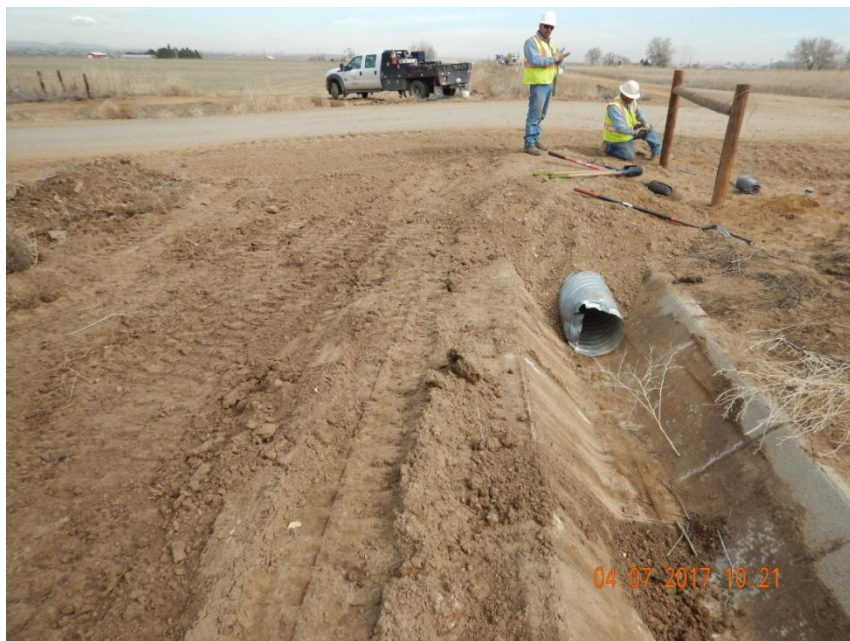
**Photo 1.** Photo taken from the entrance of location, facing North. Culvert installed in conjunction with the existing irrigation ditch. Operator shall ensure that sediment is not discharged into the ditch and ensure soil material is stabilized around the culvert.

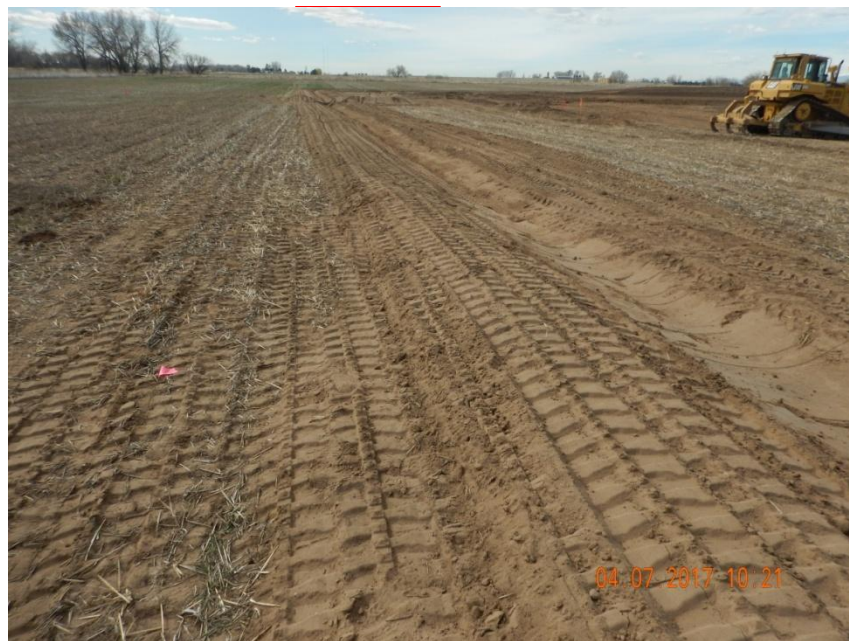
**Photo 2.** Photo taken from the northeast location, facing South. Ditch and berm BMP installed around the perimeter of location. Also, location is dominated by sandy soils so a tackifier is recommended to stabilize all disturbed areas to control for wind erosion.

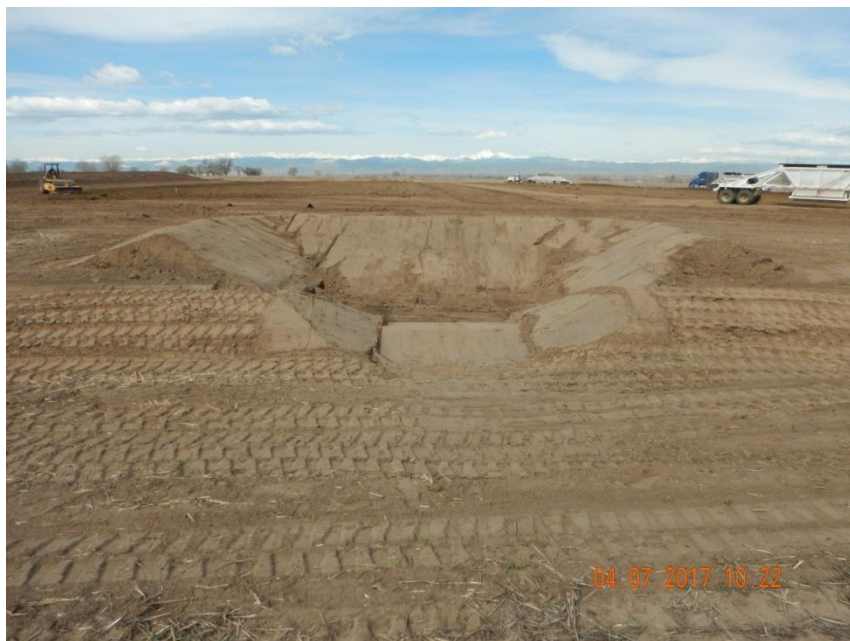
**Photo 3.** Photo taken from the eastern location, facing West. Sediment trap installed and IN-PROCESS of being completed (i.e., outlet still needs to be stabilized). Also, location is dominated by sandy soils so a tackifier is recommended to stabilize all disturbed areas to control for wind erosion.

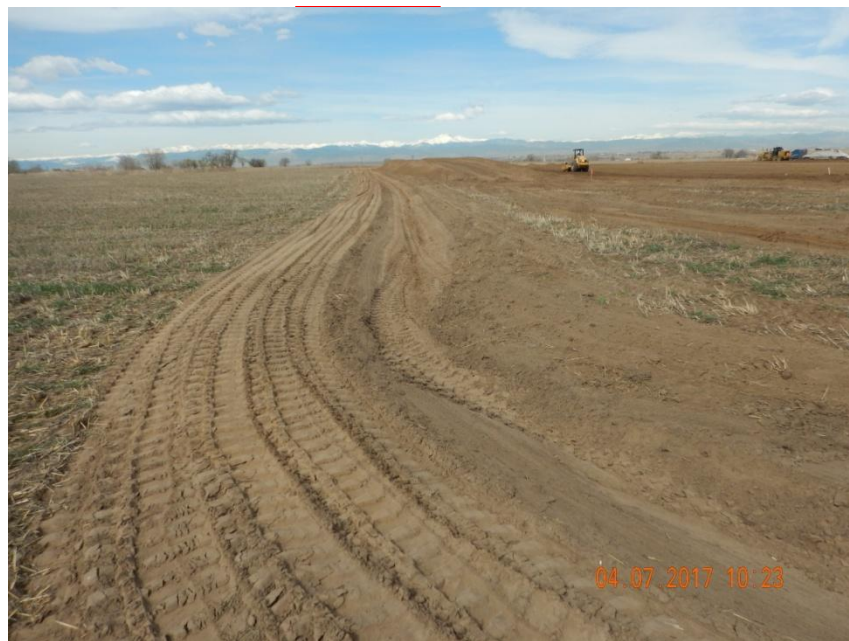
**Photo 4.** Photo taken from the southeast location, facing West. Ditch and berm BMP installed around the perimeter of location. Also, location is dominated by sandy soils so a tackifier is recommended to stabilize all disturbed areas to control for wind erosion.

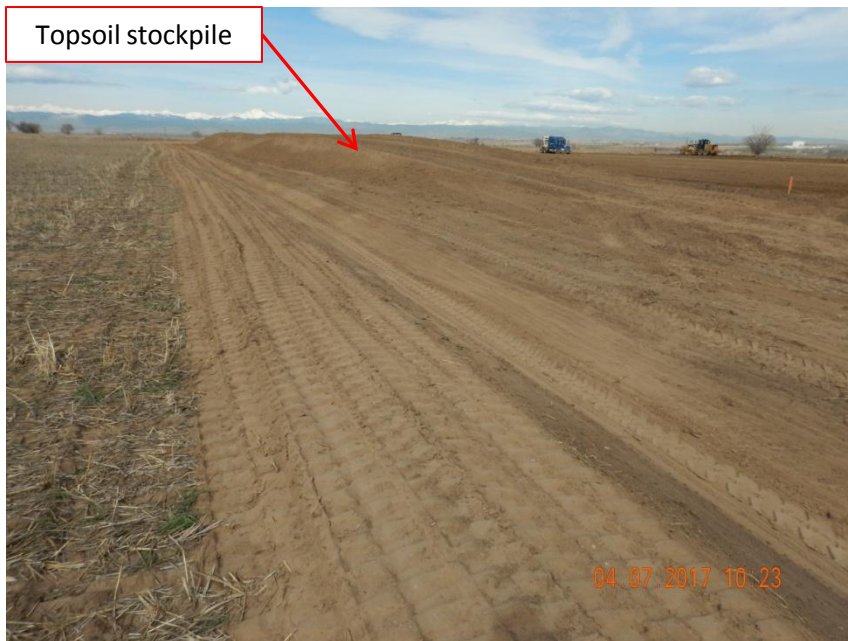
**Photo 5.** Photo taken from the southern location, facing West. Topsoil stockpile stored along the southern perimeter of the location.

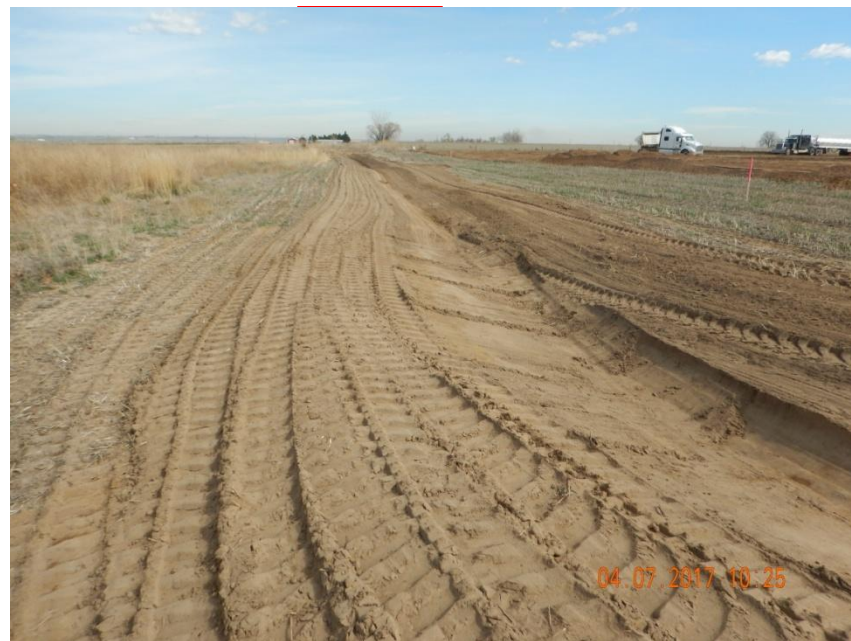
**Photo 6.** Photo taken from the southwest location, facing North. Ditch and berm BMP installed around the perimeter of location. Also, location is dominated by sandy soils so a tackifier is recommended to stabilize all disturbed areas to control for wind erosion.

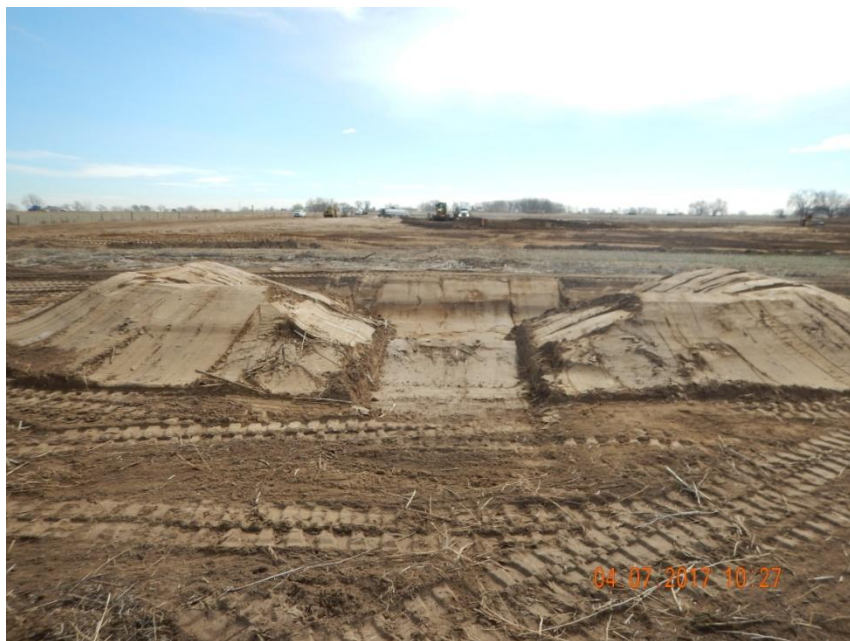
**Photo 7.** Photo taken from the western location, facing East. Sediment trap installed and IN-PROCESS of being completed (i.e., outlet still needs to be stabilized). Also, location is dominated by sandy soils so a tackifier is recommended to stabilize all disturbed areas to control for wind erosion.

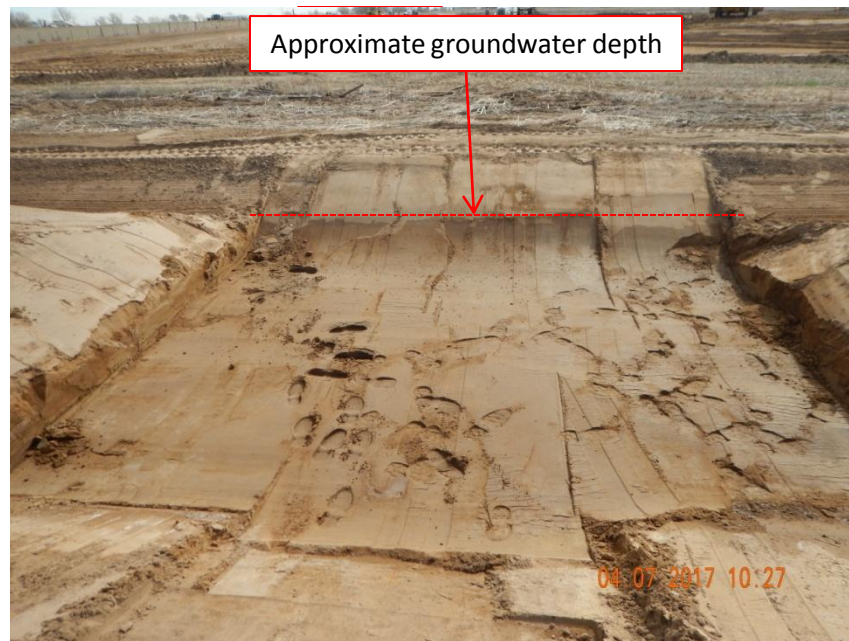
**Photo 8.** Photo taken from inside the western sediment trap. Shallow groundwater has been encountered while constructing the sediment trap. Approximate groundwater depth is illustrated with the line. Operator needs to construct BMPs in such a manner that would not have direct impact to groundwater.

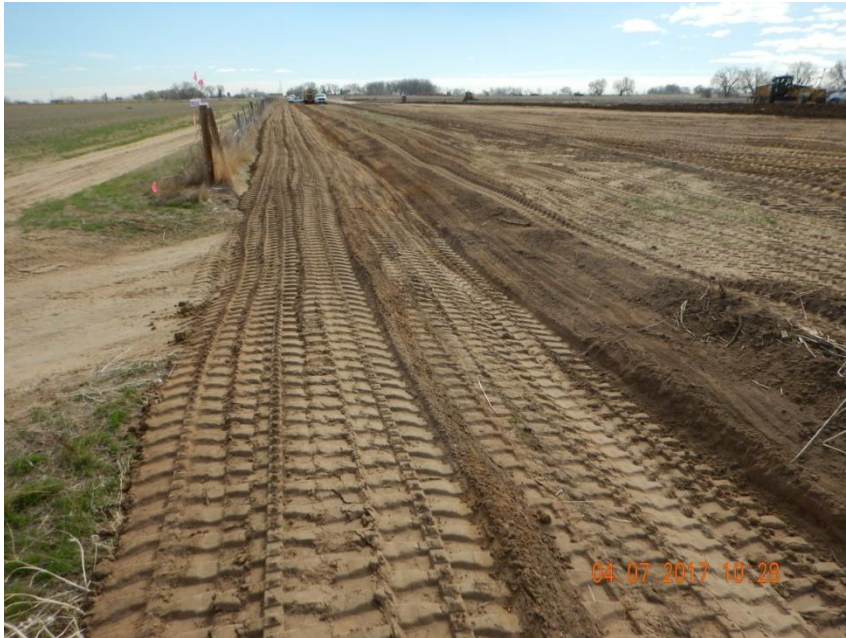
**Photo 9.** Photo taken from the northern location, facing East. Ditch and berm BMP installed around the perimeter of location. Also, location is dominated by sandy soils so a tackifier is recommended to stabilize all disturbed areas to control for wind erosion.

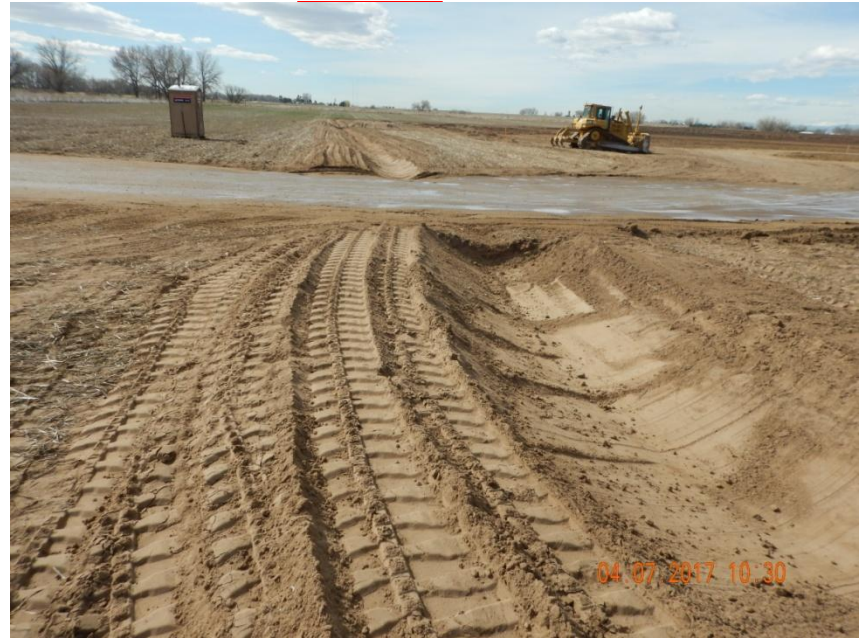
**Photo 10.** Photo taken from the northeast location, facing South. Ditch and berm BMP installed around the perimeter of location. Also, location is dominated by sandy soils so a tackifier is recommended to stabilize all disturbed areas to control for wind erosion.
