Inspection Photos
Location Name: Titanium 26-10-7HI & 2
API: 05-057-06094

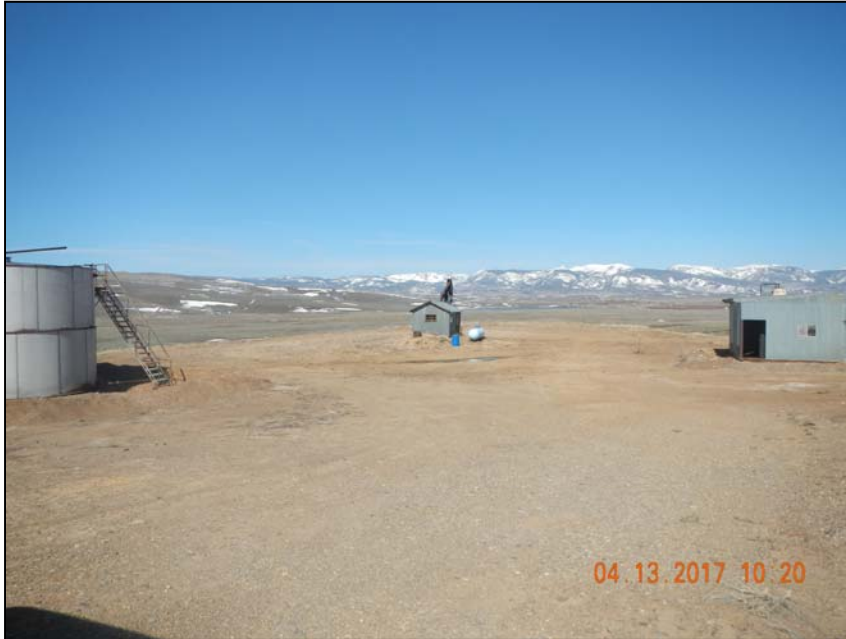
Photo 1. View of location at entrance facing west.

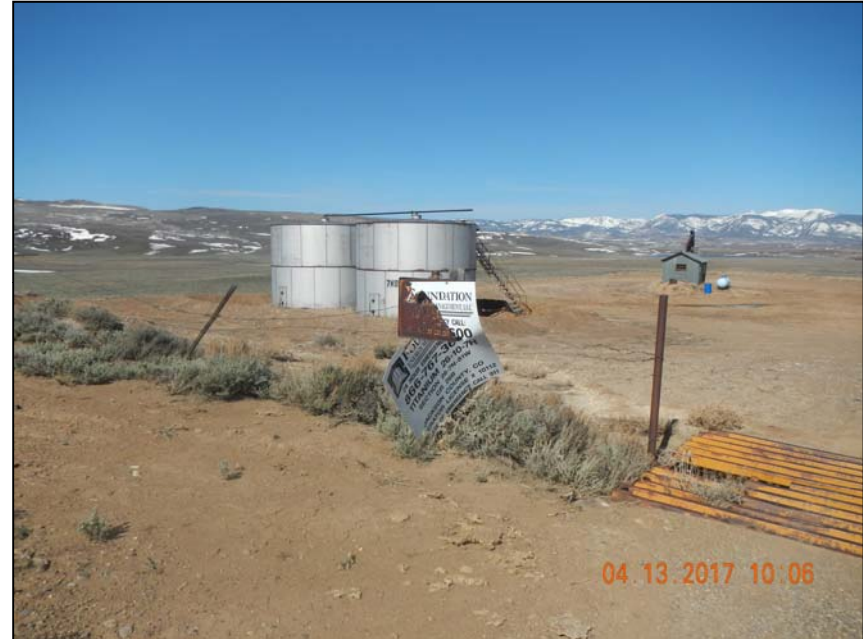
Photo 2. Torn sign at entrance.

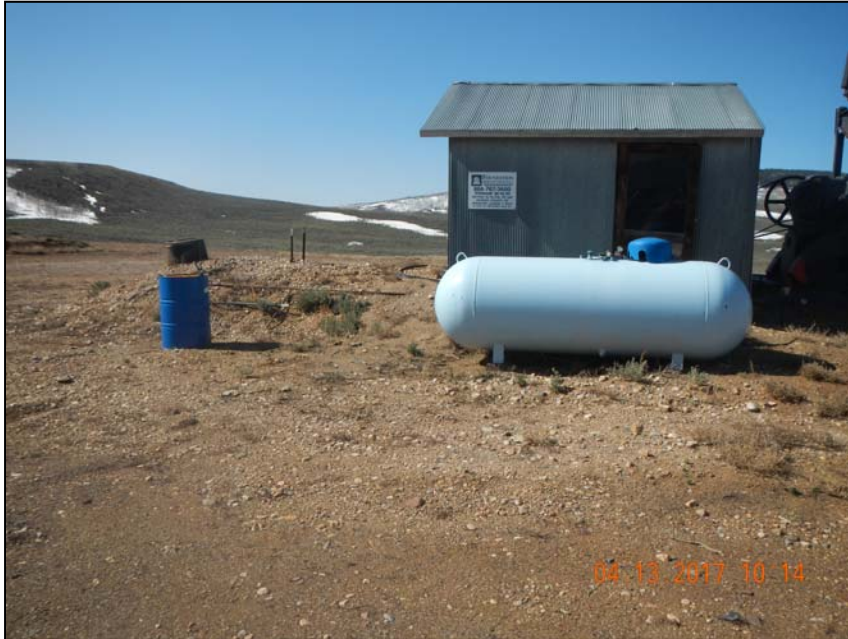
Photo 3. Unlabeled containers at wellhead. One without secondary containment.

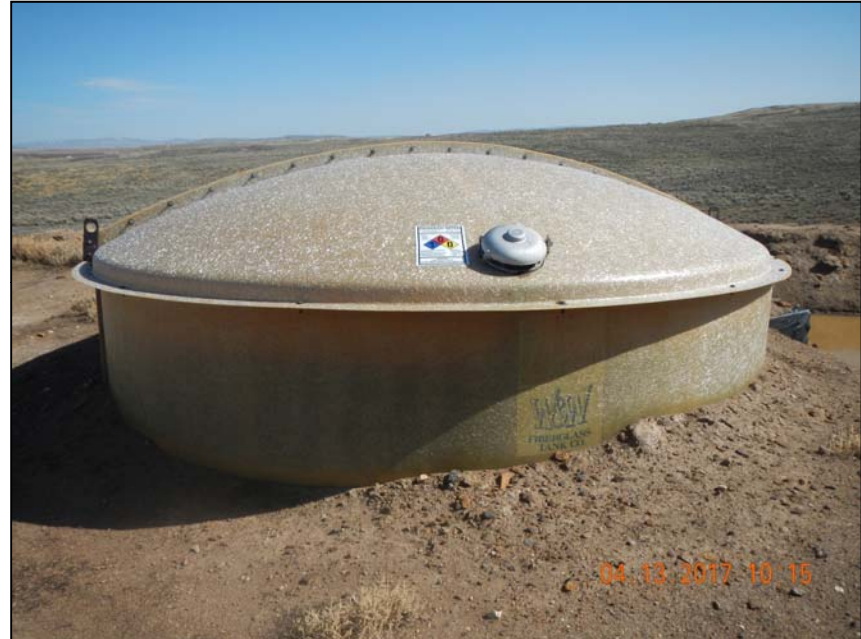
Photo 4. No capacity on produced water tank.
