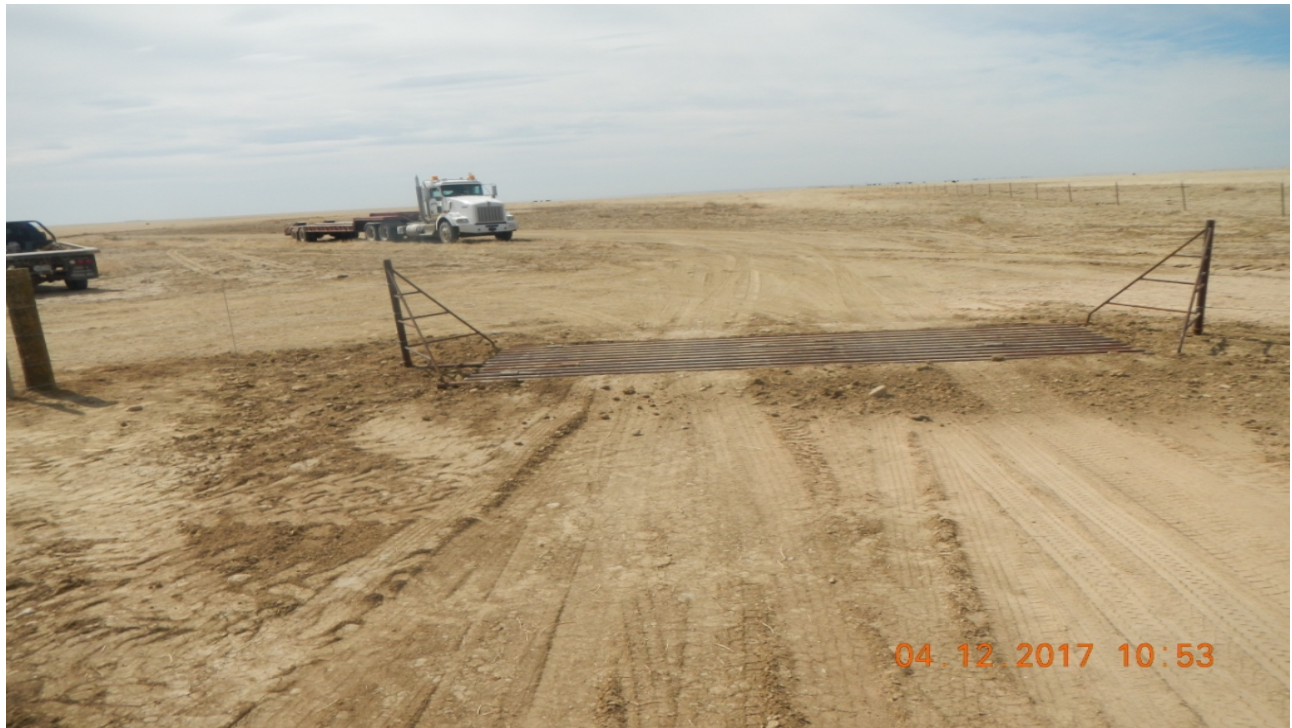
photo 1: Facing south at the beginning of the access road.

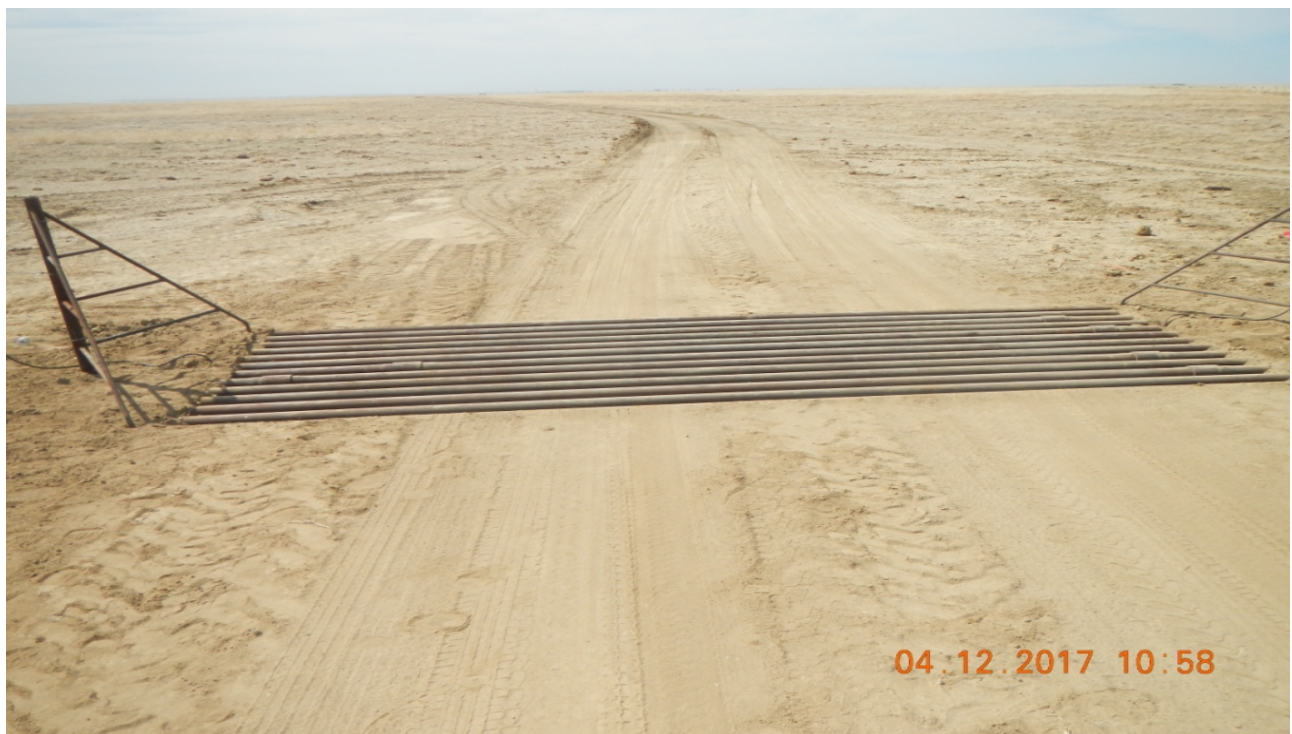
photo 2: Further south along the road, a second cattle guard is installed.

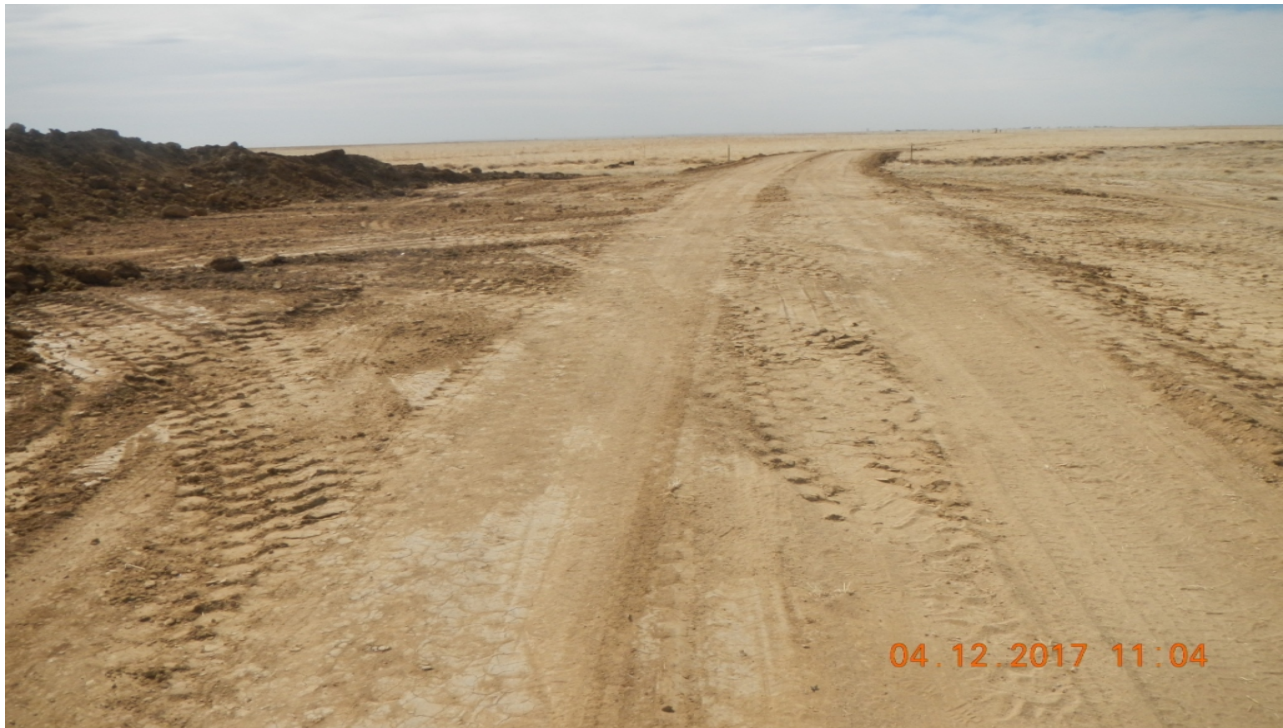
photo 3: Facing south along the access road. A soil borrow areas is being used off of the road.

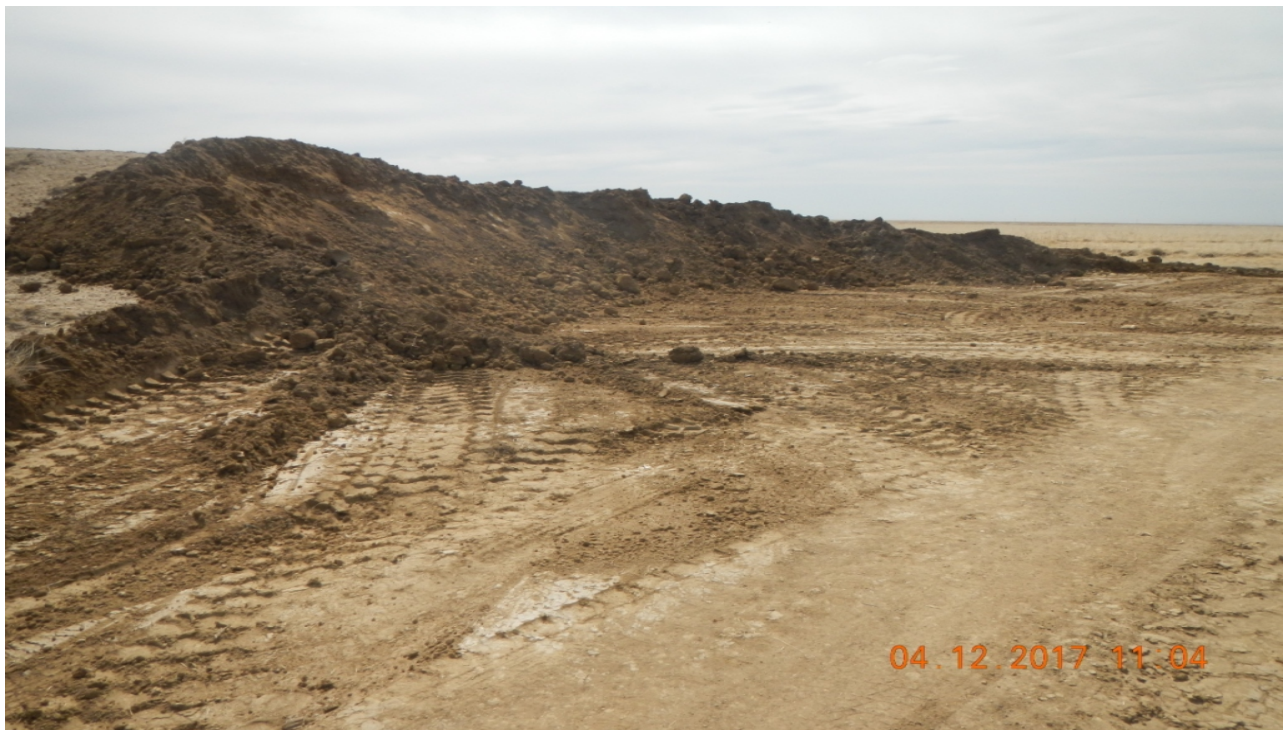
photo 4: Facing toward the borrow area.

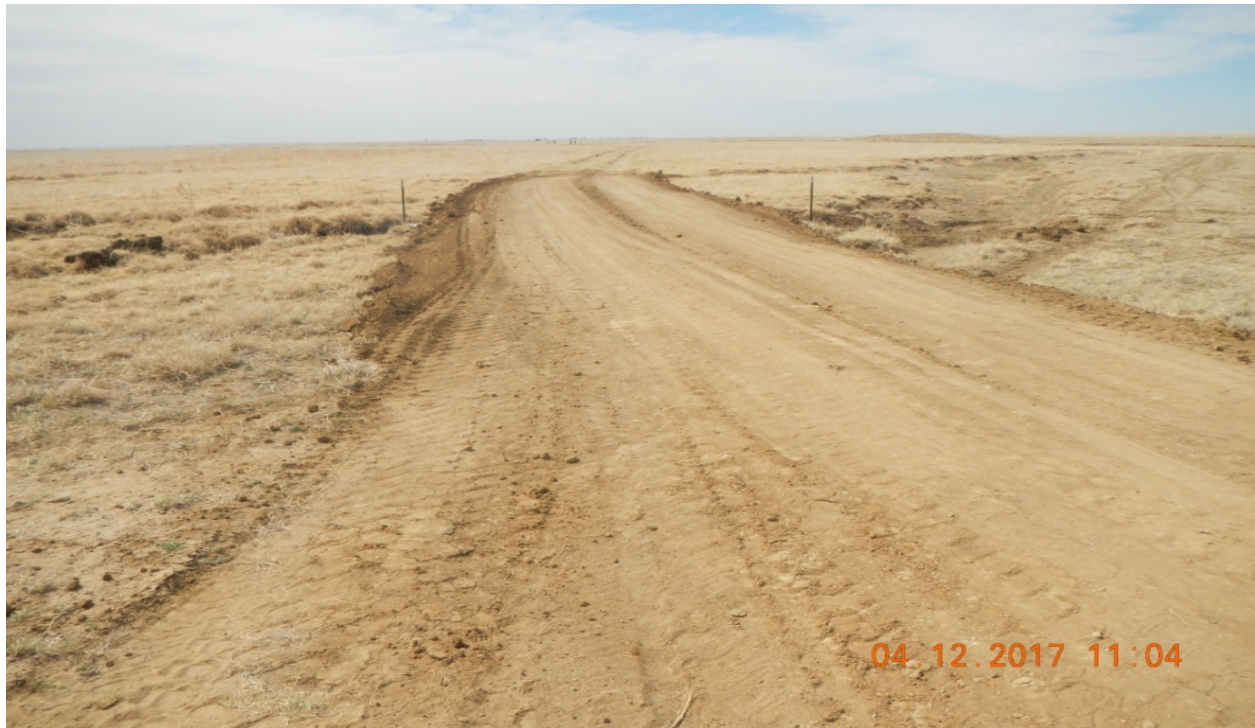
photo 5: Facing south, culverts are installed and material from the borrow area is placed over the culverts.

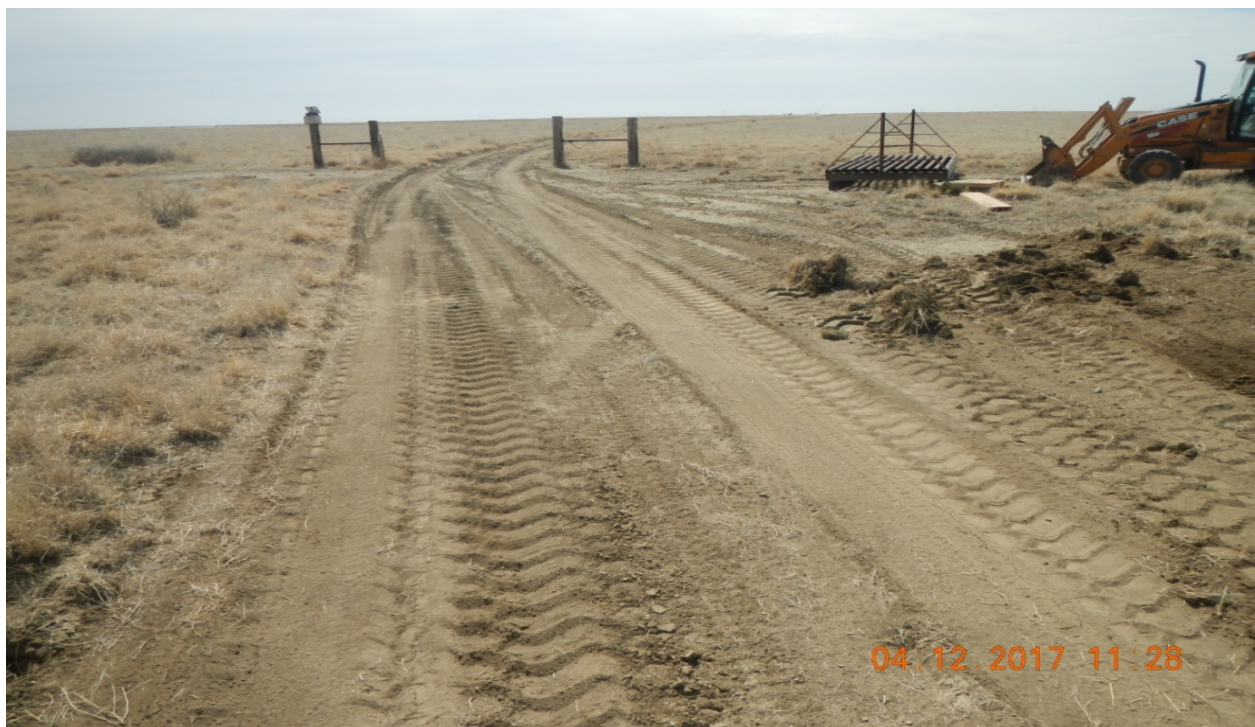
photo 6: Further south along the road, another cattle guard

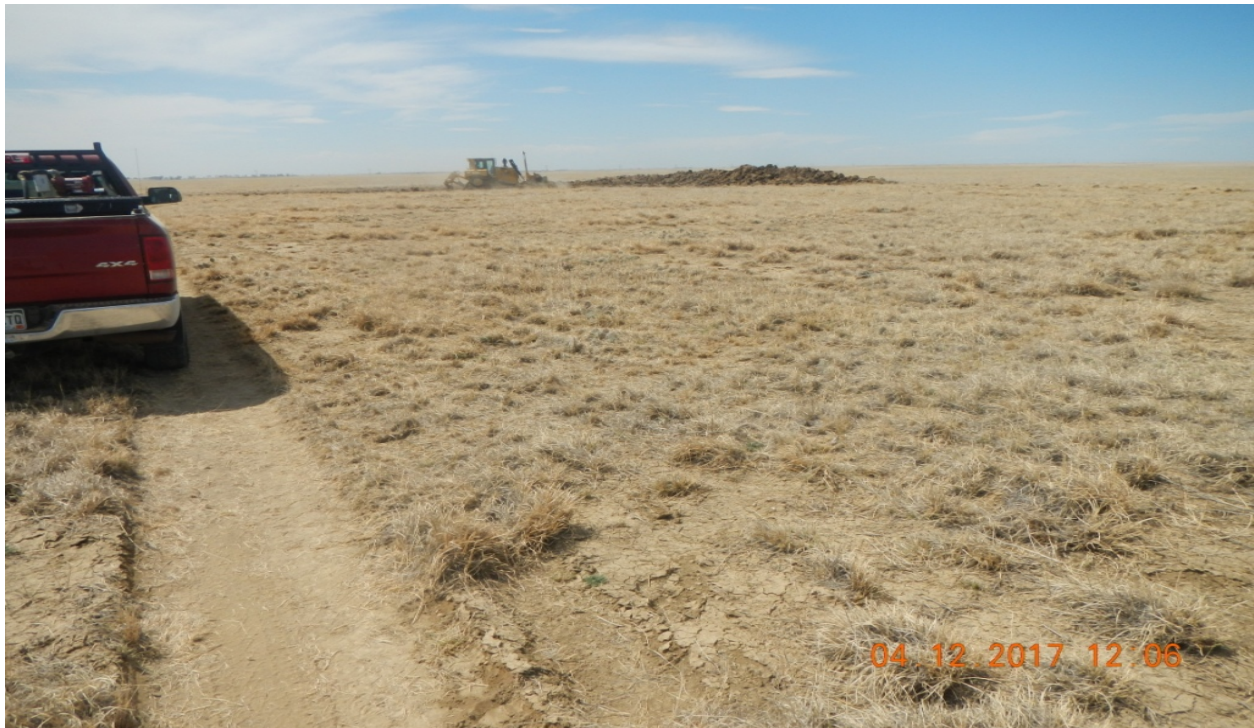
photo 7: Facing south toward the location. Construction of the location has begun.

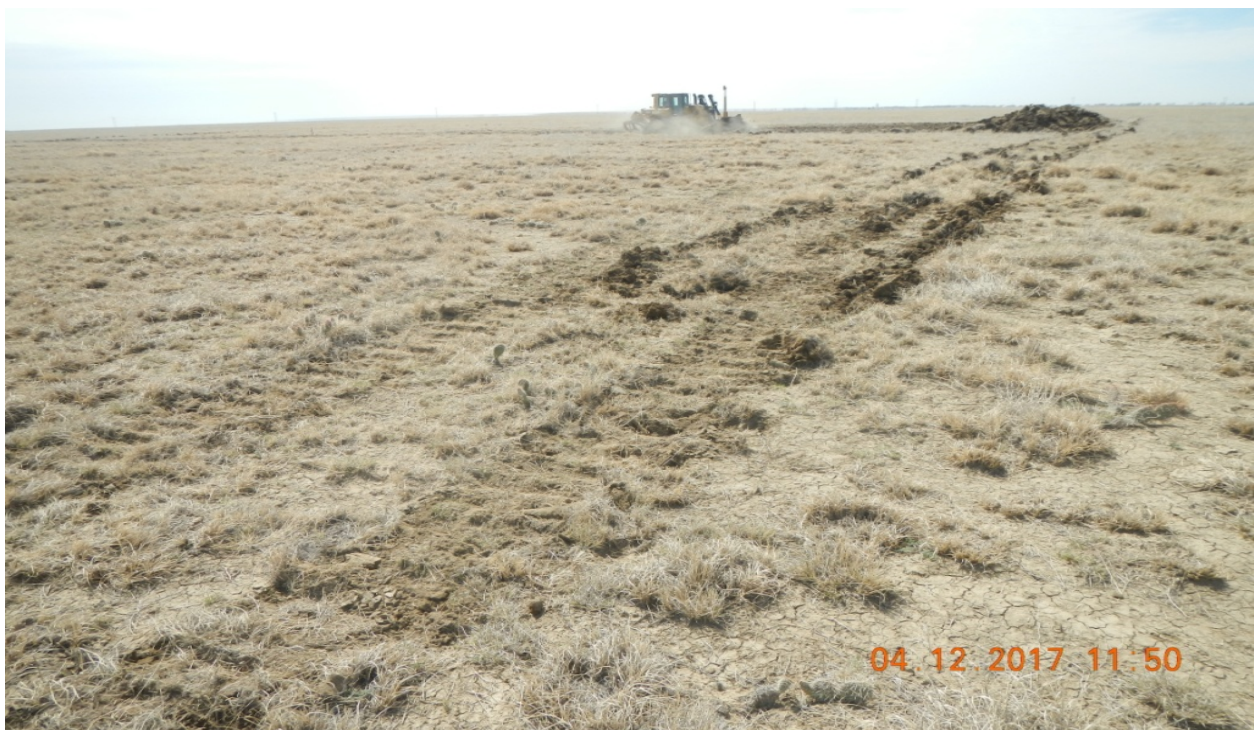
photo 8: Topsoil is being pushed toward the west side of the location.

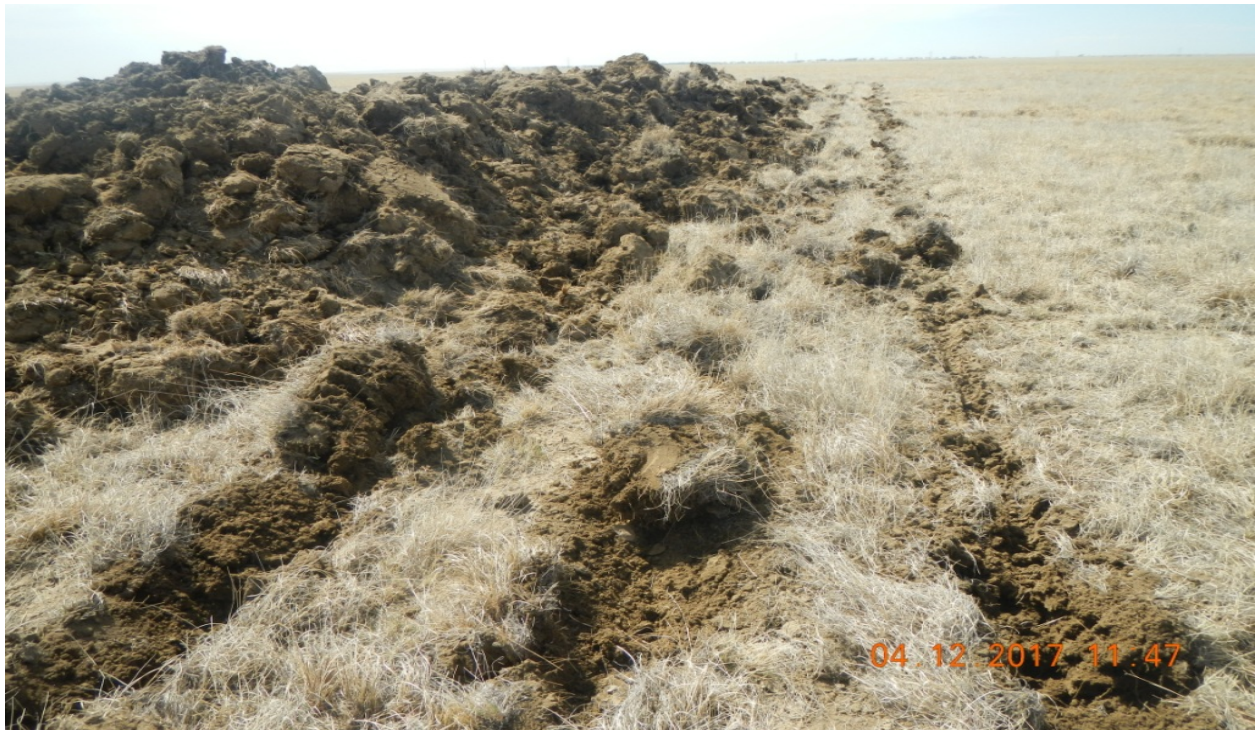
photo 9: Facing south toward topsoil pile. Surface roughening has occurred around the perimeter.

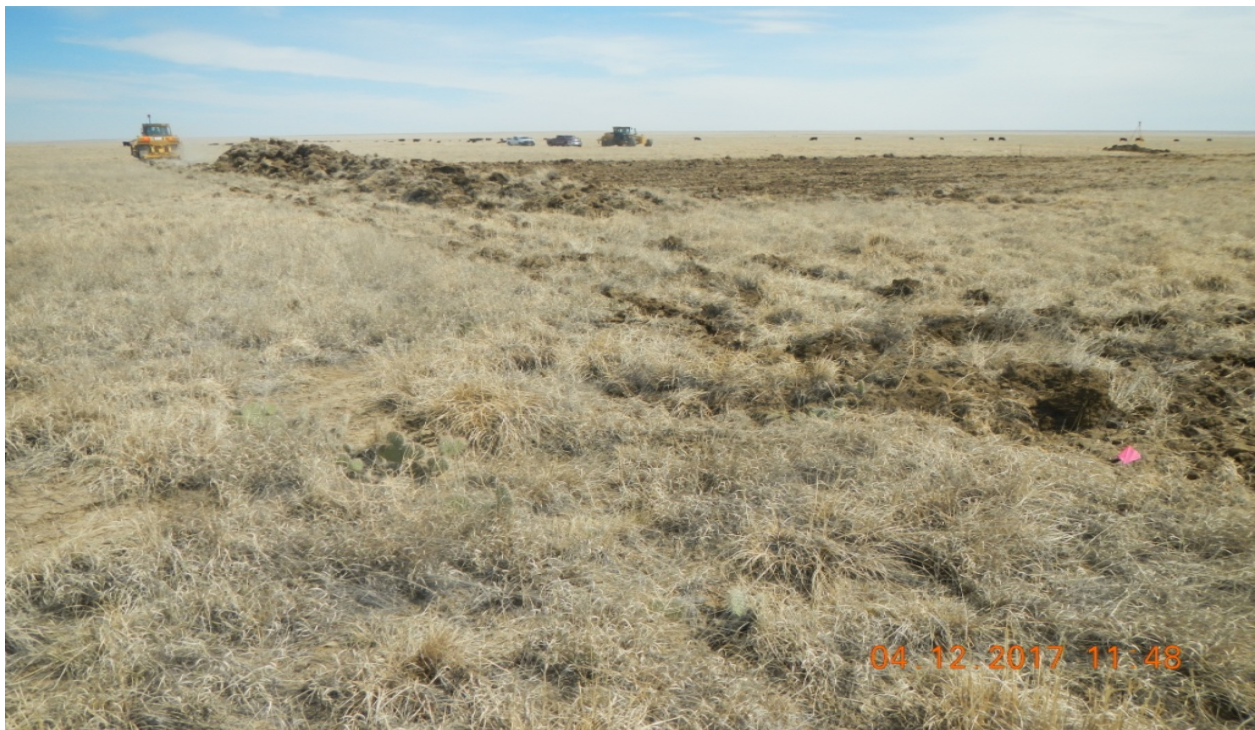
photo 10: Facing northwest toward the location.
