**Inspection Photos**  
**Location Name: Walcker AC17-64HN**  
**API: 05-123-35071**

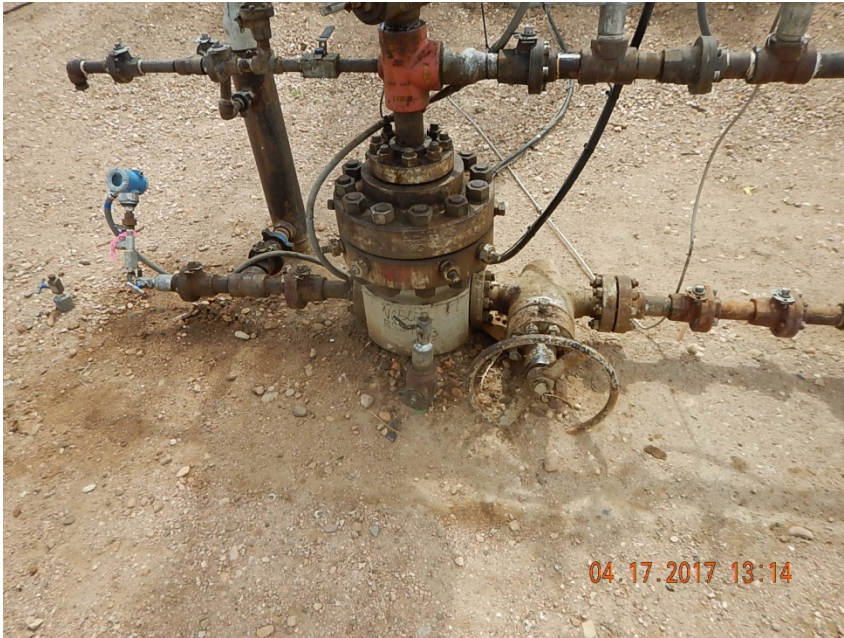
**Photo 3: Stained soil at wellhead**

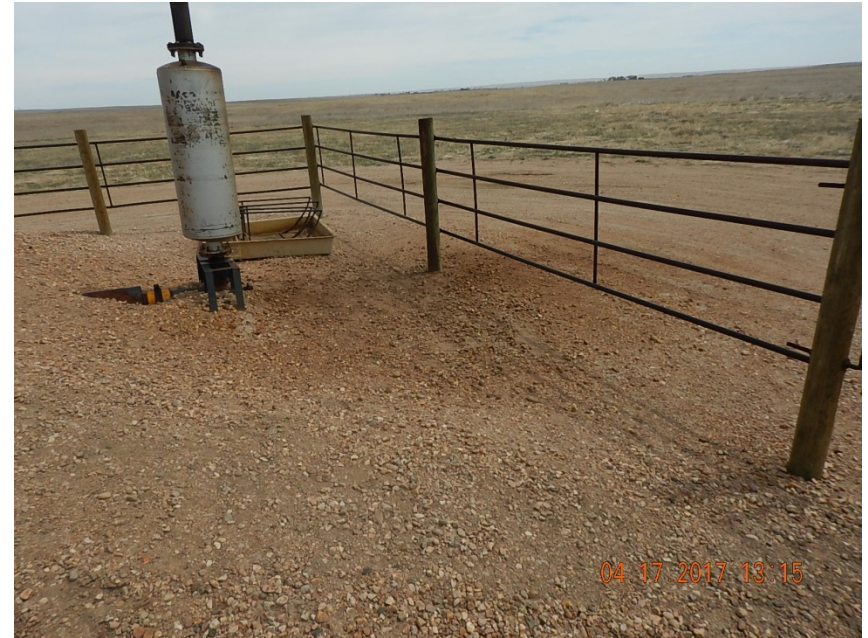
**Photo 4: Stained soil at Ajax exhaust**

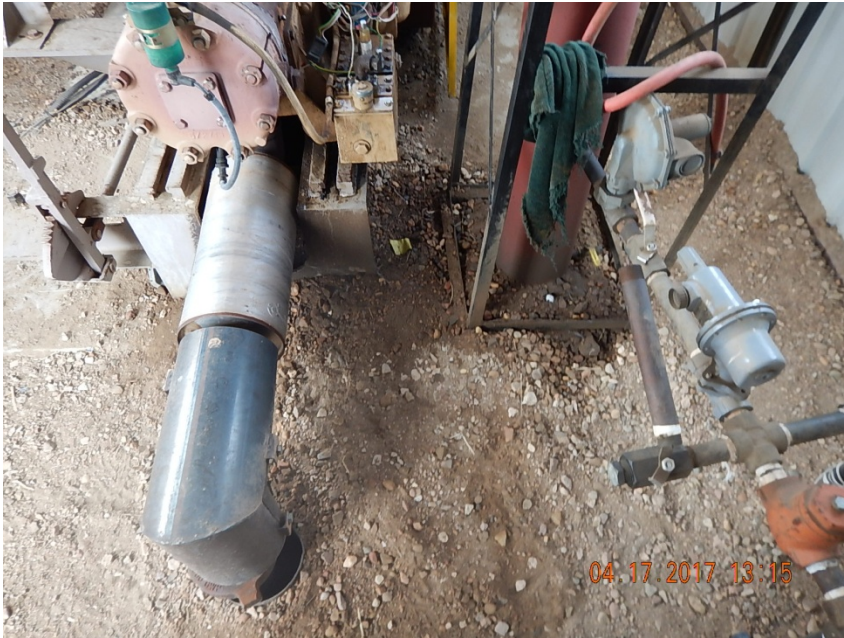
**Photo 5: Stained soil at Ajax engine**
