Inspection Photos
Location Name: Ramirez AC 29-72HN
API: 05-123-34975

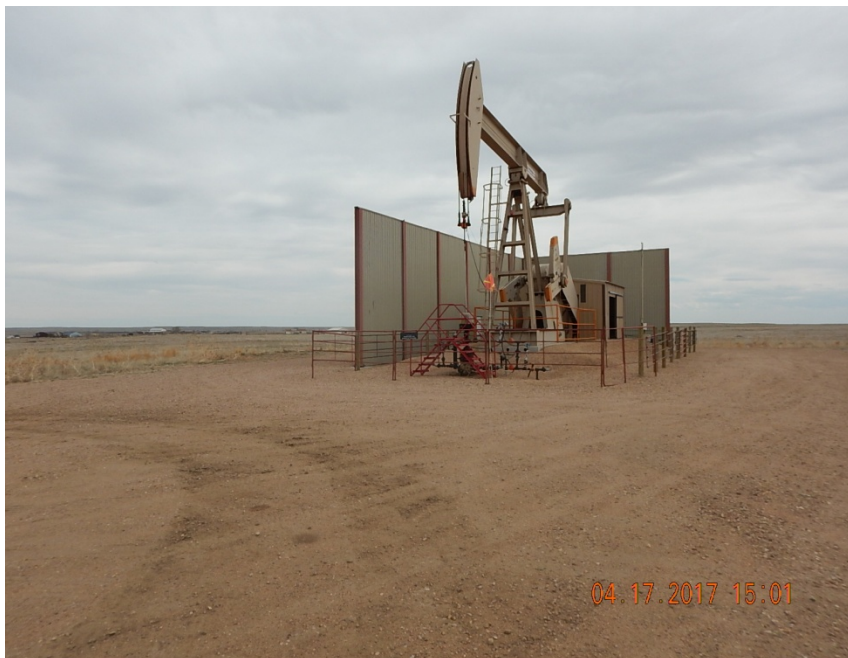
Photo 1: Wellhead, looking SE

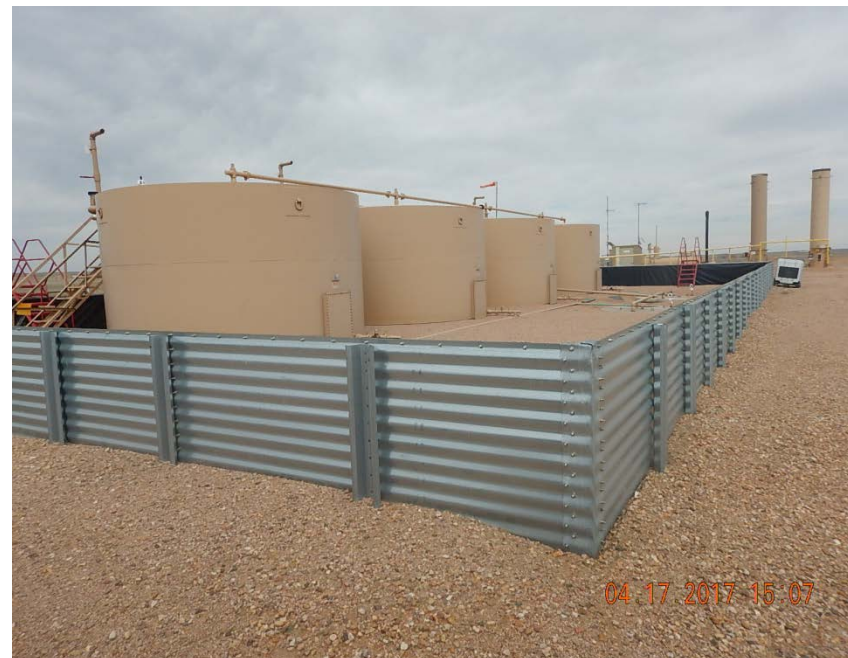
Photo 2: Location, looking NE

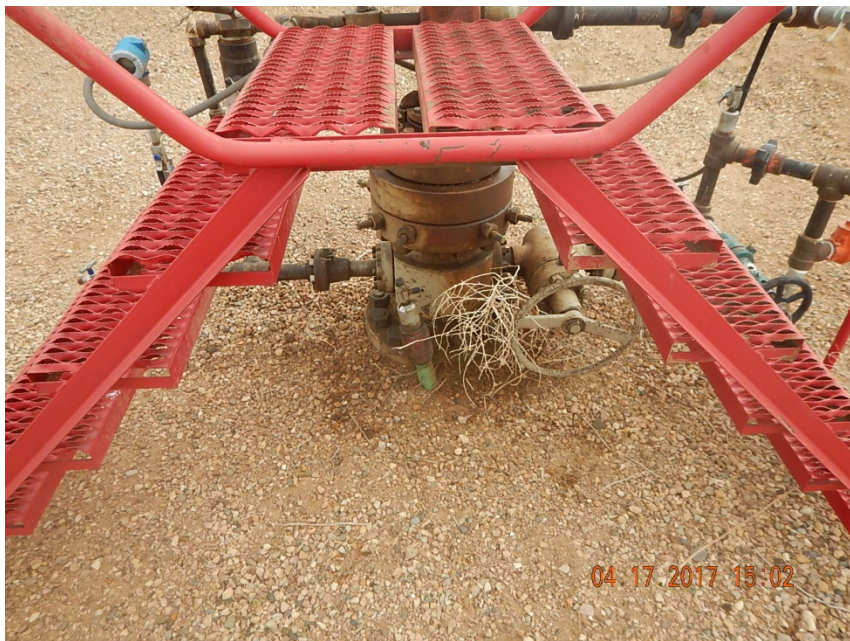
Photo 3: Stained soil at wellhead

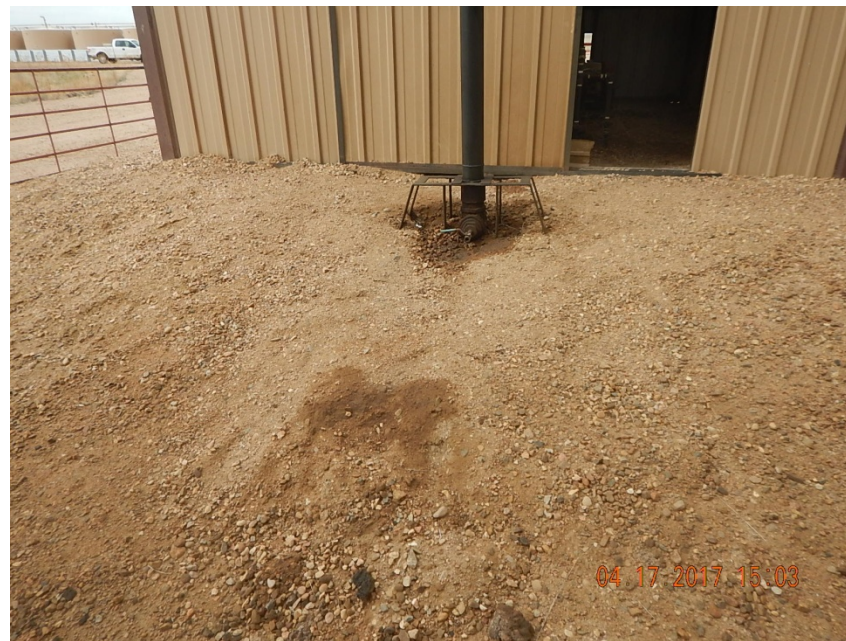
Photo 4: Stained soil at engine exhaust
