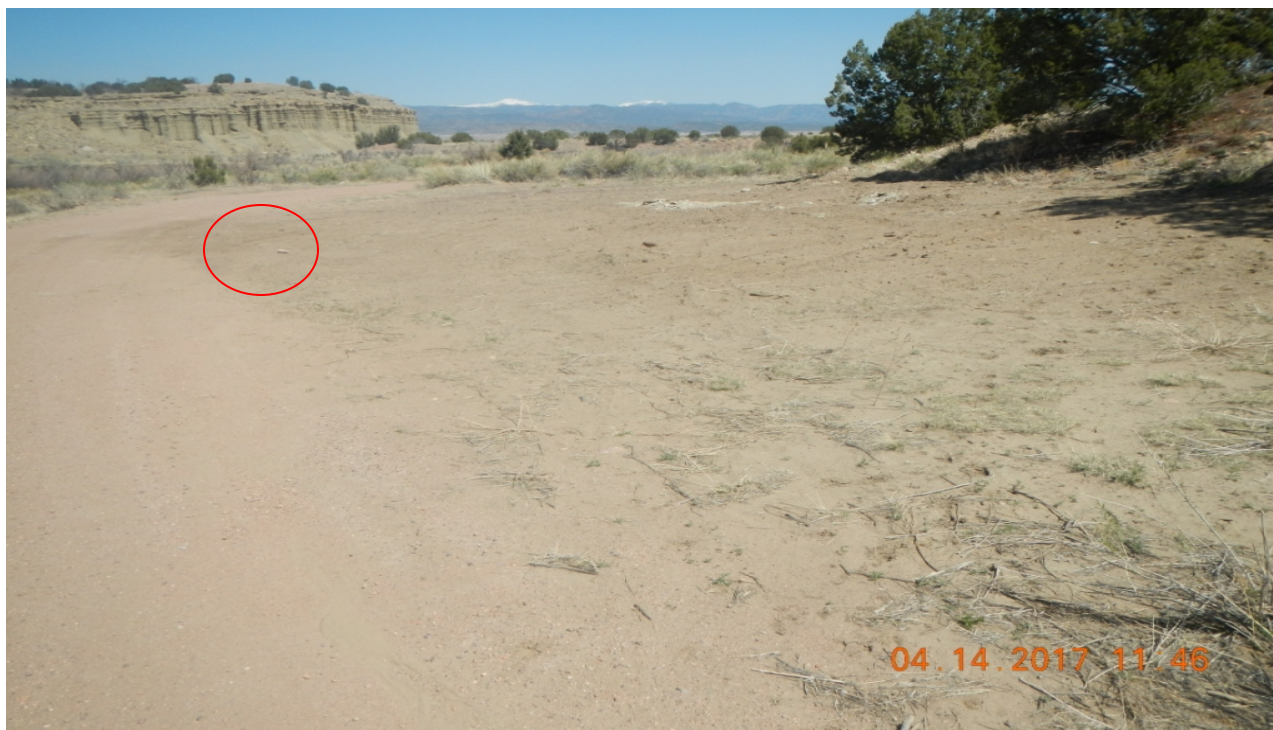
**photo 1:** Facing north toward the location. Red circle indicates photo 2 shown below.

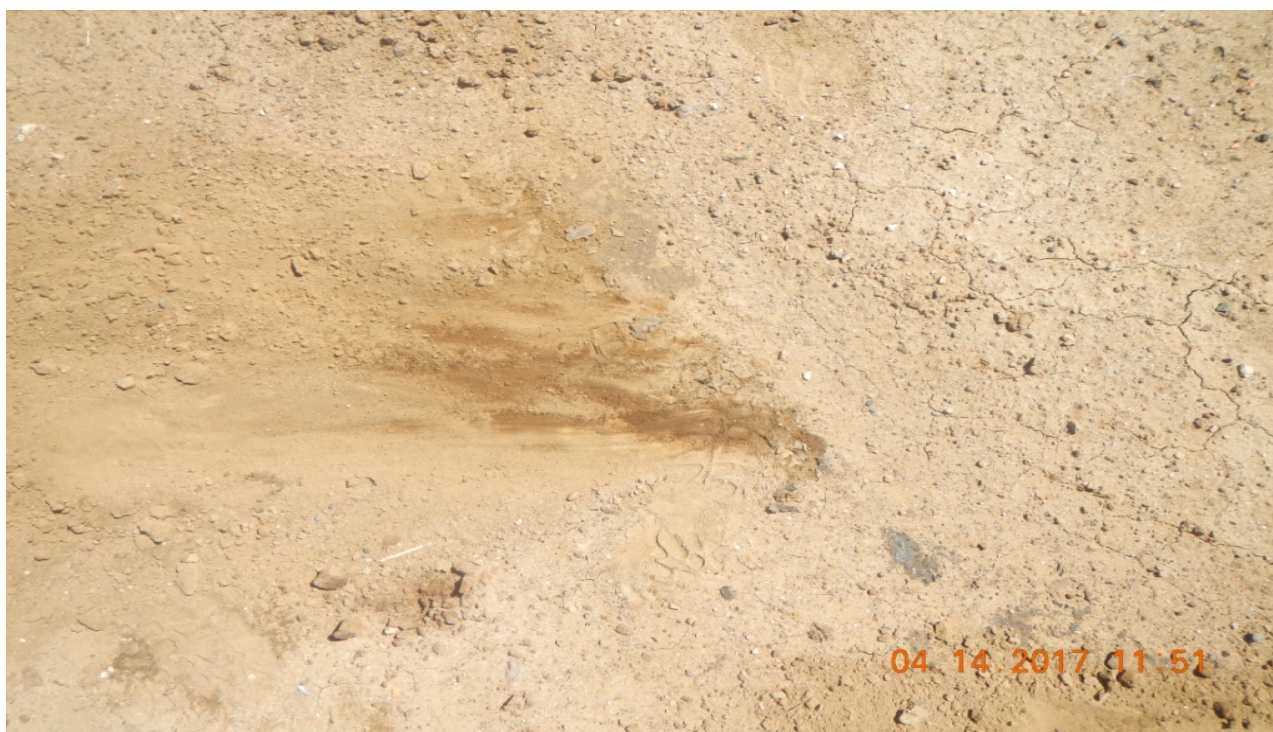
**photo 2:** Stained soils were found at center of the location adjacent to the road. Area is also circled red in the above photo.

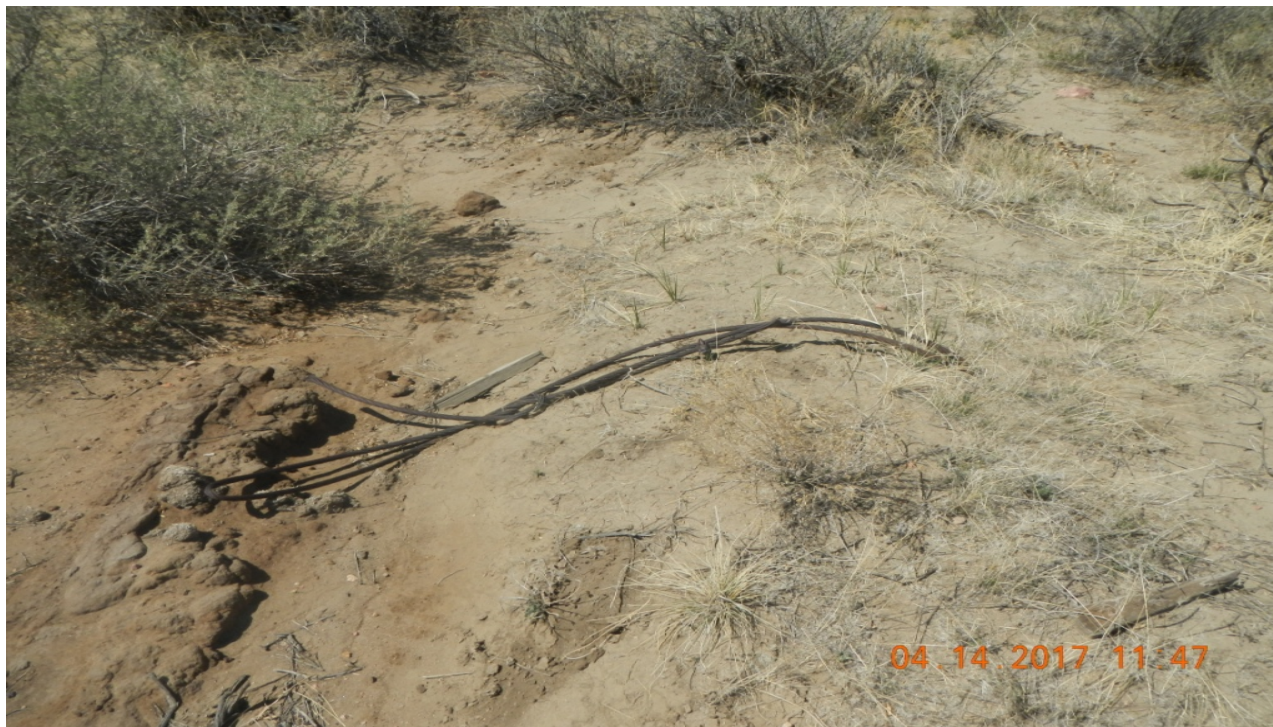
**photo 3:** Guyline anchor remains at the northwest corner of the location.

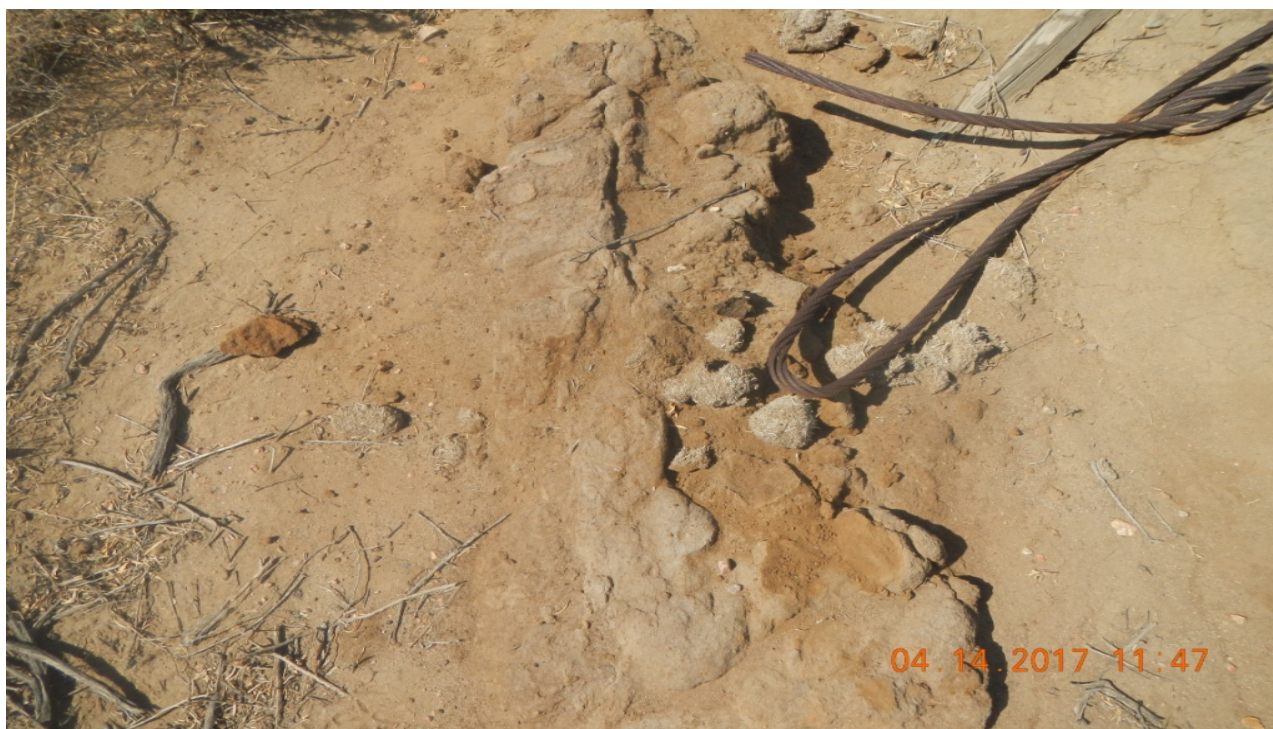
**photo 4:** The soil around the northwest guyline anchor appears to have oil stained soils.
