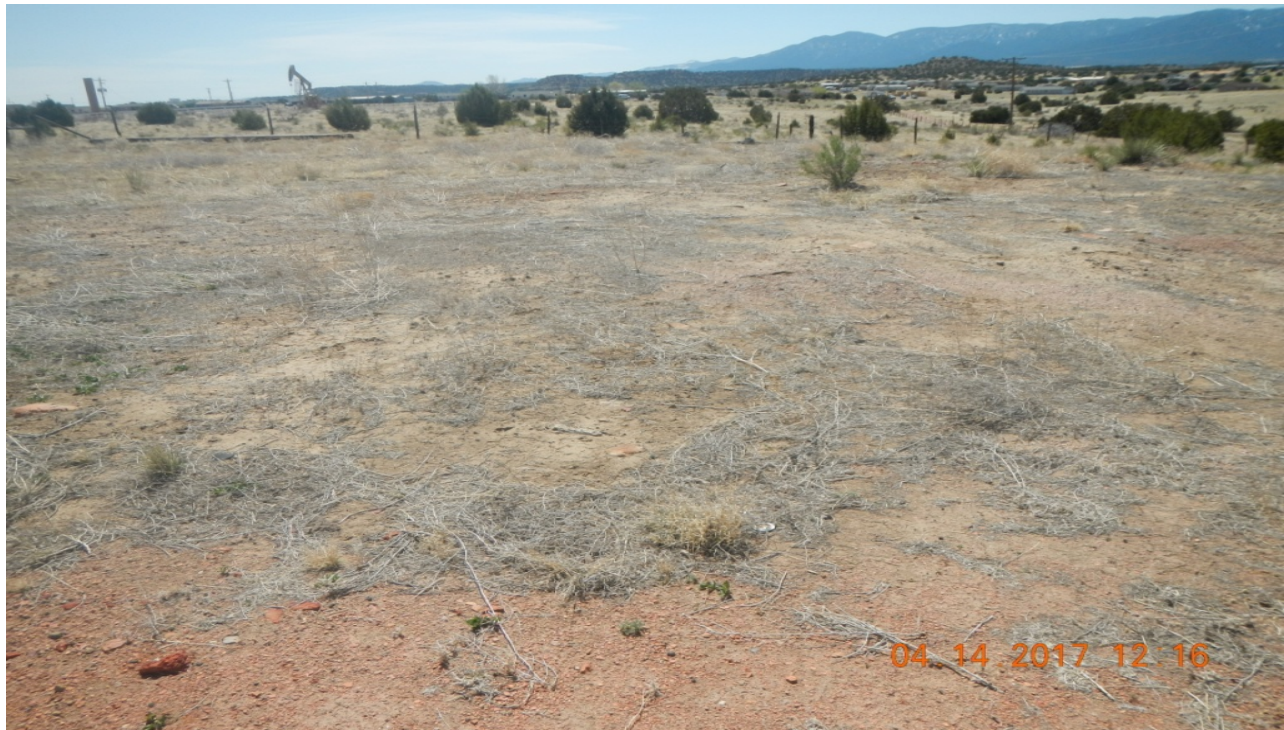
photo 1: Facing south toward the location.

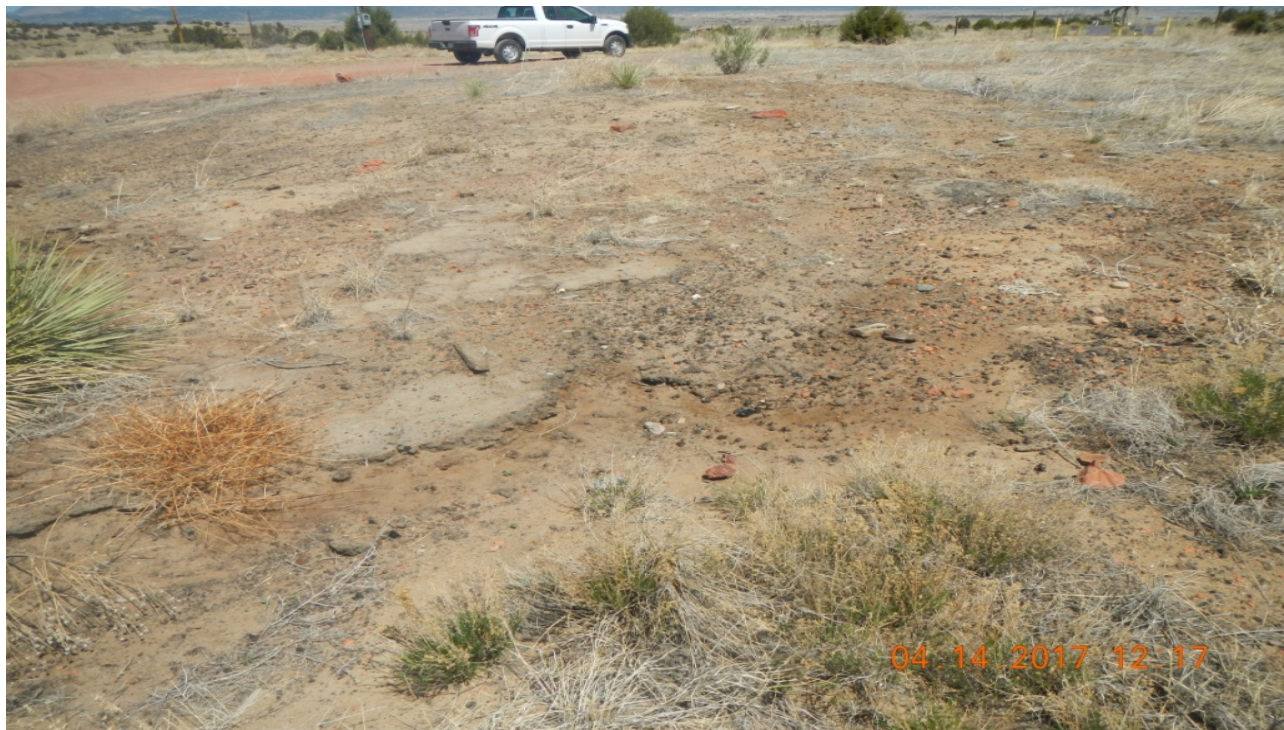
photo 2: Facing north at the location. There is miscellaneous debris throughout the site.

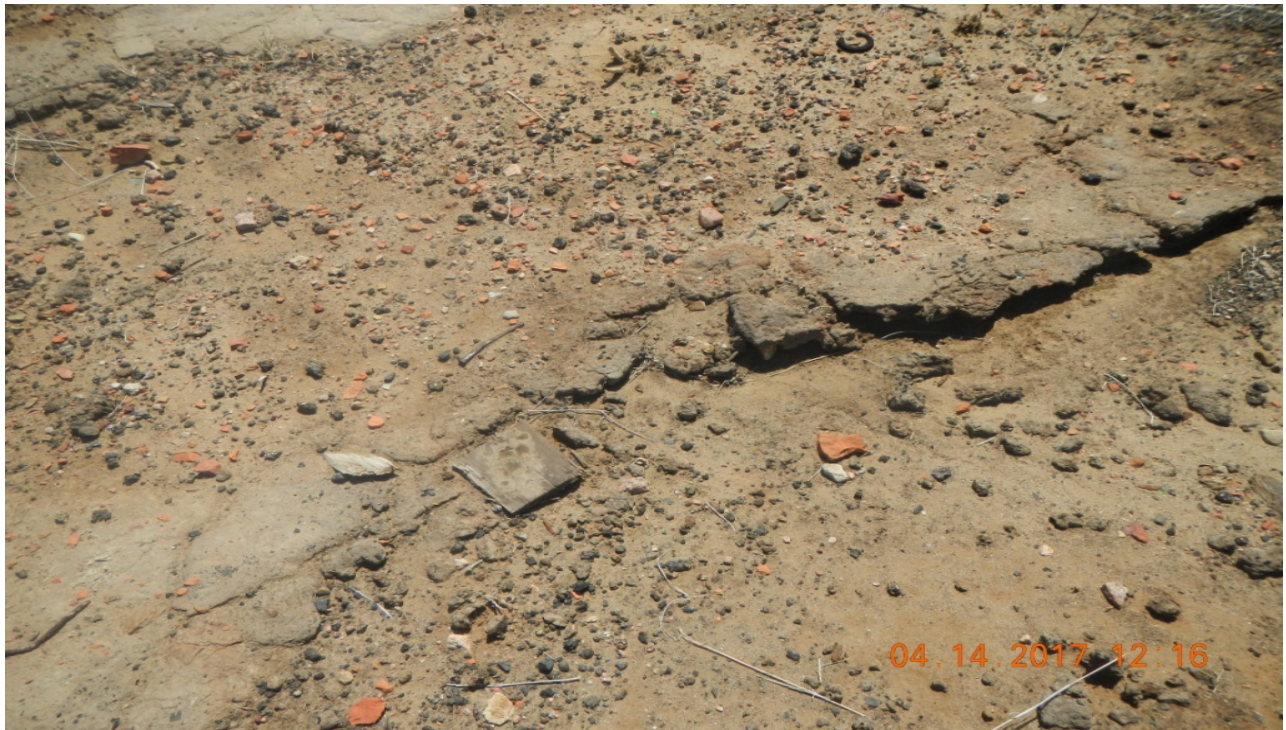
photo 3: There are pieces of concrete and oil stained soils throughout the site.

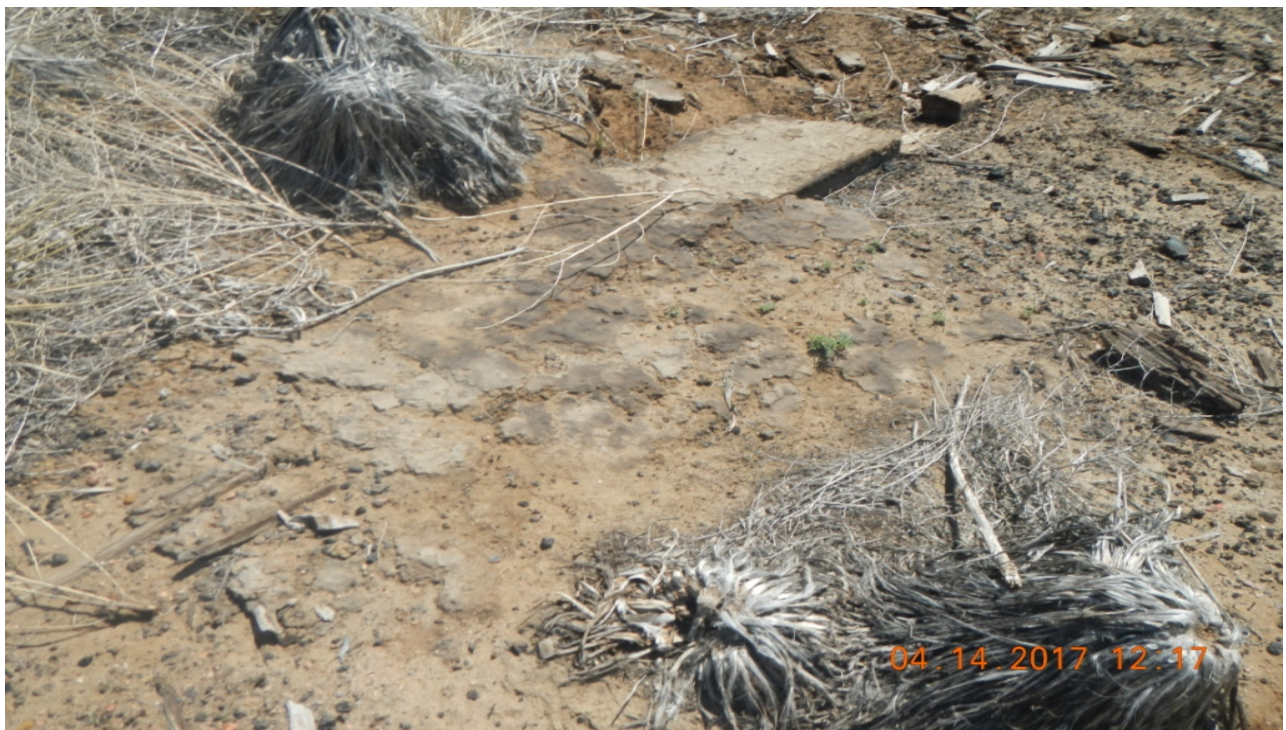
photo 4: Photo shows wooden block and oil stained soils.
