Interim Reclamation Inspection

April 14, 2017

Operator: KERR MCGEE OIL & GAS ONSHORE LP #47120

Location Name: RISSLER STATE /4N-36HZ

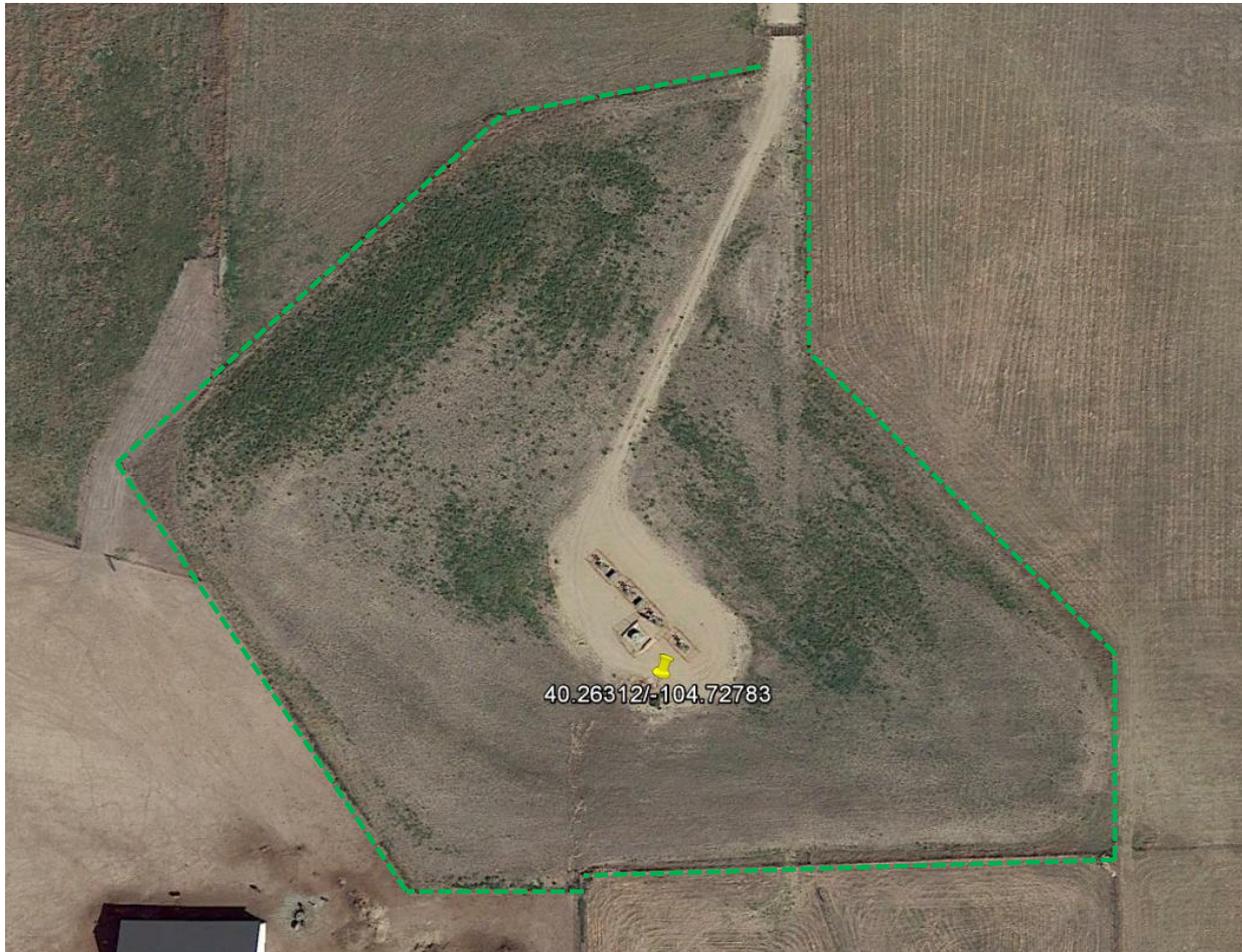
Google Earth aerial imagery taken September 7, 2016 illustrating the Rissler State location (outlined in the green dashed line). Green foliage observed inside the location appears to be Russian thistle (*Salsola tragus*) growth.

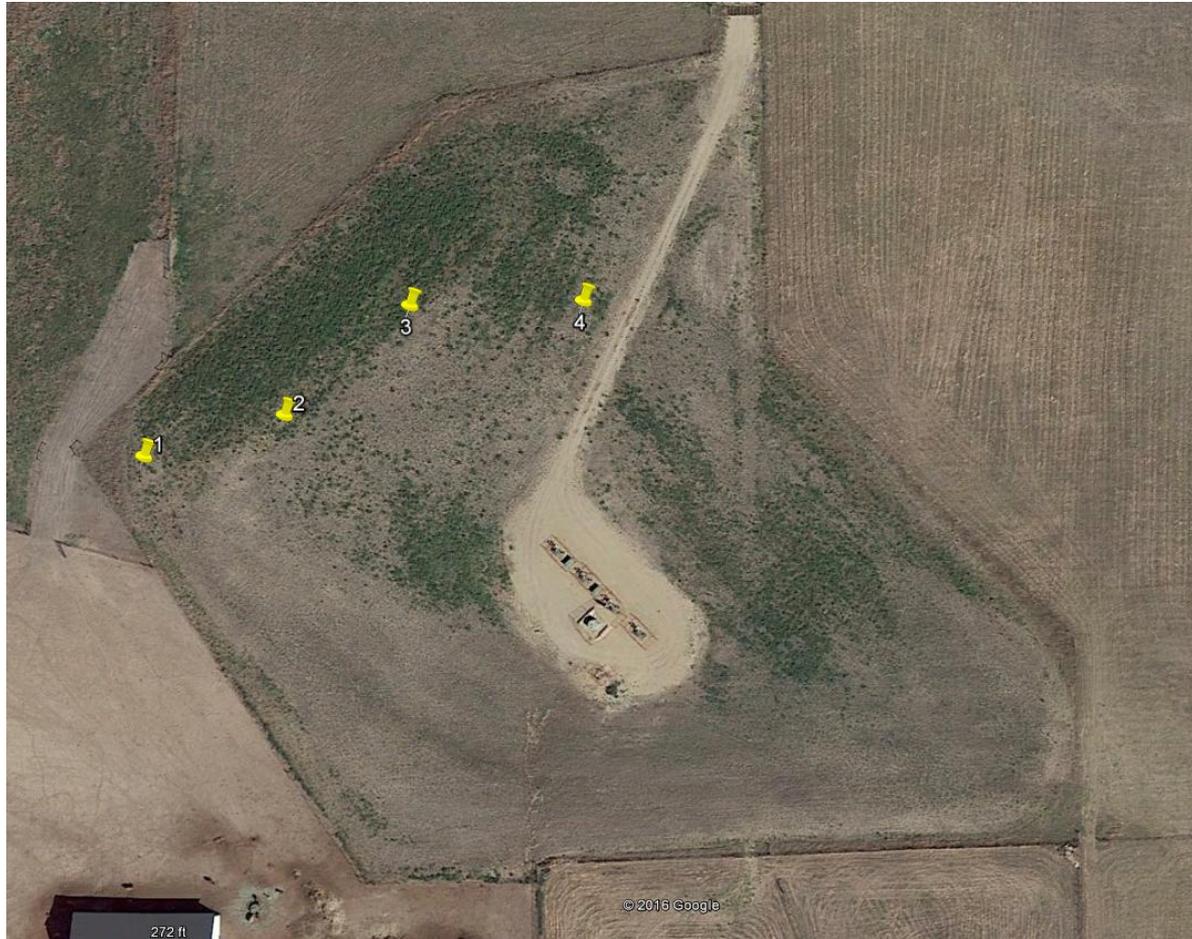
Google Earth aerial imagery taken September 7, 2016 illustrating the Rissler State location. Point markers 1-4 were taken on April 14, 2017 along the eastern perimeter of the observed dense stand of Russian thistle. Note there was Russian thistle observed along other portions of the interim area.

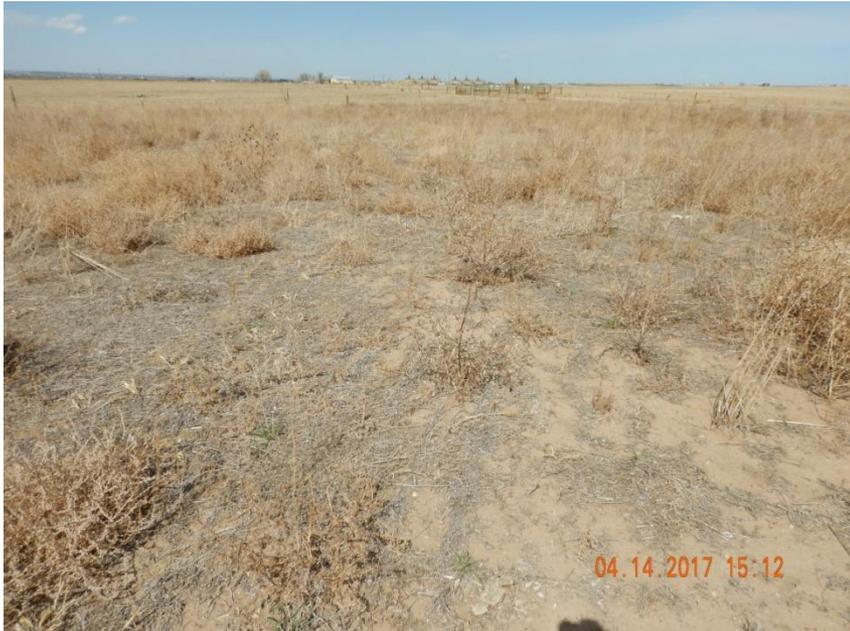
Photo 1. Photo taken from the northwestern interim area, facing North. Russian thistle observed throughout the northwestern location. Some germination was observed amongst the Russian thistle growth.

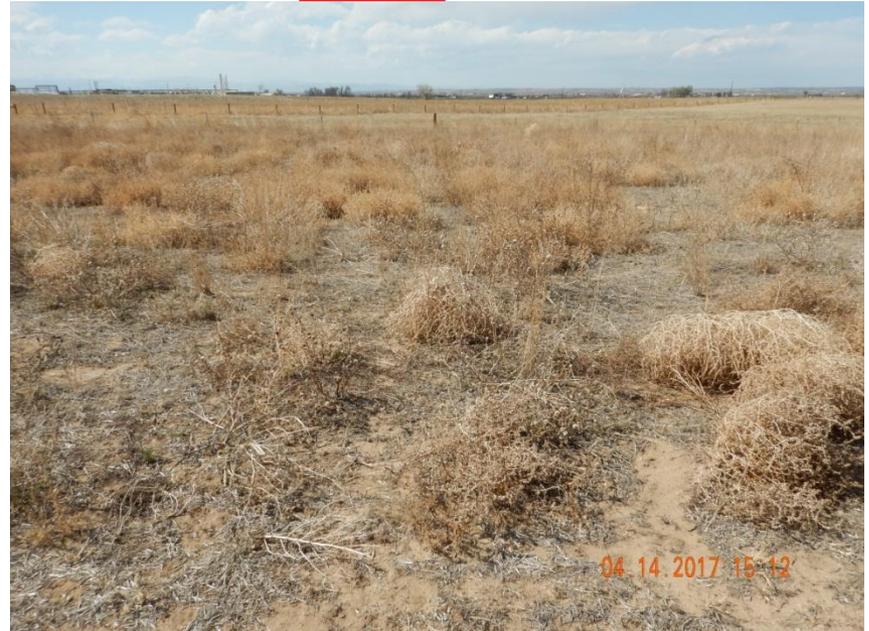
Photo 2. Photo taken from the previous photo location, facing West. Russian thistle observed throughout the northwestern location. Some germination was observed amongst the Russian thistle growth.

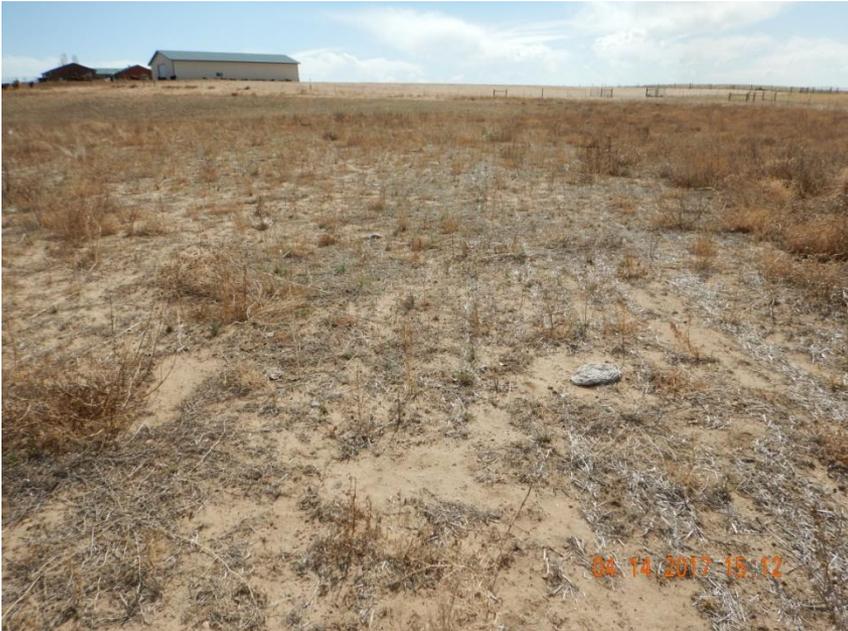
Photo 3. Photo taken from the previous photo location, facing South. Russian thistle observed throughout the northwestern location. Some germination was observed amongst the Russian thistle growth.

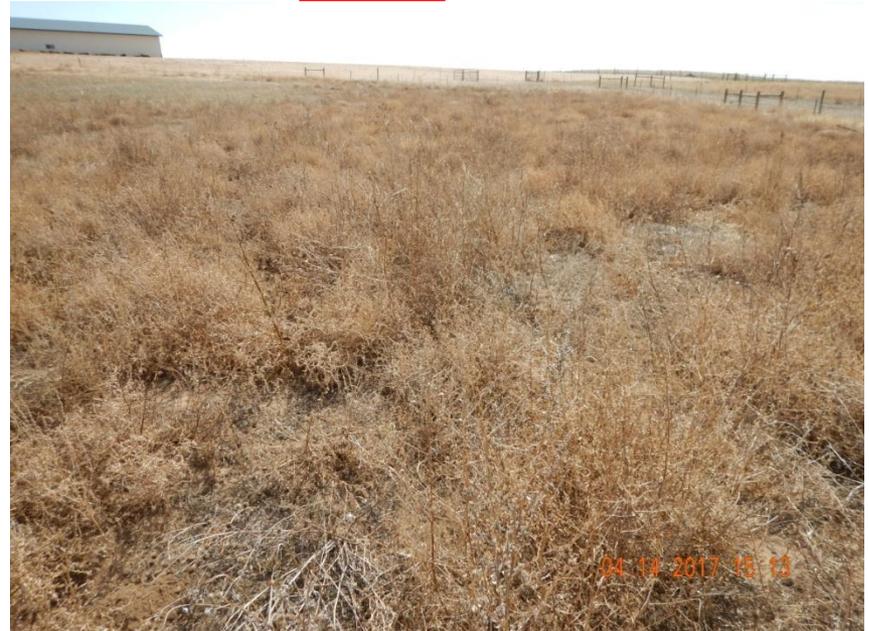
Photo 4. Photo taken from the northwestern interim area inside the Russian thistle growth area, facing South. Operator needs to perform weed management to remove Russian thistle but shall limit the seed dispersal during the removal process.

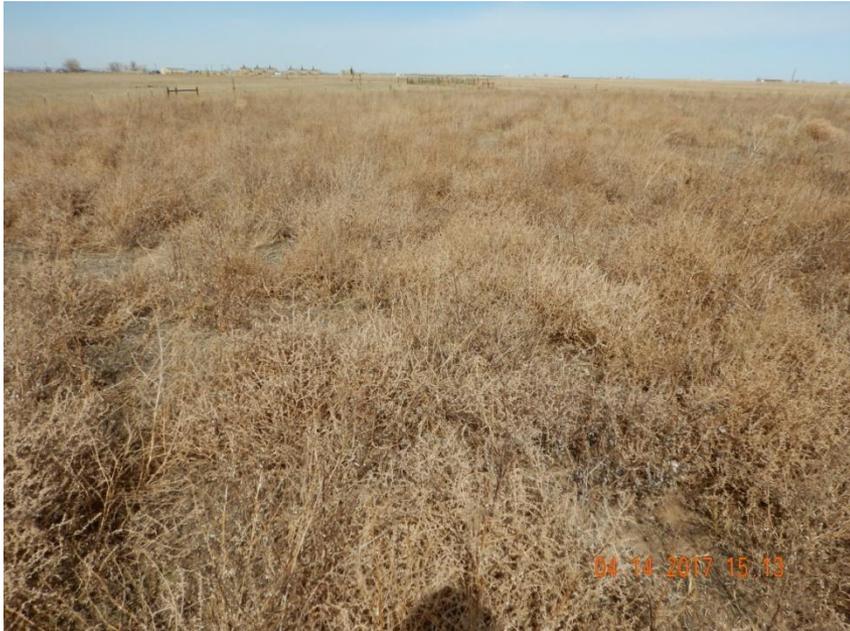
Photo 5. Photo taken from the northwestern interim area inside the Russian thistle growth area, facing North. Operator needs to perform weed management to remove Russian thistle but shall limit the seed dispersal during the removal process.

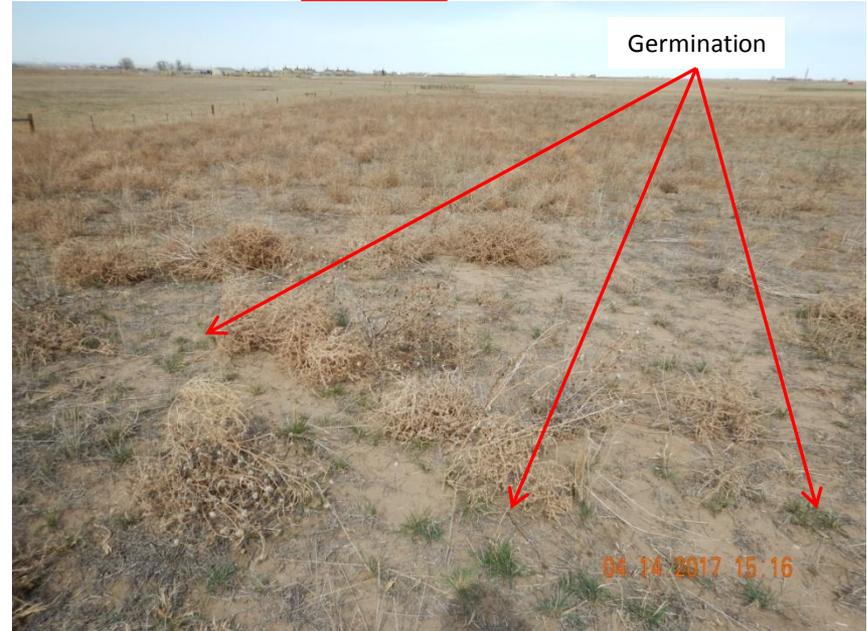
Photo 6. Photo taken from the western interim area, facing North towards the previous Russian thistle area. Germination was apparent outside the Russian thistle area but germination does not appear uniform along portions of the interim area at the time of this inspection.

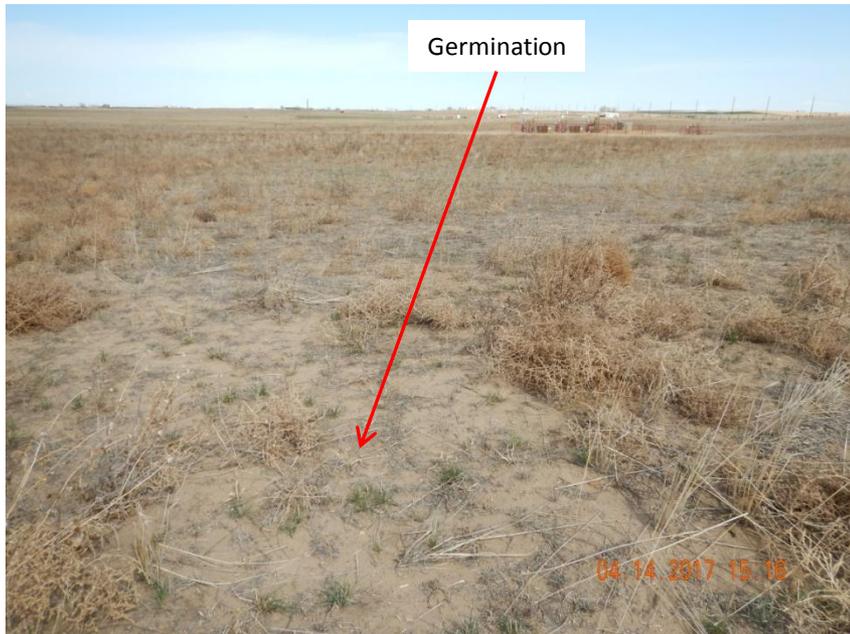
Photo 7. Photo taken from the previous photo location, facing Northeast. Germination was apparent outside the Russian thistle area but germination does not appear uniform along portions of the interim area at the time of this inspection.

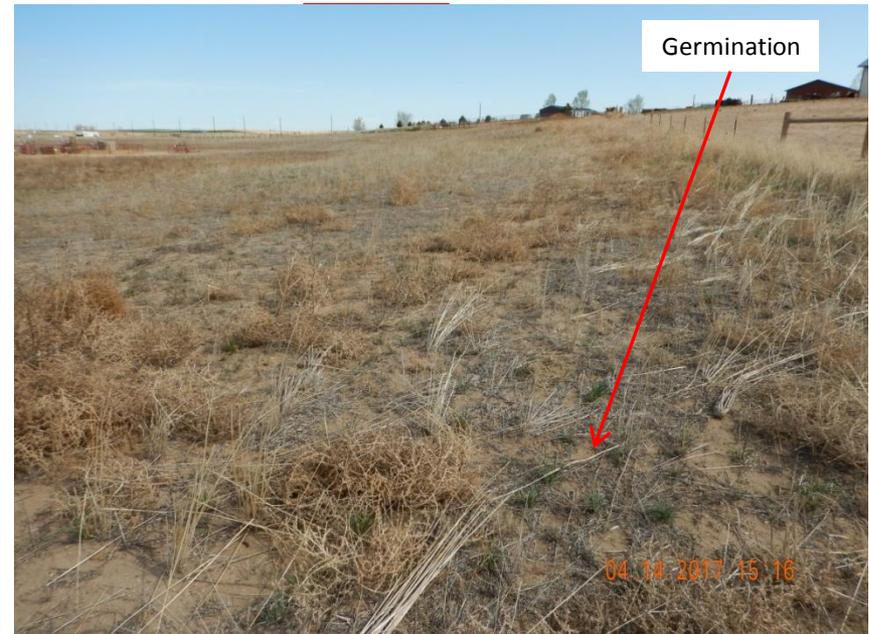
Photo 8. Photo taken from the previous photo location, facing East. Germination was apparent outside the Russian thistle area but germination does not appear uniform along portions of the interim area at the time of this inspection.

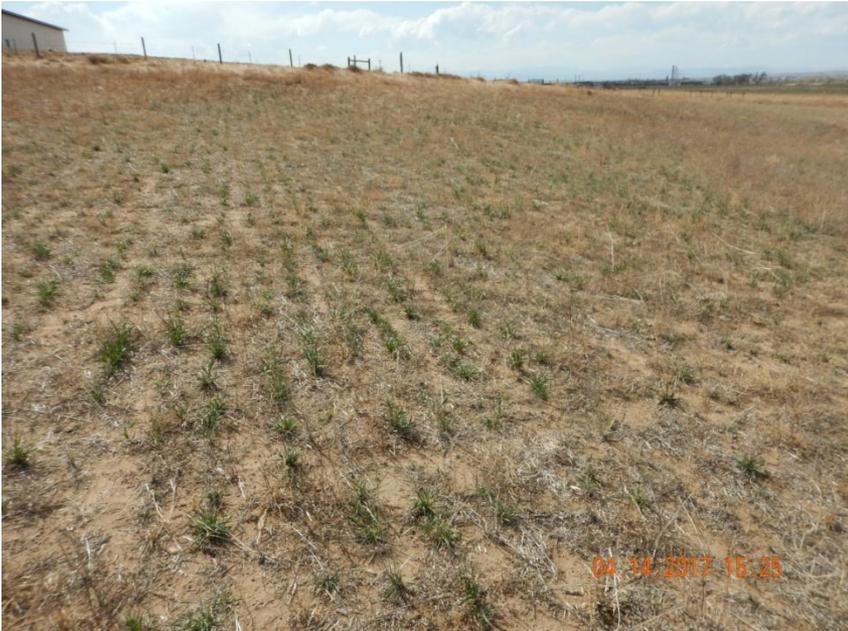
Photo 9. Photo taken from the southwestern interim area, facing West. Germination apparent throughout this area and appears to have uniform germination.

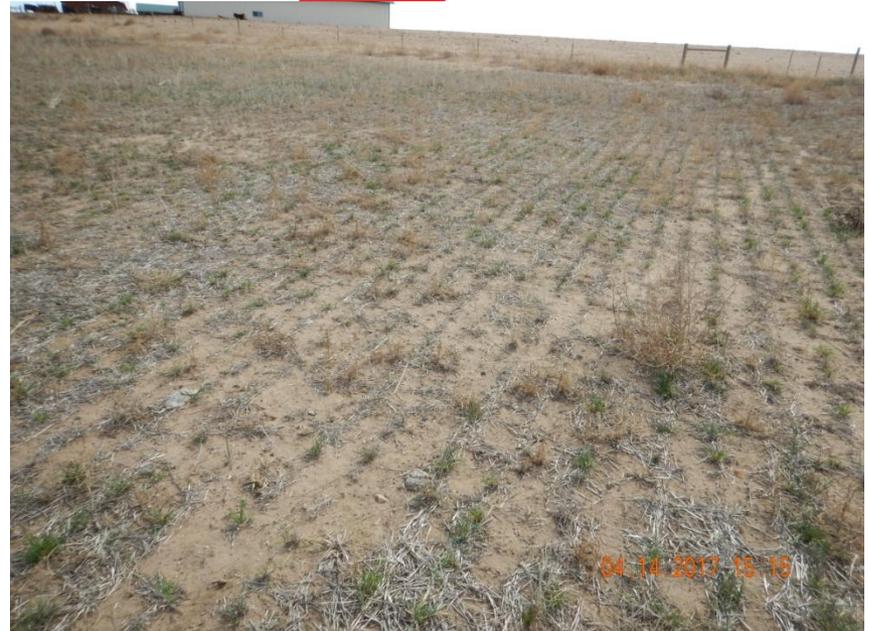
Photo 10. Photo taken from the southwestern interim area, facing South. Germination apparent throughout this area and appears to have uniform germination.

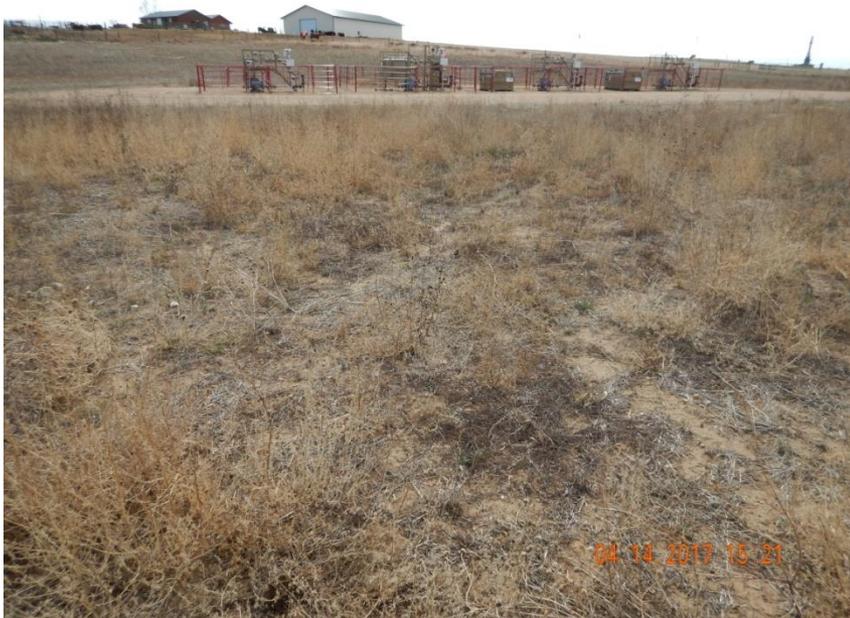
Photo 11. Photo taken north of the wellheads from the interim area, facing Southwest. Sparse to no germination was observed along portions of the eastern interim area.

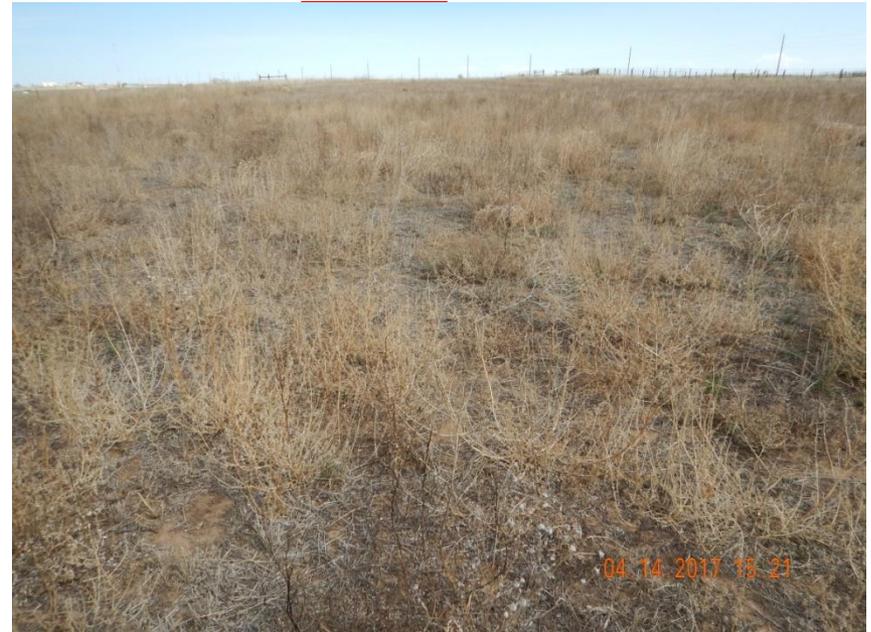
Photo 12. Photo taken from the previous photo location, facing Southeast. Sparse to no germination was observed along portions of the eastern interim area.

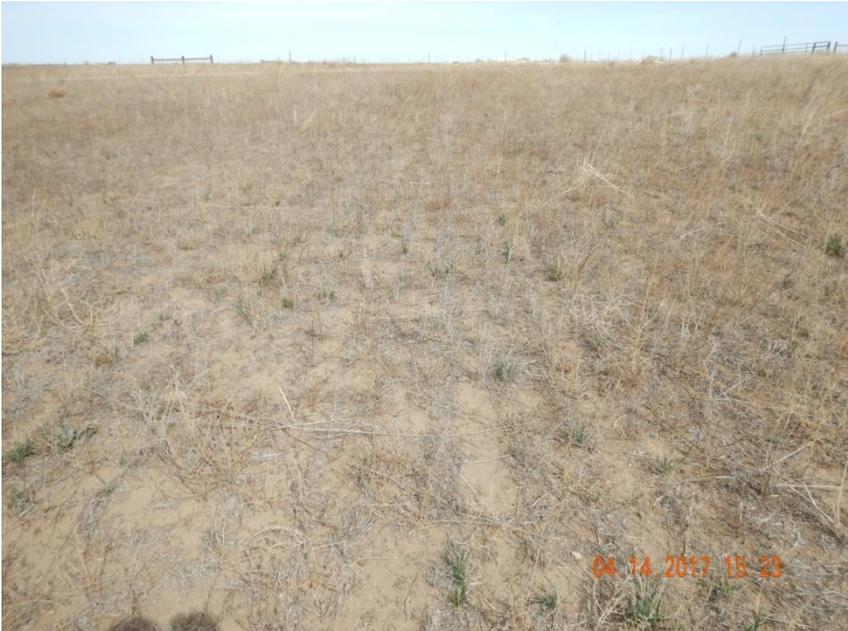
Photo 13. Photo taken from the southeastern interim area, facing East. Some germination was observed but germination does not appear uniform along portions of the interim area at the time of this inspection.

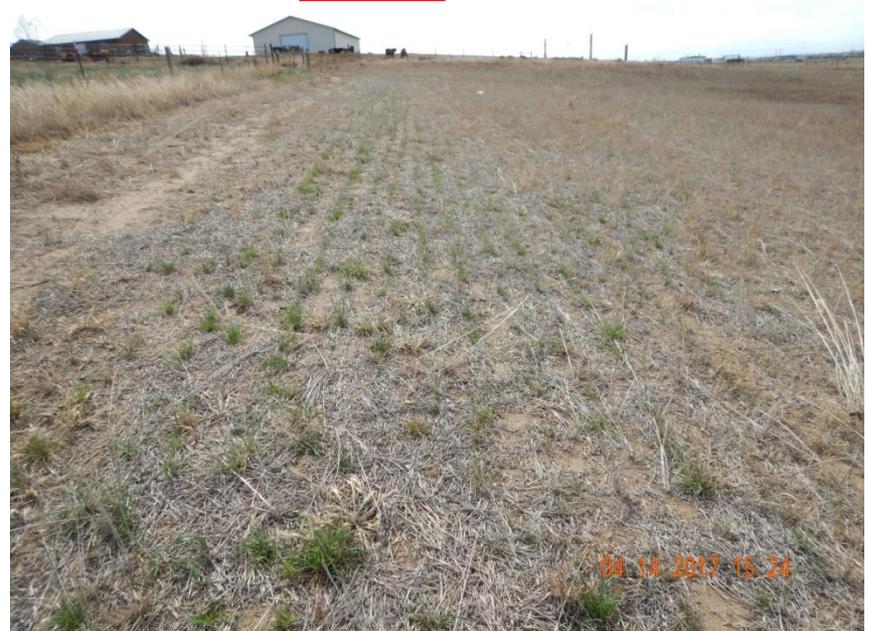
Photo 14. Photo taken from the previous photo location, facing West. Germination appears to be more uniform along the southern interim area.

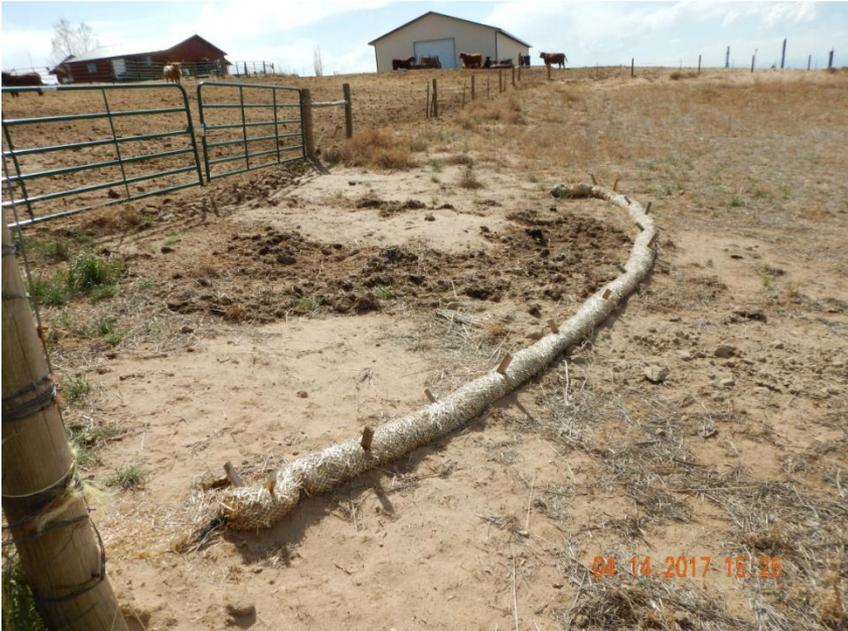
Photo 15. Photo taken from the southern location, facing West. Wattle BMPs installed to control run-on onto the interim area. Portions where erosion was previously observed still lack germination growth.

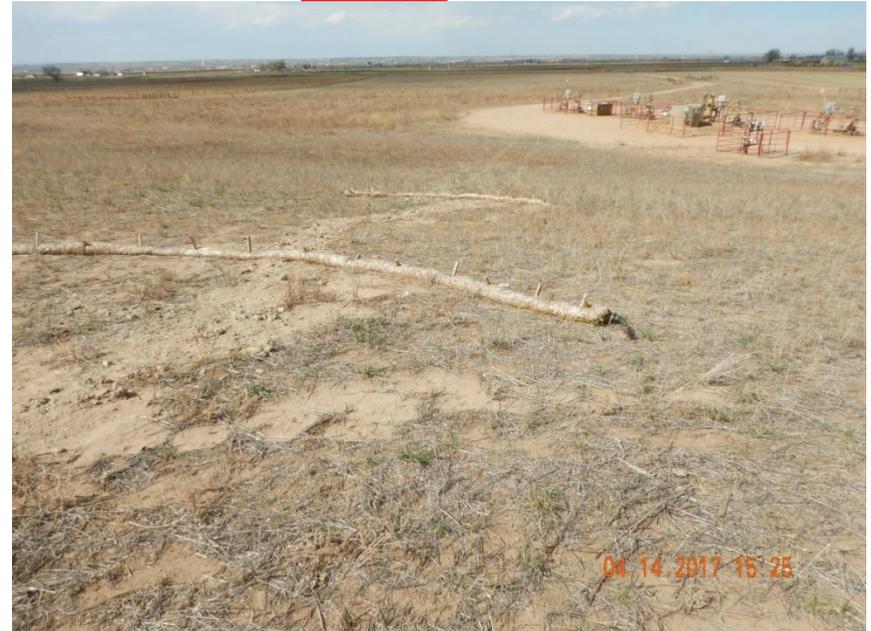
Photo 16. Photo taken from the previous photo location, facing North. A series of wattle BMPs have been installed to control run-on onto the interim area. Portions where erosion was previously observed still lack germination growth.
