Construction and Stormwater Inspection

April 12, 2017

Operator: BURLINGTON RESOURCES OIL & GAS LP- #26580

Location ID: 443722

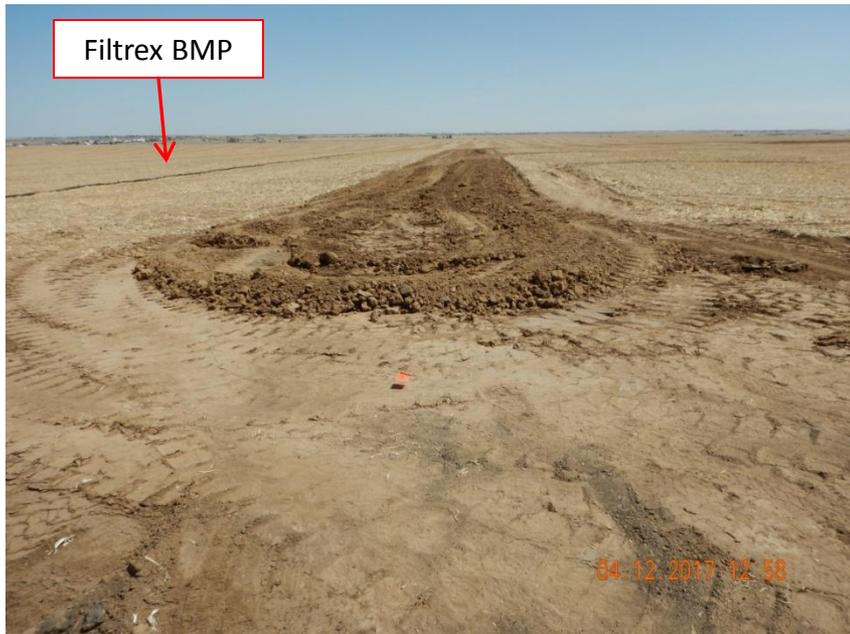
Photo 1. Photo taken from the access point off North Haysmount Road, facing East. Topsoil has been stripped off from the access road and subsoil material is being used to build up the access road. Temporary stormwater BMP installed along the north, east, and south of the location in the form of a filtrex wattle.

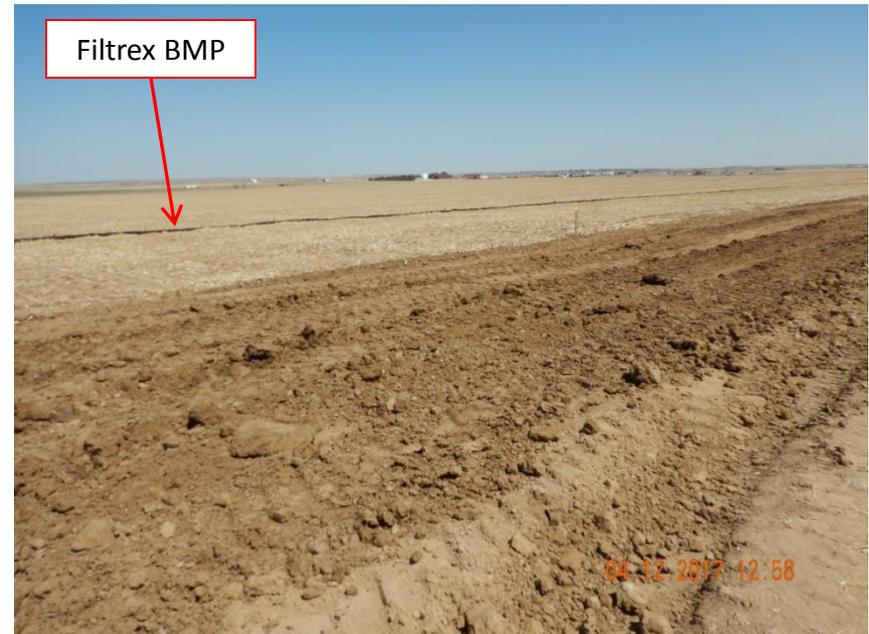
Photo 2. Photo taken from the access road, facing Northeast. Topsoil has been stripped off from the access road and subsoil material is being used to build up the access road. Temporary stormwater BMP installed along the north, east, and south of the location in the form of a filtrex wattle.

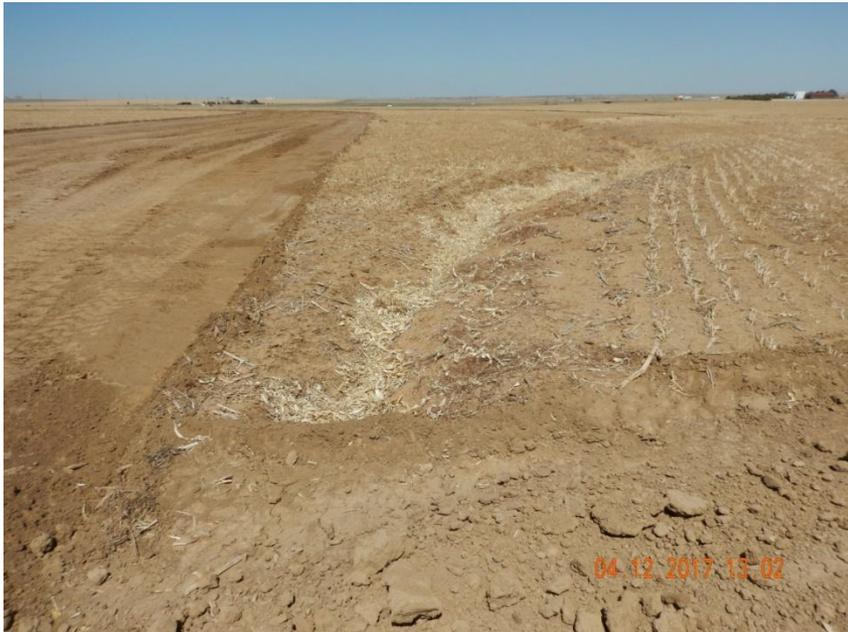
Photo 3. Photo taken along the northern location perimeter and the intersection of the eastern access point, facing North. Photo illustrates swale area where potential stormwater runoff would likely flow.

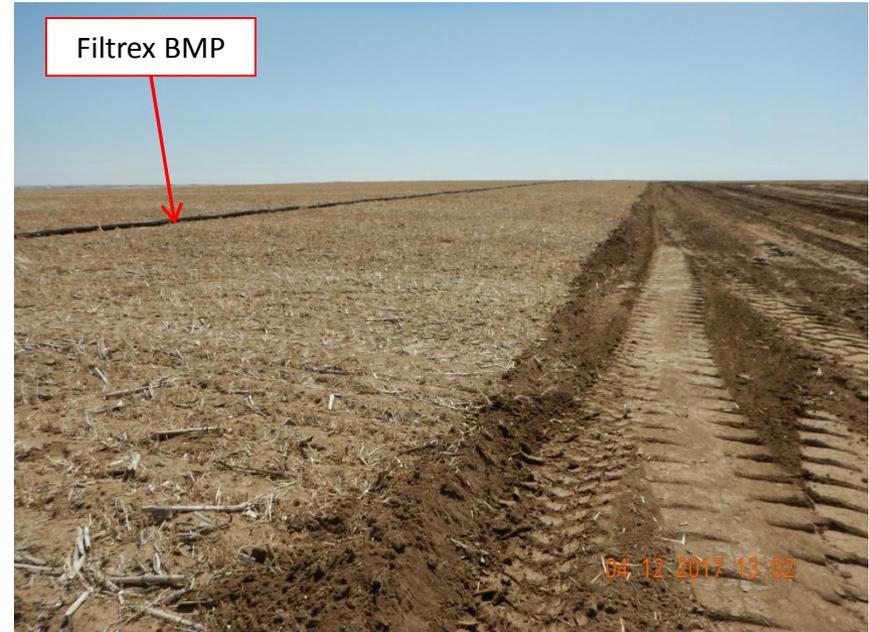
Photo 4. Photo taken from the eastern perimeter of the location, facing South. Topsoil is in the process of being salvaged. Topsoil did not appear to be evenly salvaged throughout portions of the location. Temporary stormwater BMP installed along the north, east, and south of the location in the form of a filtrex wattle.

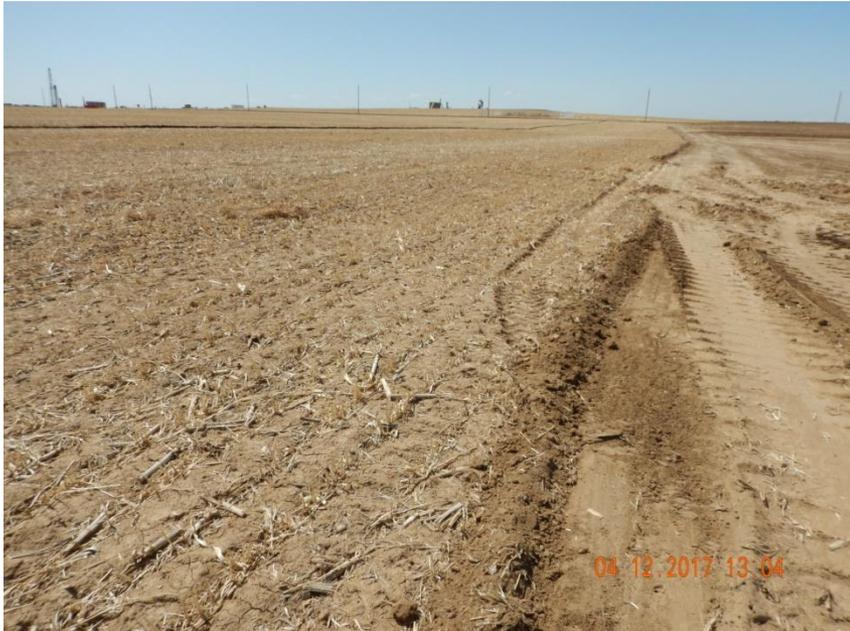
Photo 5. Photo taken from the southern perimeter of the location, facing West. Topsoil is in the process of being salvaged. Topsoil did not appear to be evenly salvaged throughout portions of the location. Temporary stormwater BMP installed along the north, east, and south of the location in the form of a filtrex wattle.

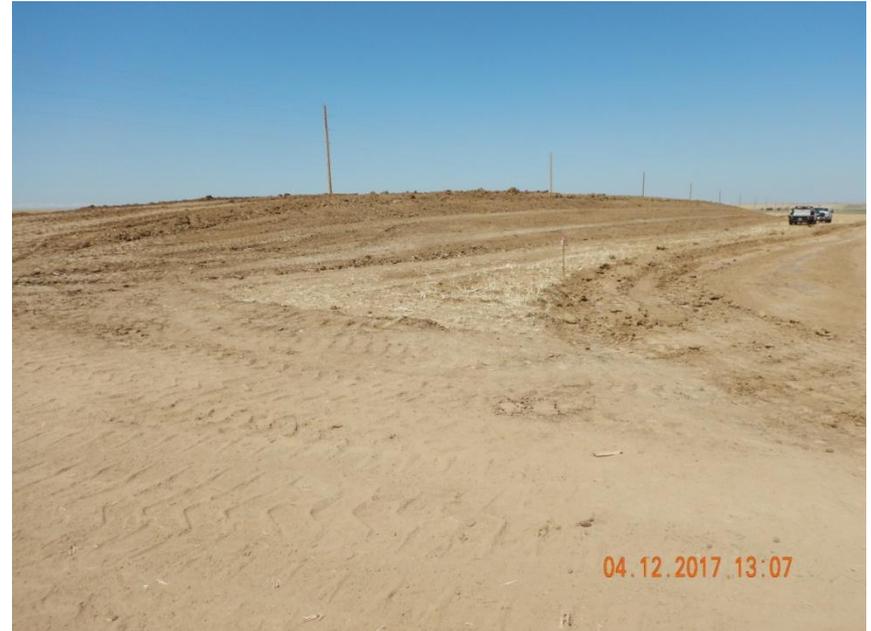
Photo 6. Photo taken from the southern location, facing Northwest towards the topsoil stockpile. Topsoil did not appear to be evenly salvaged throughout portions of the location.

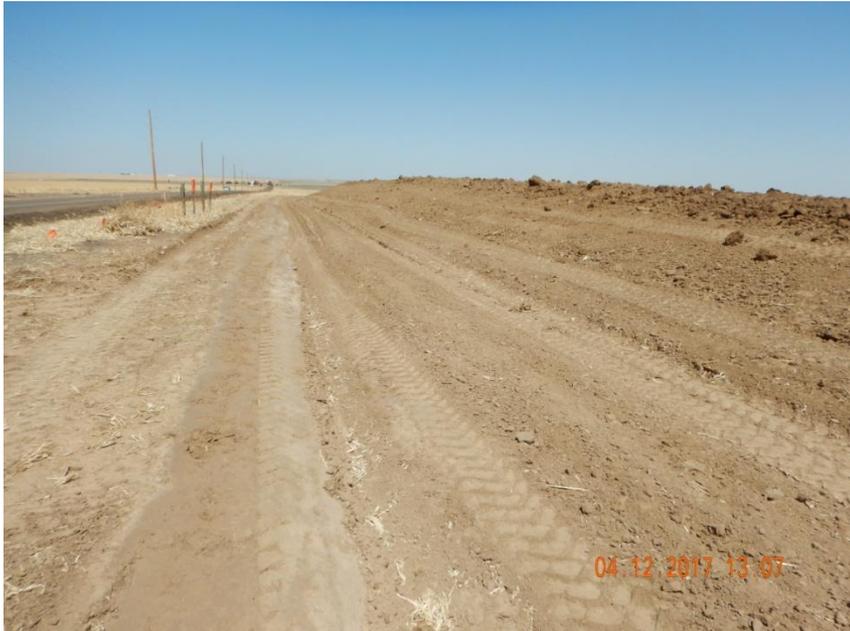
Photo 7. Photo taken from the western perimeter of the location, facing North. Ditch BMP has been installed along the western side of the topsoil stockpile.
