Interim Reclamation Inspection

April 14, 2017

Operator: KERR MCGEE OIL & GAS ONSHORE LP #47120

Location ID: 438023

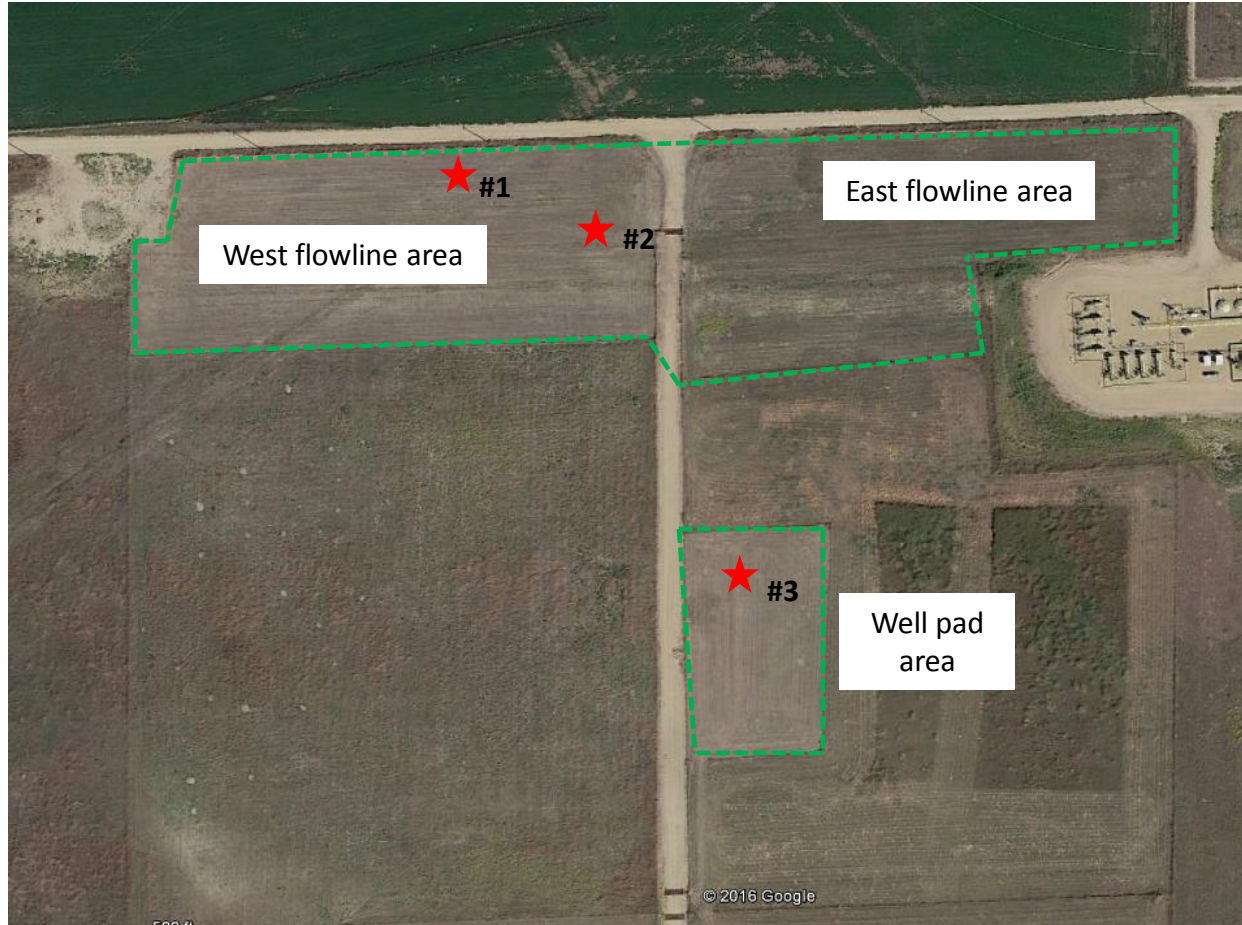
Google Earth aerial imagery taken September 7, 2016 illustrating the flowline area and well pad that are the subject areas for this follow up interim reclamation inspection (outlined in the green dashed line). Approximate locations of each germination assessment (red star) .

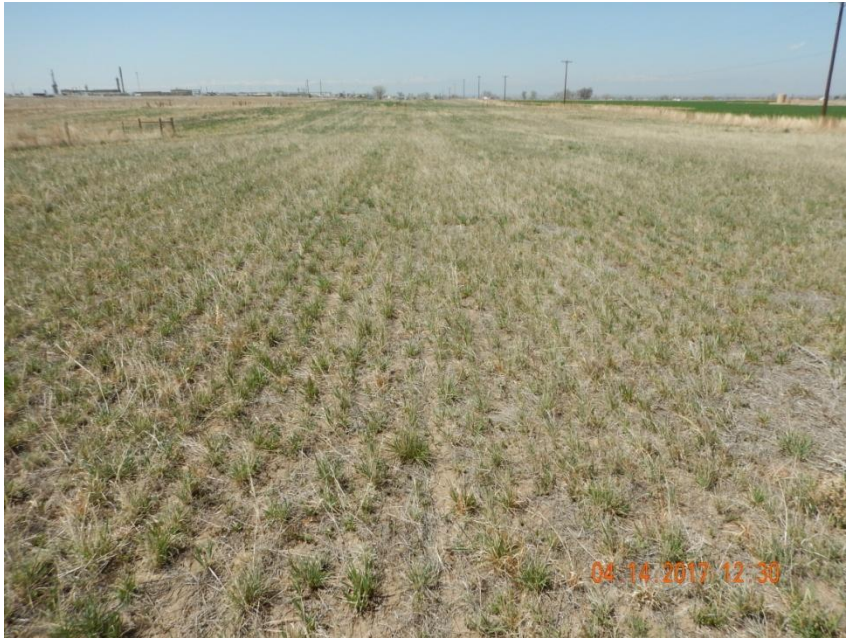
Photo 1. Photo taken from the eastern, east flowline area, facing West. Germination apparent throughout this area and appears to have uniform germination.

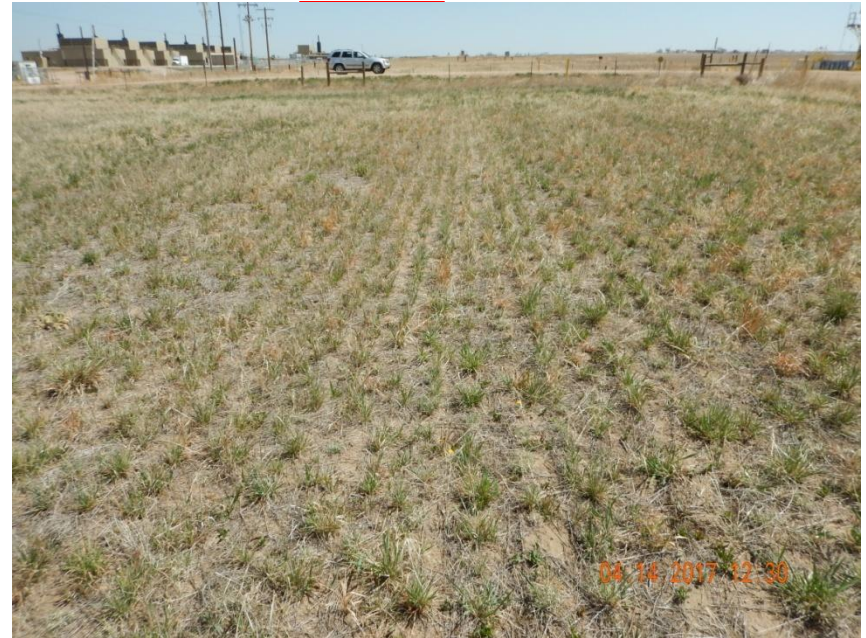
Photo 2. Photo taken from the previous photo location, facing East. Germination apparent throughout this area and appears to have uniform germination.

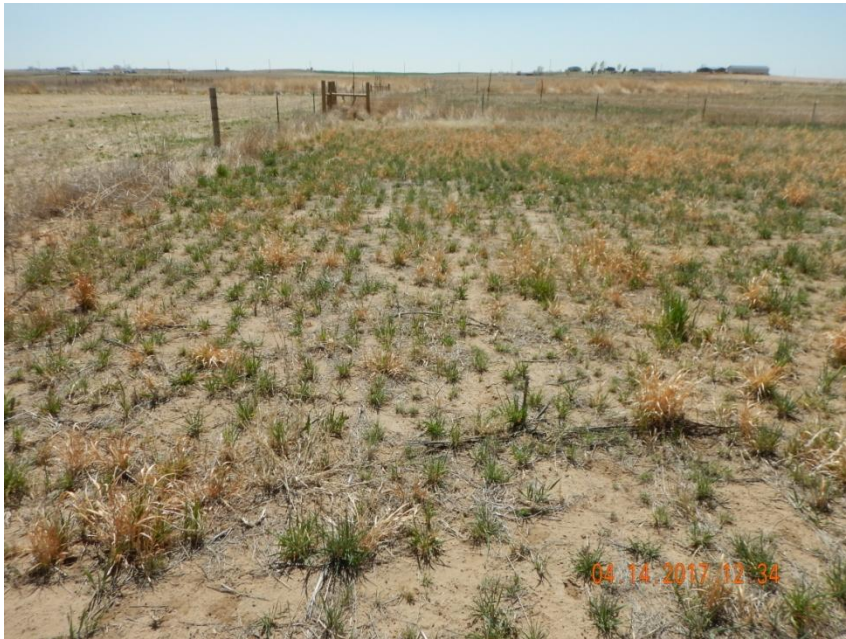
Photo 3. Photo taken from the southeastern, east flowline area, facing South. Germination apparent throughout this area and appears to have uniform germination.

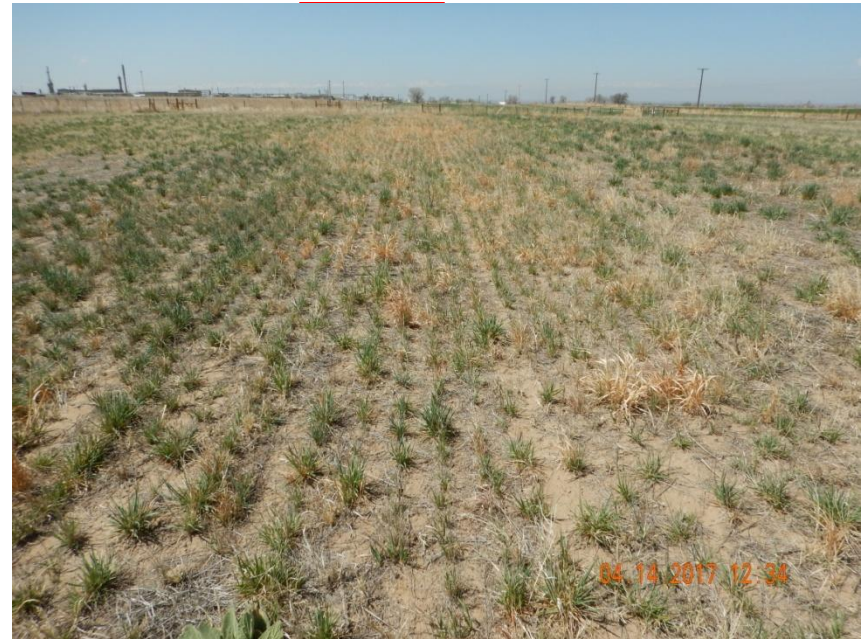
Photo 4. Photo taken from the previous photo location, facing East. Germination apparent throughout this area and appears to have uniform germination.

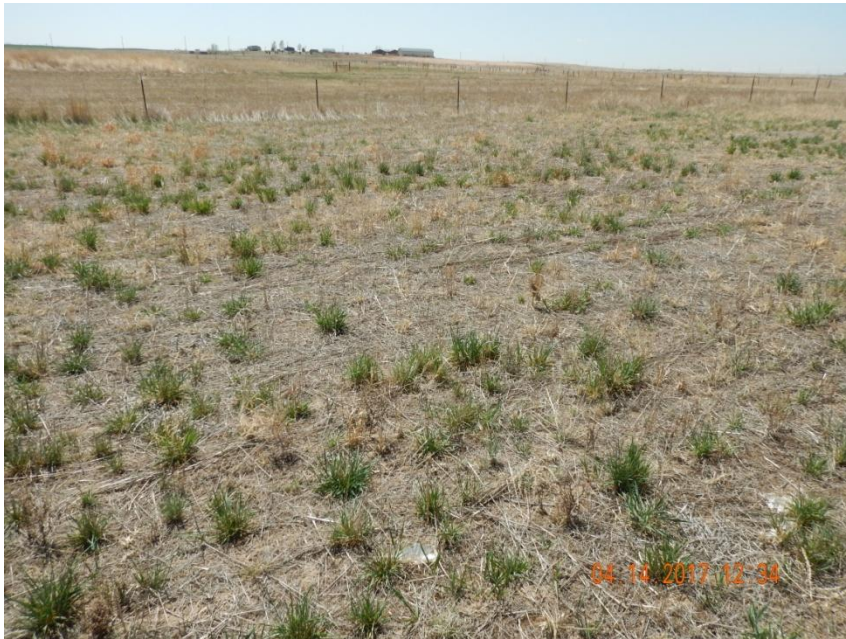
Photo 5. Photo taken from the southern, east flowline area, facing Southwest. The obvious green grass seedlings observed in this photo are likely cool season species; whereas, the warm season grass species are harder to observe but still apparent. Sandbur was observed in higher abundance along this area.

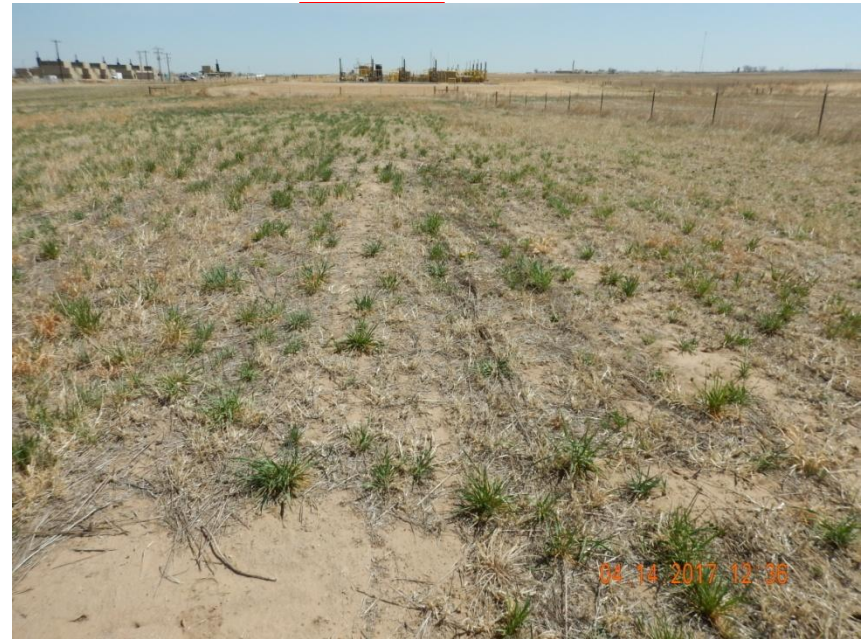
Photo 6. Photo taken from the southwest, east flowline area, facing East. The obvious green grass seedlings observed in this photo are likely cool season species; whereas, the warm season grass species are harder to observe but still apparent. Sandbur was observed in higher abundance along this area.

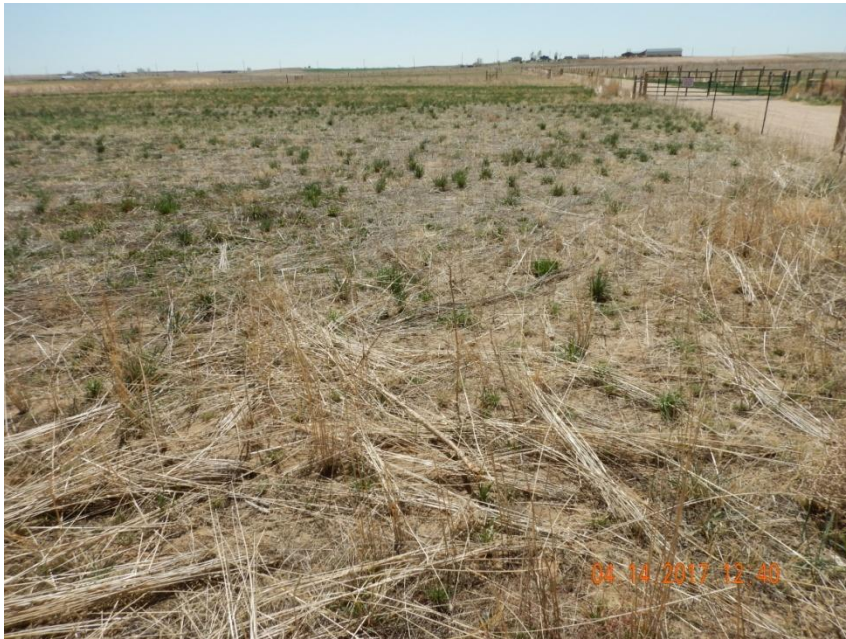
Photo 7. Photo taken from the northwest, east flowline area, facing South. The obvious green grass seedlings observed in this photo are likely cool season species; whereas, the warm season grass species are harder to observe but still apparent. Sandbur was observed in higher abundance along this area.

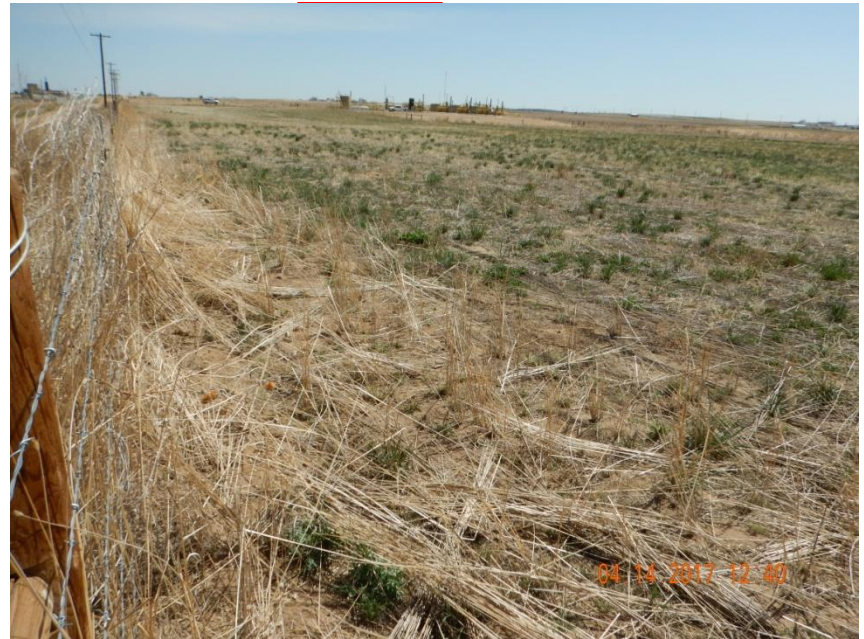
Photo 8. Photo taken from the previous photo location, facing East. The obvious green grass seedlings observed in this photo are likely cool season species; whereas, the warm season grass species are harder to observe but still apparent. Sandbur was observed in higher abundance along this area.

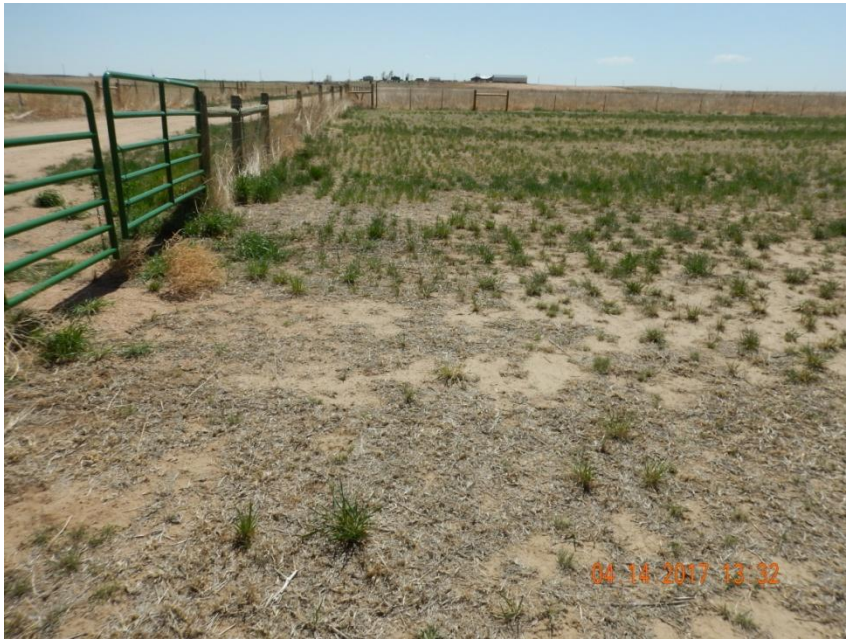
Photo 9. Photo taken from the east, west flowline area, facing South. The obvious green grass seedlings observed in this photo are likely cool season species. Germination was not as apparent along this area and sandbur was observed along this area.

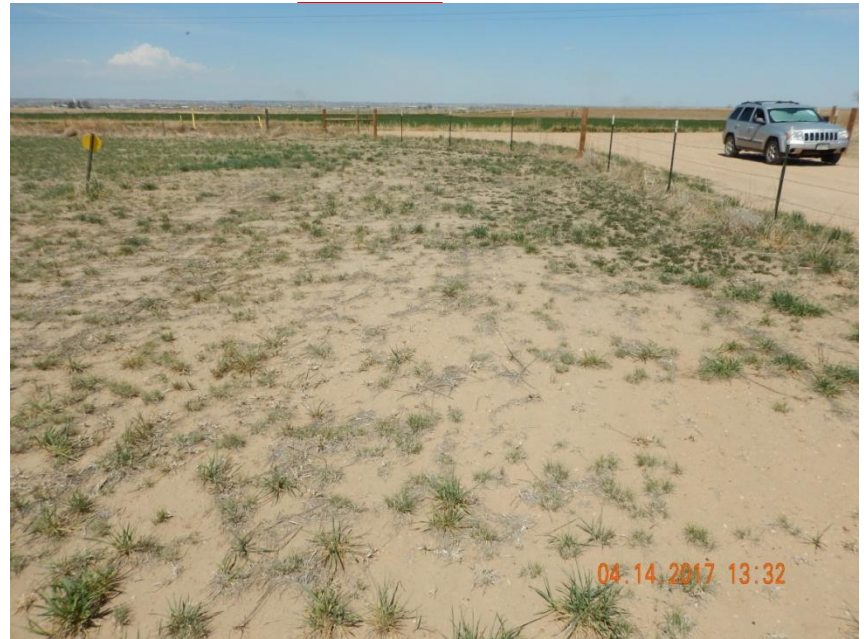
Photo 10. Photo taken from the previous photo location, facing North. The obvious green grass seedlings observed in this photo are likely cool season species. Germination was not as apparent along this area and sandbur was observed along this area.

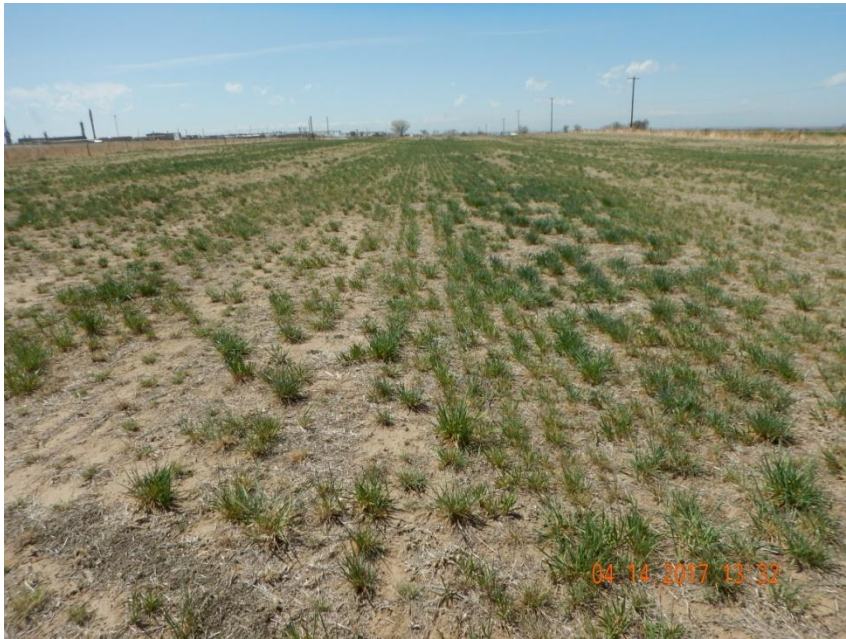
Photo 11. Photo taken from the eastern, west flowline area, facing West. The obvious green grass seedlings observed in this photo are likely cool season species; whereas, the warm season grass species are harder to observe but still apparent.

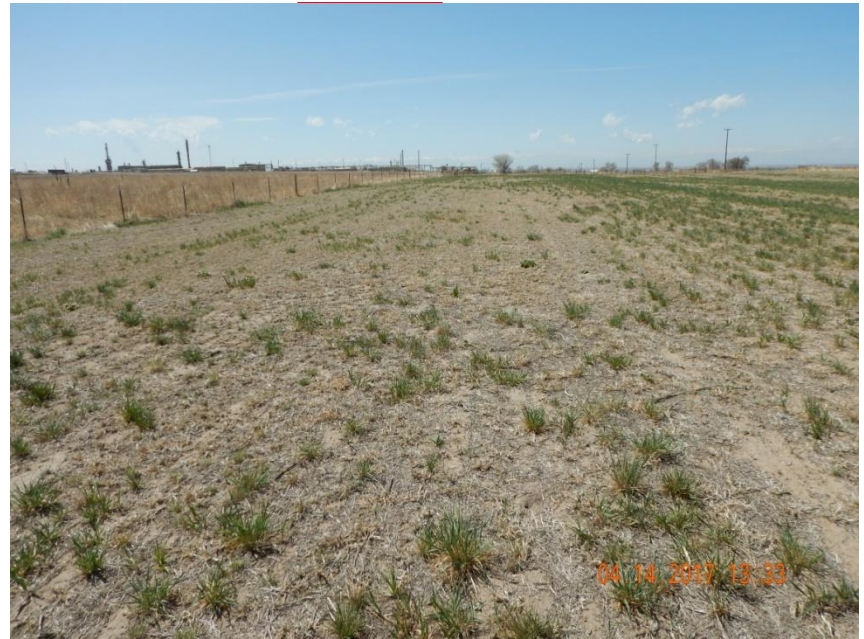
Photo 12. Photo taken from the southeastern, west flowline area, facing West. The obvious green grass seedlings observed in this photo are likely cool season species; whereas, the warm season grass species are harder to observe but still apparent. Sandbur was observed in higher abundance along this area.

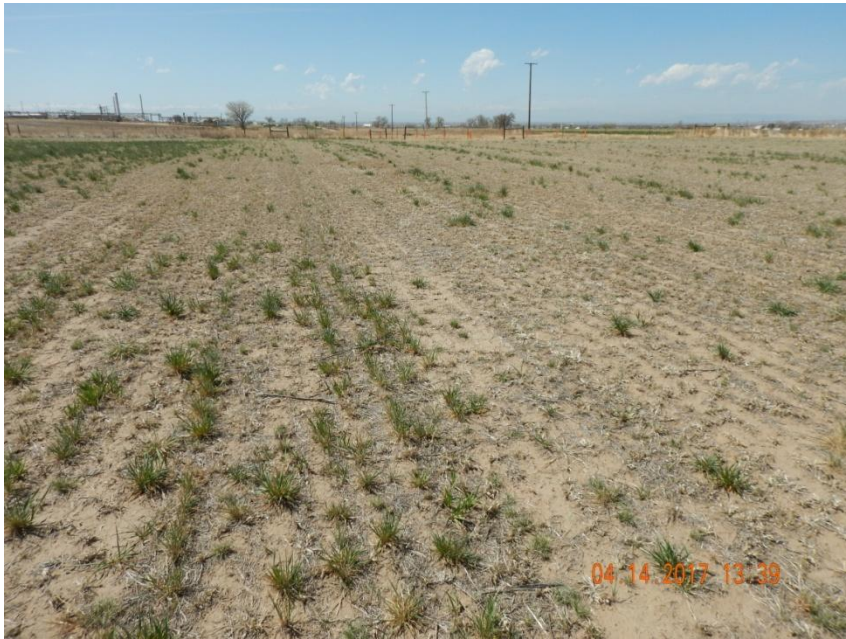
Photo 13. Photo taken from the central, west flowline area, facing West. The obvious green grass seedlings observed in this photo are likely cool season species; whereas, the warm season grass species are harder to observe but still apparent.

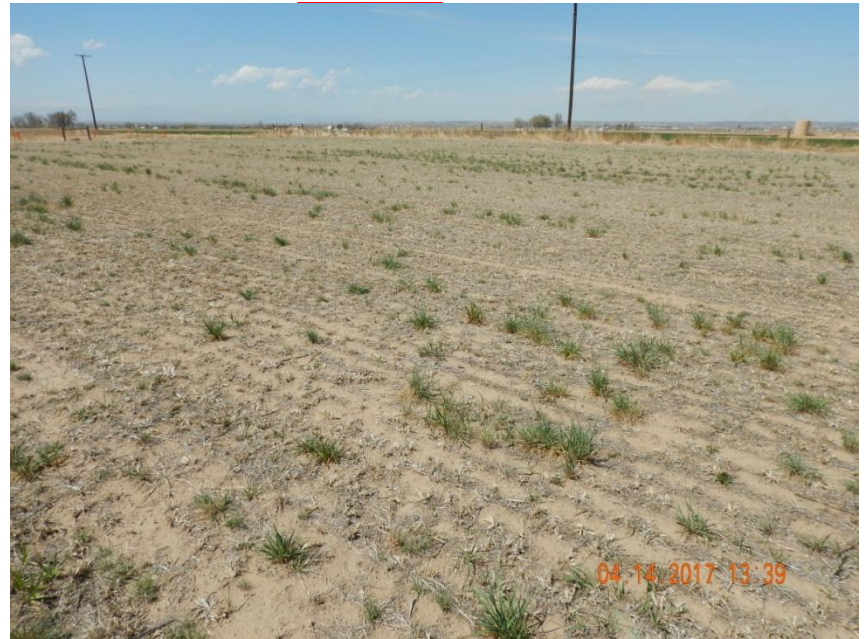
Photo 14. Photo taken from the previous photo location, facing Northwest. The obvious green grass seedlings observed in this photo are likely cool season species; whereas, the warm season grass species are harder to observe but still apparent.

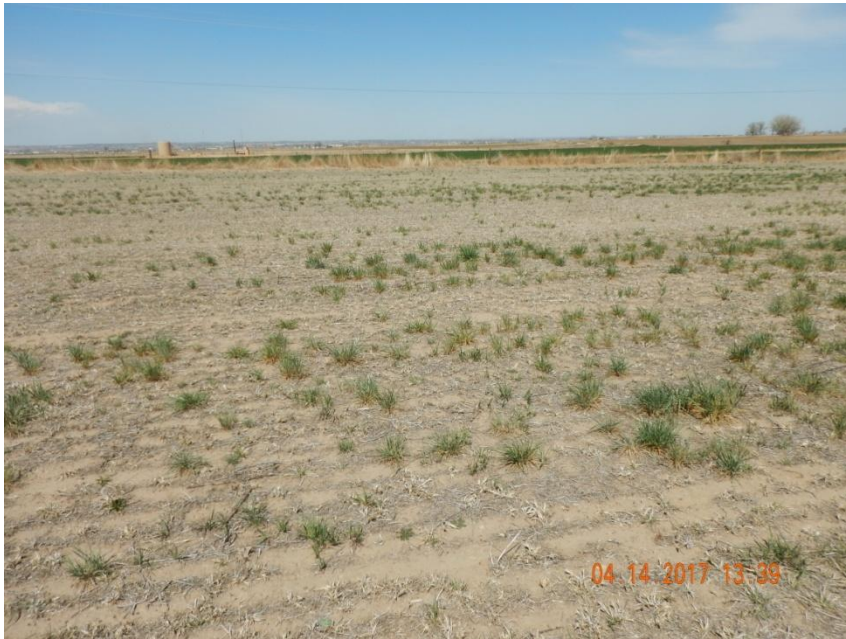
Photo 15. Photo taken from the previous photo location, facing North. The obvious green grass seedlings observed in this photo are likely cool season species; whereas, the warm season grass species are harder to observe but still apparent.

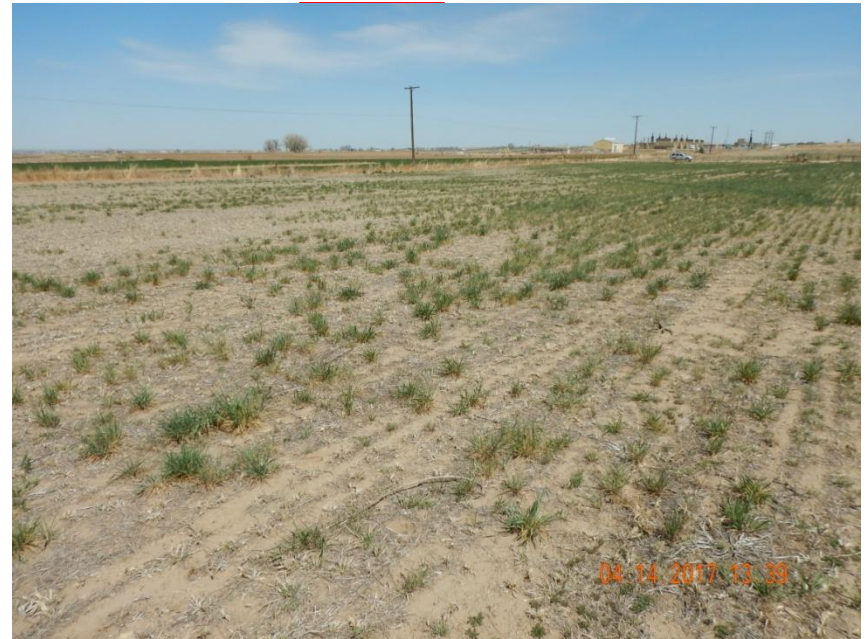
Photo 16. Photo taken from the previous photo location, facing Northeast. The obvious green grass seedlings observed in this photo are likely cool season species; whereas, the warm season grass species are harder to observe but still apparent.

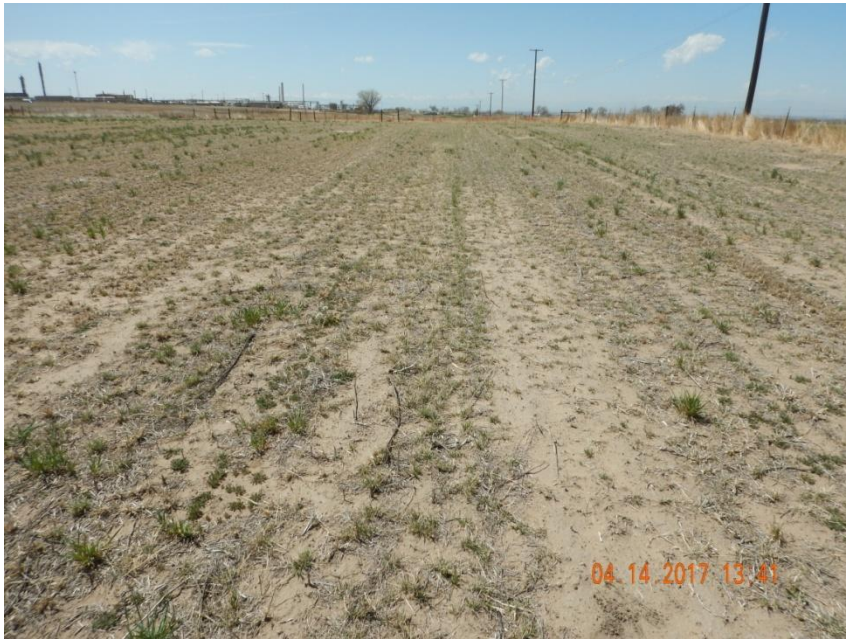
Photo 17. Photo taken from the north central, west flowline area, facing West. Germination does not appear apparent in this photo but germination was observed throughout this area.

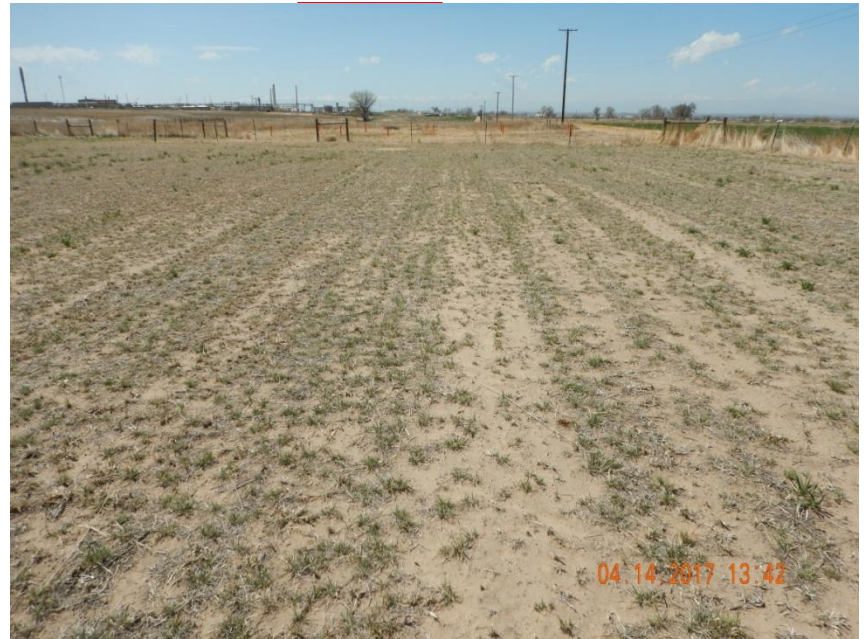
Photo 18. Photo taken from northwestern, west flowline area, facing West. Germination does not appear apparent in this photo but germination was observed throughout this area.

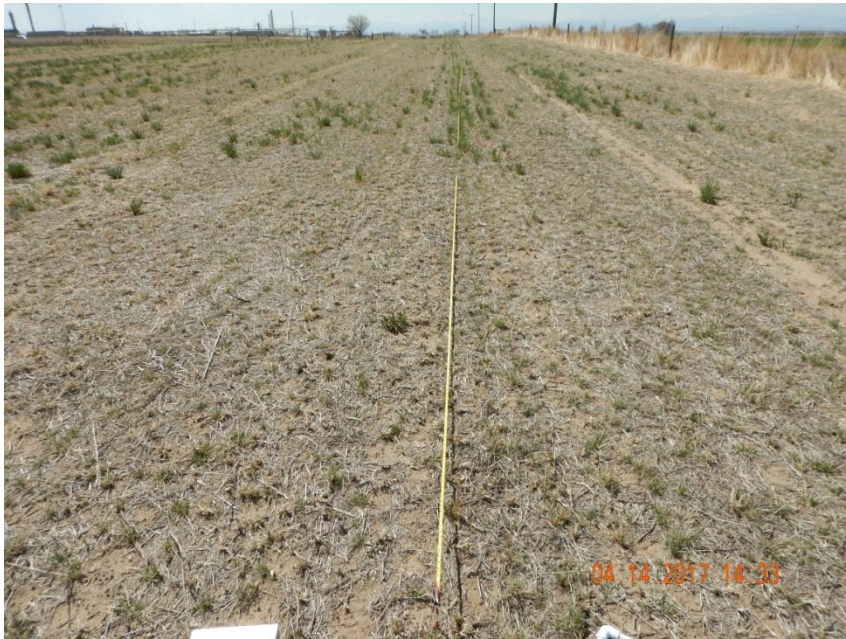
Photo 19. Photo taken from the start of transect Location #1: 40.26850, -104.72856 @263°, facing West. A total of 224 grass seedling species were detected during the assessment along this transect.

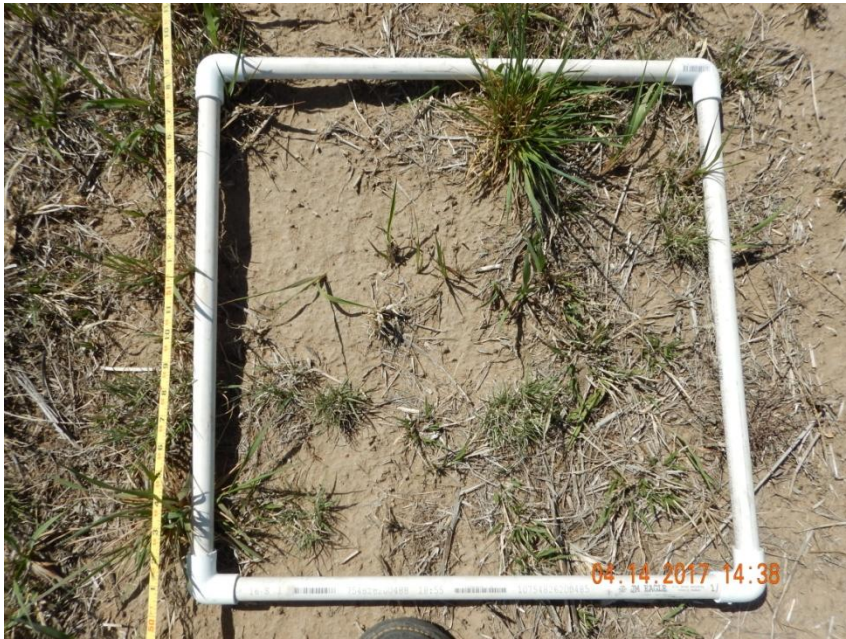
Photo 21. Photo taken from the 50 foot mark along the right side of transect Location #1. A total of 21 seedling grass species were counted inside the quadrat sampling area.

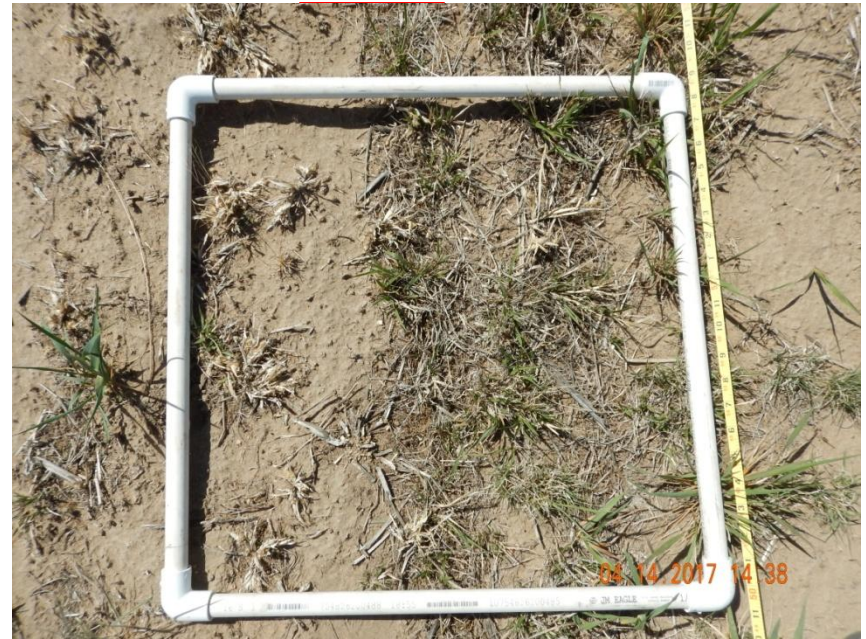
Photo 22. Photo taken from the 50 foot mark along the left side of transect Location #1. A total of 15 seedling grass species were counted inside the quadrat sampling area.

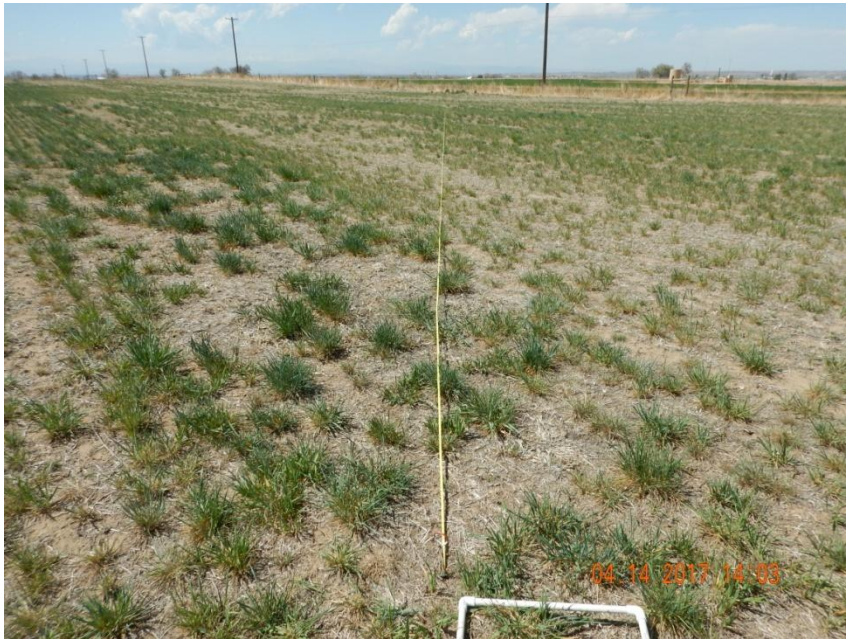
Photo 23. Photo taken from the start of transect Location #2: 40.26824, -104.72781 @295°, facing Northwest. A total of 250 grass seedling species were detected during the assessment along this transect.

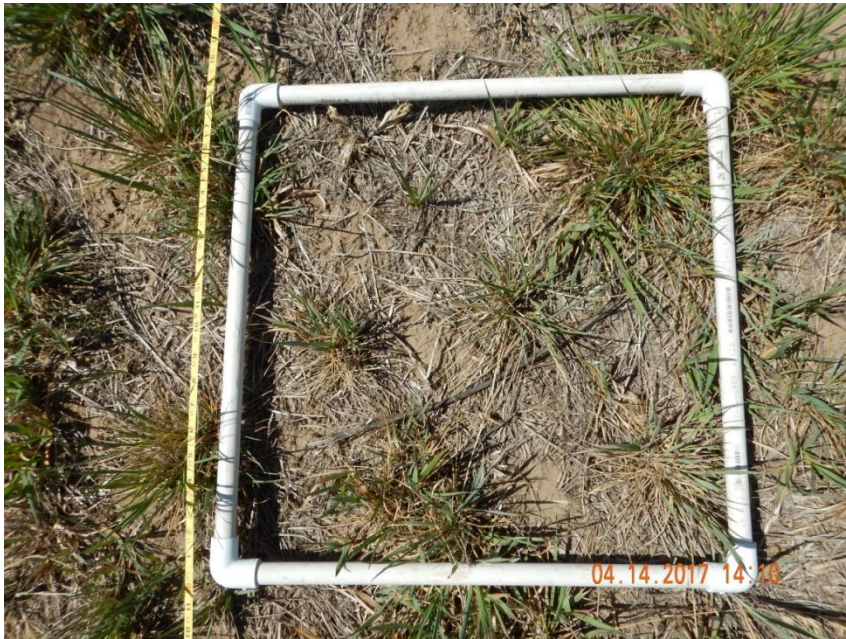
Photo 25. Photo taken from the 50 foot mark along the right side of transect Location #2. A total of 14 seedling grass species were counted inside the quadrat sampling area.

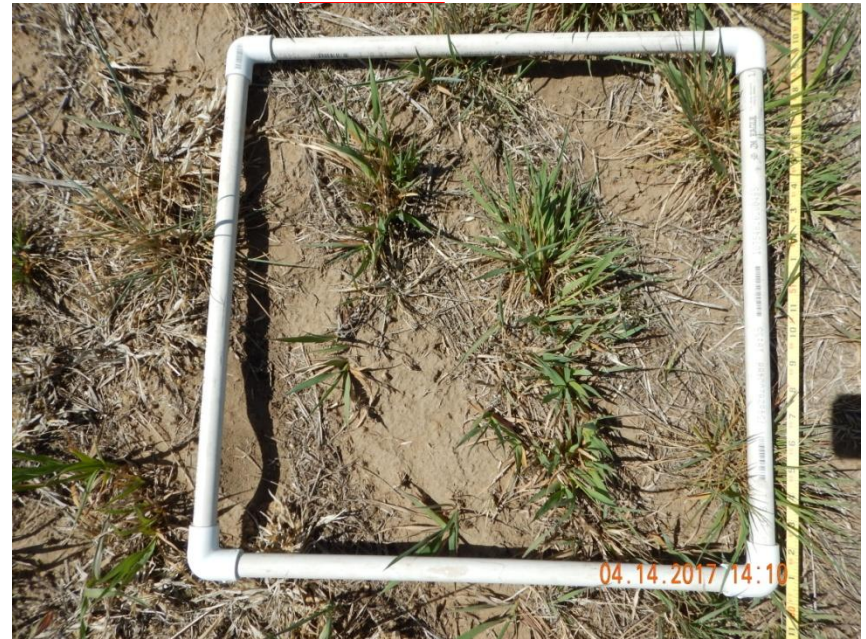
Photo 26. Photo taken from the 50 foot mark along the left side of transect Location #2. A total of 16 seedling grass species were counted inside the quadrat sampling area.

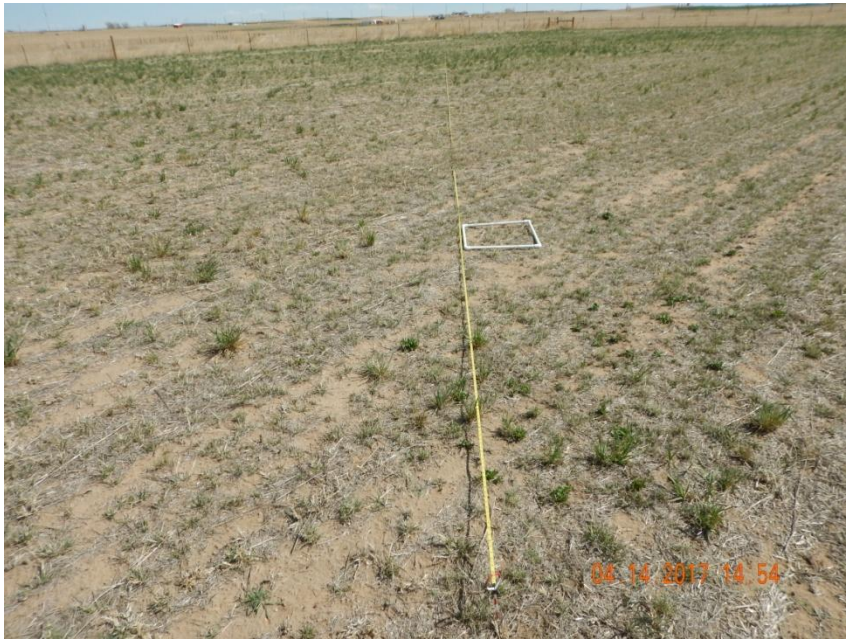
Photo 27. Photo taken from the start of transect Location #3: 40.26701, -104.72720 @126°, facing Southeast. A total of 239 grass seedling species were detected during the assessment along this transect.

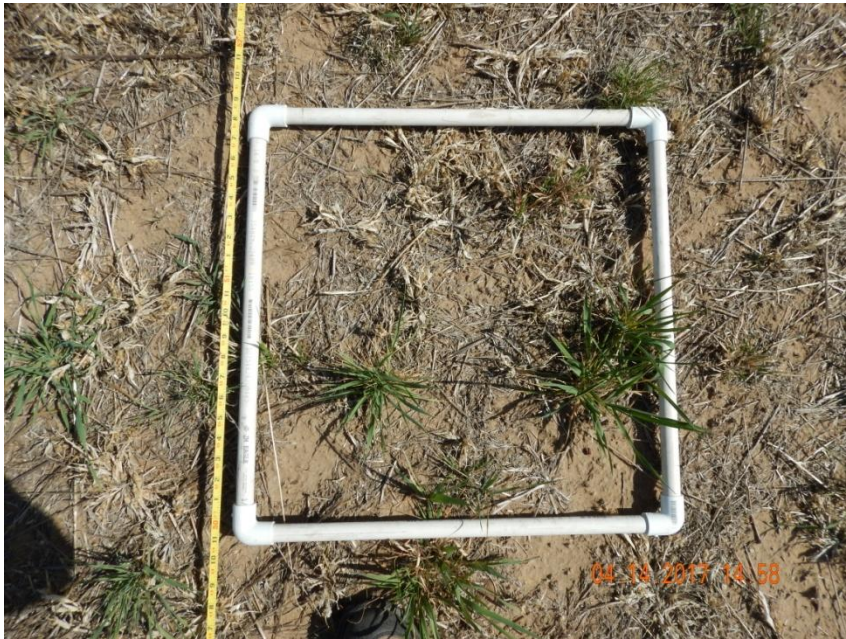
Photo 29. Photo taken from the 50 foot mark along the right side of transect Location #3. A total of 10 seedling grass species were counted inside the quadrat sampling area.

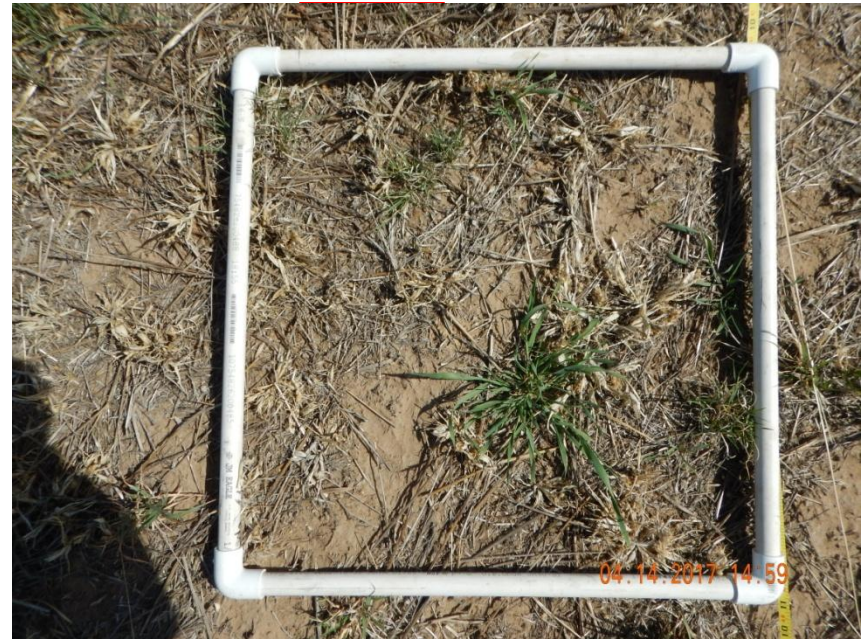
Photo 30. Photo taken from the 50 foot mark along the left side of transect Location #3. A total of 7 seedling grass species were counted inside the quadrat sampling area.
