Inspection Photos

Operator: Rampart Energy Co #5685

Location ID: 387264

Inspection Doc. Number: 682501891

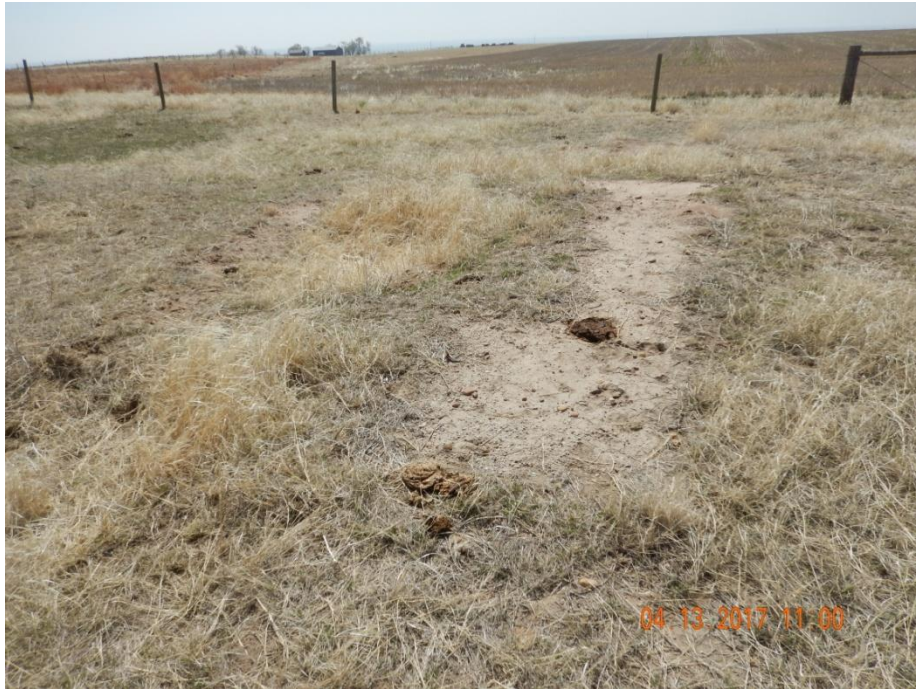
Photo 1: Photo taking from the concrete pumping unit, facing south. This needs to be removed and the area reclaimed.

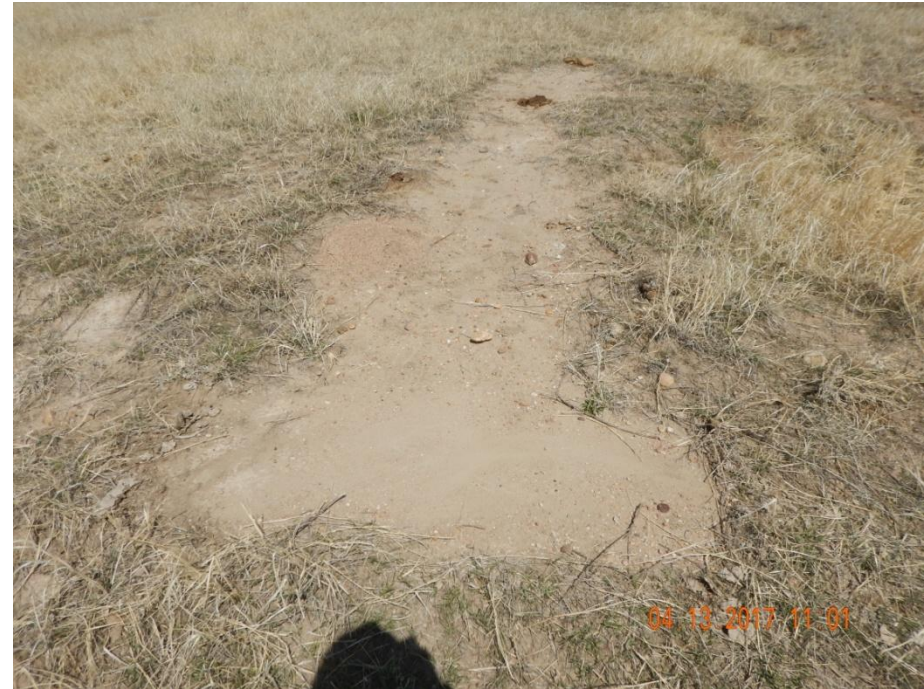
Photo 2: Photo taking from the concrete pumping unit, facing south. Photo shows that a thin layer of soil has accumulated on top of unit, after a little scraping the concrete base was evident. This needs to be removed and the area reclaimed.

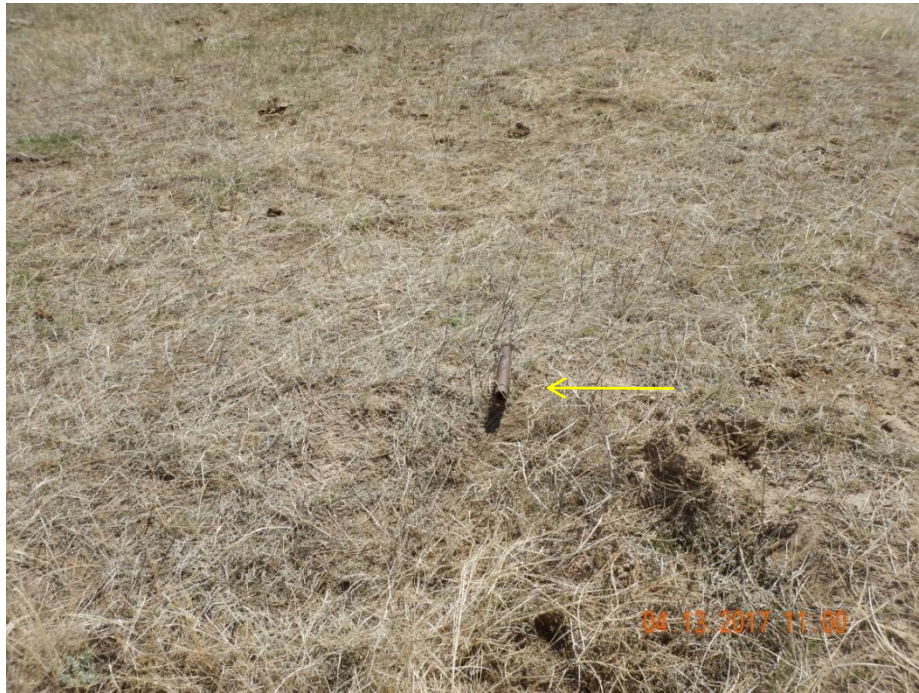
Photo 3: Photo taken from the east end of where the concrete pumping unit remains. Photo shows pipe still remaining and sticking out of the ground. This will need to be removed.

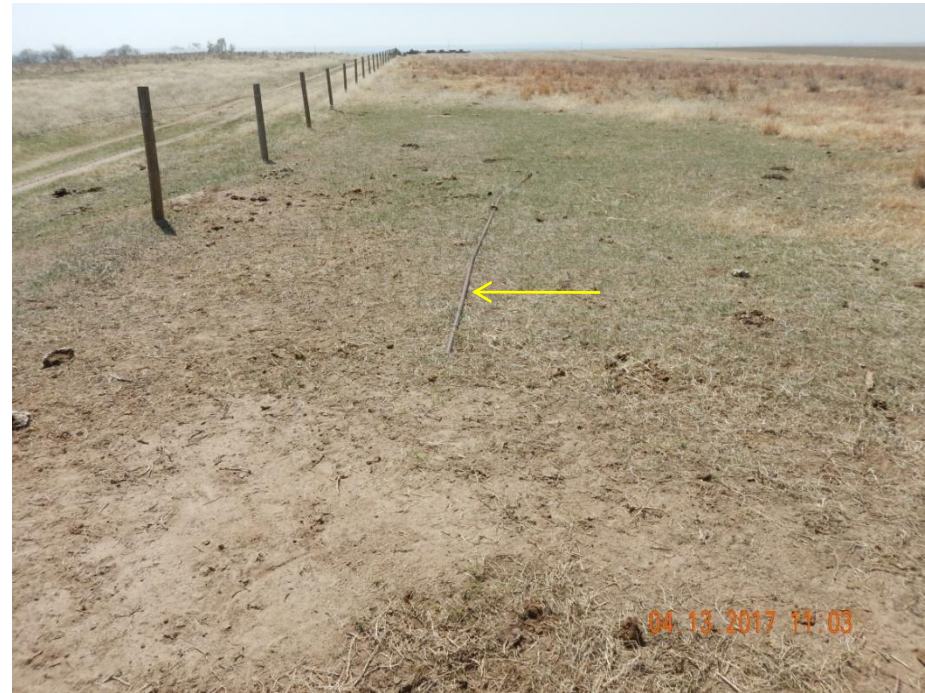
Photo 4: Photo taken from the fence corner east of the concrete pumping unit, facing south. Photo shows pipe still remaining and sticking out of the ground. This will need to be removed.

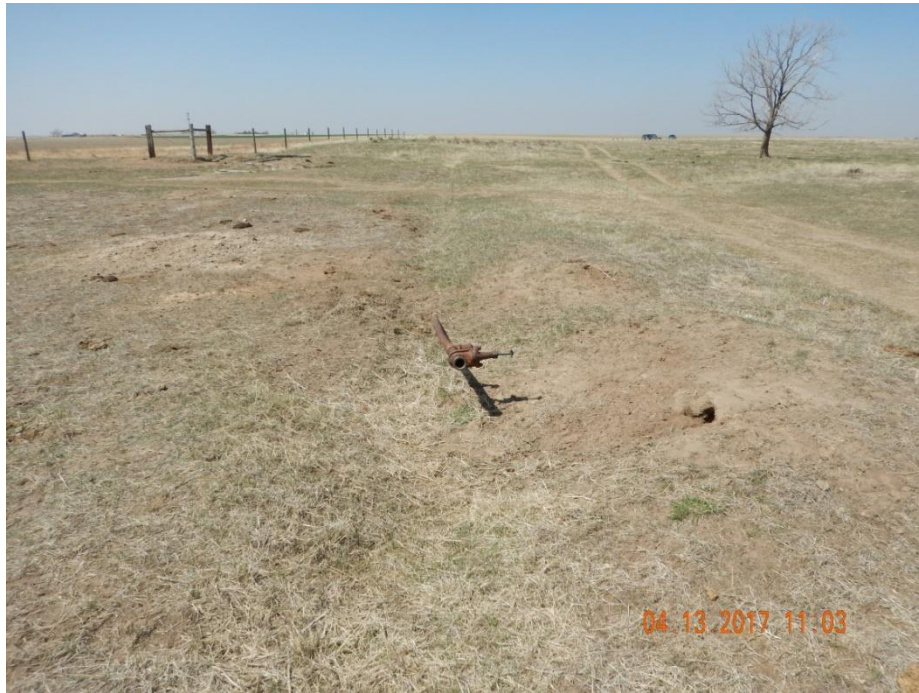
Photo 5: Photo taken from the east of the concrete pumping unit. Photo shows pipe remaining and sticking out of ground. Likely gathering/flow line. This needs to be removed and area reclaimed.

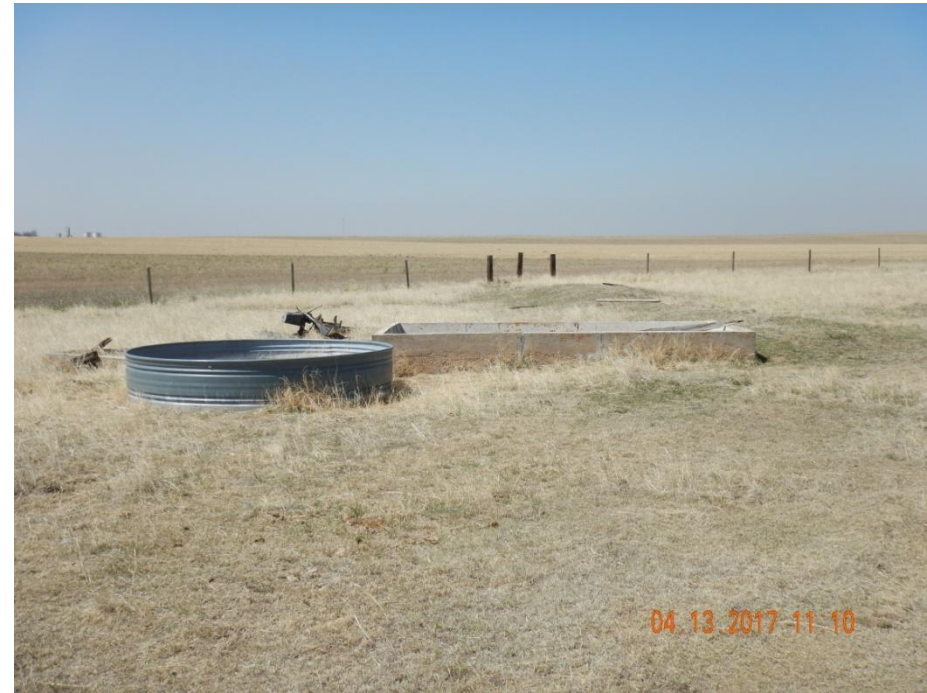
Photo 6: Photo taken from the north end of the location, facing west. Photo shows additional concrete structures remaining in the immediate area. Tank likely surface owners, it is unclear if the concrete structures area related to the O&G location. Surface owner appears to be storing equipment/debris in area.

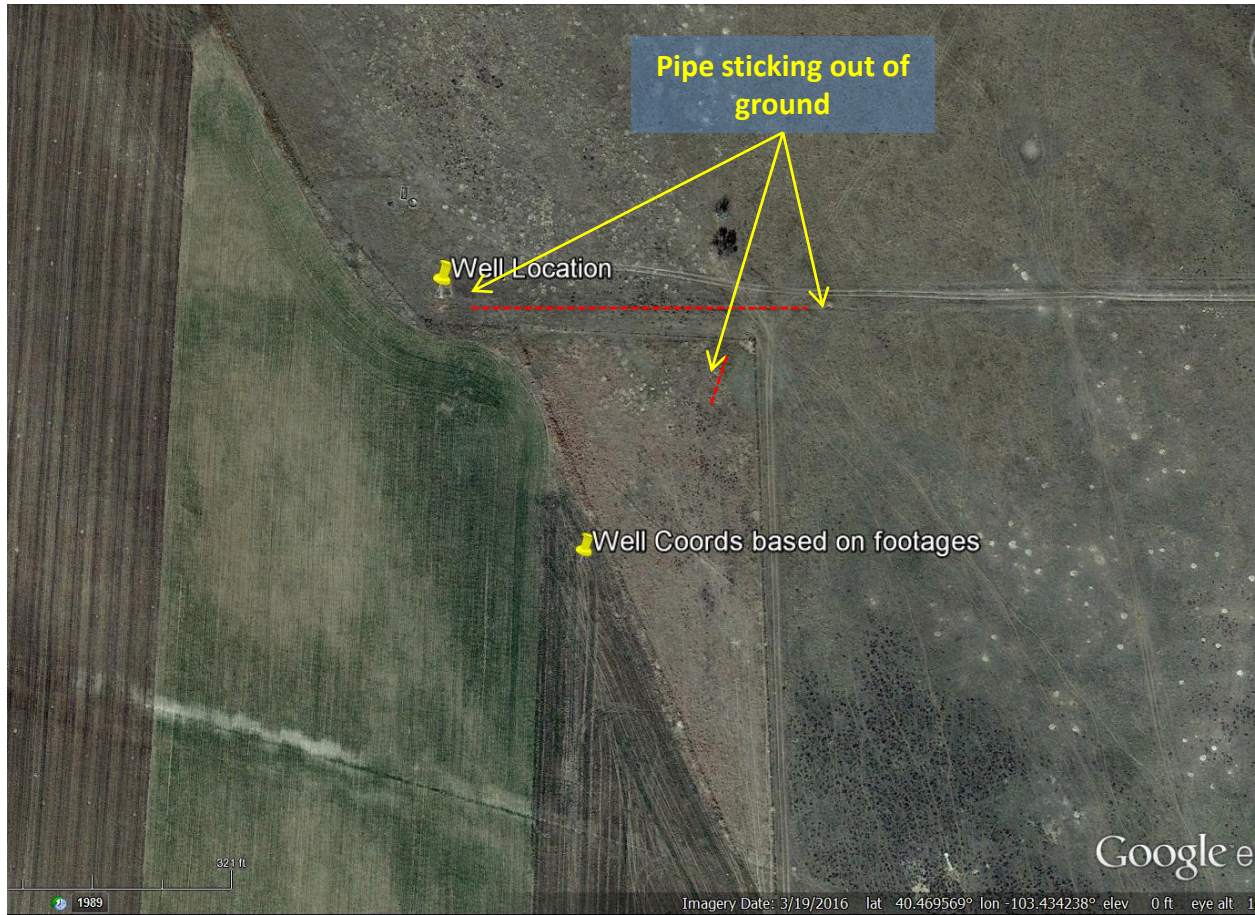
Photo 7: 2016 aerial imagery. Photo shows actual well location compared to coordinates on well file based on footages. Photo also shows area where the flow/gathering lines remain and are visible above ground (red line) and areas where pipe are sticking out of the ground (yellow arrows)
