Inspection Photos

Operator: Adkins Oil / COGCC

Location ID: 393754

Inspection Doc. Number: 682501907

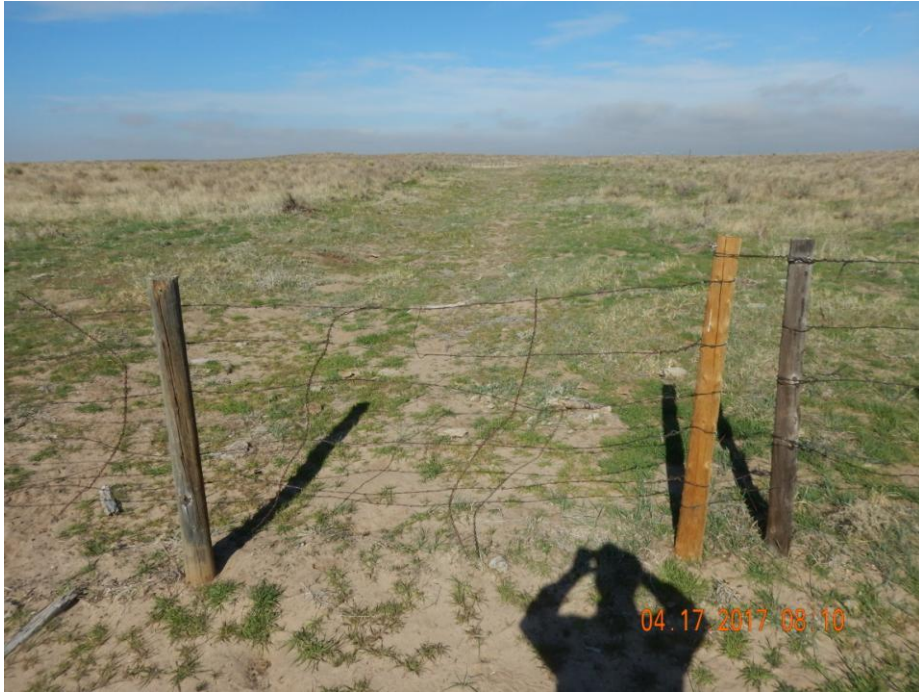
Photo 1: Photo taken from the fence line east of the well location, facing west. Photo shows reclamation in process along access road.

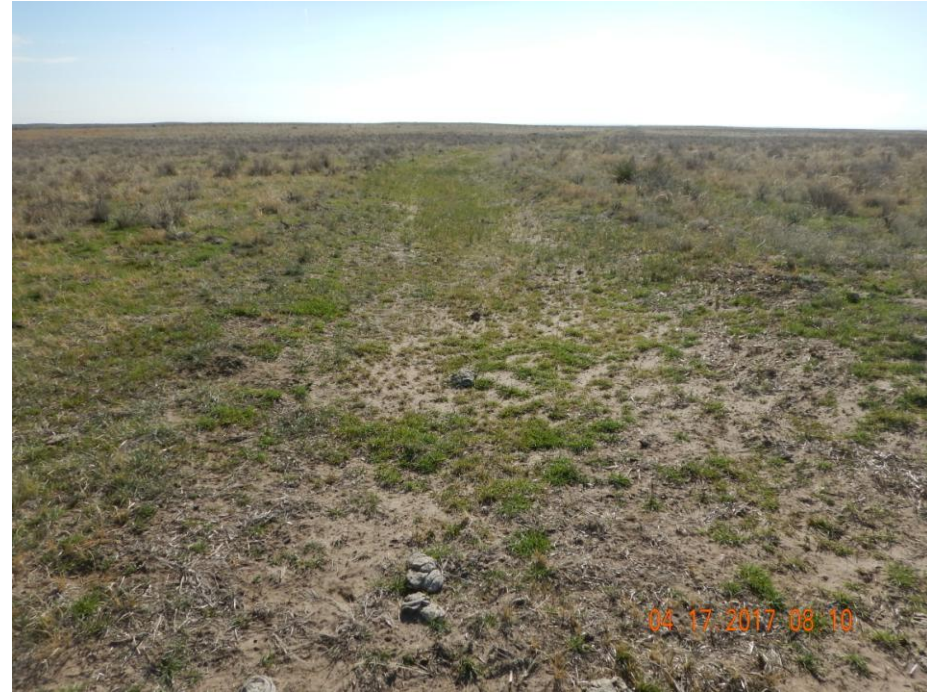
Photo 3: Photo taken from the fence line east of the well location, facing east. Photo shows reclamation in process along access road.

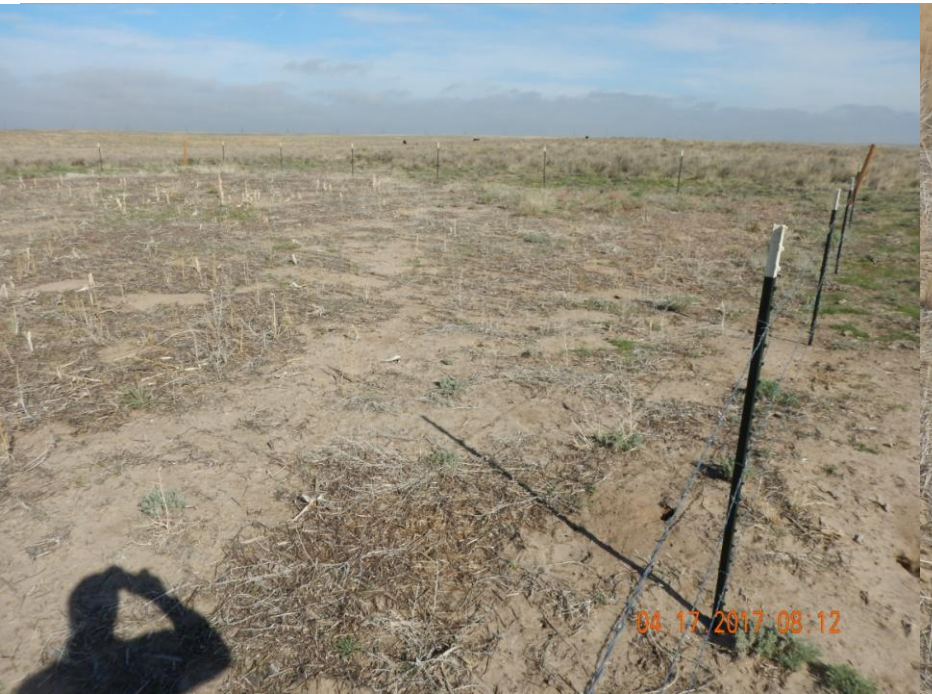
Photo 3: Photo taken from the southeast corner of the well location, facing northwest. Photo shows the reclamation process of the well. Area of the well does not appear to be progressing as well as reclamation areas outside of fence. Will continue to monitor the reclamation to evaluate progression.

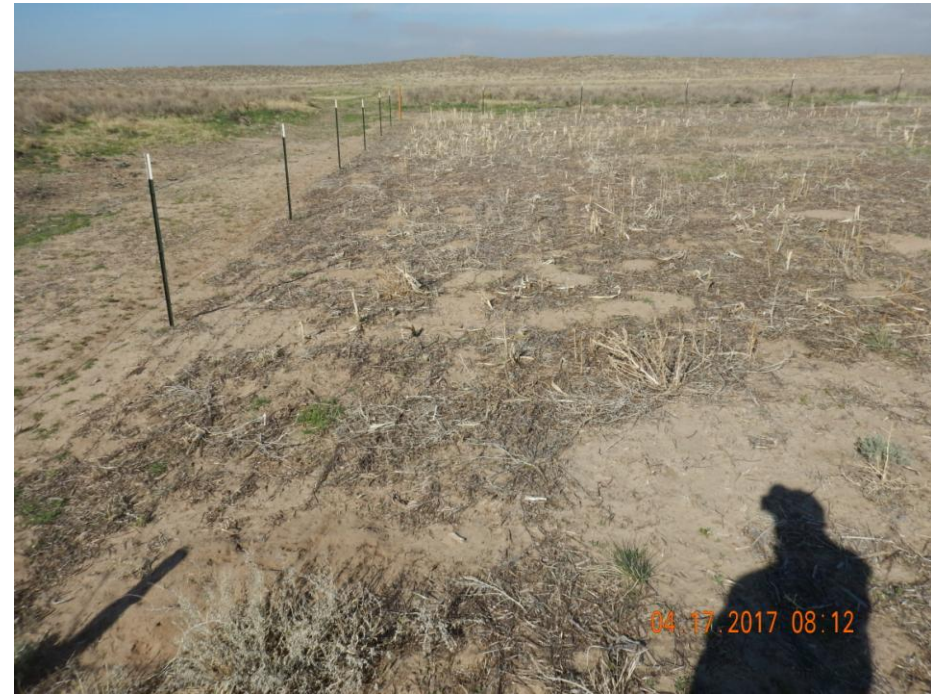
Photo 4: Photo taken from the southeast corner of the well location, facing west. Photo shows the reclamation process of the well. Area of the well does not appear to be progressing as well as reclamation areas outside of fence. Will continue to monitor the reclamation to evaluate progression. .

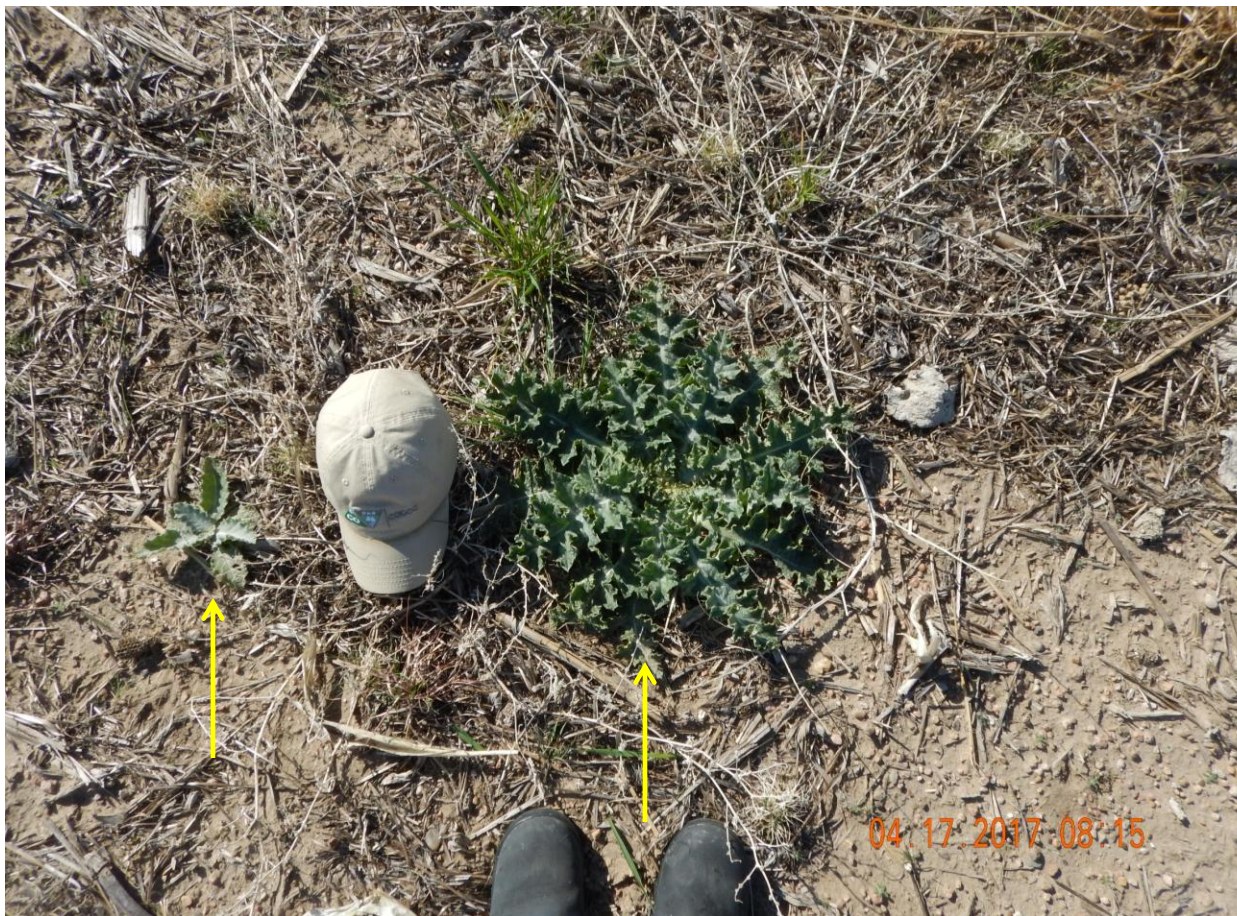
Photo 5: Photo taken from within fenced reclamation area. Photo shows two rosettes found within reclamation area. The rosette to the right had large leaves covered in fine “grayish” hairs, features similar to that found with Scotch thistle. The rosette to the left had features similar to that found with Canada thistle rosettes. Will need to monitor, until more pronounced and defining features of the plant become evident and allow for a more accurate ID. Hat used for reference.

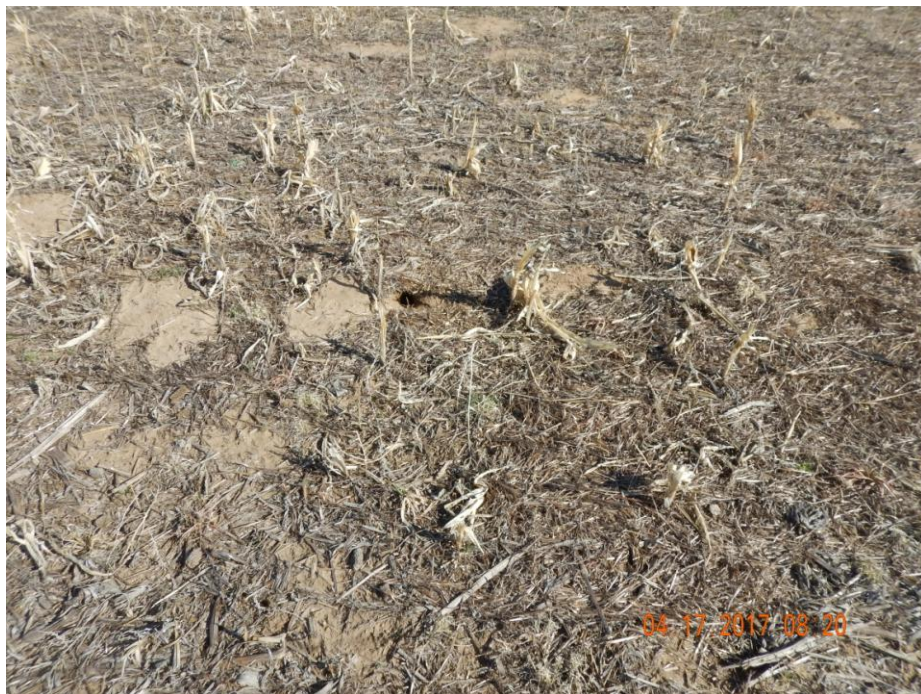
Photo 6: Photo taken from the south end of the fenced reclamation area. Photo shows areas of the reclamation area where desirable plant germination is evident, however in low numbers compared to other areas of the reclamation area. Species such as Amaranth, Salsola, and Panicum capillare appeared prevalent.

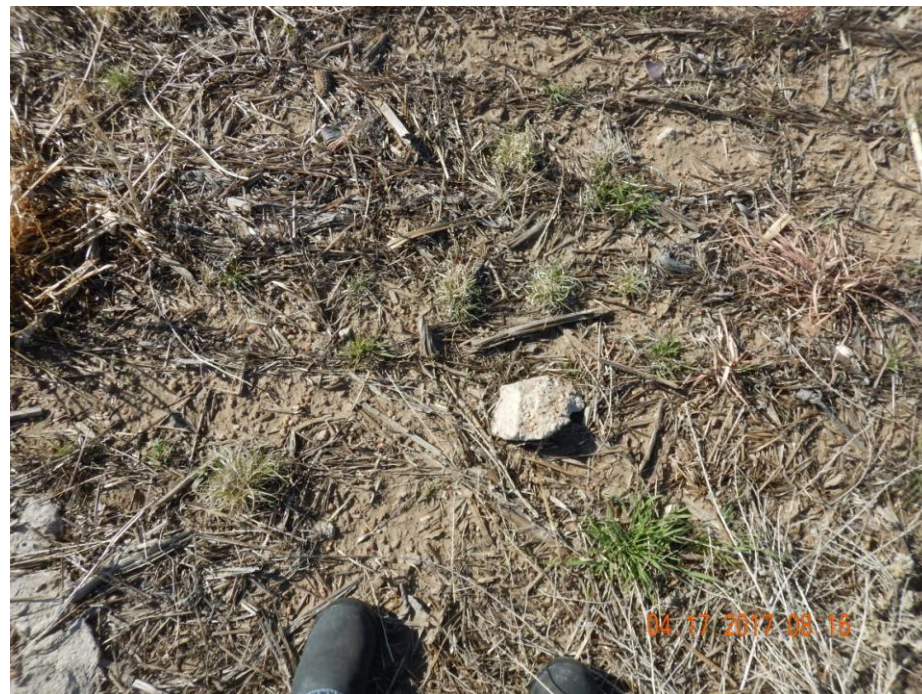
Photo 7: Photo taken from the north end of the fence reclamation. Photo shows areas of the reclamation where desirable plant germination is evident
