Construction and Stormwater Inspection

April 20, 2016

Operator: HIGHLANDS NATURAL RESOURCES CORPORATION- #10625

Location ID: 449920

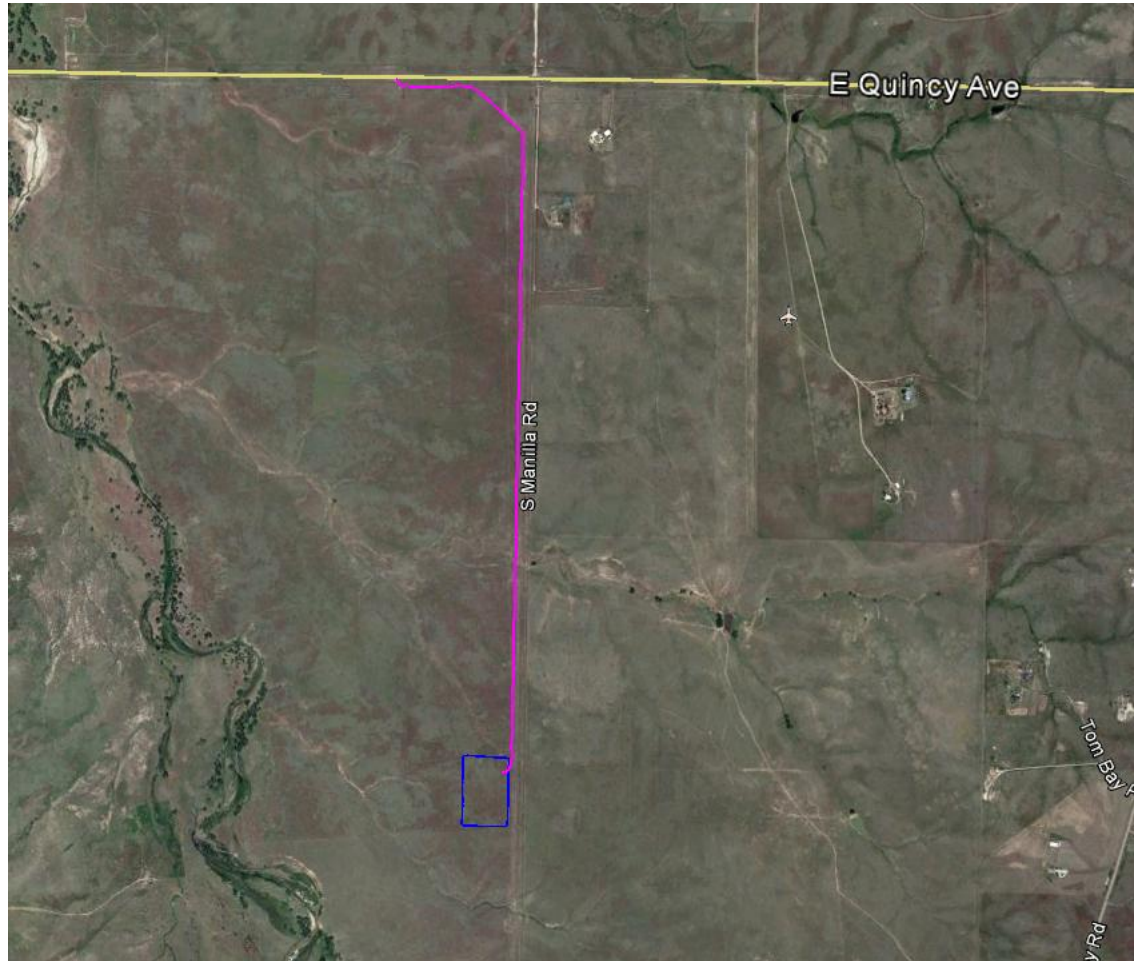
Google Earth aerial imagery taken June 14, 2016 of the Highlands /5-64 15-16 Pad overlaid with field collected data using a Trimble handheld GPS from the April 20, 2017 inspection. Aerial imagery illustrates the well pad area (blue) and access road (pink) that was built for the well location.

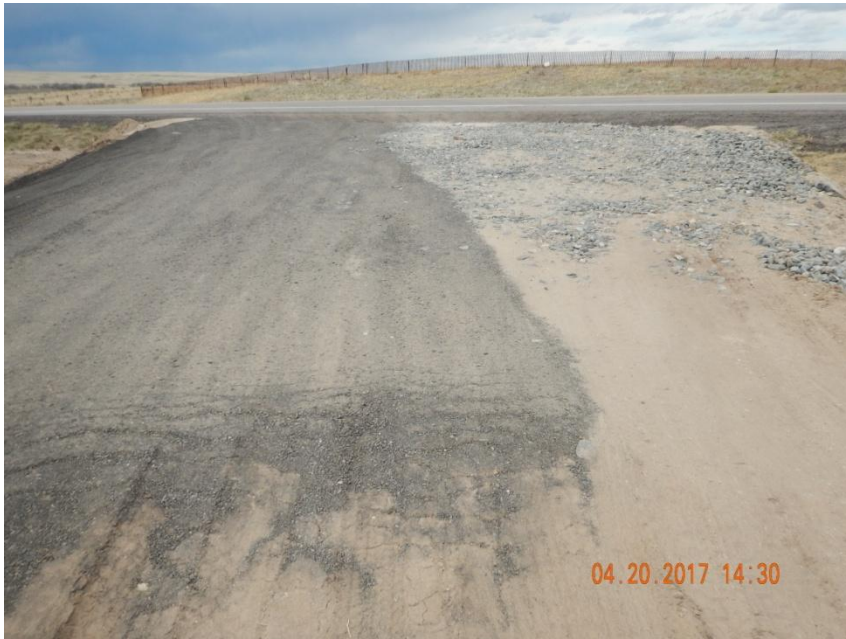
Photo 1. Photo taken from the entrance of the location just off Quincy Ave., facing North. Tracking pad material installed but does not appear to be consistently installed throughout the entrance. However, crushed asphalt has been installed along the entire access road which should minimize sediment discharge via vehicle tracking.

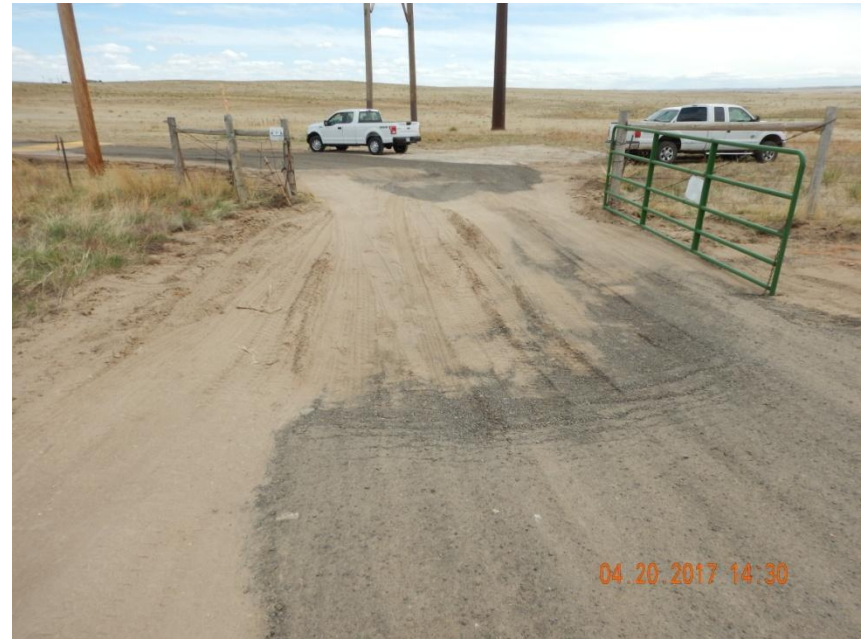
Photo 2. Photo taken from the entrance of the location just off Quincy Ave., facing South. Tracking pad material installed but does not appear to be consistently installed throughout the entrance. However, crushed asphalt has been installed along the entire access road which should minimize sediment discharge via vehicle tracking.

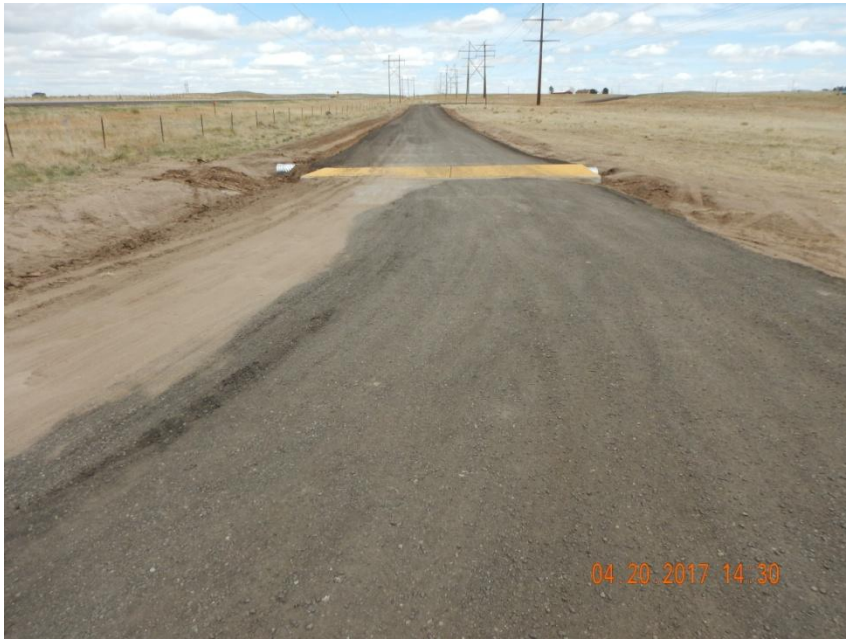
Photo 3. Photo taken just beyond the entrance off Quincy Ave., facing East. Cattle guard installed in conjunction with a culvert. Crushed asphalt has been installed along the entire access road which should minimize sediment discharge via vehicle tracking.

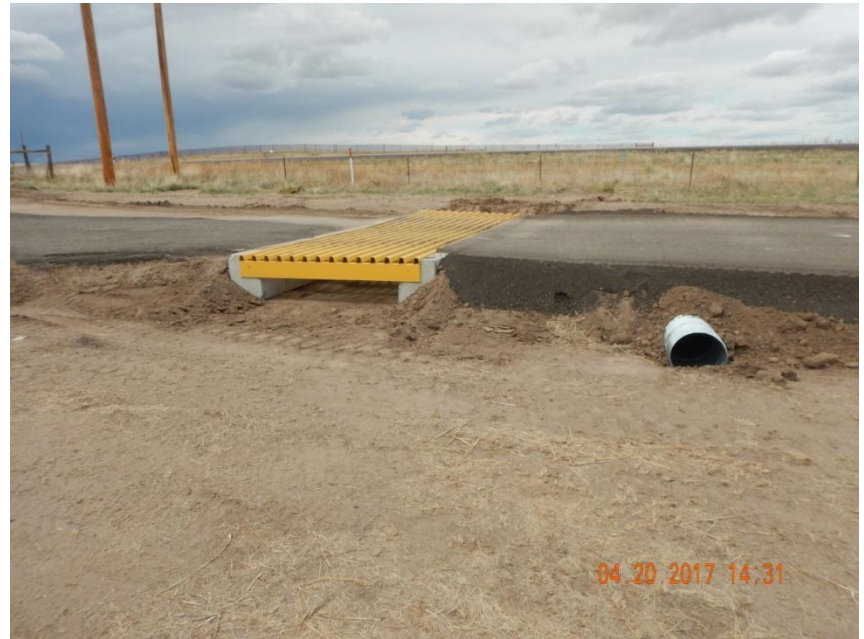
Photo 4. Photo taken from the cattle guard and culvert, facing North.

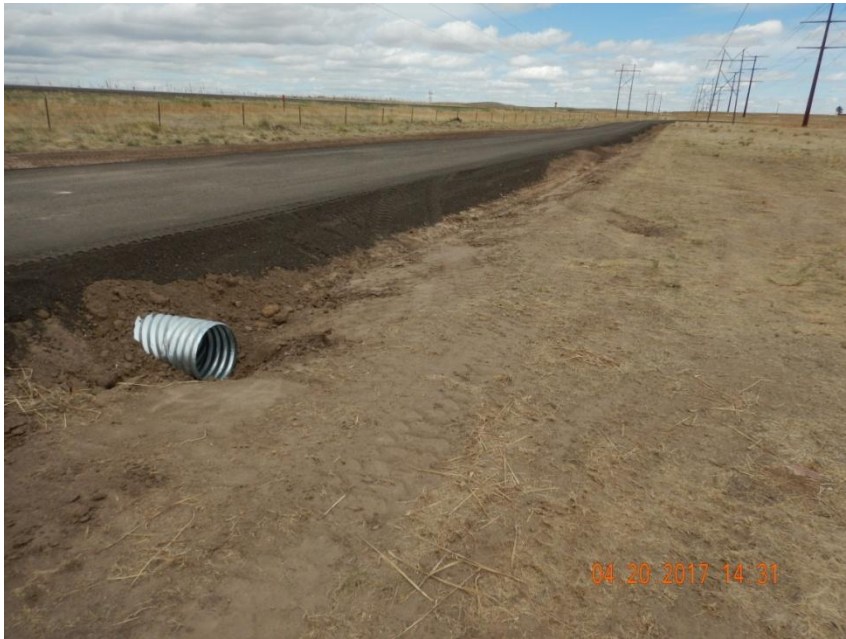
Photo 5. Photo taken from the cattle guard and culvert, facing East. Photo illustrates the crushed asphalt that has been installed along the access road.

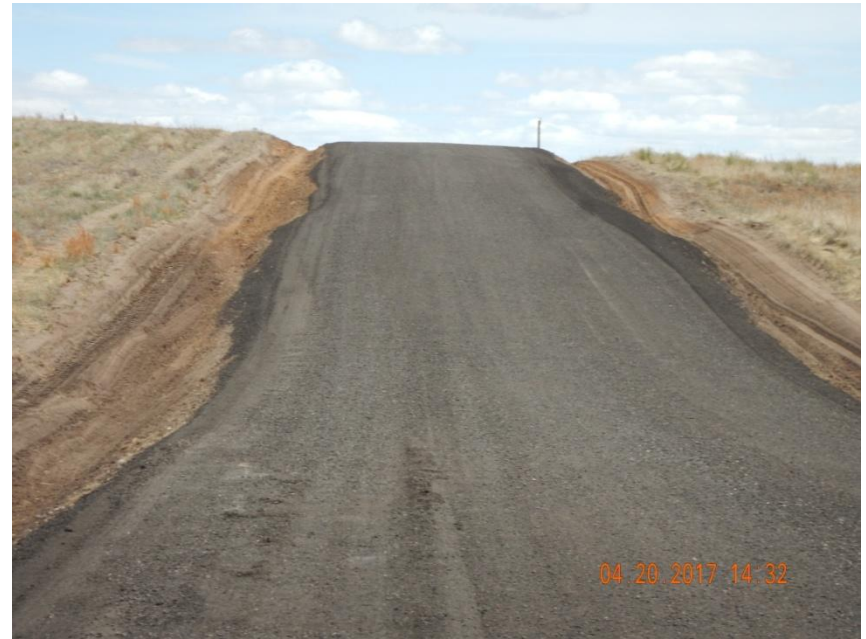
Photo 6. Photo taken from along the access road, facing South. Photo illustrates the crushed asphalt that has been installed along the access road. Also, it appears a diversion ditch has been installed along both sides of the entire access road.

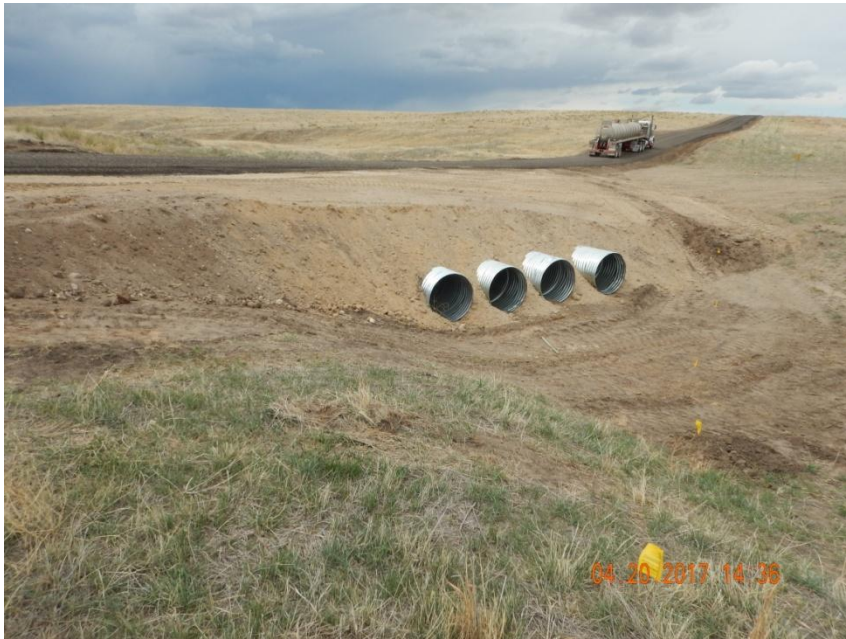
Photo 7. Photo taken along a drainage area on the east side, facing Northwest. Culverts have been installed along the drainage area. This area has potential for erosion along the fill slopes and stormwater runoff from the access road. Did not observe any erosion control BMPs along this area at the time of this inspection.

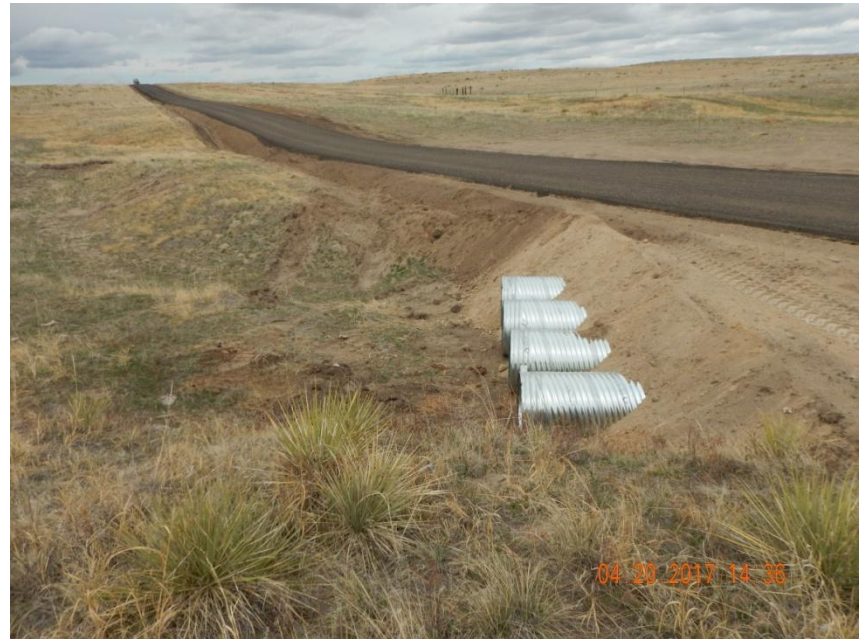
Photo 8. Photo taken along a drainage area on the west side, facing Northeast. Culverts have been installed along the drainage area. This area has potential for erosion along the fill slopes and stormwater runoff from the access road. Did not observe any erosion control BMPs along this area at the time of this inspection.

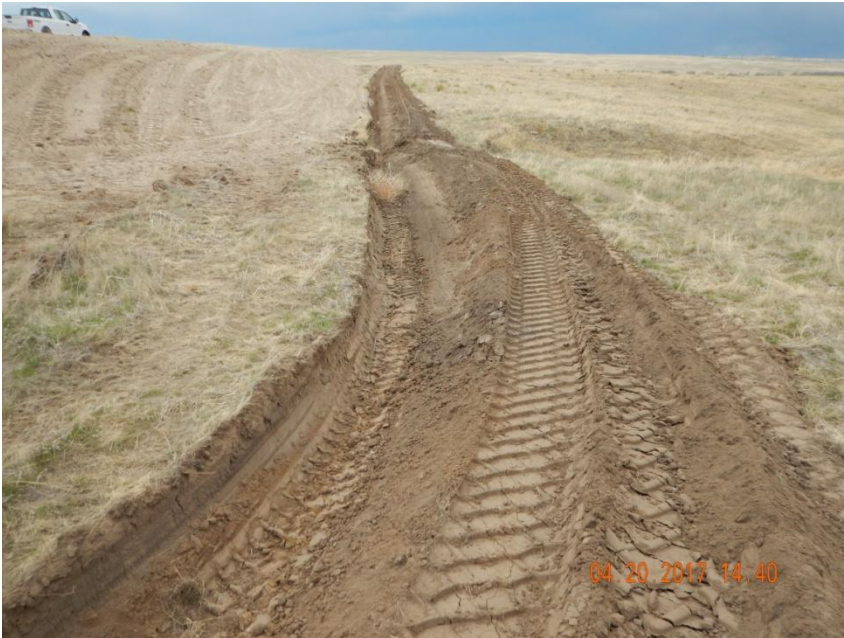
Photo 9. Photo taken from the northeast perimeter of the well pad location, facing West. A ditch and berm BMP has been installed along the entire perimeter of the location.

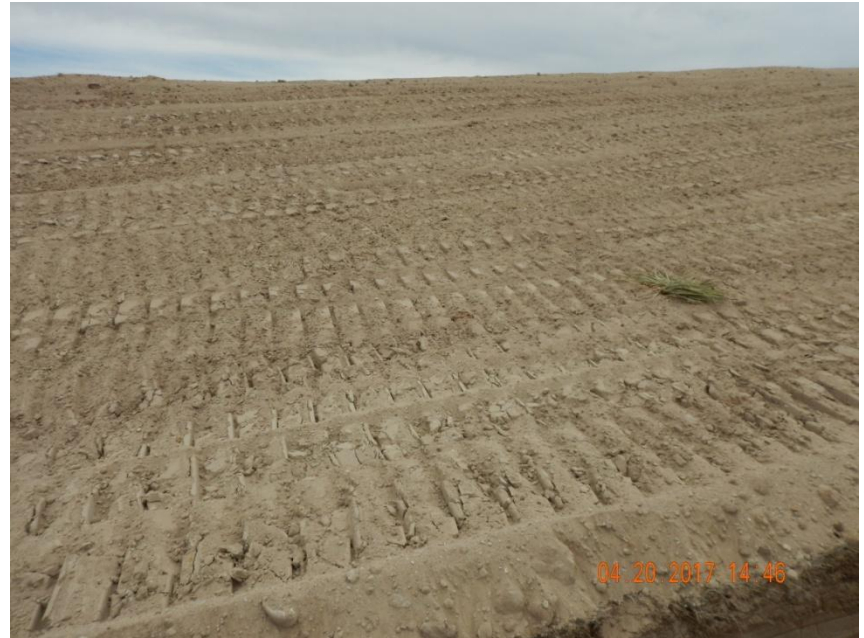
Photo 10. Photo taken along the northern fill slope, facing South. Fill slope has not been tracked perpendicular to the slope which could increase potential erosion along this area.

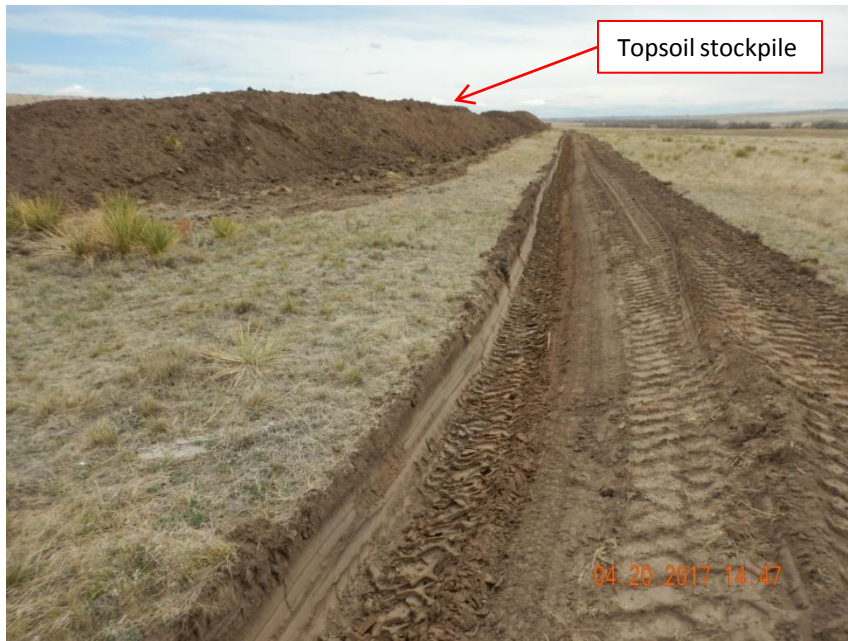
Photo 11. Photo taken from the northwest perimeter of the well pad location, facing South. A ditch and berm BMP has been installed along the entire perimeter of the location.

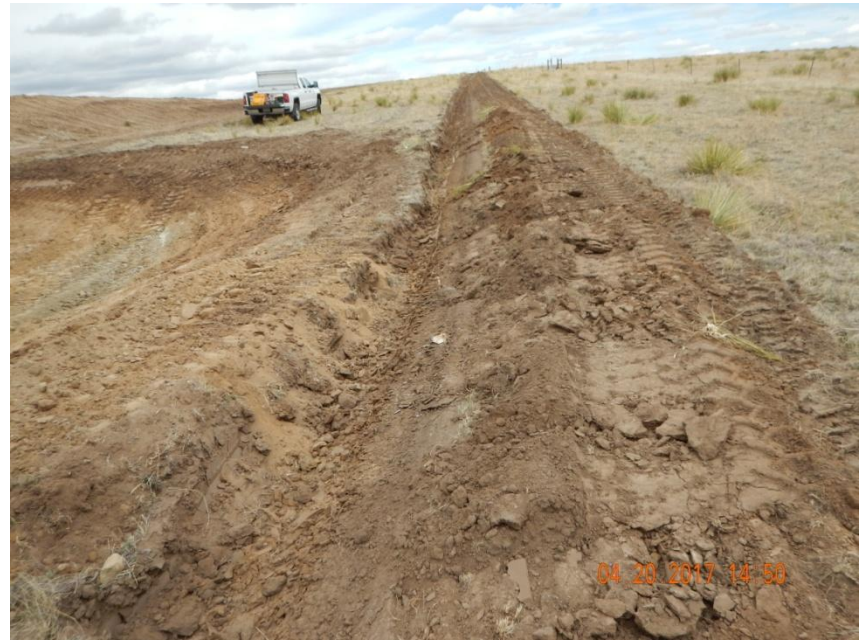
Photo 12. Photo taken from the southwest perimeter of the well pad location, facing East. A ditch and berm BMP has been installed along the entire perimeter of the location.

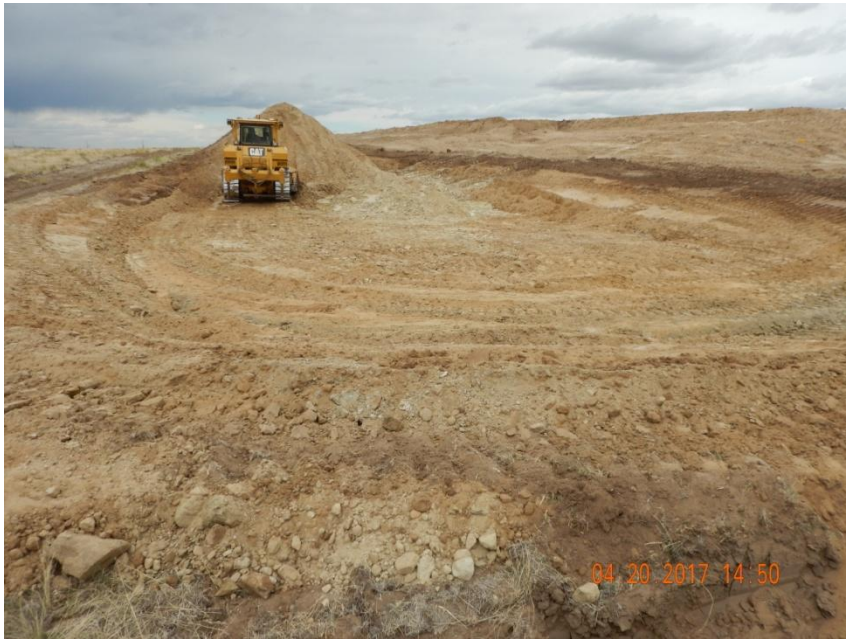
Photo 13. Photo taken from the southwest perimeter of the well pad location, facing North. Operator in the process of installing a retention area for stormwater control. At the time of this inspection, it was unclear how stormwater runoff will be directed to the retention area from the ditch and berm BMP.

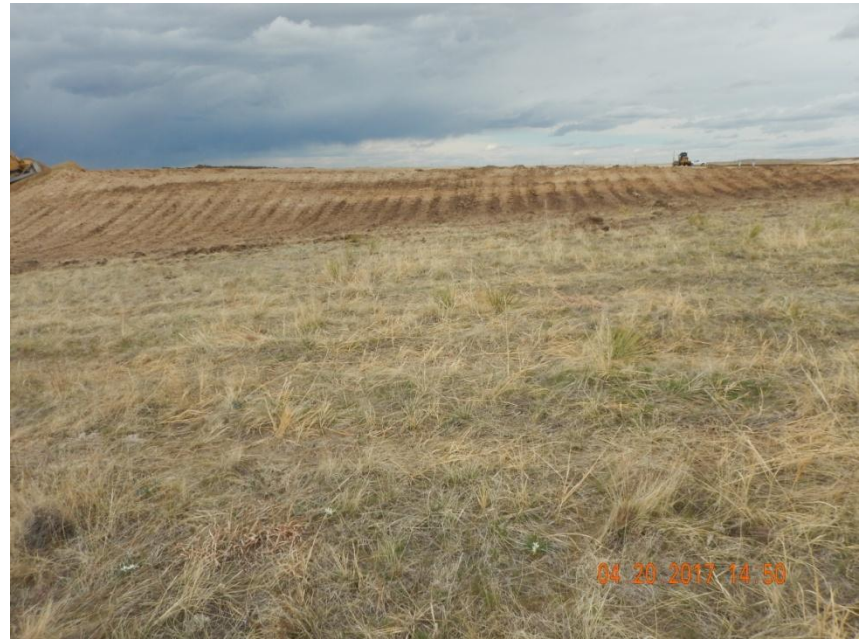
Photo 14. Photo taken from the southern location, facing North. Fill slope appears to be properly tracked.

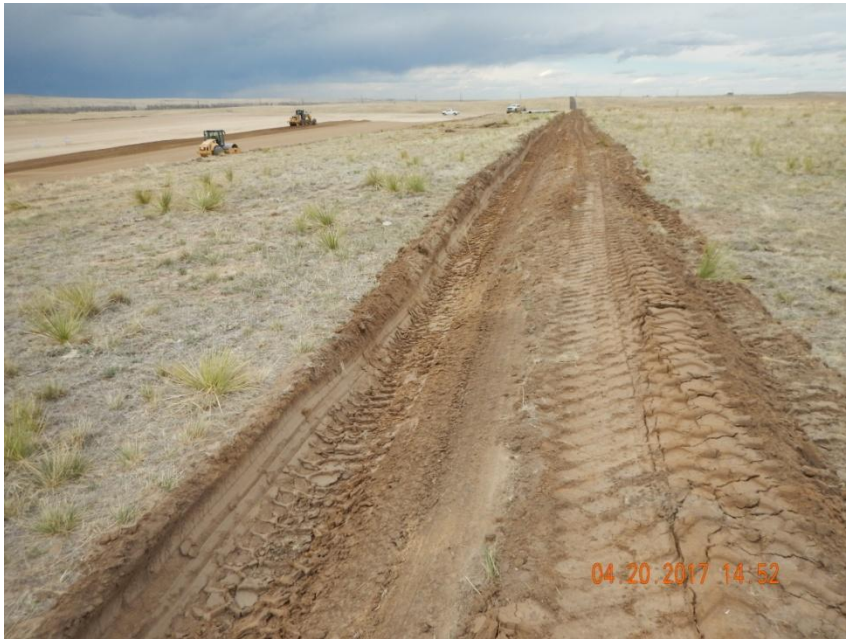
Photo 15. Photo taken from the southeast perimeter of the well pad location, facing North. A ditch and berm BMP has been installed along the entire perimeter of the location.

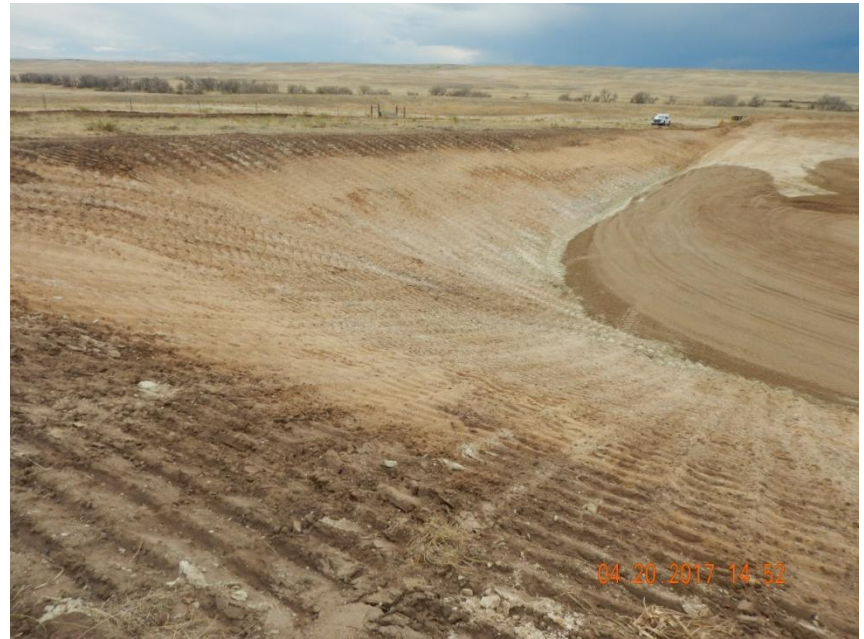
Photo 16. Photo taken from the southeast cut slope of the well pad location, facing West. Cut slope along the entire well pad area appears to be properly tracked.

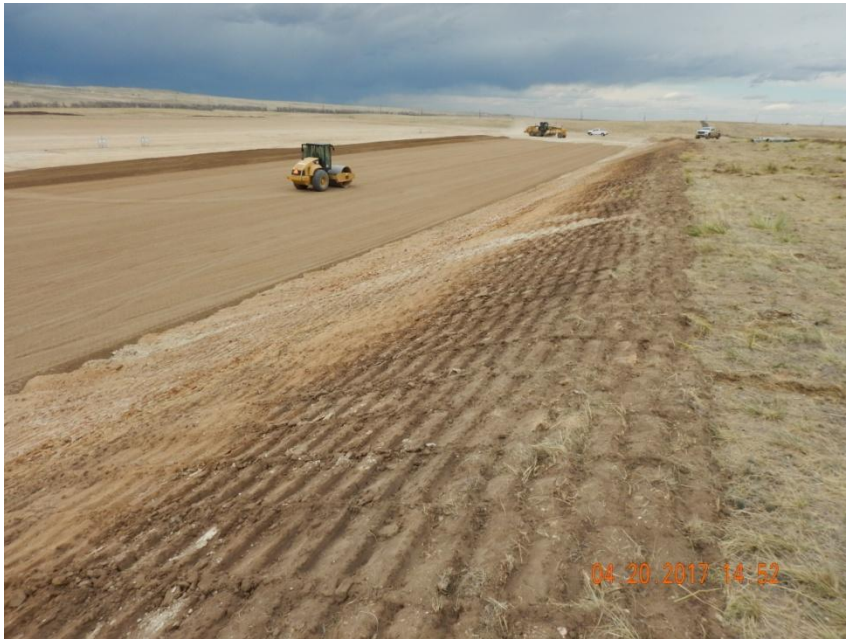
Photo 17. Photo taken from the southeast cut slope of the well pad location, facing North. Cut slope along the entire well pad area appears to be properly tracked.

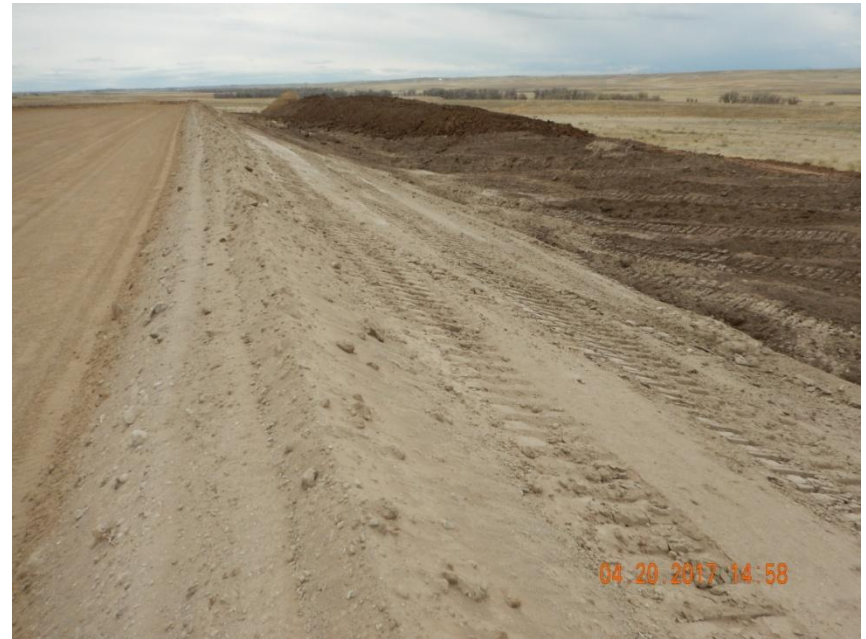
Photo 18. Photo taken from the western fill slope of the well pad location, facing North. Fill slope has not been tracked perpendicular to the slope which could increase potential erosion along this area.
