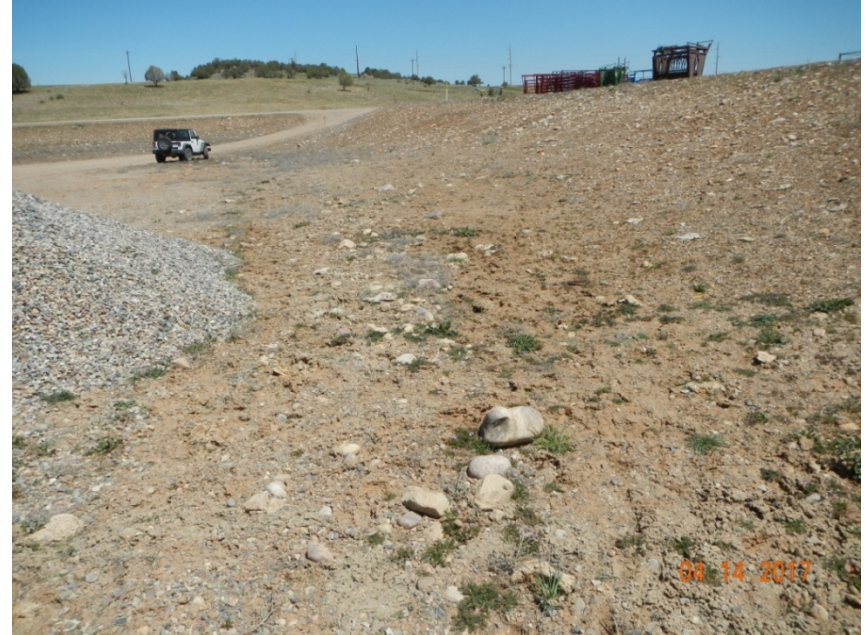
**Photo 2:** View of the eastern portion of the project area from the southeastern corner facing northward. There is little to no successful revegetation within the interim reclamation area.

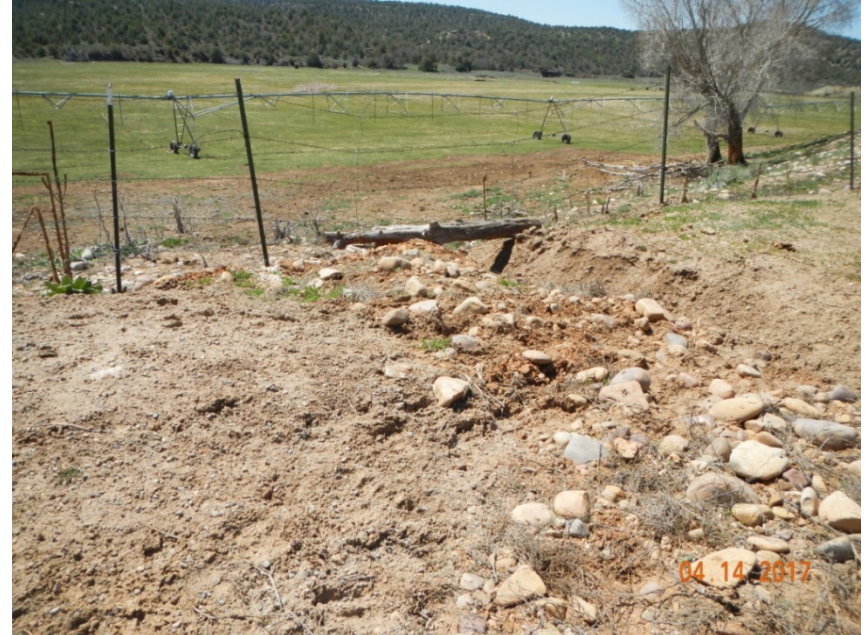
**Photo 4: View of erosional channel forming within the southern portion of the project area.**

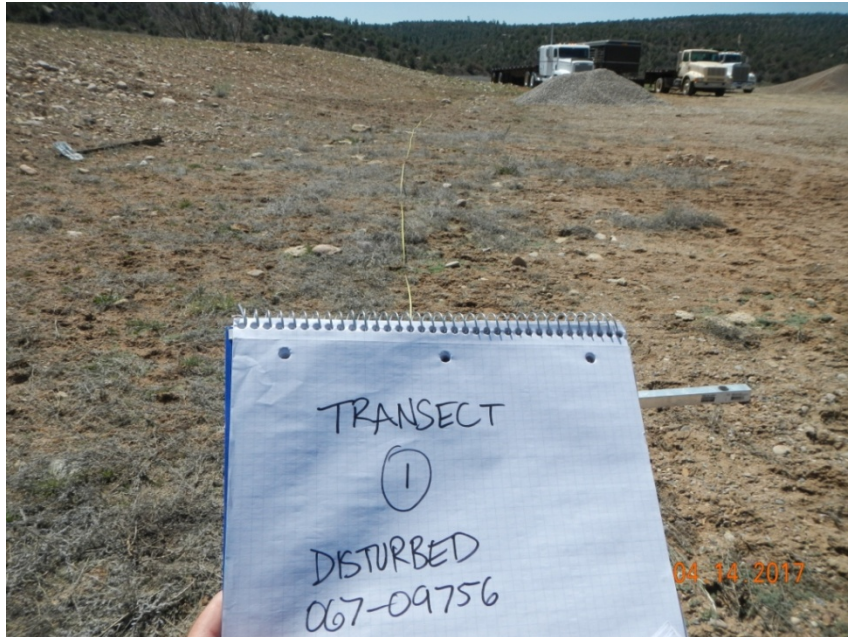
**Photo 5: View of vegetation transect within the eastern portion of the project area. No desirable vegetation was documented along the vegetation transect.**

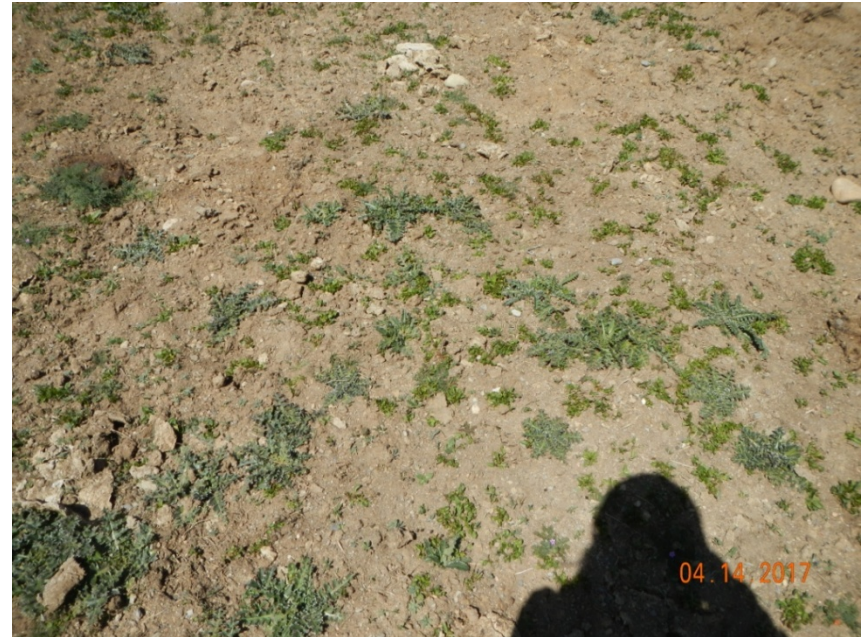
**Photo 6: Birdseye view of musk thistles within the southeastern portion of the project area.**
