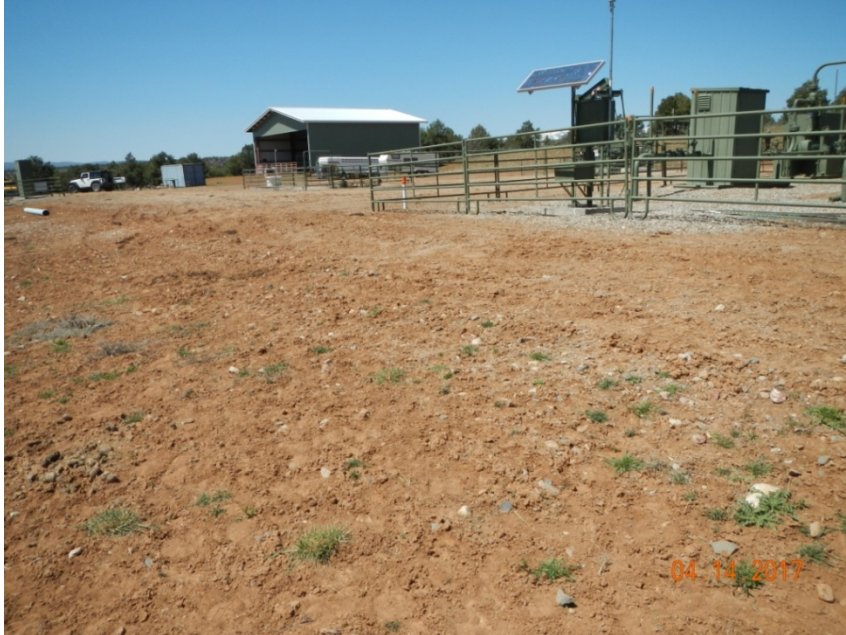
Photo 1: View of the project area from the southeastern corner facing center.

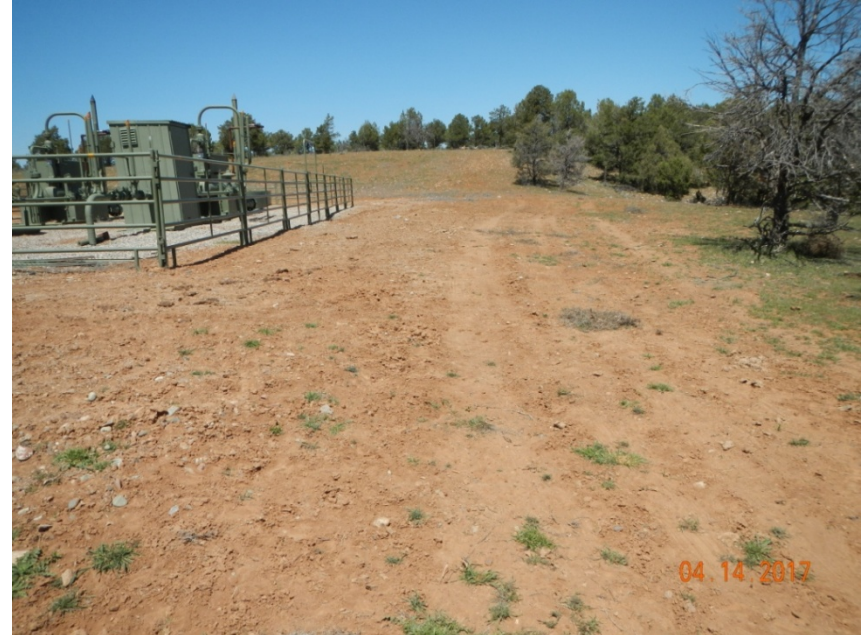
Photo 2: View of the eastern portion of the project area from the southeastern corner facing northward. Revegetation is grazed and largely comprised of crested wheatgrass (*Agropyron cristatum*). Other species were not identifiable.

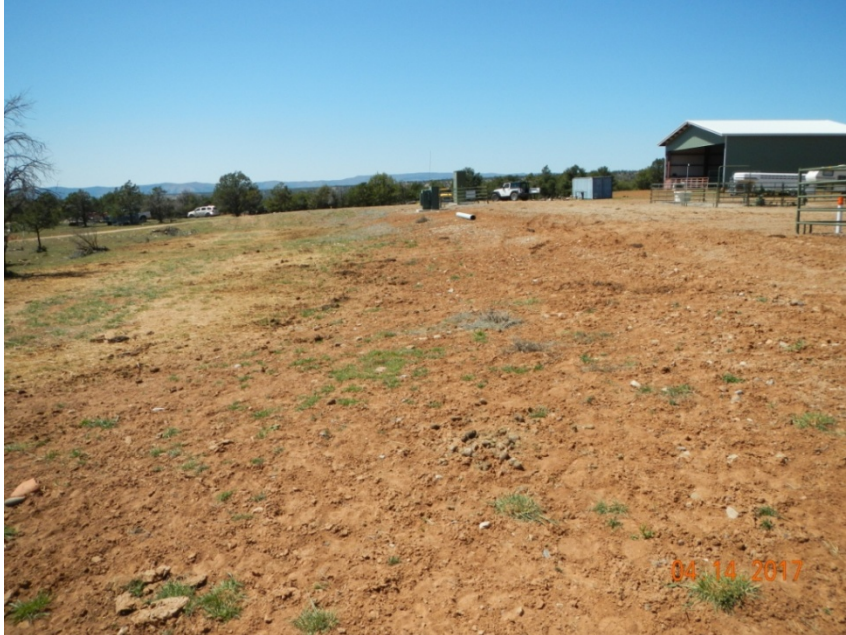
Photo 3: View of the southern portion of the project area from the southeastern corner facing westward.

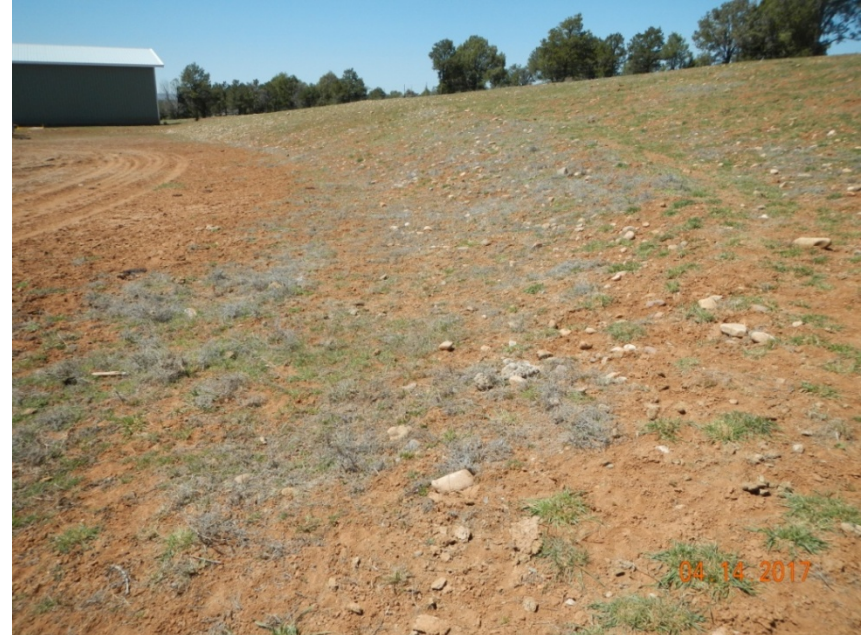
Photo 4: View of the northern portion of the project area from the northeastern edge facing westward.

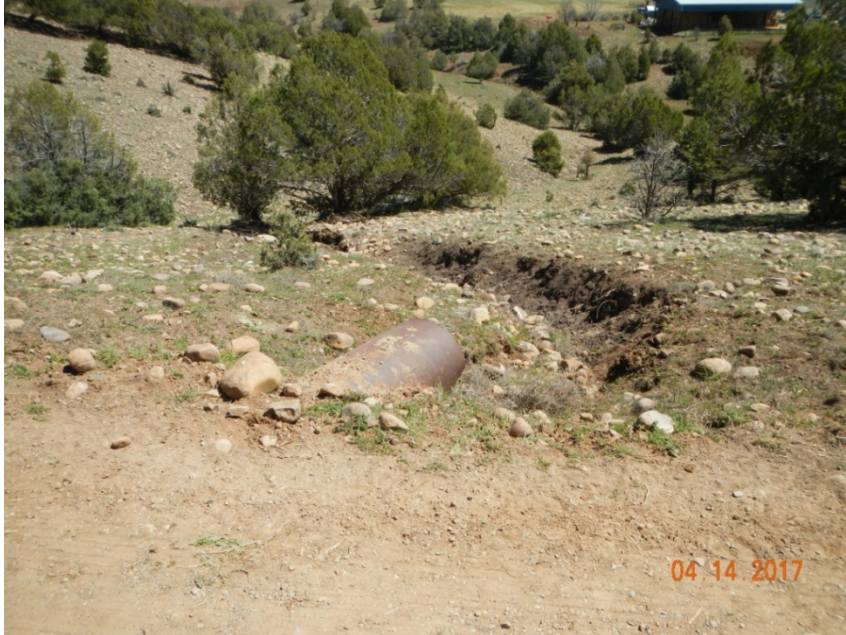
Photo 5: View of erosional channel at culvert along access. Erosion is approximately 2 feet deep and 3 feet wide. Needs to be stabilized.
