Reference Area Photographs

**Inspection Conducted on April 20, 2017
In Response to Complaint #200441313**

**Encana
GMR #34
Grass Mesa Ranch
Location Facility ID # 335102**

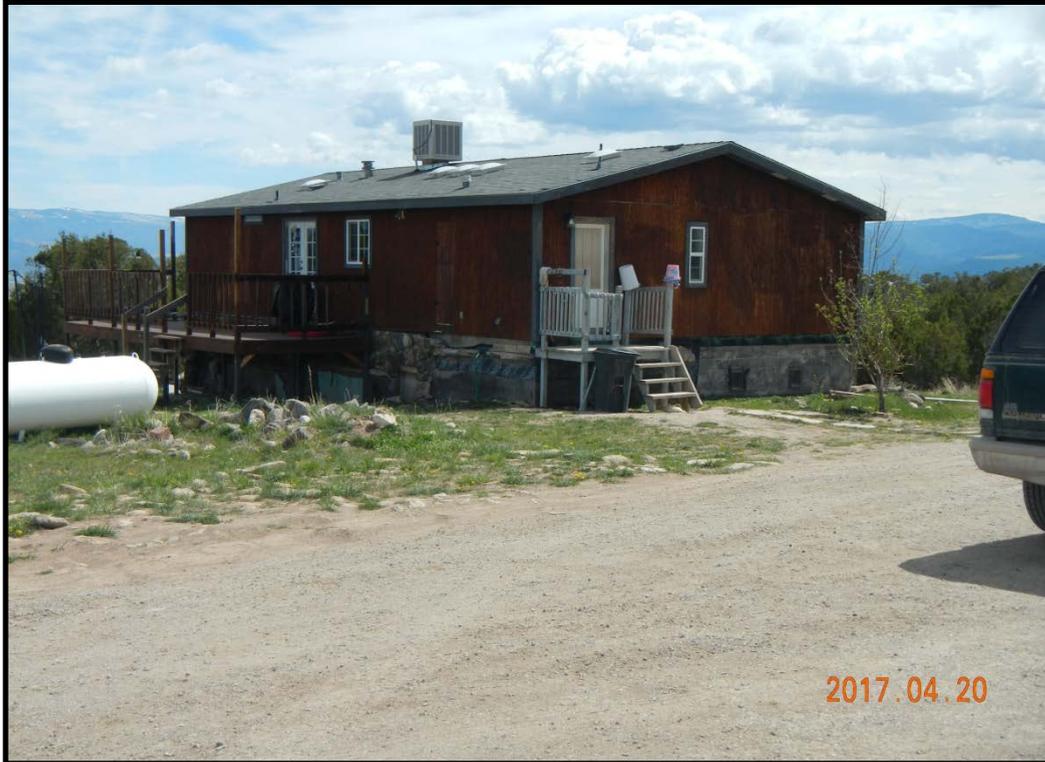
Mr. Rodriguez Home – Complaint #200441313 - Looking southeast

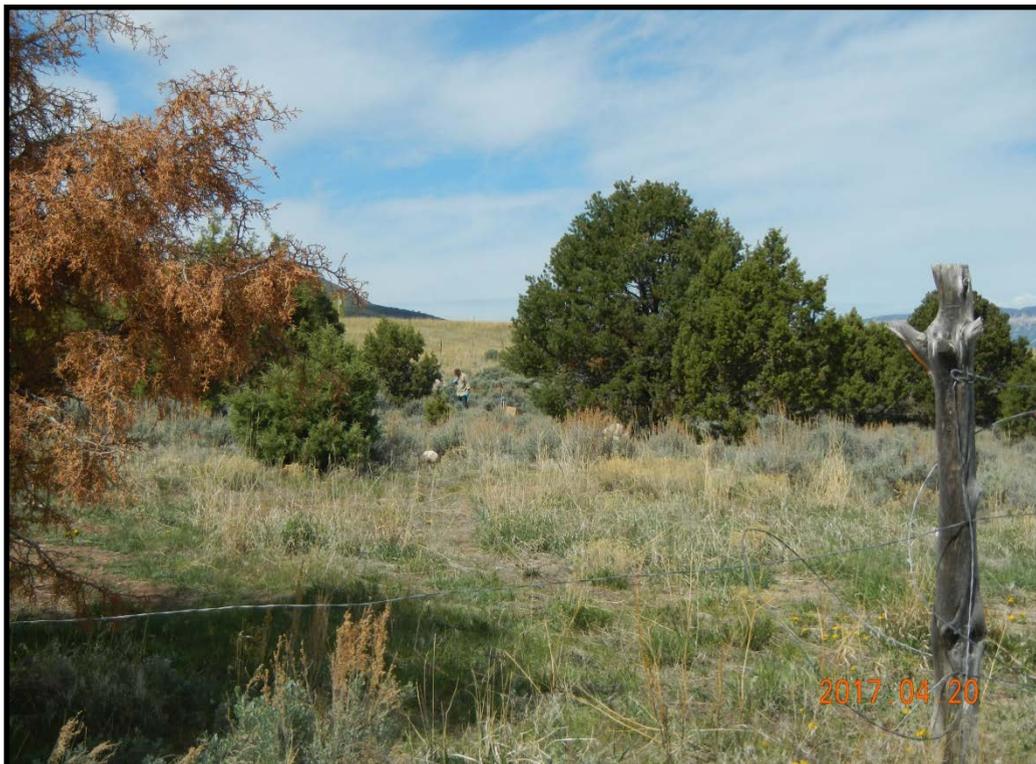
Water well Permit #36551 ((1999). Well was perforated to a depth of 160 feet. Looking west from the same location of photo above.

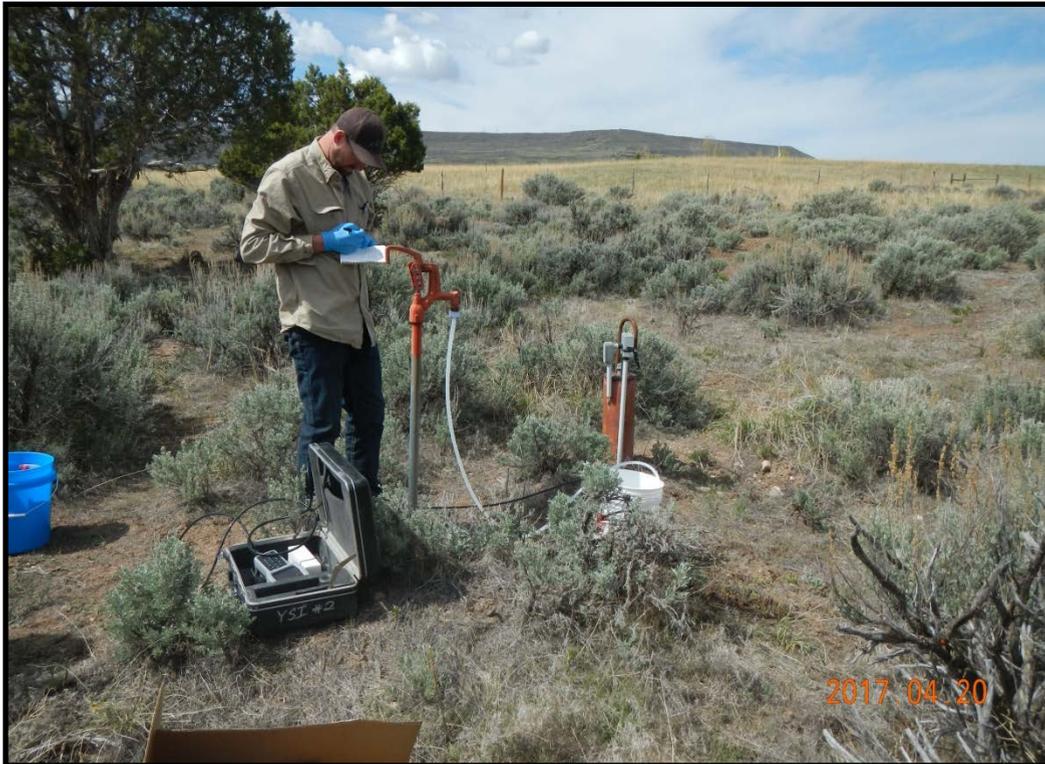
Taking samples from the water well. Looking northwest. Distance from the water well to closest Encana well on Location #335102 is about 600 feet.

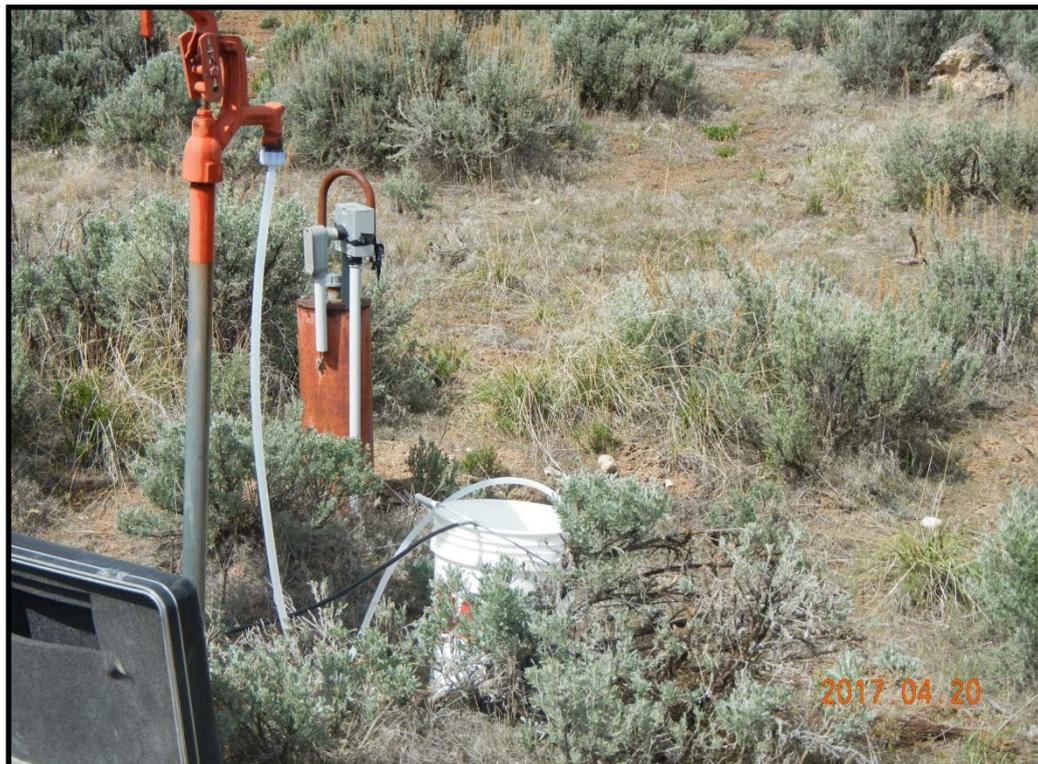
Water well close-up

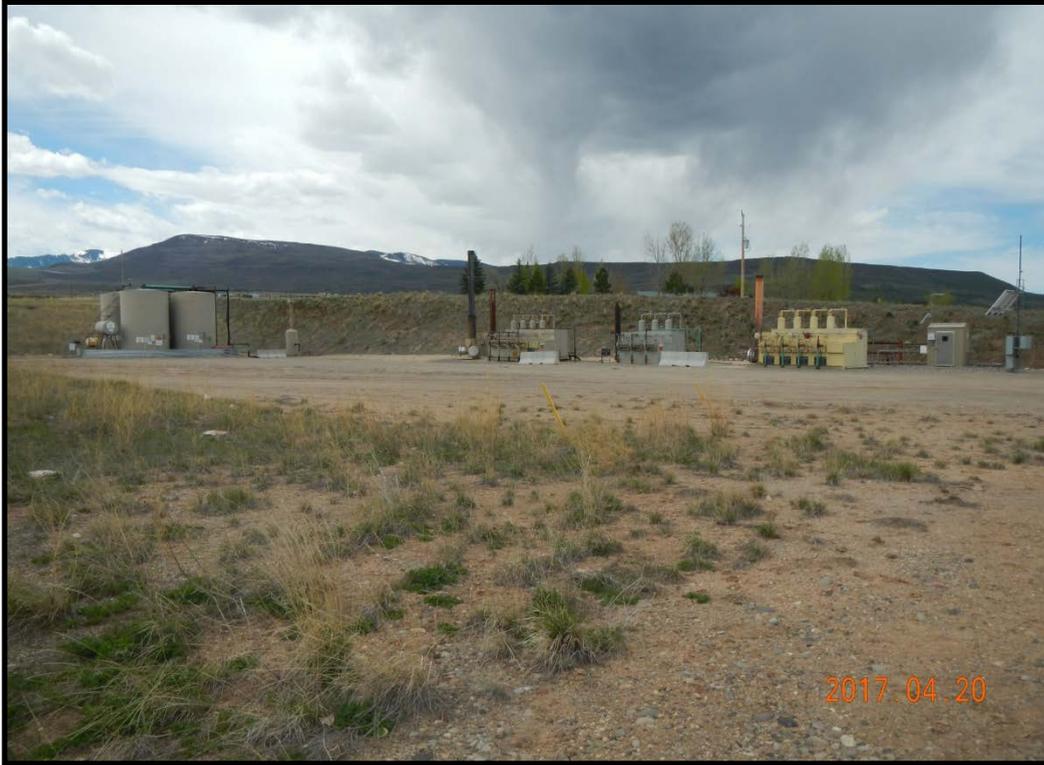
Facilities on Pad Location ID #335102) – Separators, tanks, meter house. Looking southwest. No staining, no junk, good housekeeping.

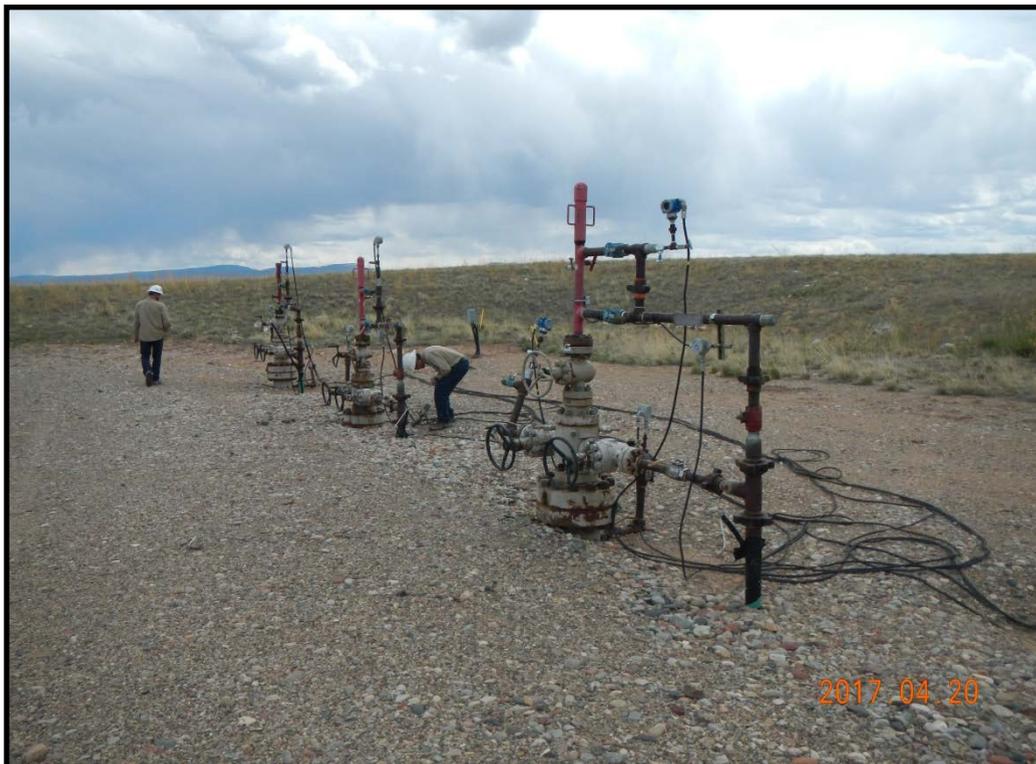
Inspecting well heads. Bradenhead pressure zero on all wells. No staining observed. Looking east-southeast.

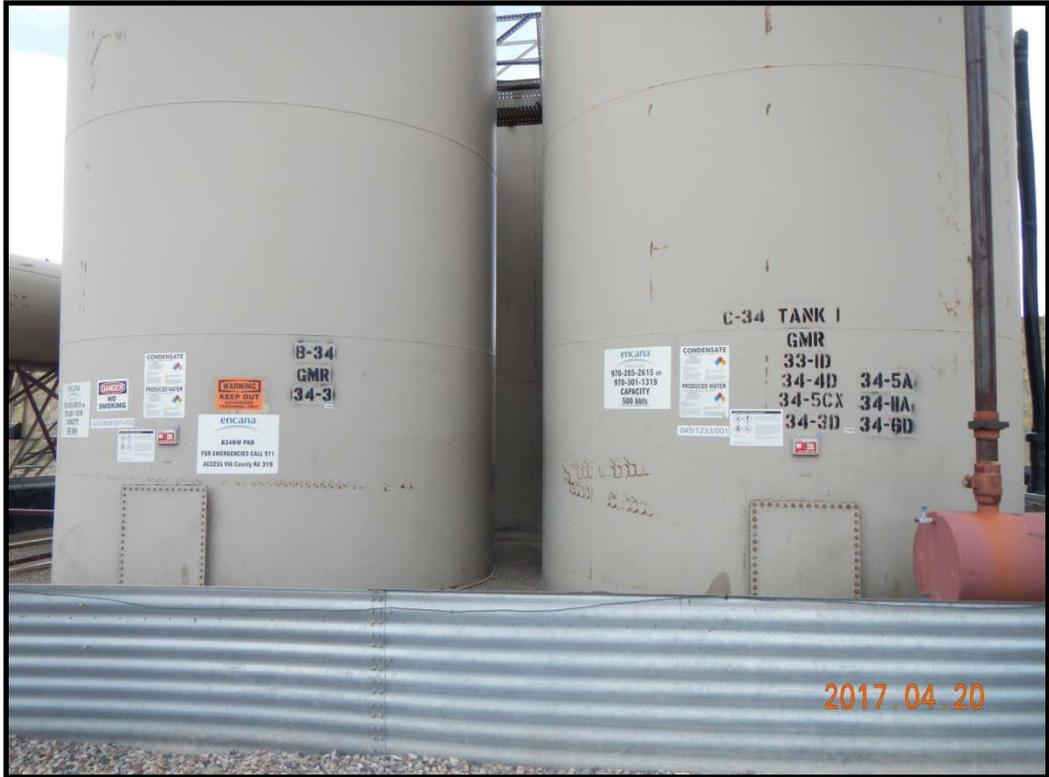
Four Condensate/Produced Water tanks (500 bbls each). Signs in place. Lined secondary containment.

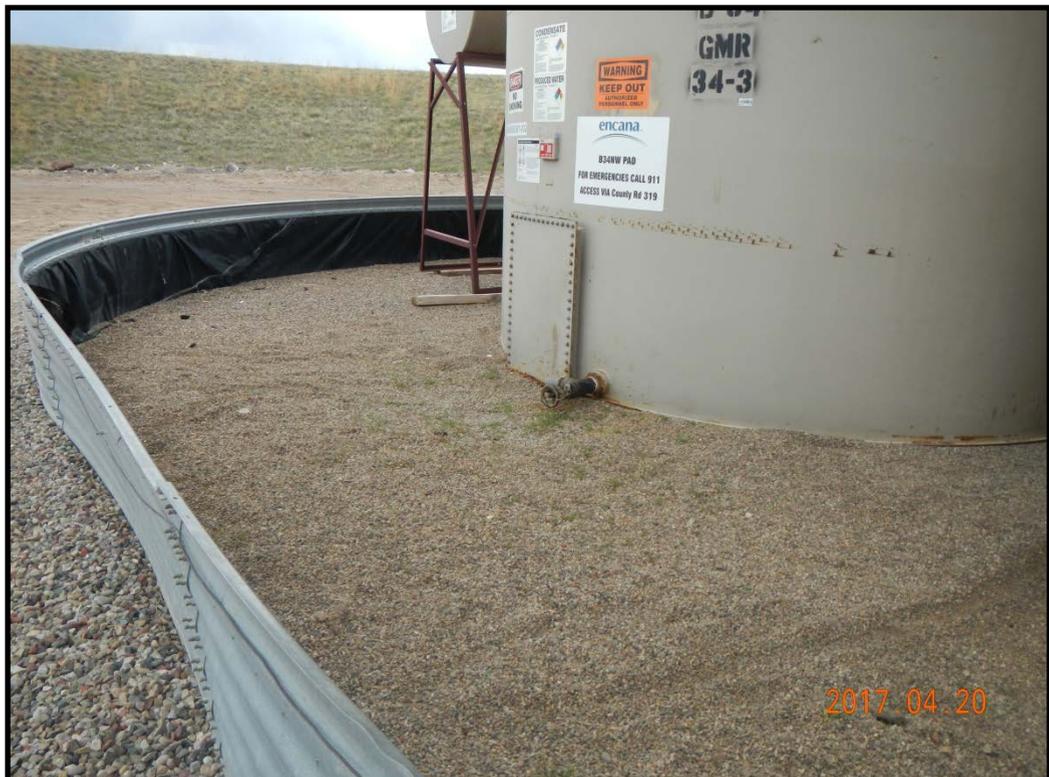
No signs of staining within the secondary containment.

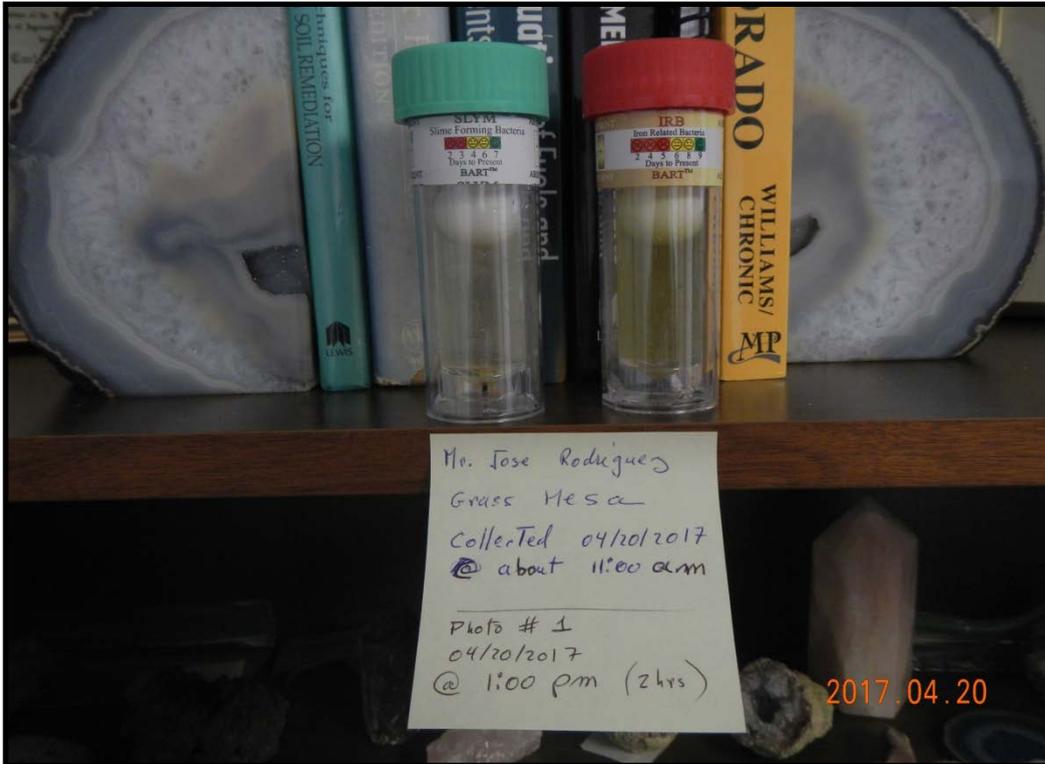
BART analysis for slime and iron bacteria. Very light yellow color observed on the iron sample, 2 hours after sample was taken.

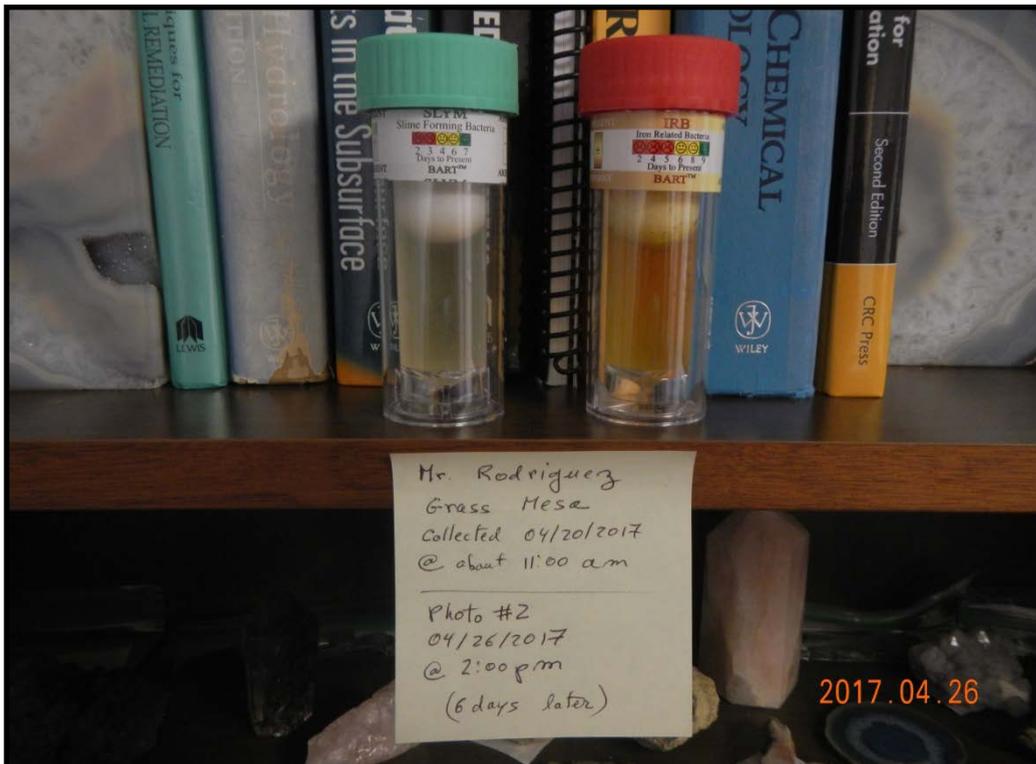
BART analysis for slime and iron bacteria. Yellow color observed on the iron sample after 6 days. Actual color is lighter than photo. Cloudy water on the slime sample.
