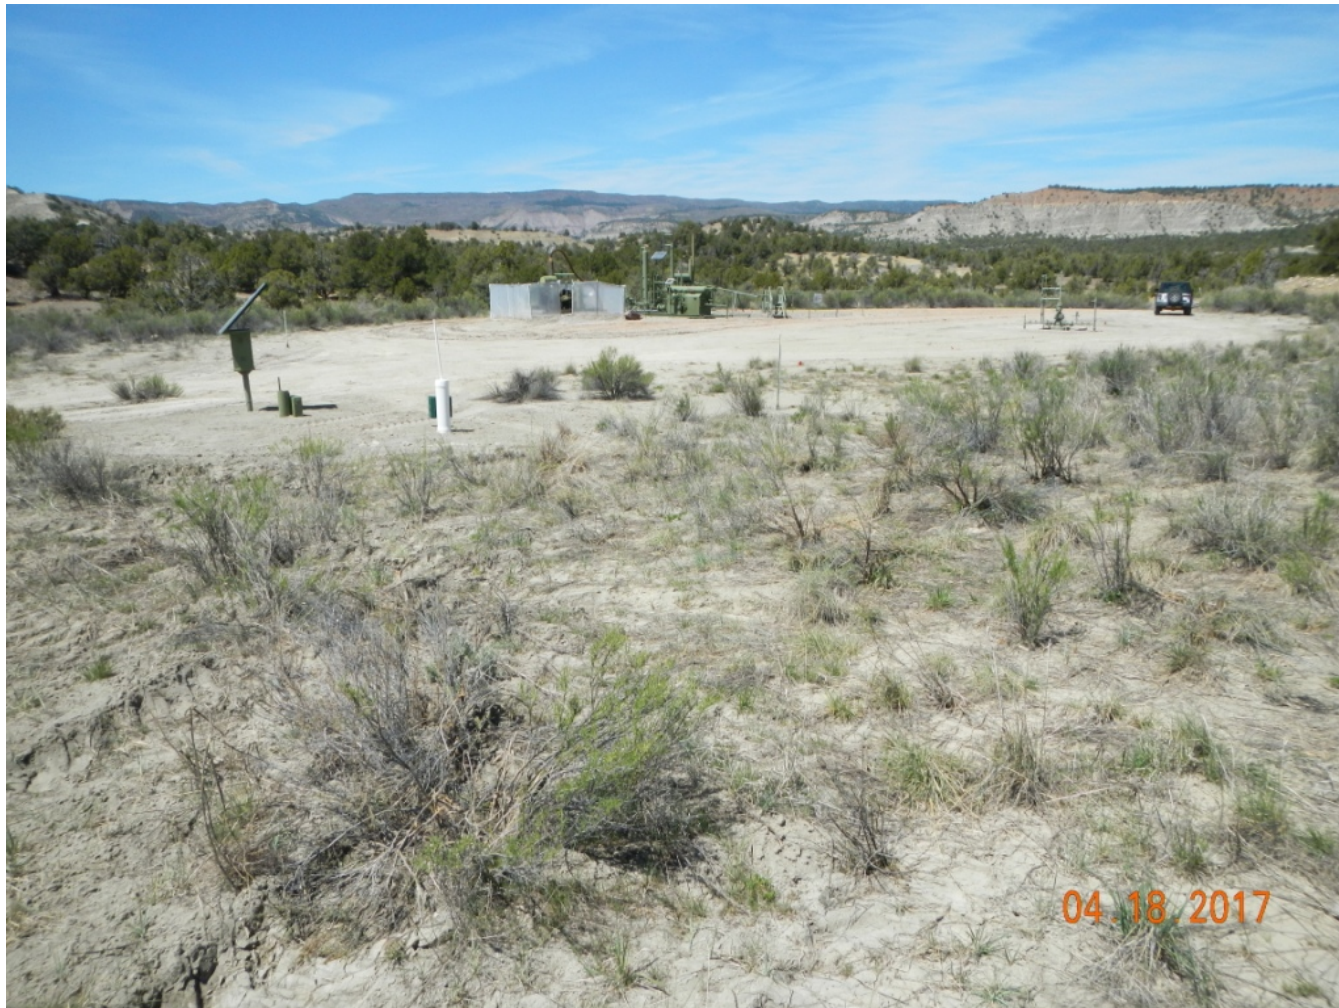
Photo 1: View of the project area from the southeastern corner facing center. Equipment has left deep ruts and damaged vegetation within the southeastern portion of the project area (lower left corner of photo).

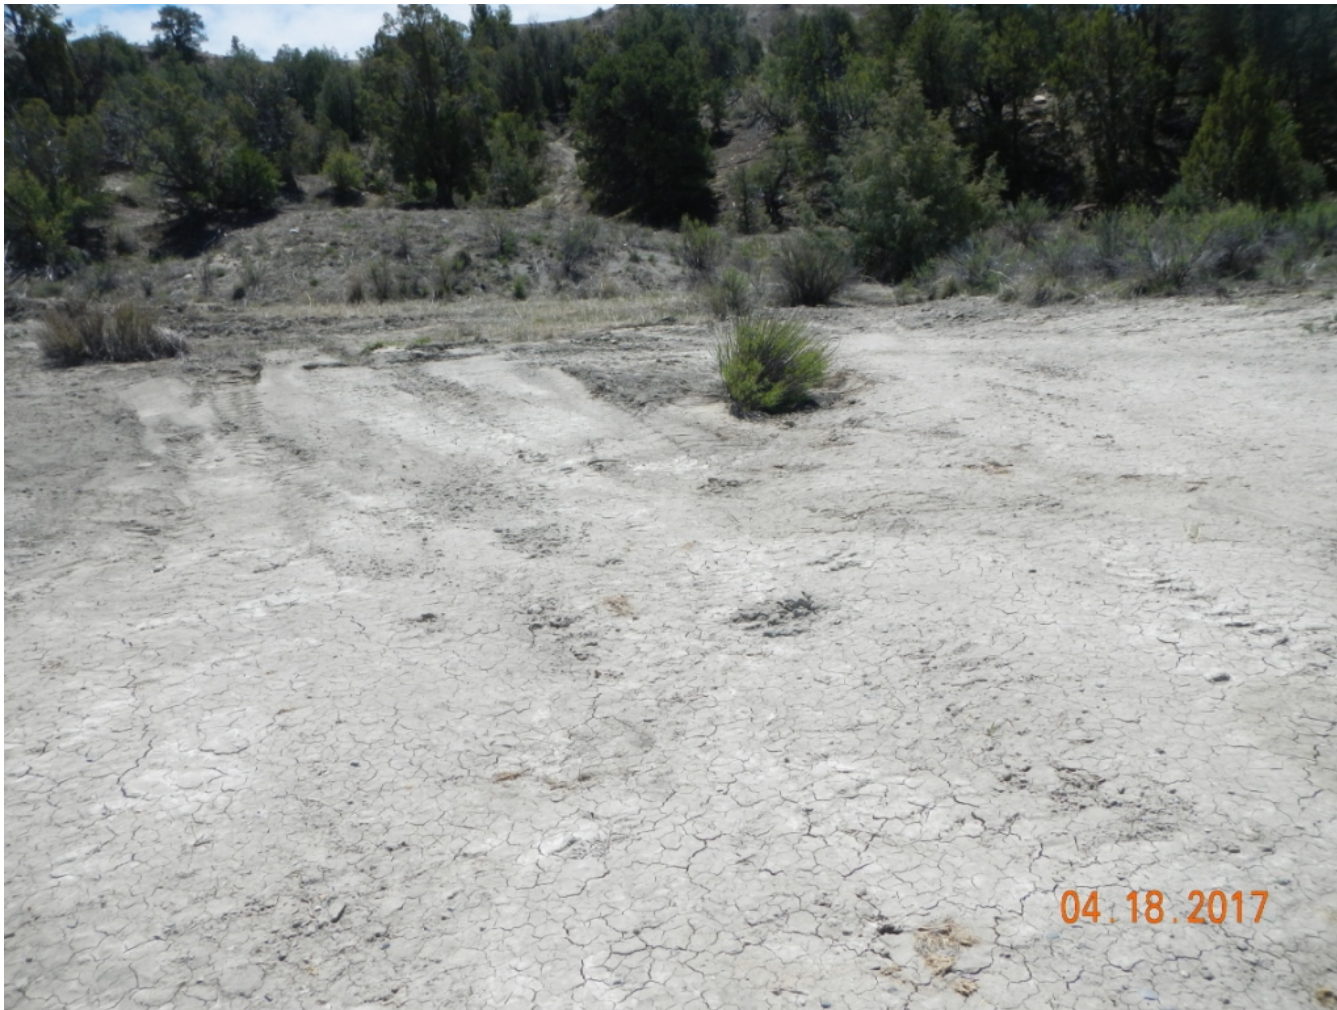
Photo 2: View of the southeastern portion of the working area where erosional channel is filled. Vegetation has been damaged and removed, and bare areas need revegetation.

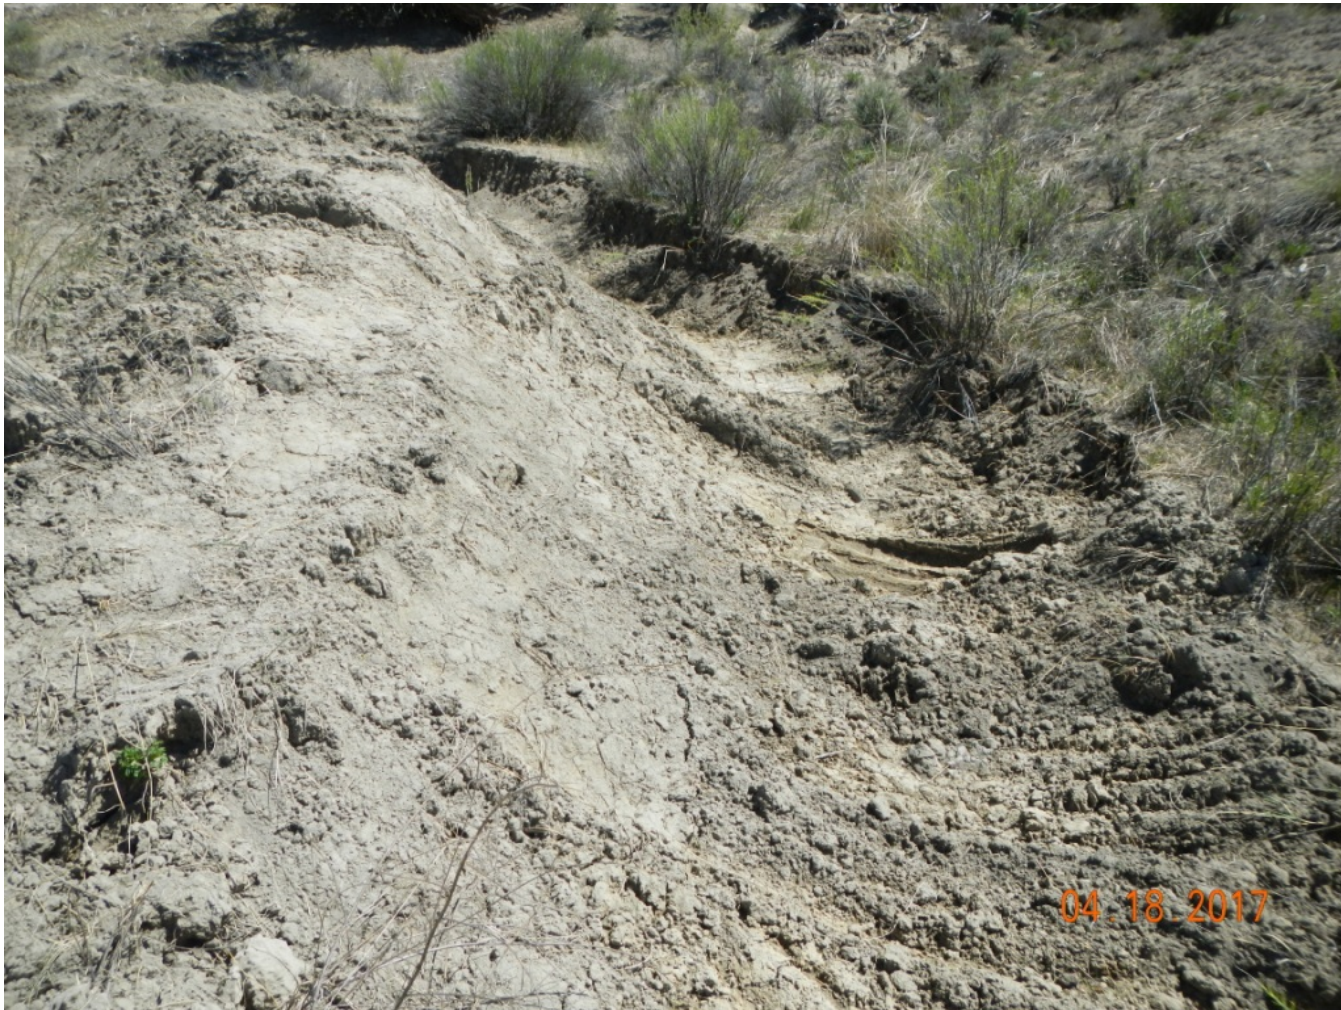
Photo 3: View of diversion channel that was recently graded. Soil is not stabilized and needs to be stabilized with erosion and sediment controls (i.e. vegetation and check dams).

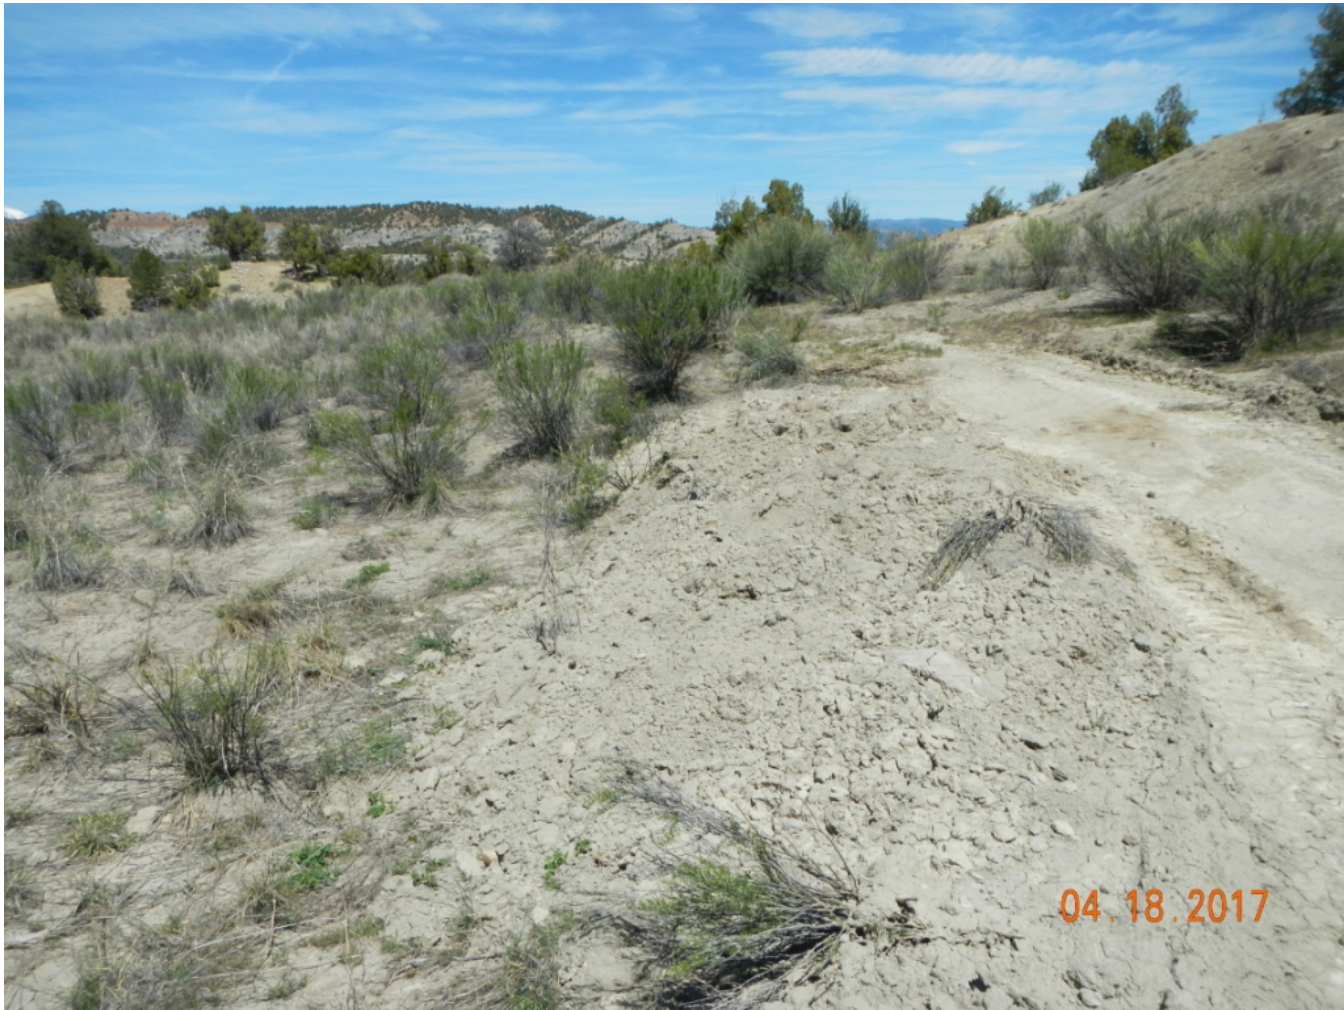
Photo 4: View of disturbed vegetation and loose soil along the southeastern edge of the project area.

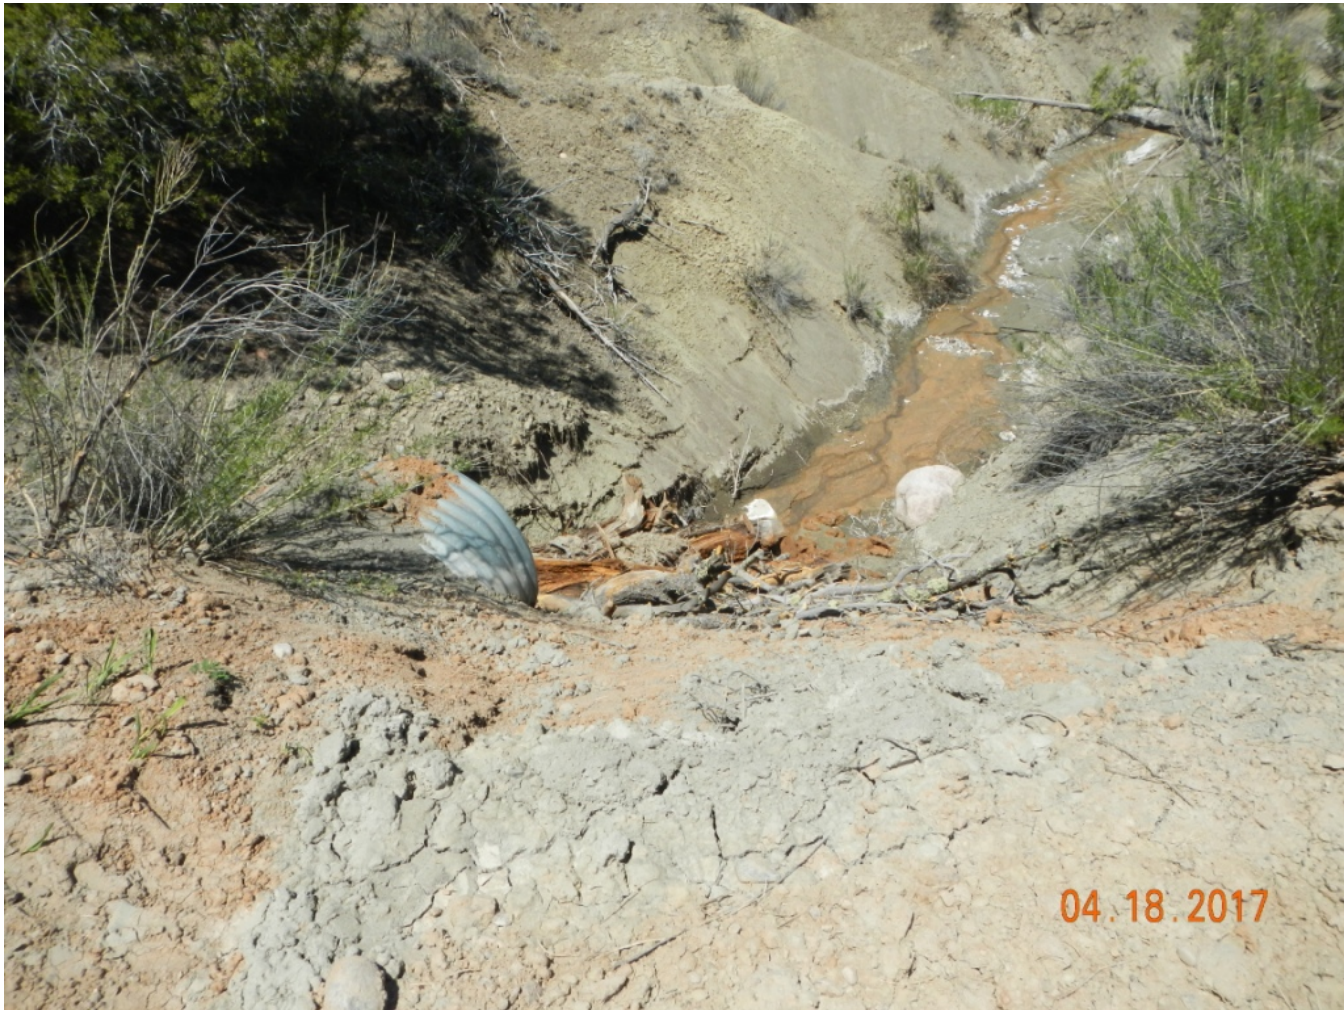
Photo 5: View of area at culvert along access road where erosional channel was filled with soil but is not stabilized.

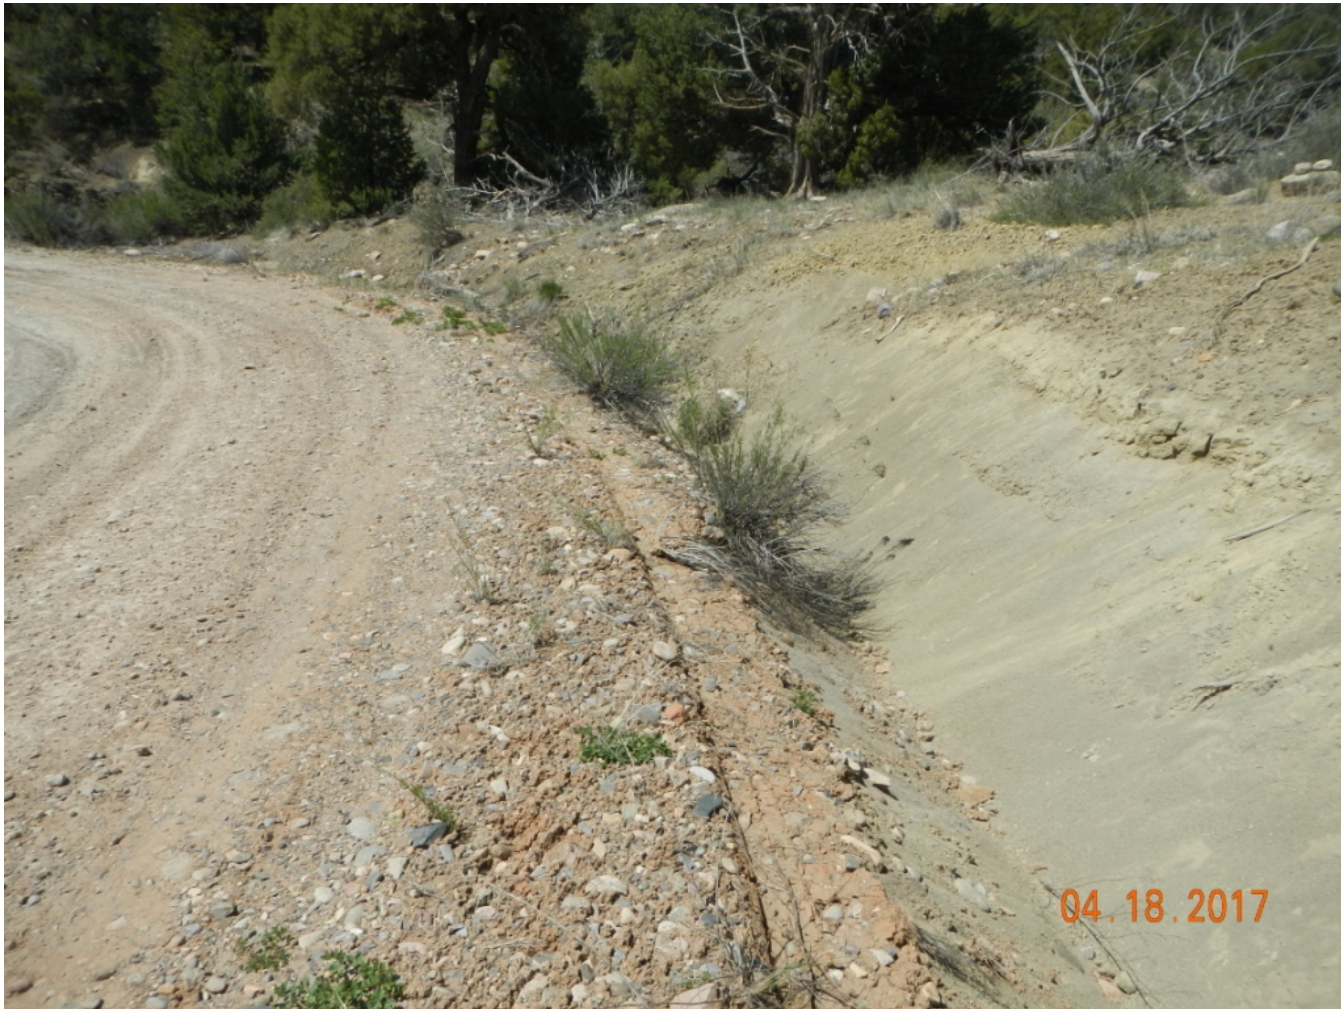
Photo 6: View of drainage along northern edge of access that was recently scraped. Soils are exposed and no sediment controls are in place.

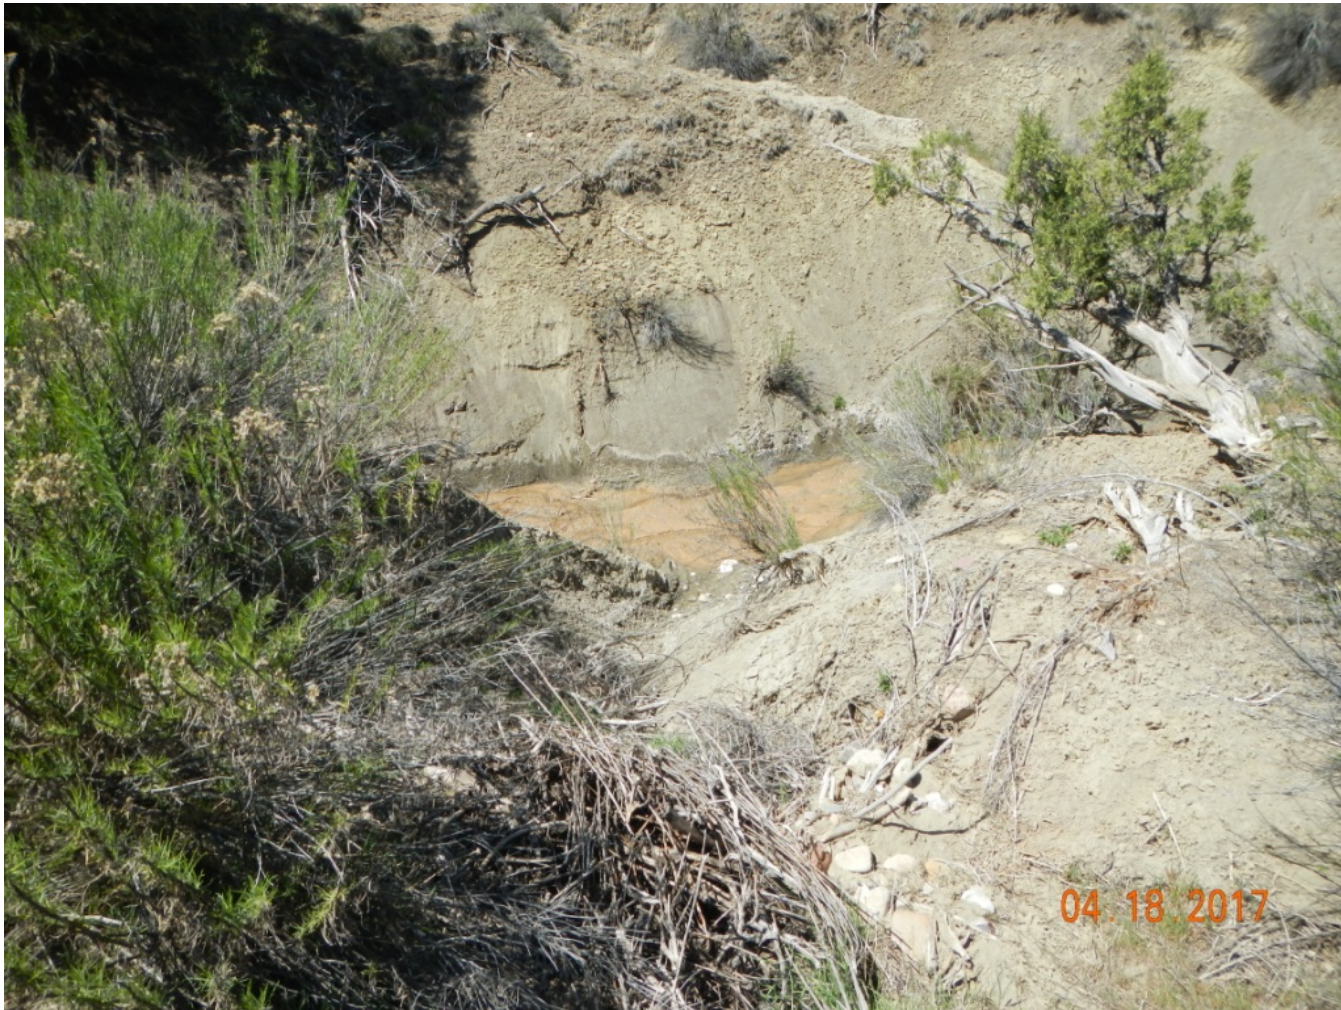
Photo 7: View of area where stormwater flows from the roadside drainage in Photo 6 into a stream, and is eroding the bank.

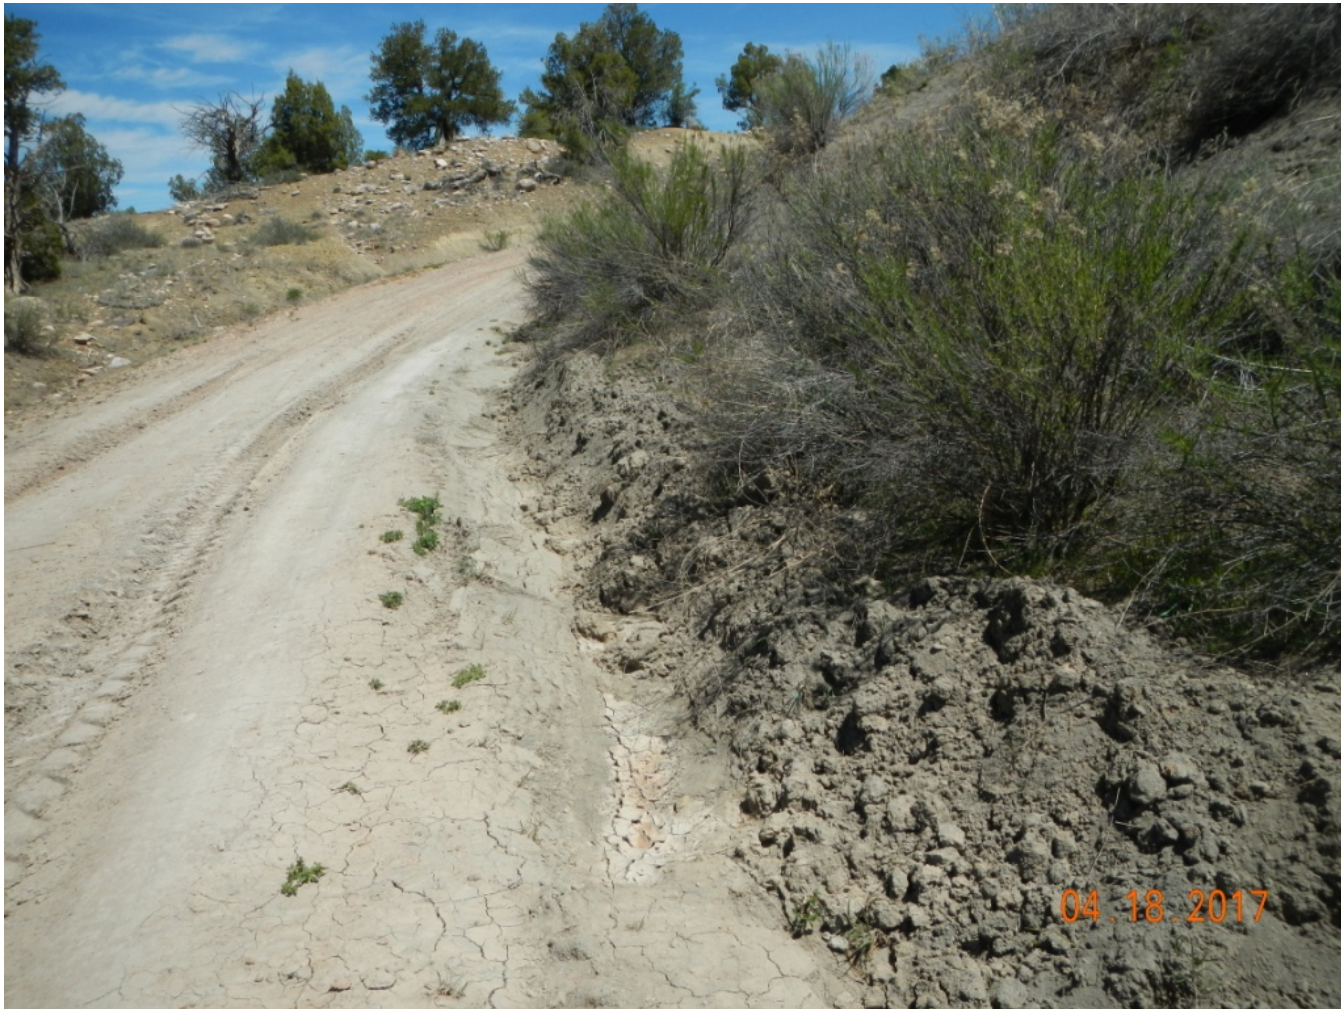
Photo 8: View of drainage along southern edge of access that was recently scraped. Soils are exposed and no sediment controls are in place.

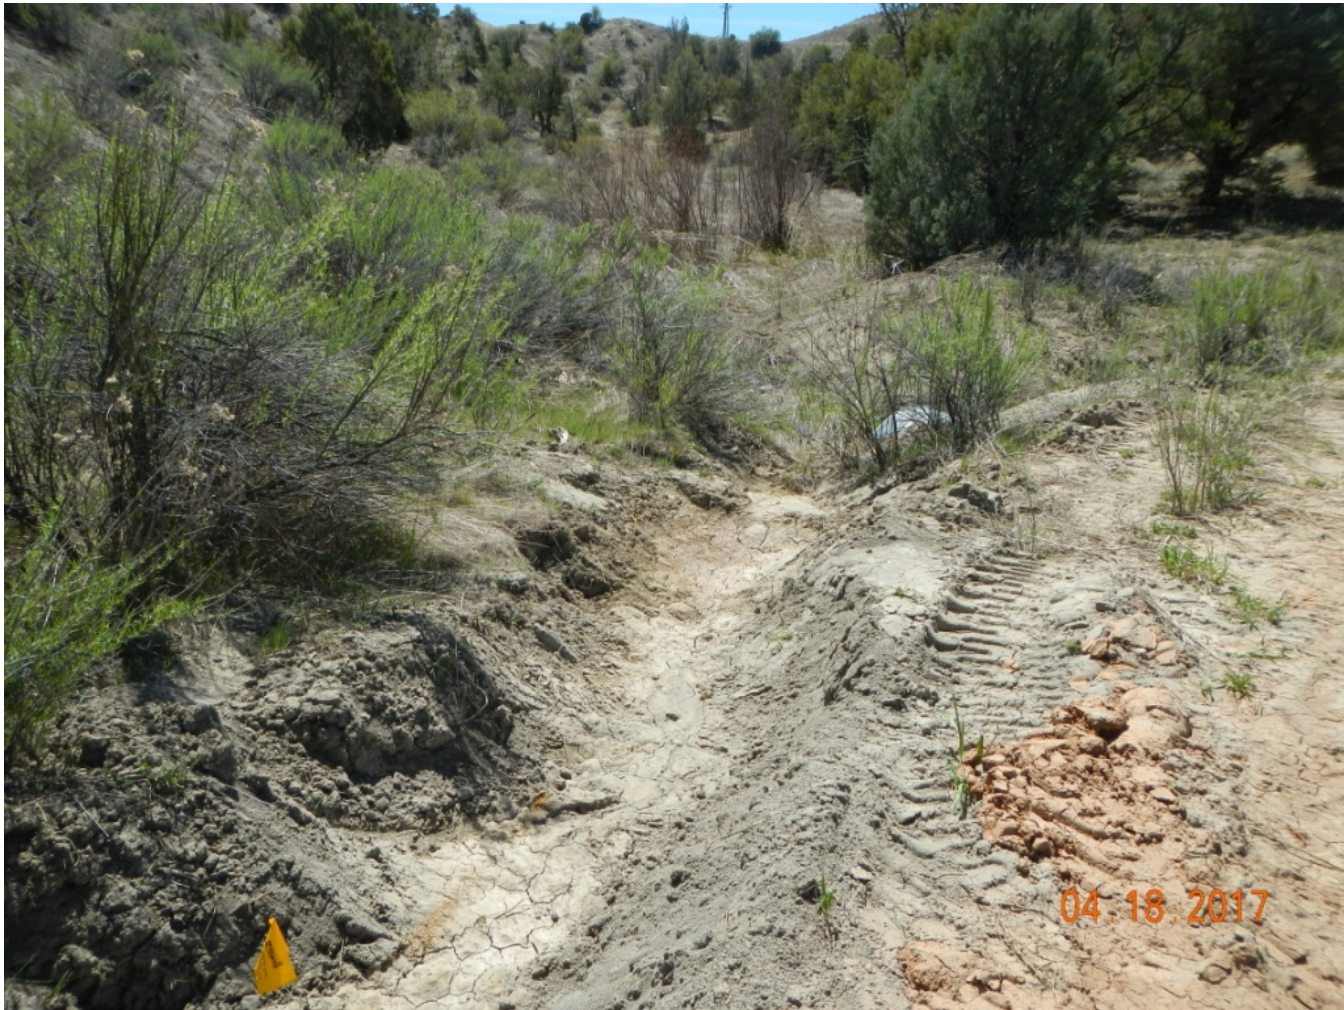
Photo 9: View of area where stormwater flows from the roadside ditch in Photo 8 into a stream and is eroding the bank. Soils are exposed and no erosion or sediment controls are in place.
